Peace of Mind Automotive Inspection Report.

Site conducted	Unanswered
Customer name	Luis Imj auto motor sales
Date / Time	Dec 26th
Payment method	Invoice
Inspection cost	Fleet
Vehicle Year / Make / Model / Color	2013 ford f250 with fenced truck bed
VIN	36317 last 5
	Photo 1
license plate	Dealer
Mileage	95427
Color	White

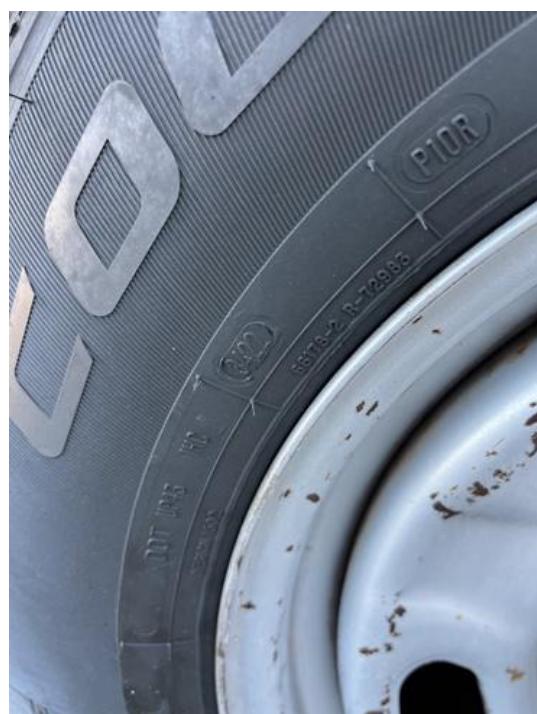
Photo 114

The front driver side tire and both rear tires are matching with right around 75% tread life remaining

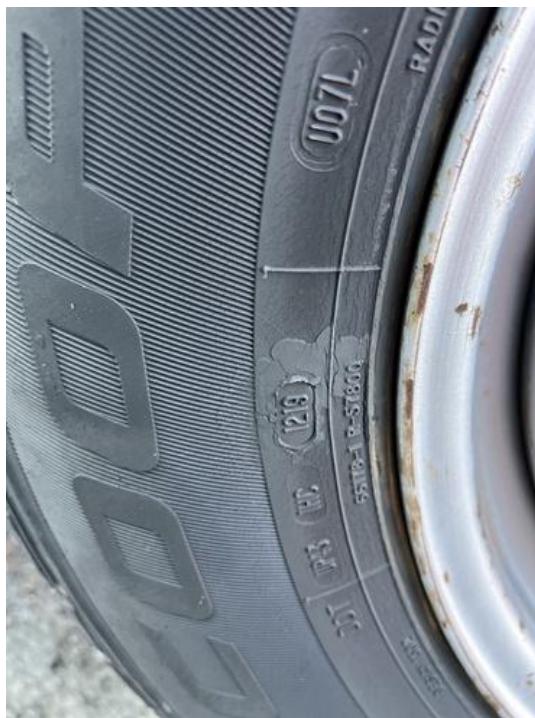
Photo 117

This tire is a bit older than the other three tires, this tire has right around 50% tread life remaining

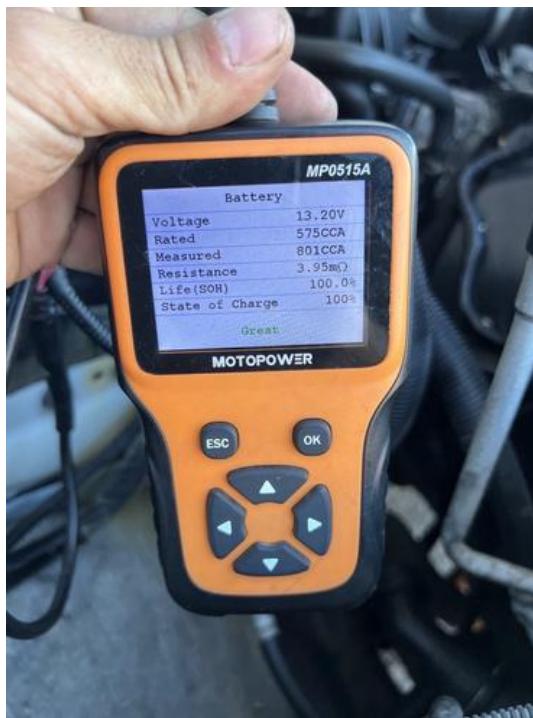
Photo 129

Standing voltage 13.20

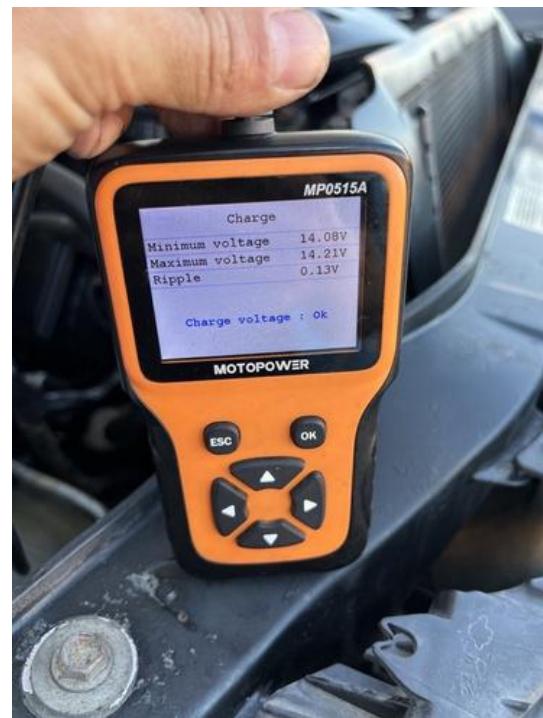
Photo 130

Loaded voltage 14.08

Battery is accepting the charge from the alternator and the alternator charge output is correct

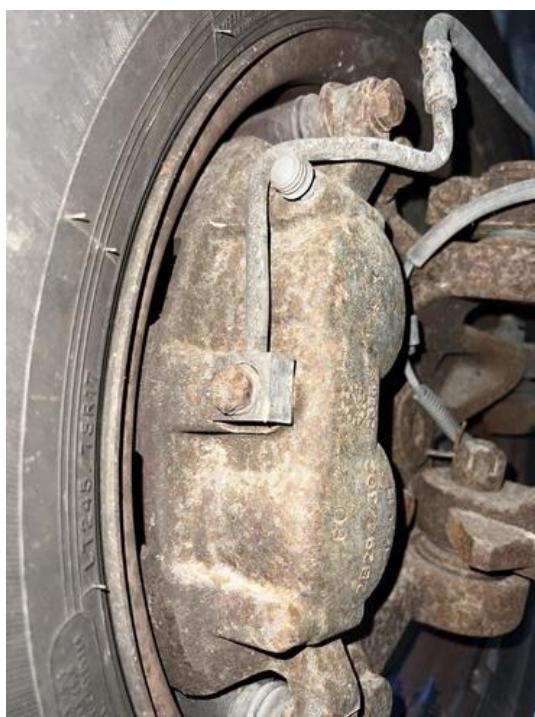
Photo 179

Right around 40% brake pad life remaining

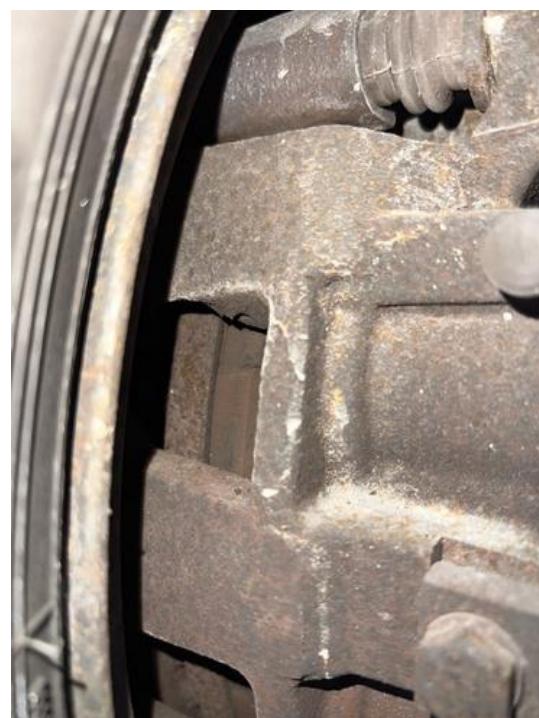
Photo 182

Right about 60% brake pad life remaining

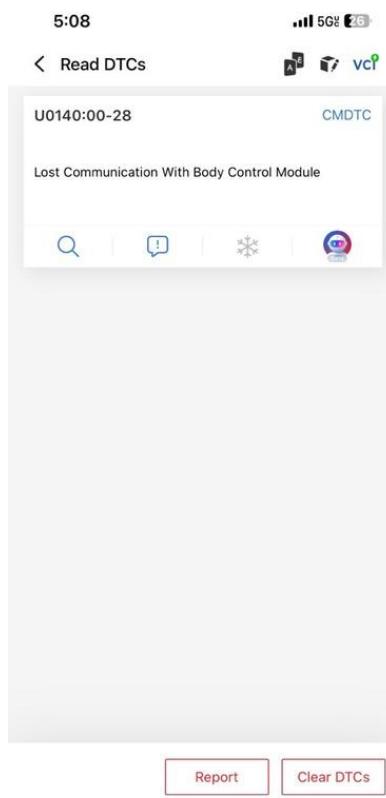
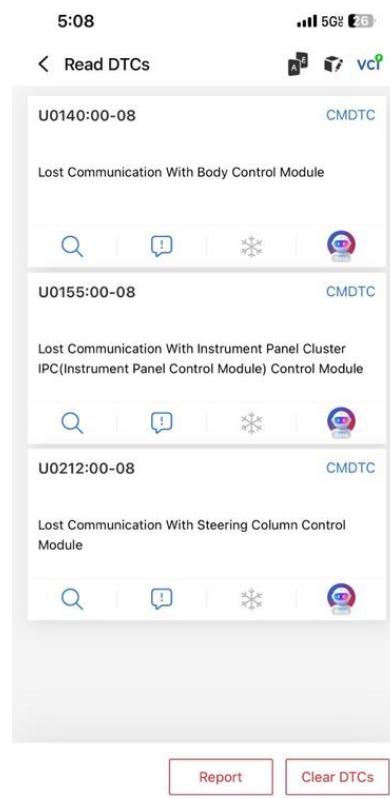
Photo 185

All of the control modules on the vehicle were free of any live/active diagnostic fault codes. There were a few different historical fault codes present across various control modules on the vehicle. None of these codes were live/active and are not of any current concern.
