## Peace of Mind Automotive Inspection Report.

**Complete**

| Score | 4 / 4 (100%) | Flagged items | 0 | Actions | 0 |
|---|---|---|---|---|---|
| Vehicle Year / Make / Model / Color | | 2013 Honda fit | | | |

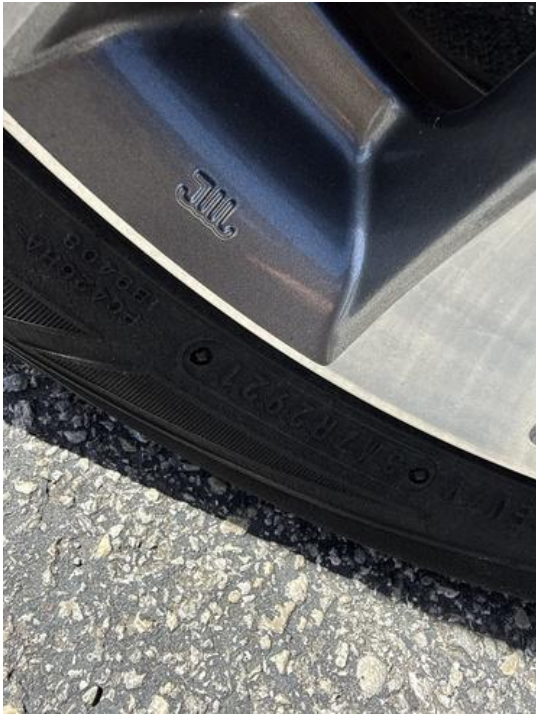
Photo 81

All four tires are matching. Tires are dated from 2021. Tires have right around 75% tread light remaining all around and are evenly worn.

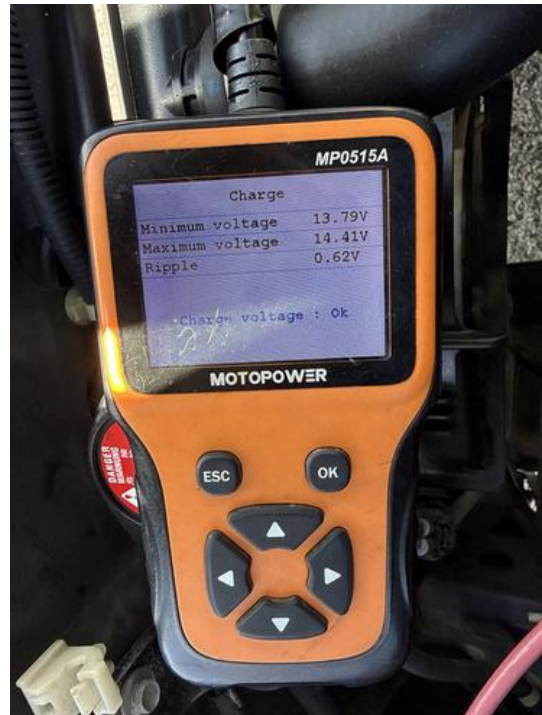
Photo 90

Battery is accepting the charge from the alternator and the alternator charge output is correct

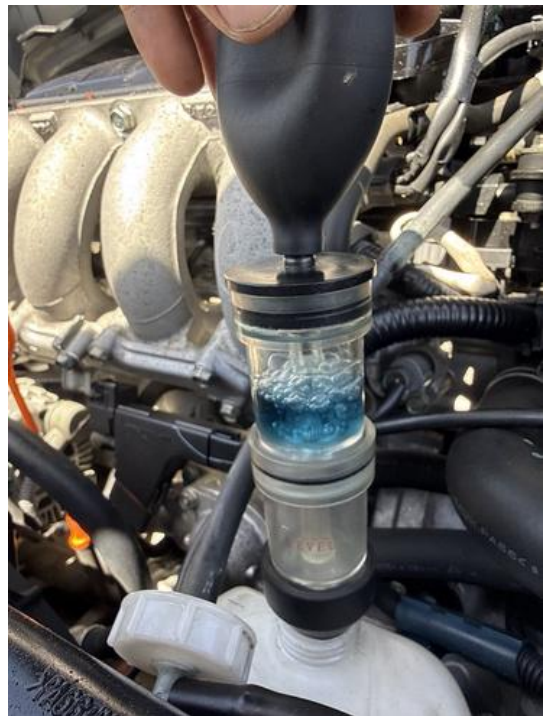
Photo 104

Pass

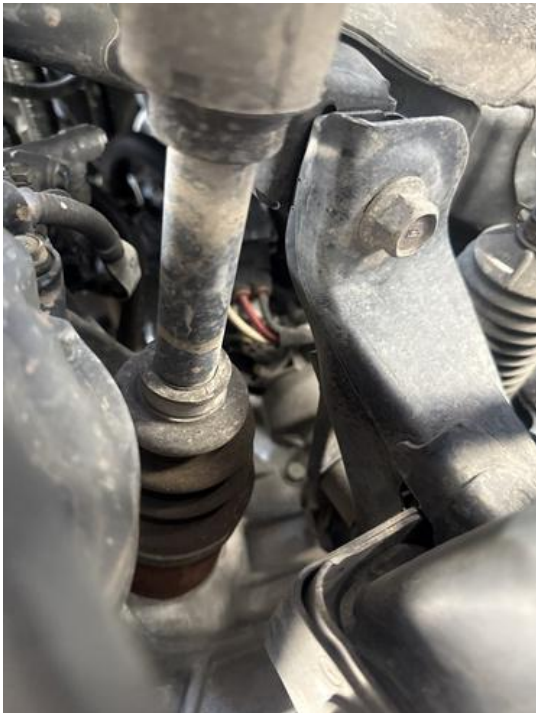
Photo 107

No transmission fluid leaks from the transmission casing. Both the left and right side axle seals are free of any fluid leaks. Both the left and right side CV axle are in healthy condition. Shift transition out on the road are correct.

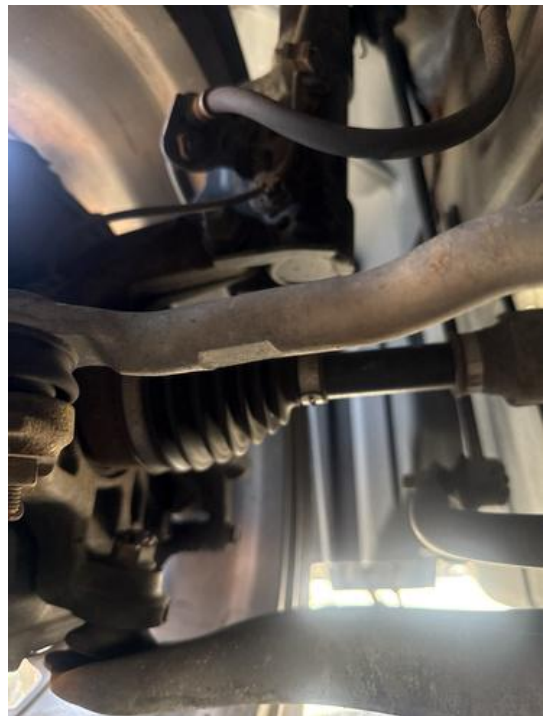
Photo 112

Normal fatigue notice to the suspension components. All of the suspension components seem to be original. None of the suspension components are blown out and due form the replacement. The No excessive surface rust on the exposed metal. No abnormal noise or feedback from the suspension while out on the road. All of the rubber in relation to the mounts, joints and bushings has decent texture.

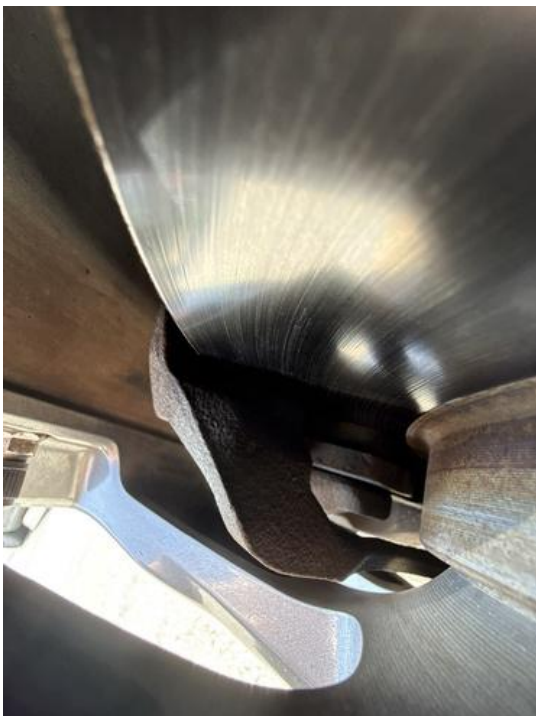
Photo 123

| Braking system condition | |
|---|---|
| Right about 75% brake pad life remaining | |

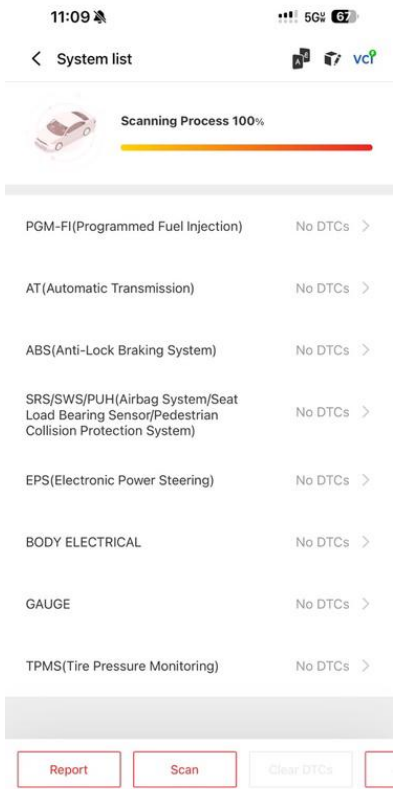
Photo 125

At the time of the inspection, there were no active warning lights present. All of the live feed diagnostic test testing was successfully passed. All of the live feed emission test testing was successfully passed.
