Peace of Mind Automotive Inspection Report.

Score	4 / 4 (100%)	Flagged items	0	Actions	0
Site conducted					Unanswered
Customer name					Luis Imj auto motor sales
Date / Time					June 2nd
Payment method					Invoice
Inspection cost					Fleet
Vehicle Year / Make / Model / Color					2013 Honda civic
VIN					74608 last 5

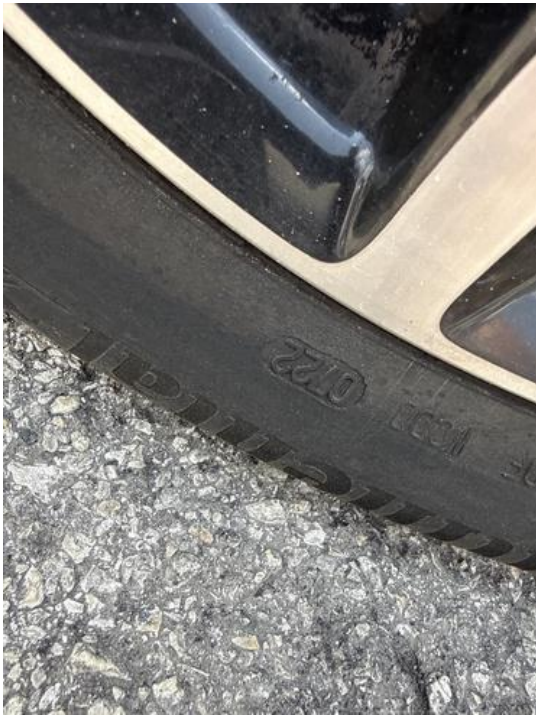
Photo 81

Front driver side tire

75-100% remaining

All four tires are matching and in healthy condition. Tires are dated from late 2022. All four tires are evenly worn and have right around 75% tread life remaining.

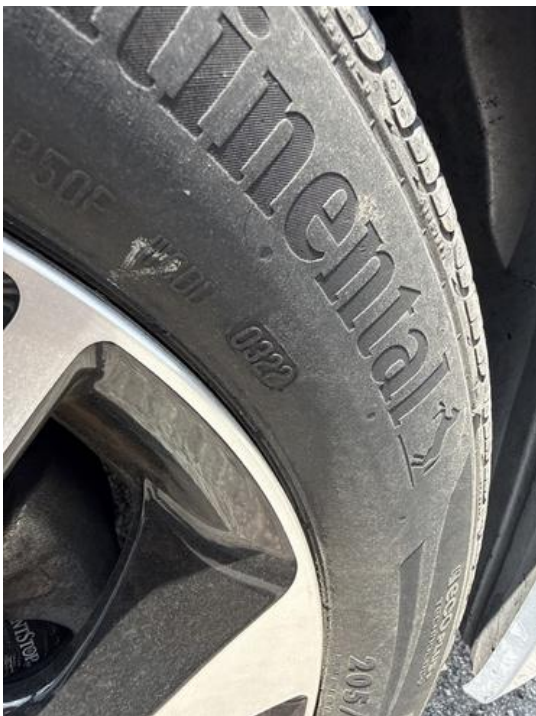
Photo 84

Front passenger side tire

75-100% remaining

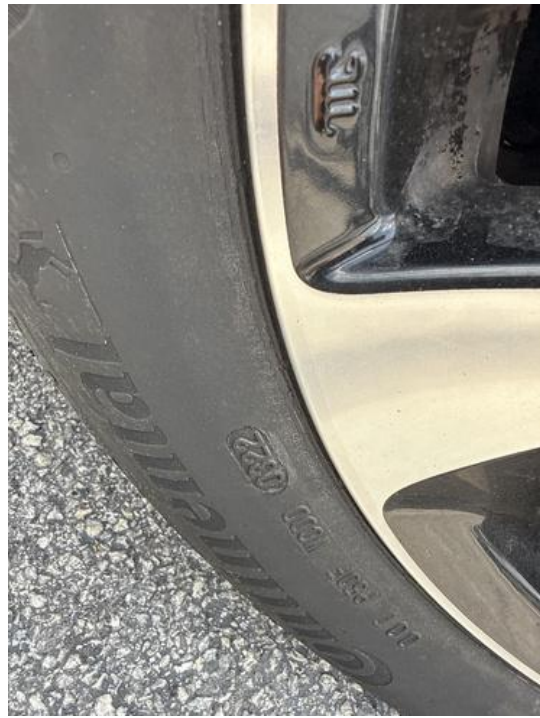
Photo 87

Rear driver side tire

75-100% remaining

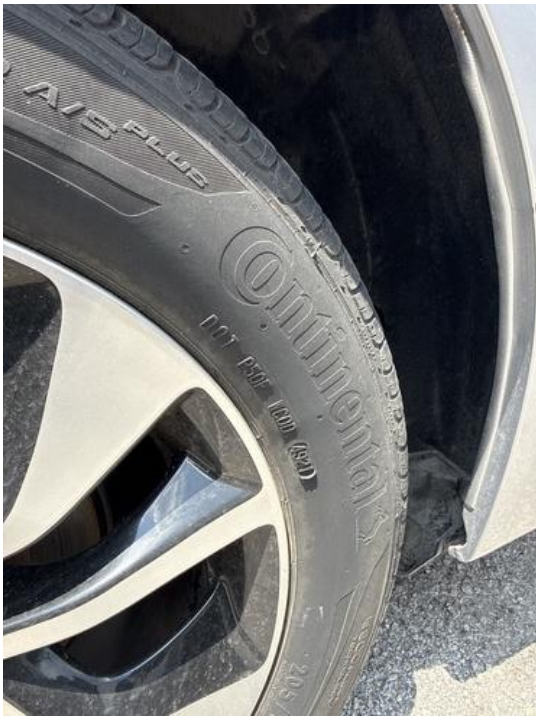
Photo 90

Rear passenger side tire

75-100% remaining

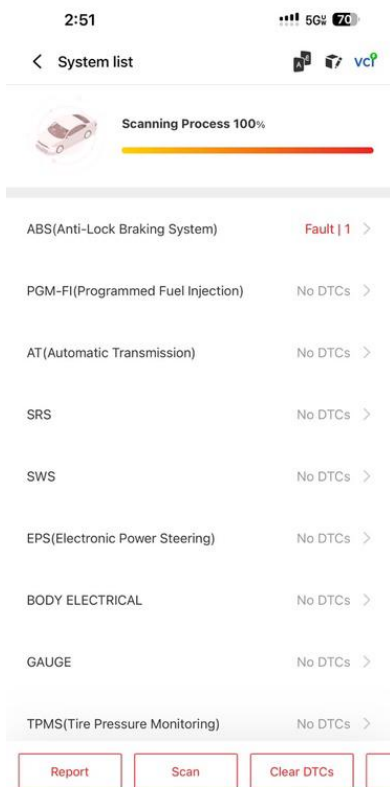
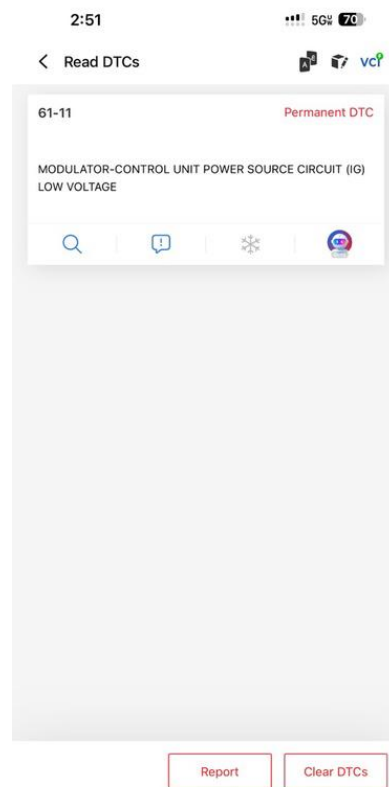
All of the main control modules on the vehicle were free of any live/active diagnostic fault codes. All live feed diagnostic test testing was successfully passed.
