## Peace of Mind Automotive Inspection Report.

**Joe Trejo Jr.**  
**210-557-0686**

| Vehicle Year / Make / Model / Color | | | | 2014 ford f150 | |

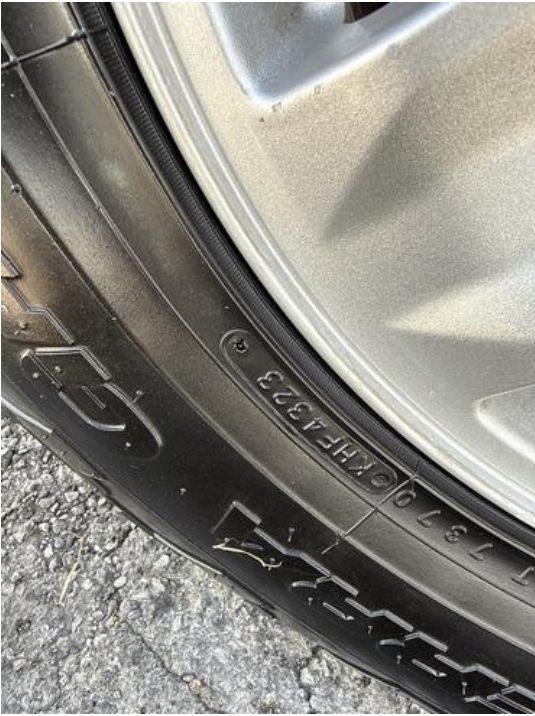
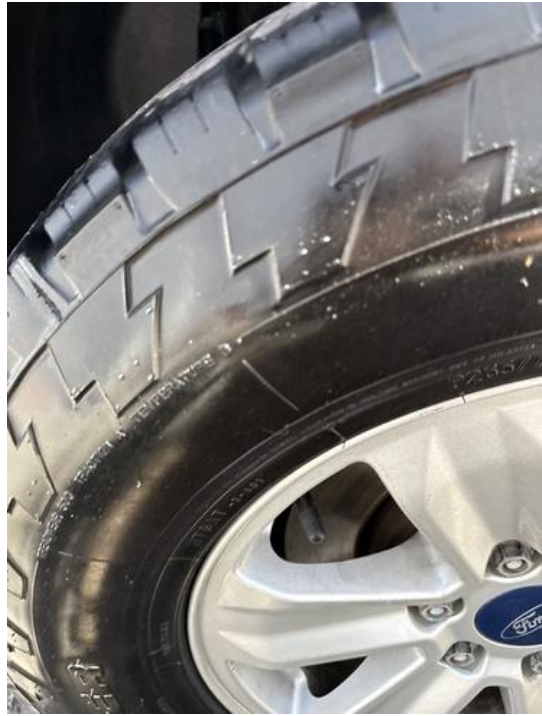
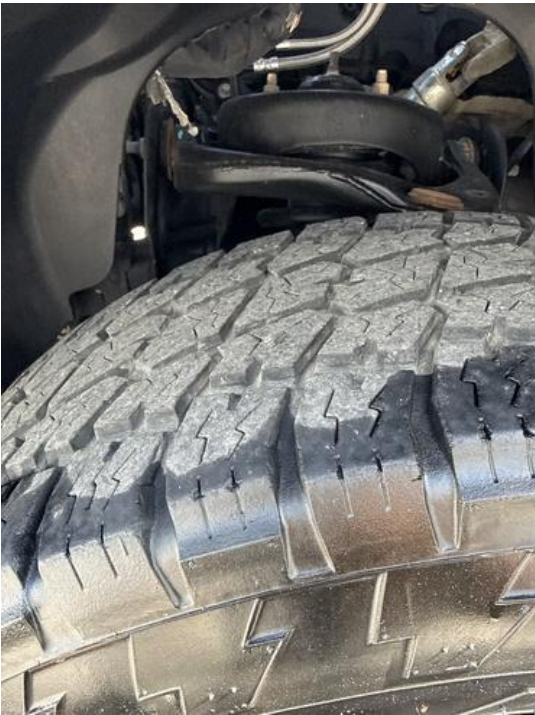
All four tires are matching. Tires are in decent condition with right about 55% tread life remaining. Tires are evenly worn and road safe.

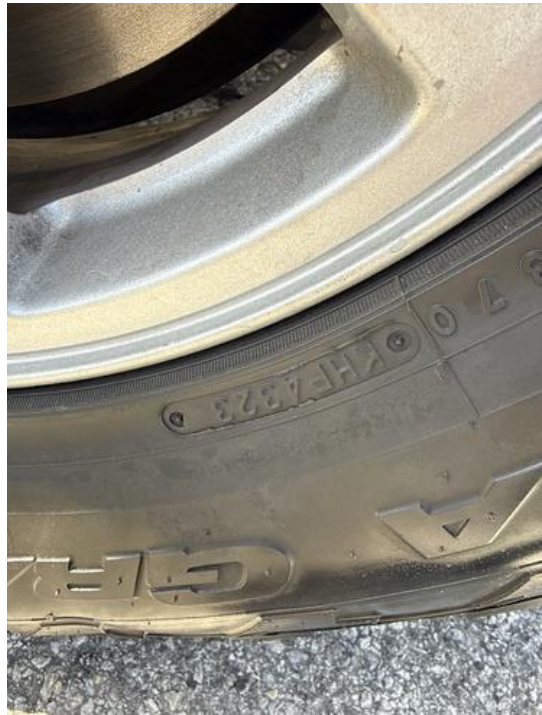
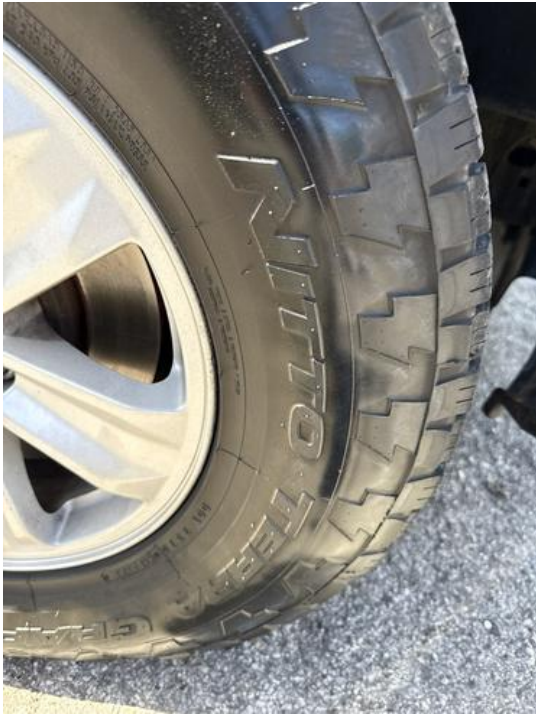
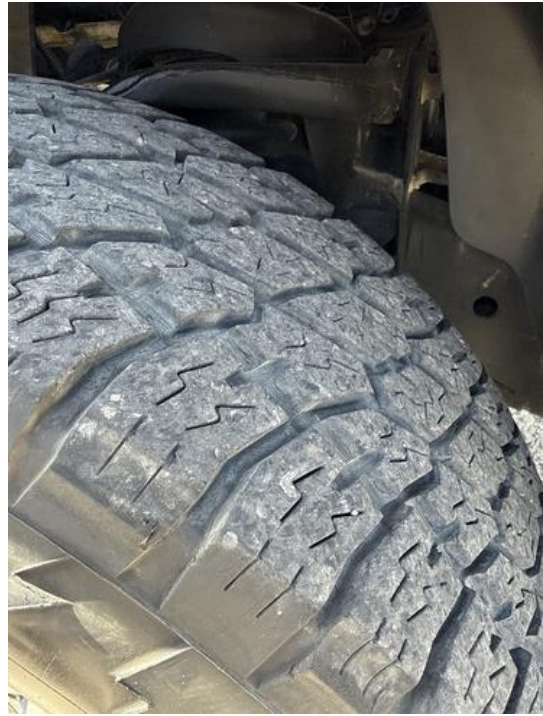
50-75% remaining

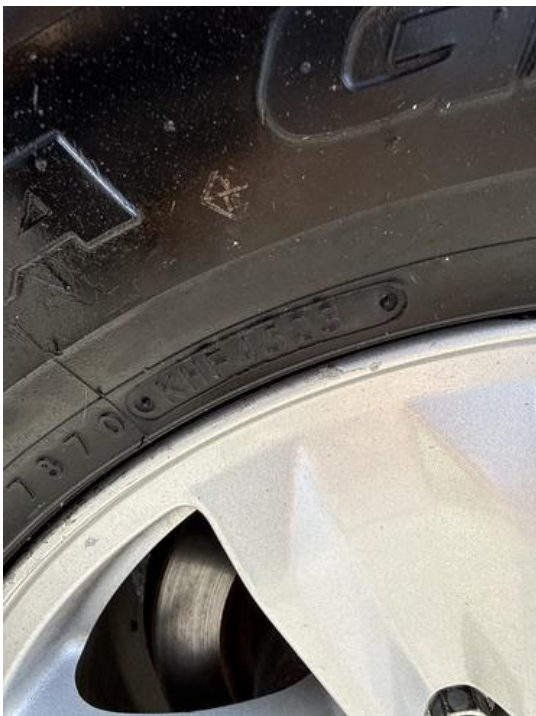
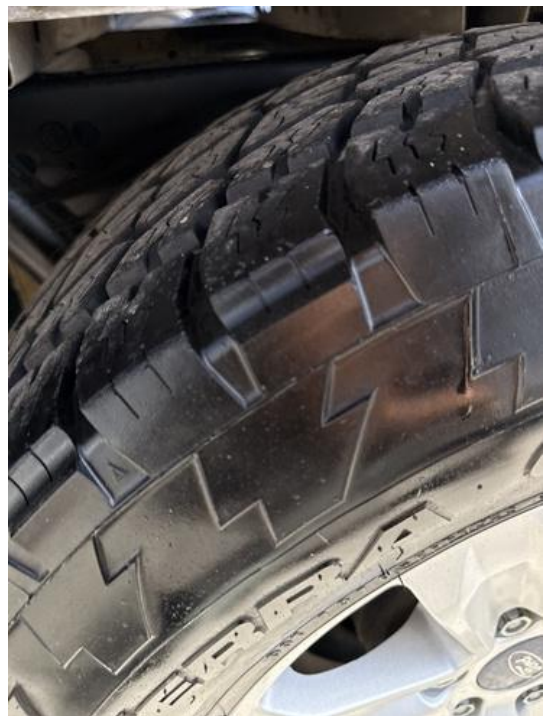
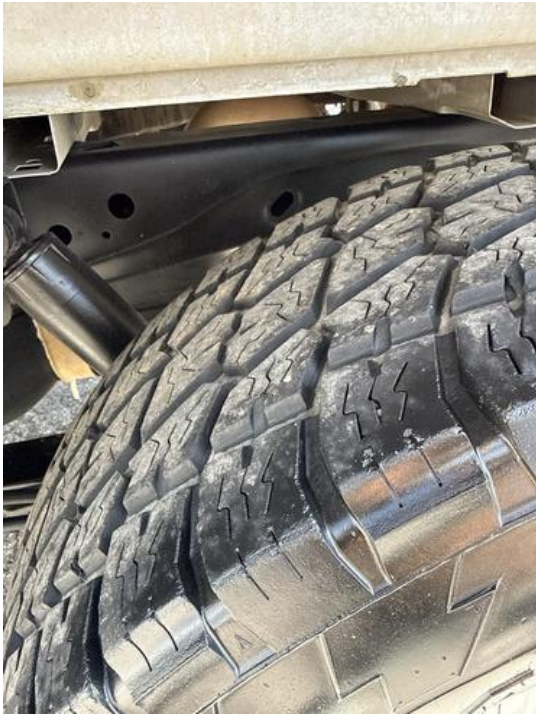
50-75% remaining

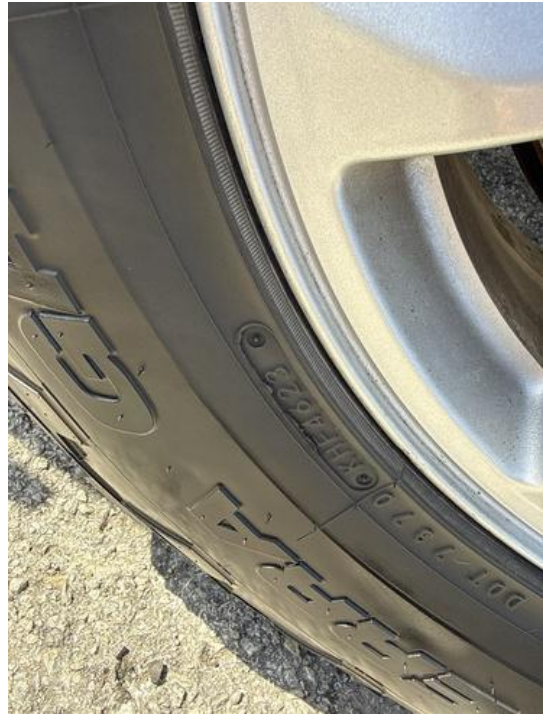
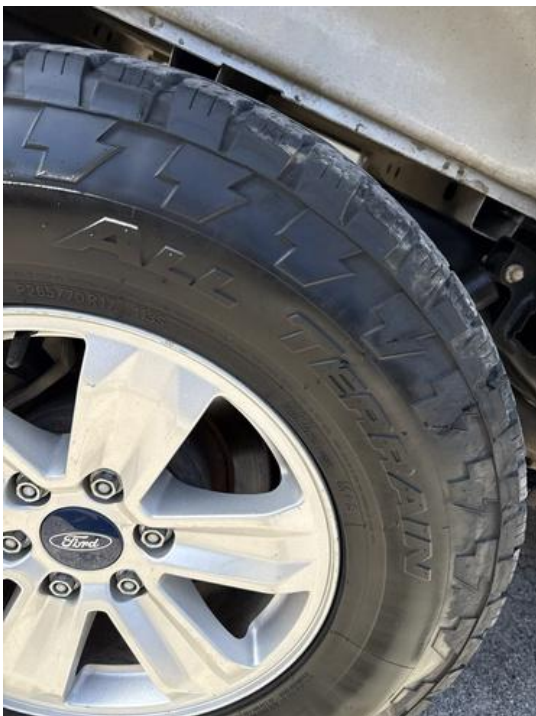
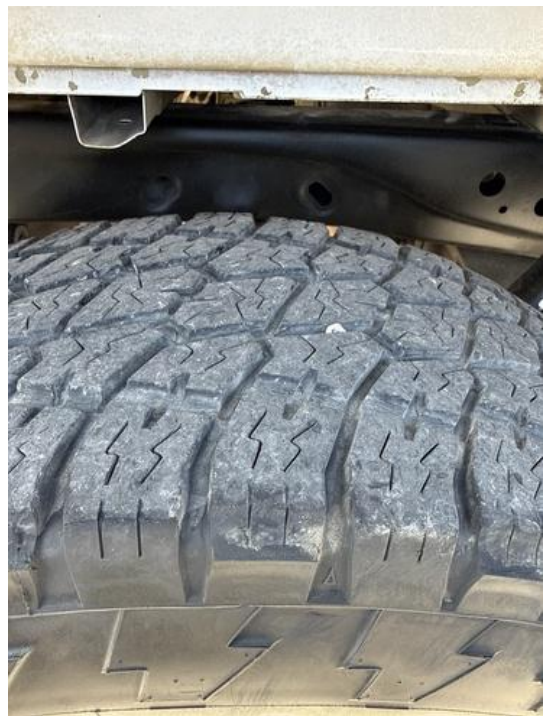
50-75% remaining

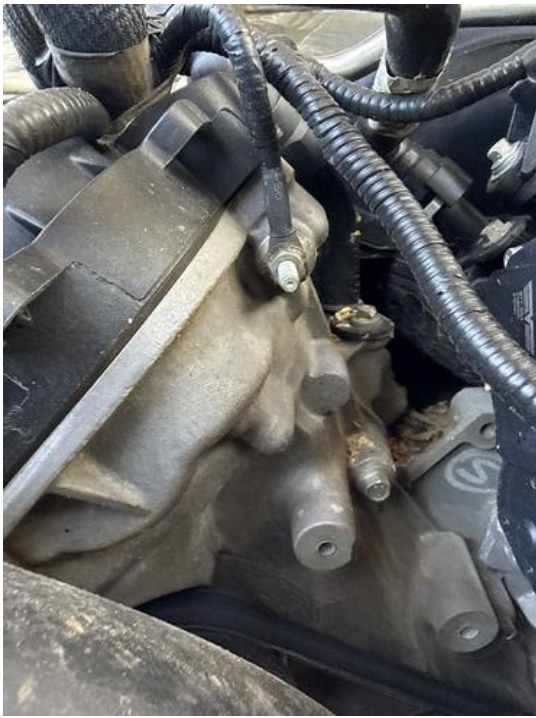
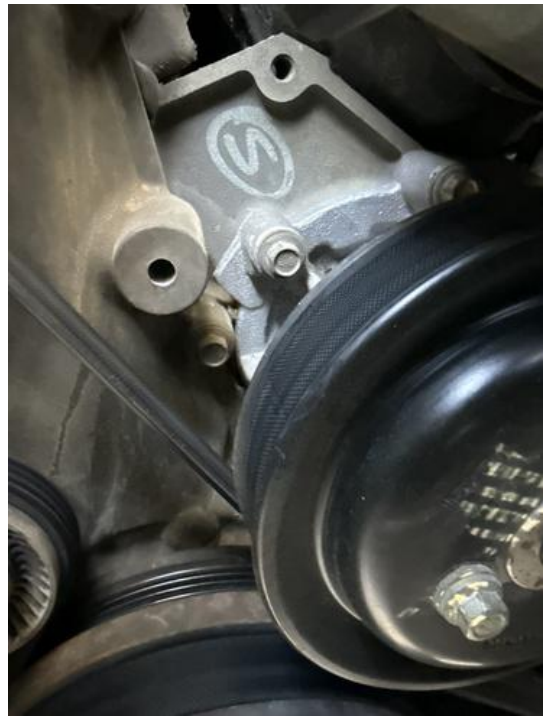
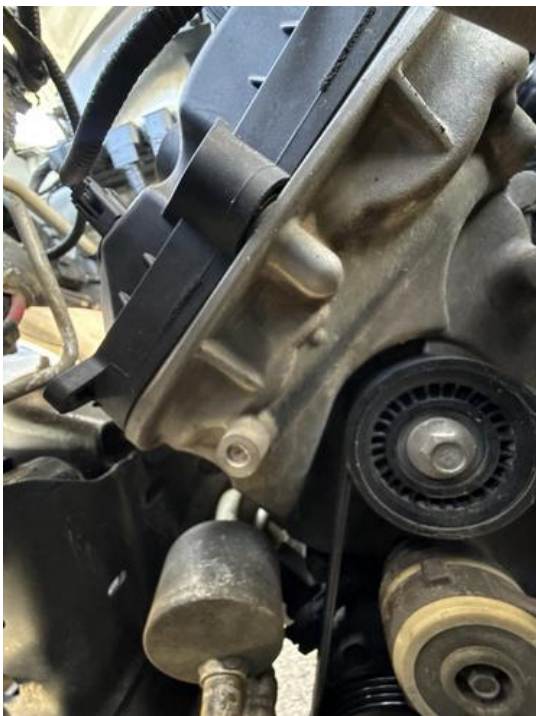
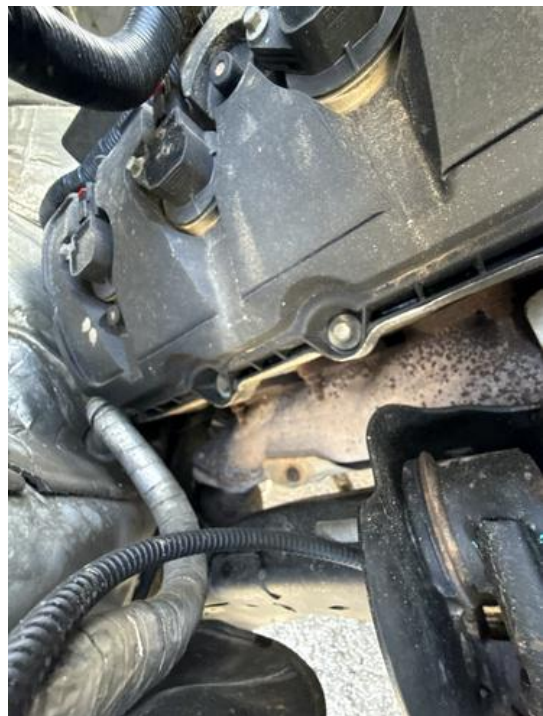
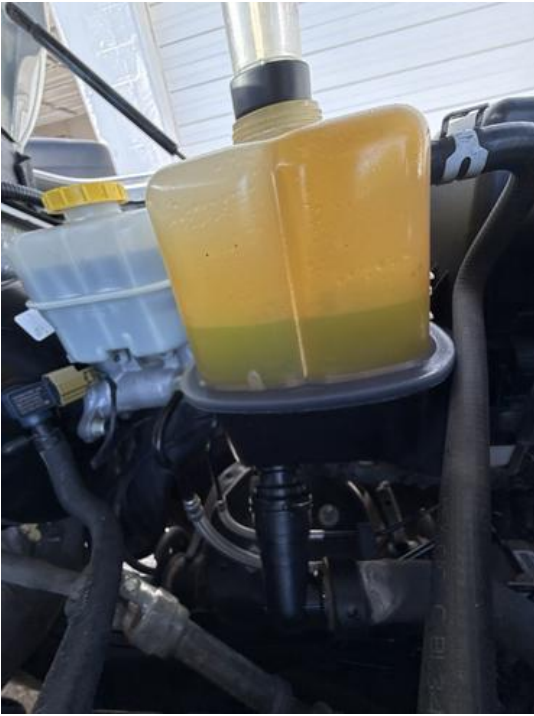
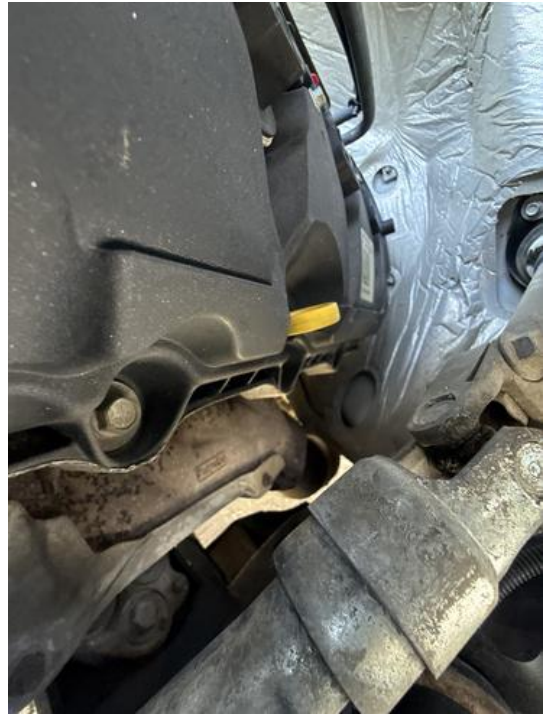
Engine clean internally, no gunk or sludge presents. Proper signs of maintenance present. Block test passed, no internal combustion leak out. Coolant mixture correct and cooling system functionality is healthy. All external engine accessories in good working. No leaks or seepage from anywhere on the engine. External drive belts in decent condition. Currently no concern in mechanical issues present in relation to the engine or related accessories.

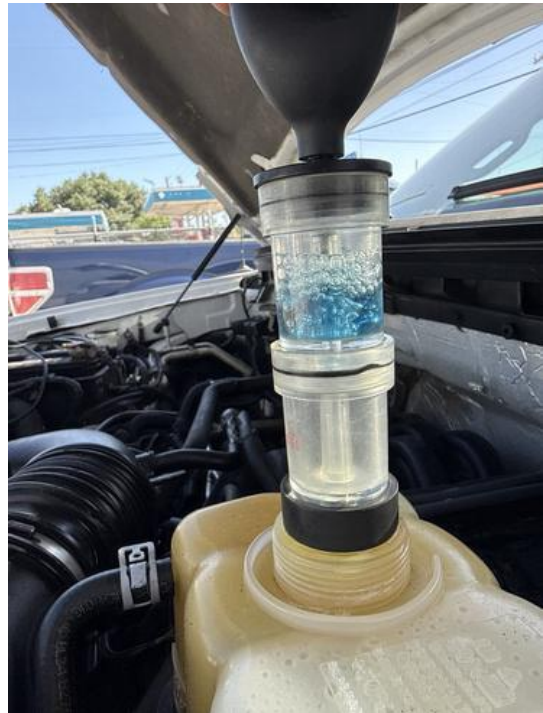
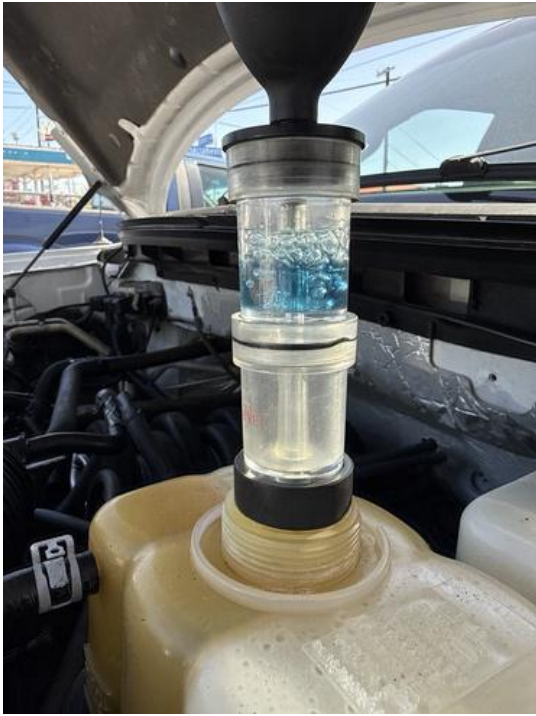
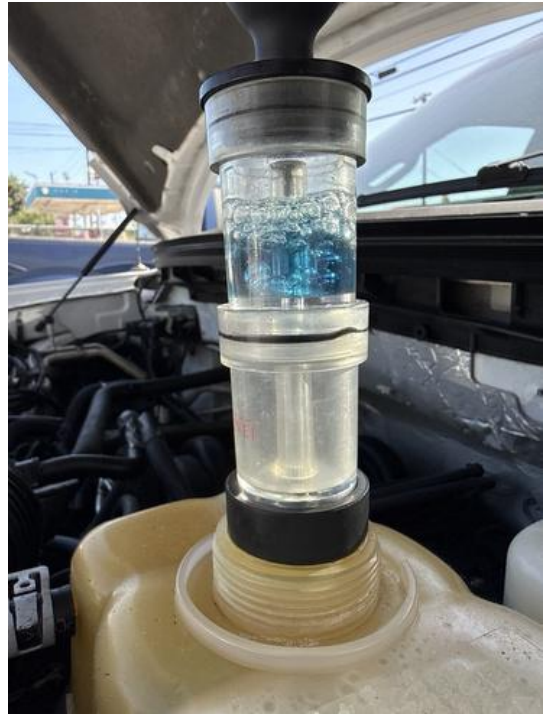
Pass

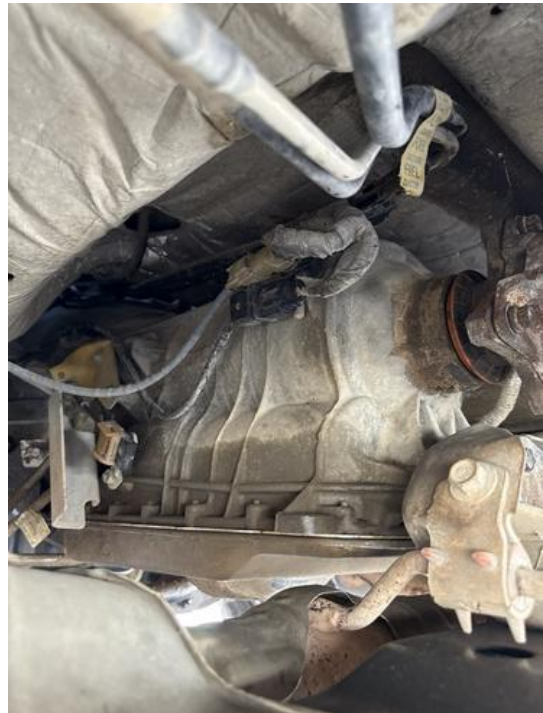
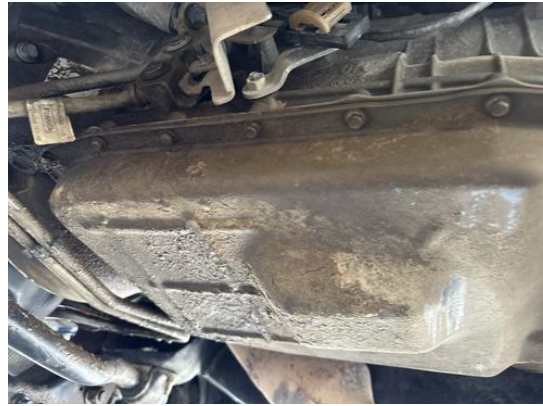
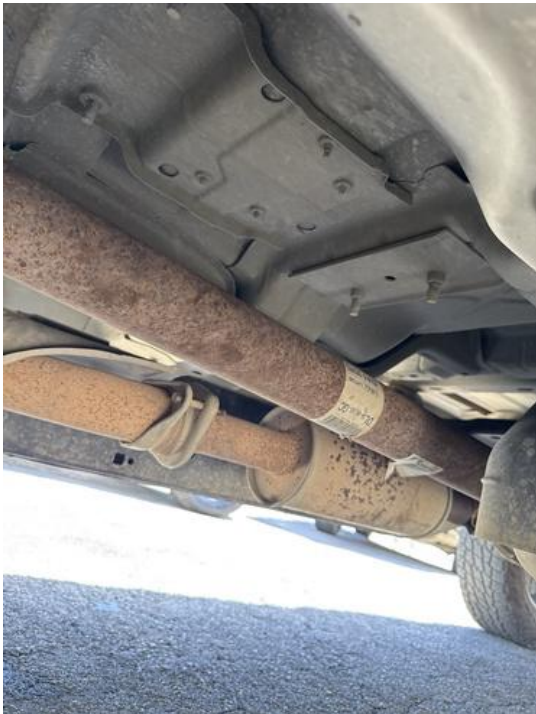
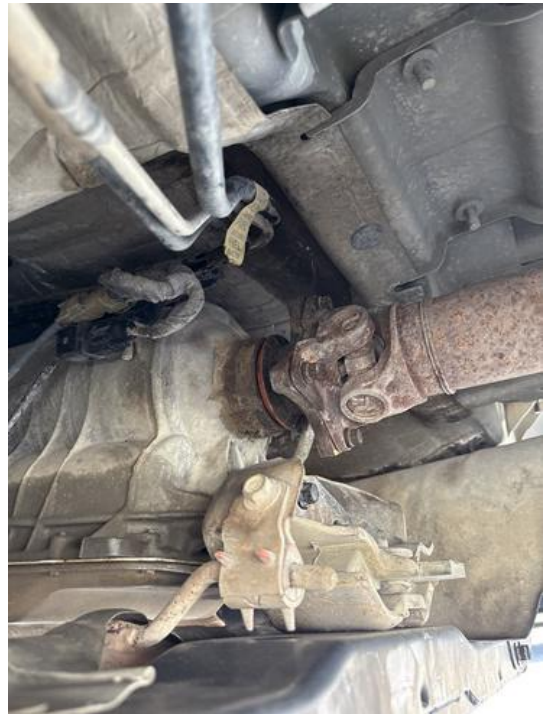
| Transmission / Differentials | |
|---|---|
| <p>No transmission fluid leaks from the transmission casing or the transmission pan area. The tail shaft seal is free of any fluid leaks. The driveshaft is in healthy condition. Shift transitions out on the road are correct across the board. No fluid leak out from the rear differential.</p> | |

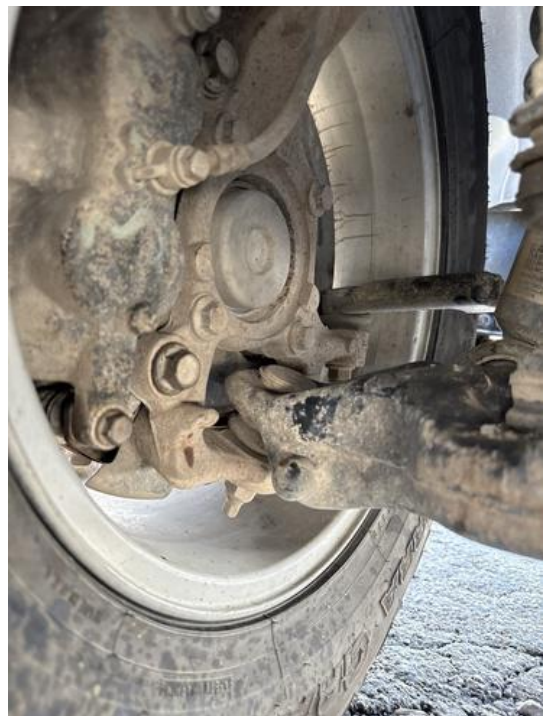
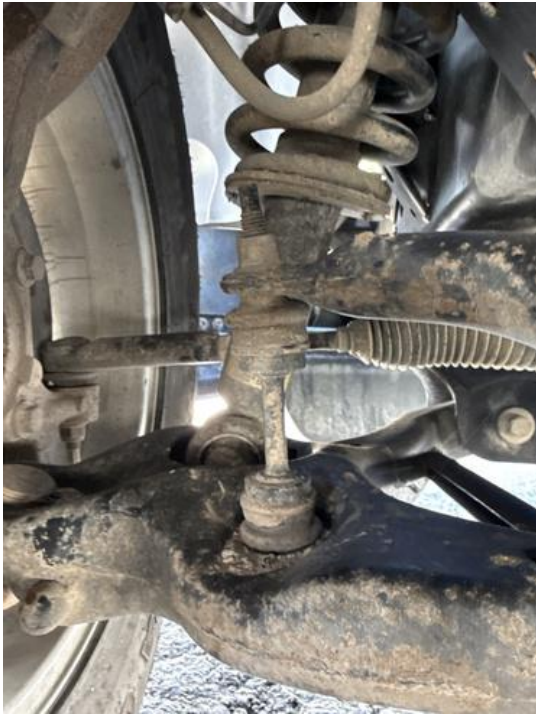
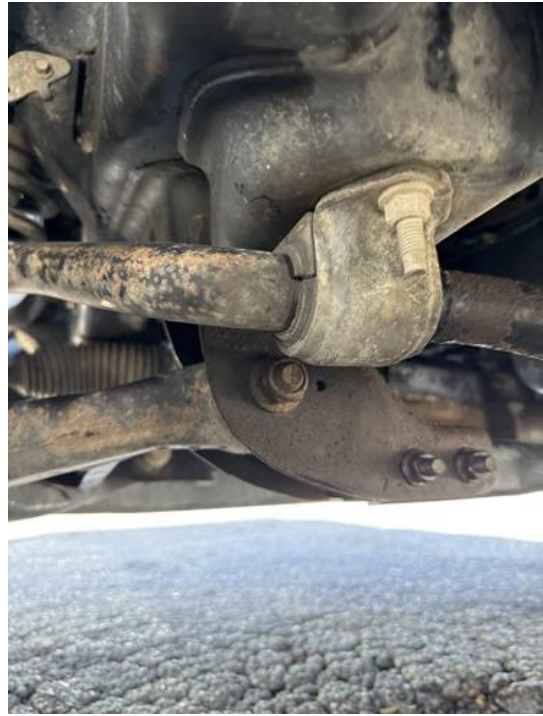
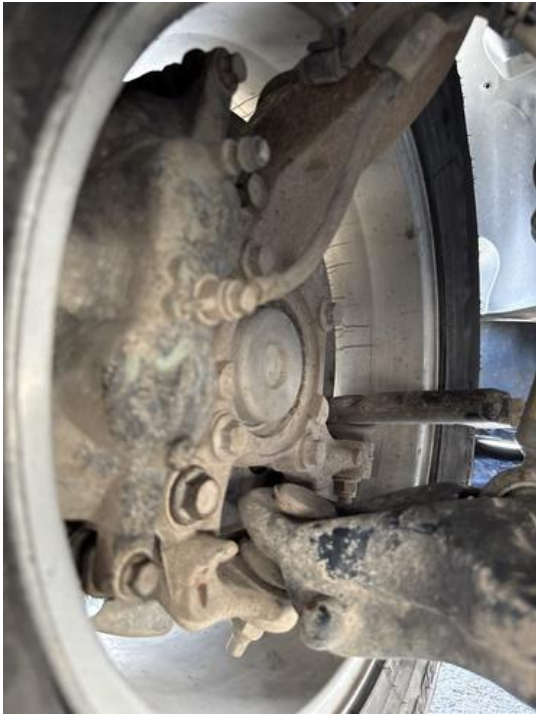
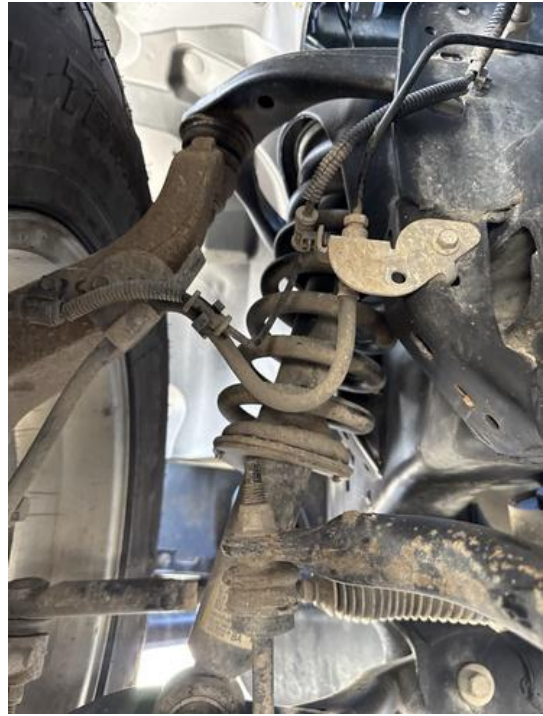
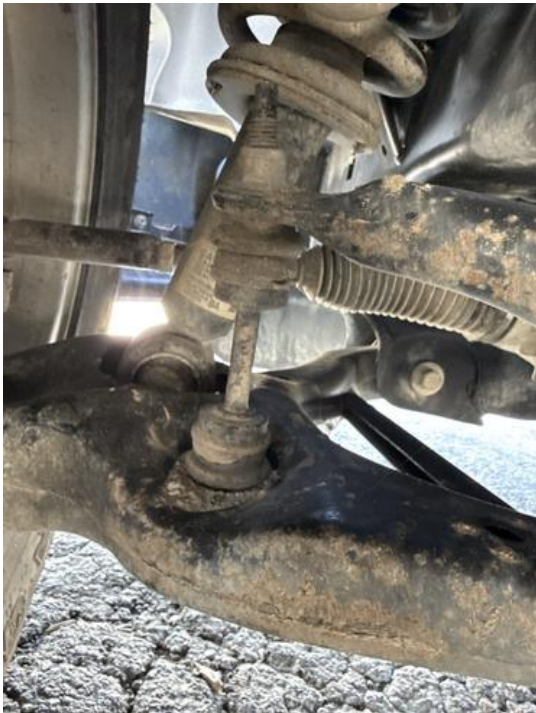
Normal fatigue notice to the suspension components. All of the suspension components seem to be original. None of the suspension components are blown out and due form the replacement. The No excessive surface rust on the exposed metal. No abnormal noise or feedback from the suspension while out on the road. All of the rubber in relation to the mounts, joints and bushings has decent texture.
