Peace of Mind Automotive Inspection Report.

Site conducted	Unanswered
Customer name	Luis LMJ auto motor sales
Date / Time	Jan 21st
Payment method	Invoice
Inspection cost	199
Vehicle Year / Make / Model / Color	2013/14 ford f150

VIN	24733 last 5
------------	--------------

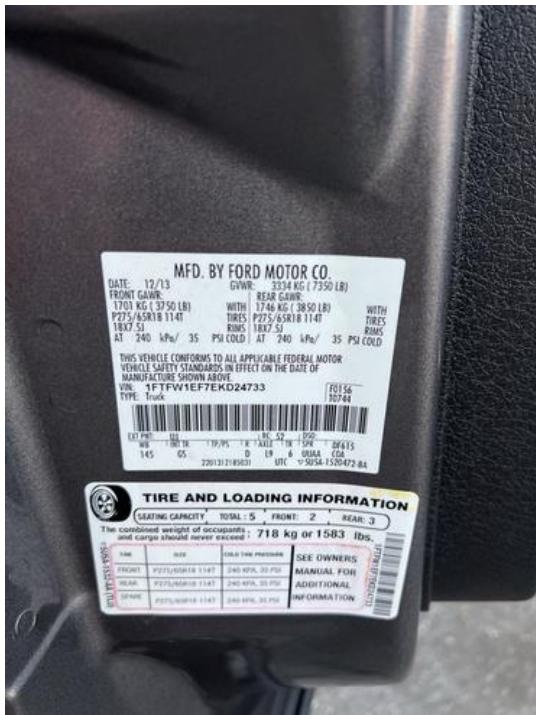
Photo 1

license plate	Dealer
Mileage	157633
Color	Grey

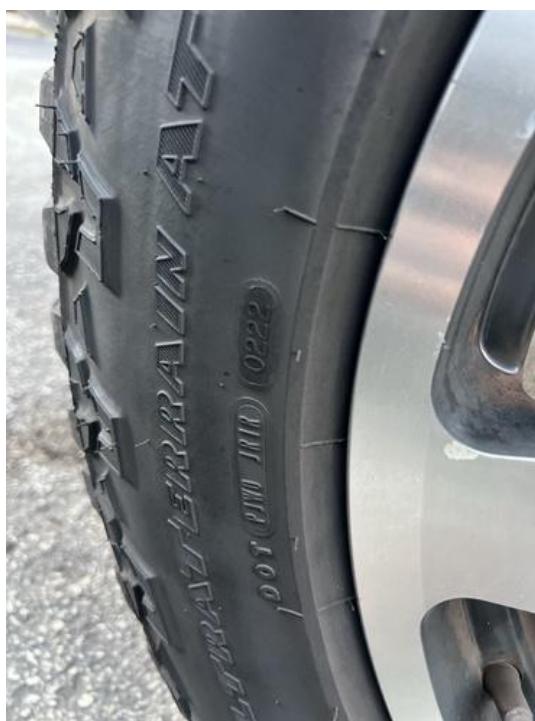
Photo 113

All four tires are dated from 2022. All four tires are healthy and matching all around. All four tires have right around 65% tread life remaining and are evenly worn.

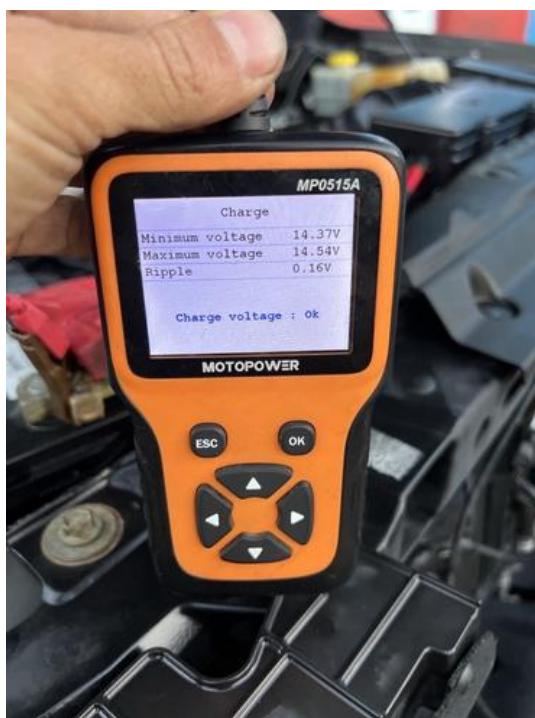
Photo 129

Battery is accepting the charge from the alternator and the alternator charge output is correct

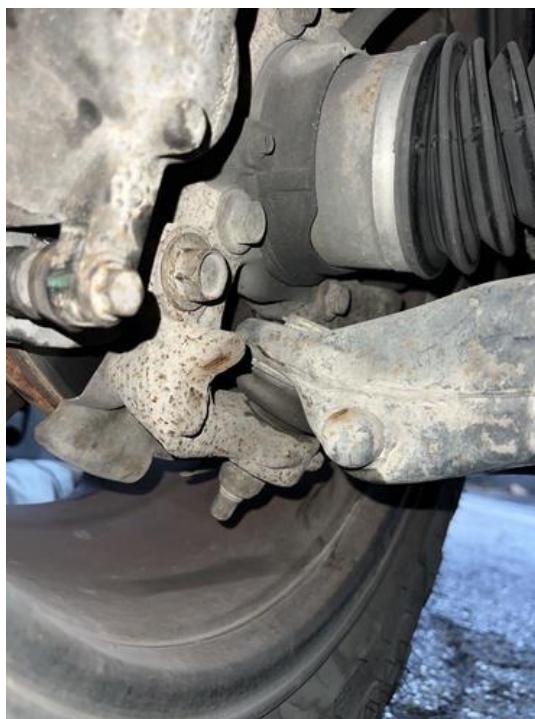
Photo 157

Normal fatigue notice to the suspension components. All of the suspension components seem to be original. None of the suspension components are blown out and due form the replacement. The No excessive surface rust on the exposed metal. No abnormal noise or feedback from the suspension while out on the road. All of the rubber in relation to the mounts, joints and bushings has decent texture.

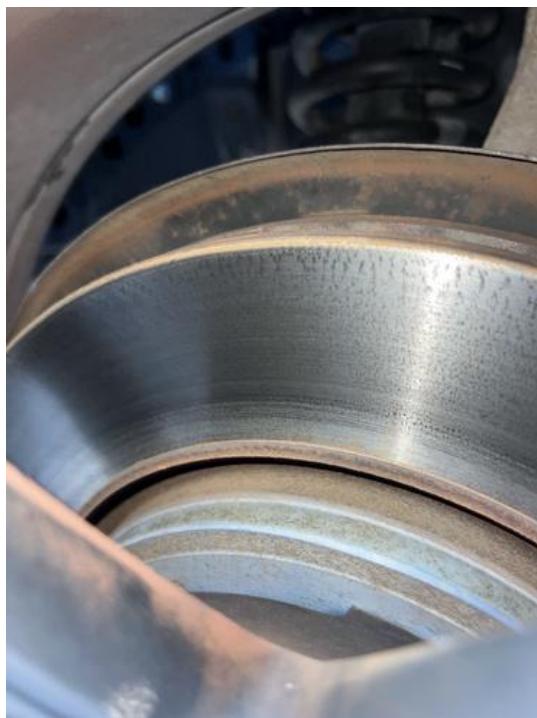
Photo 171

Both the front and rear brakes have just been serviced, front and rear brake pads are brand new as well as resurface rotors

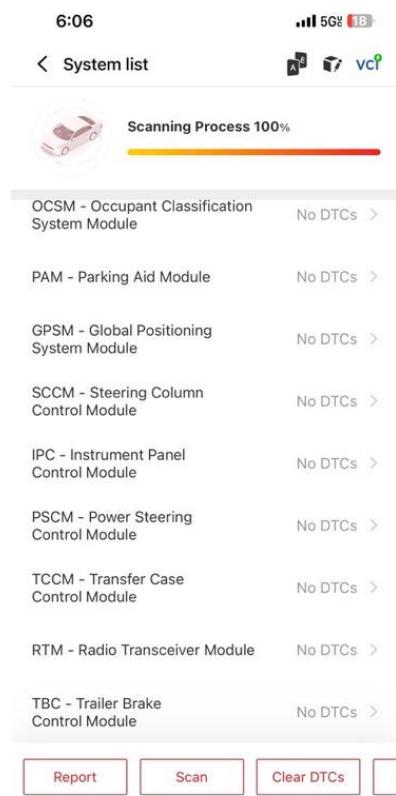
Photo 177

All of the control modules on the vehicle are free of any live/active diagnostic fault codes. All live feed diagnostic testing was successfully passed. All live feed emissions testing was successfully passed. There were a couple of historic diagnostic fault codes present across various control modules on the vehicle. None of these codes were live/active and are not of any current concern.
