## Peace of Mind Automotive Inspection Report.

| Score | 4 / 4 (100%) | Flagged items | 1 | Actions | 0 |
|---|---|---|---|---|---|
| Vehicle Year / Make / Model / Color | | | | | 2015 ford f350 |
| Mileage | | | | | 197800 |

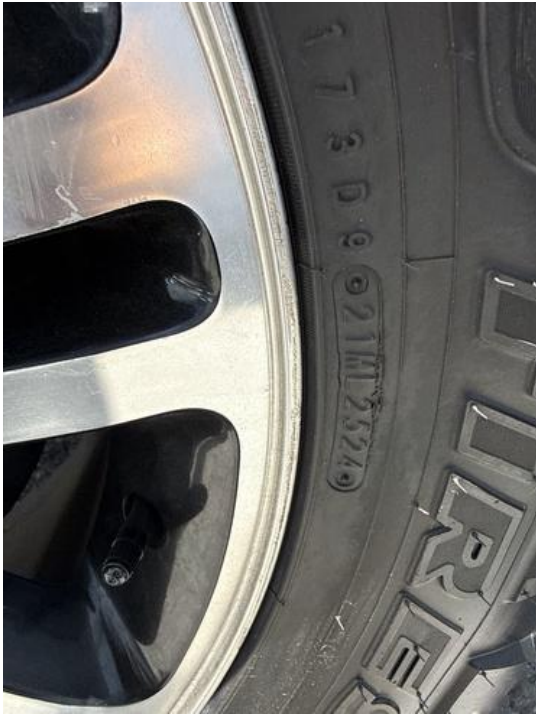
Photo 97

All four tires are matching and in decent condition. Tires are evenly worn and have right around 70% tread life remaining

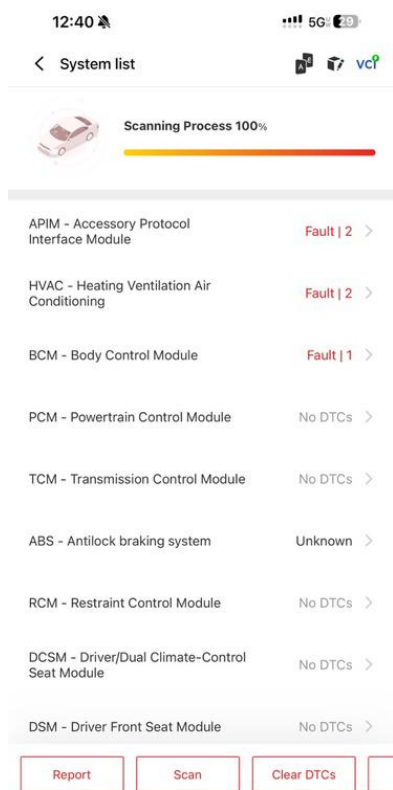
Photo 157

At the time of the inspection, there were no active warning lights present. All of the live feed diagnostic testing was successfully passed. There were a couple of non-active/historical fault codes present.
