# Peace of Mind Automotive Inspection Report.

Score	4 / 4 (100%)	Flagged items	0	Actions	0
<b>Site conducted</b>					Unanswered
<b>Customer name</b>					Lmj auto motor sales
<b>Date / Time</b>					May 19th
<b>Payment method</b>					Invoice
<b>Inspection cost</b>					199
<b>Vehicle Year / Make / Model / Color</b>					Honda accord 2015
<b>VIN</b>					12414 last 5

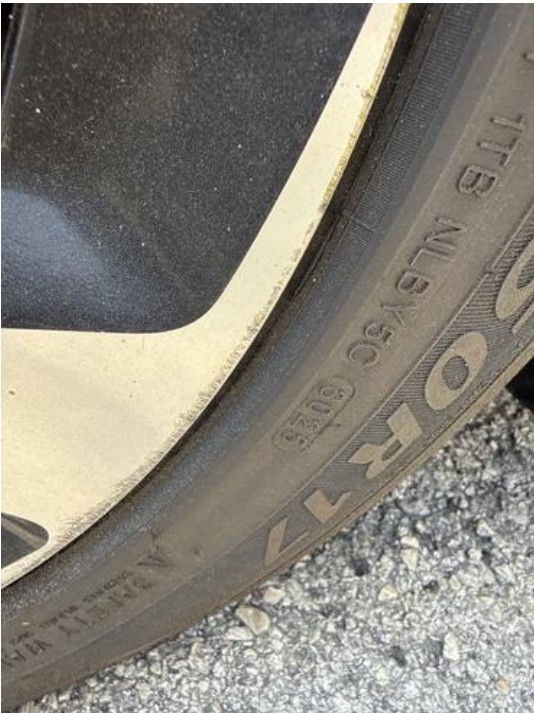
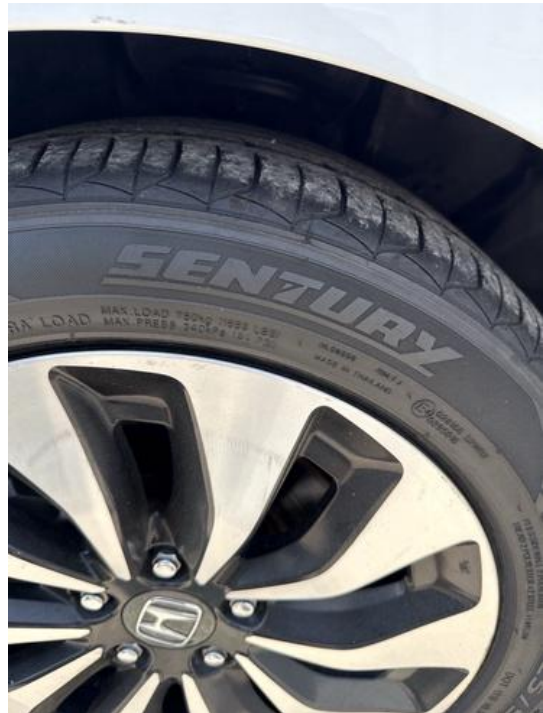
Front tires are a matching set with right around 75% tread life remaining

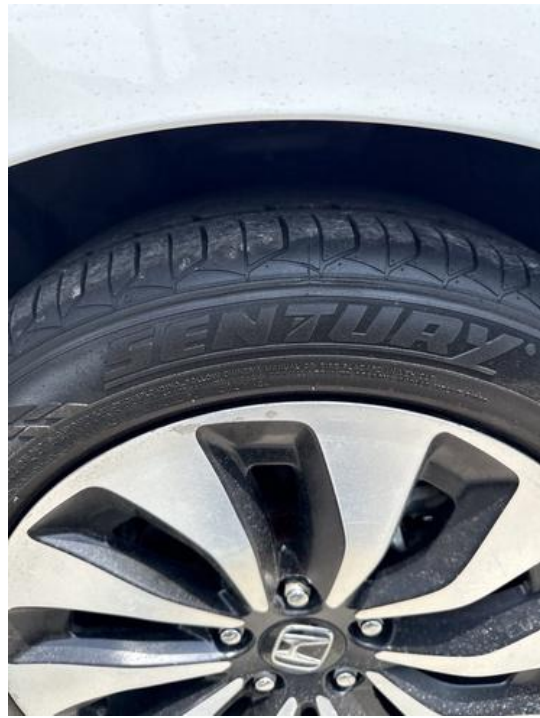
75-100% remaining

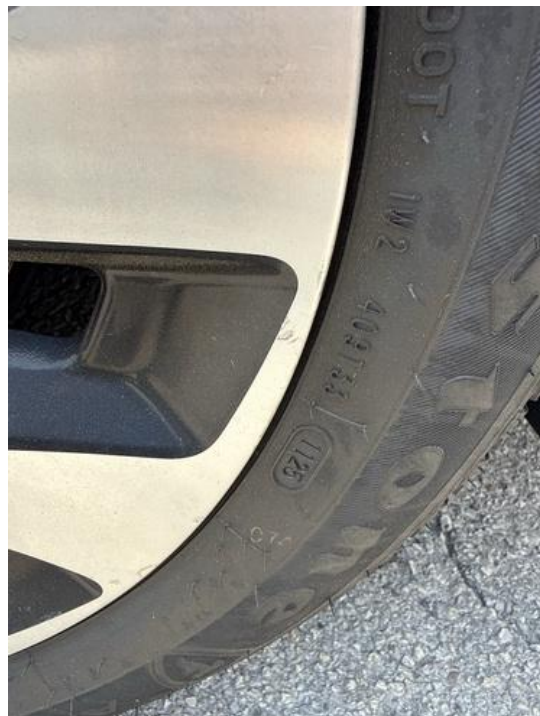
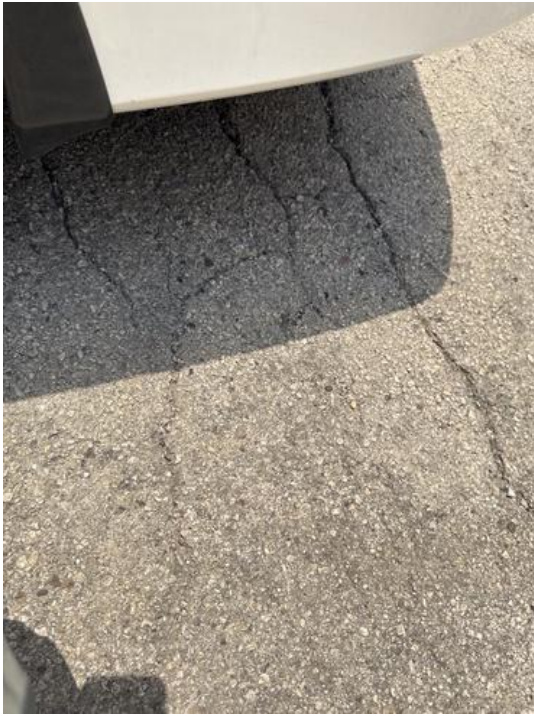
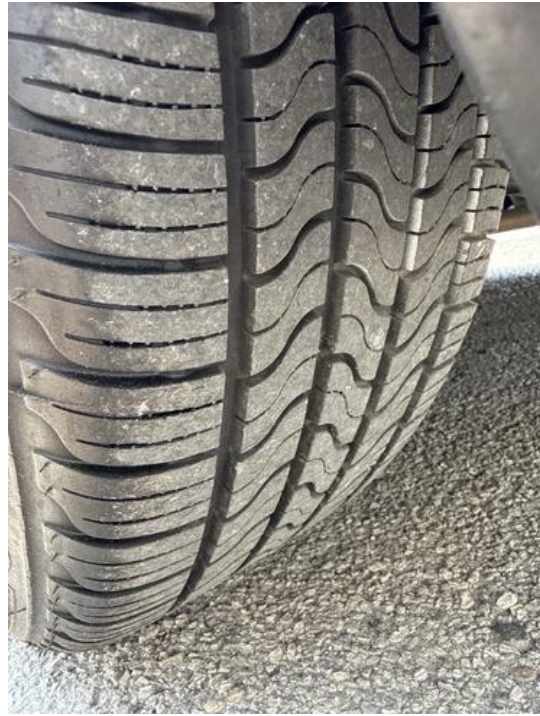
Both rear tires are random tires that are mismatched, rear tires do not match the front rear passenger side tire has around 55% tread light remaining, rear driver side tire has around 85% tread life remaining

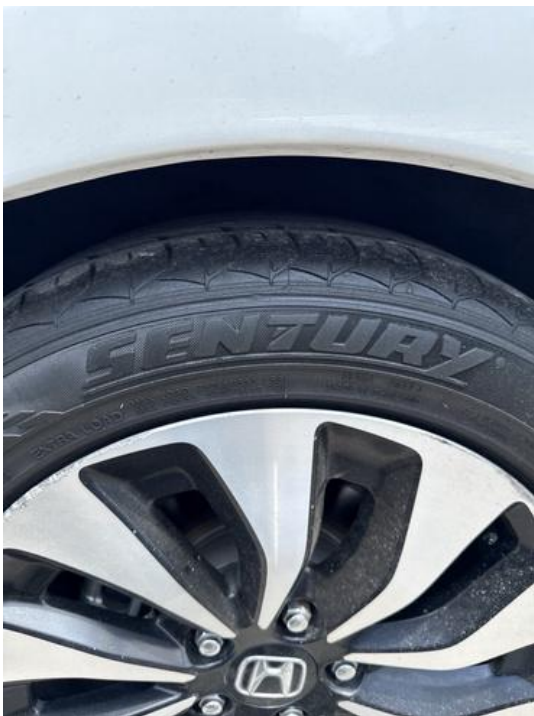
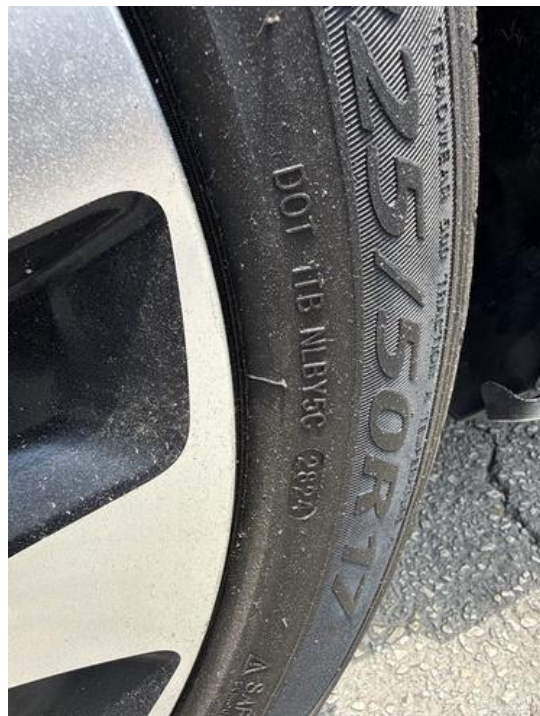
50-75% remaining

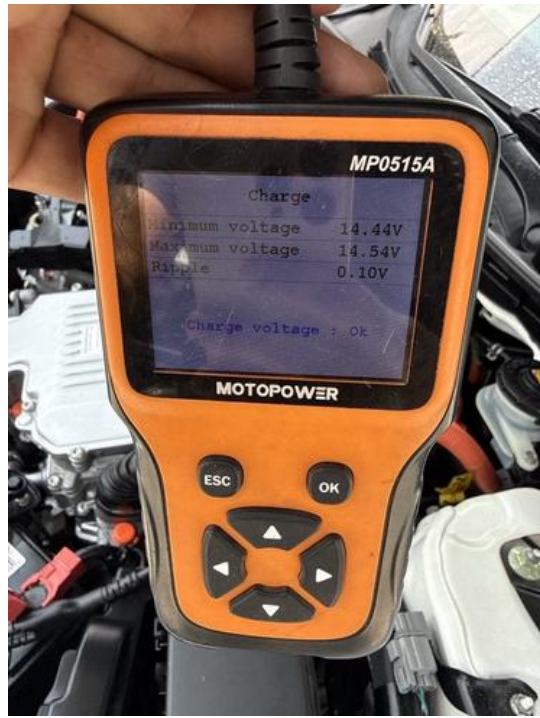
Photo 110

Battery is accepting the charge from the alternator and the alternator charge output is correct

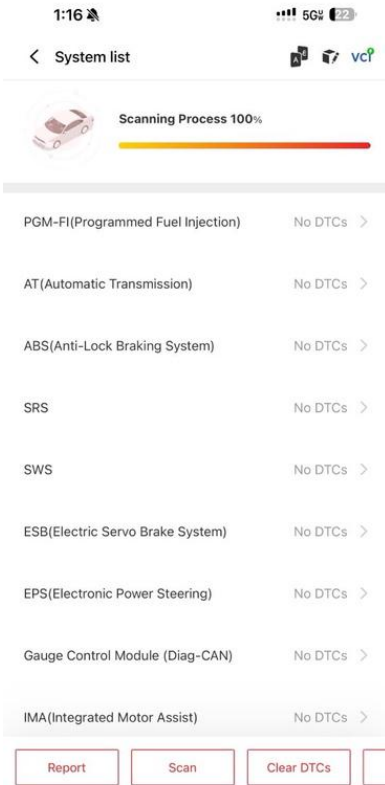
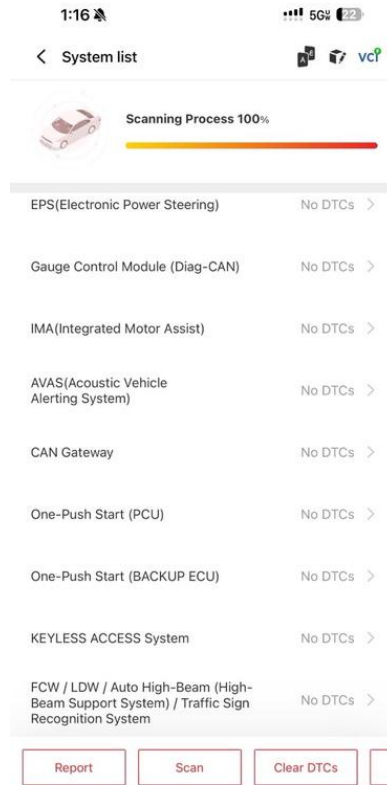
Proper correlation between the engine and hybrid system. There were no active warning lights at the time of the Inspection. All of the live feed diagnostic testing was successfully passed. All of the live feed emission testing was successfully passed.
