## Peace of Mind Automotive Inspection Report.

| Score | 4 / 4 (100%) | Flagged items | 0 | Actions | 0 |
|---|---|---|---|---|---|
| Vehicle Year / Make / Model / Color | | | | | 2015 Lexus RX350 |
| VIN | | | | | 84895 last 5 |

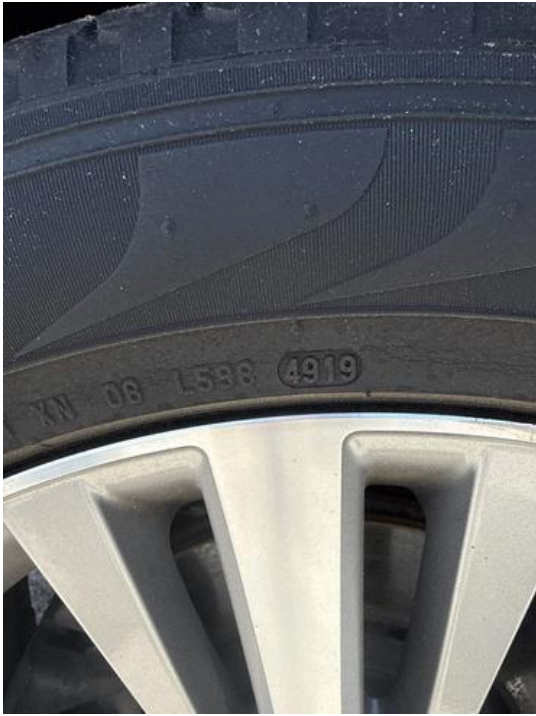
Photo 87

25-50% remaining

Both front tires are a matching set, front tires are dated from 2019 and have only around 30% tread life remaining. Rear tires are a matching set which are a little newer. Rear tire tires have around 60% tread life remaining.

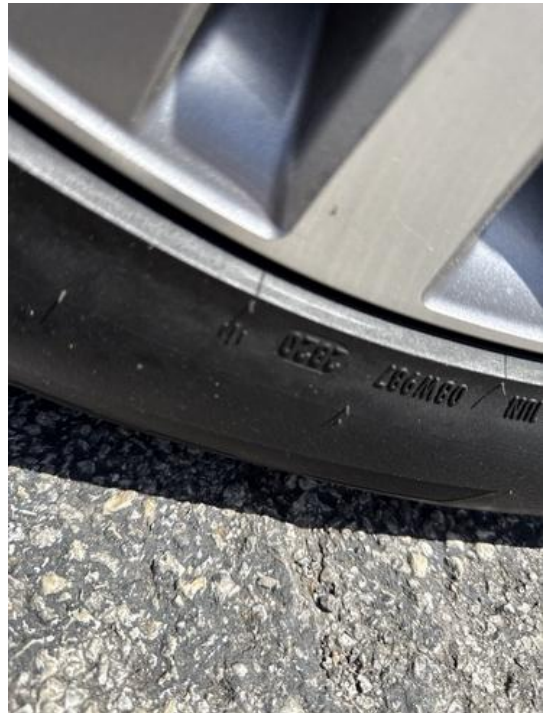
Photo 90

25-50% remaining

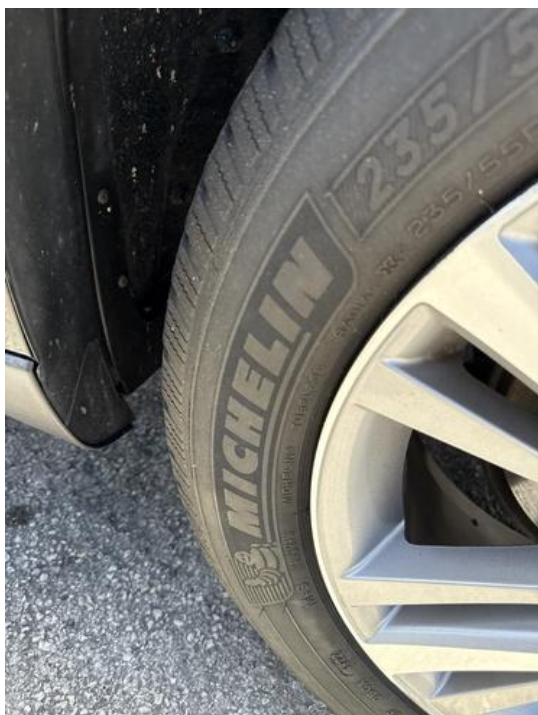
Photo 93

50-75% remaining

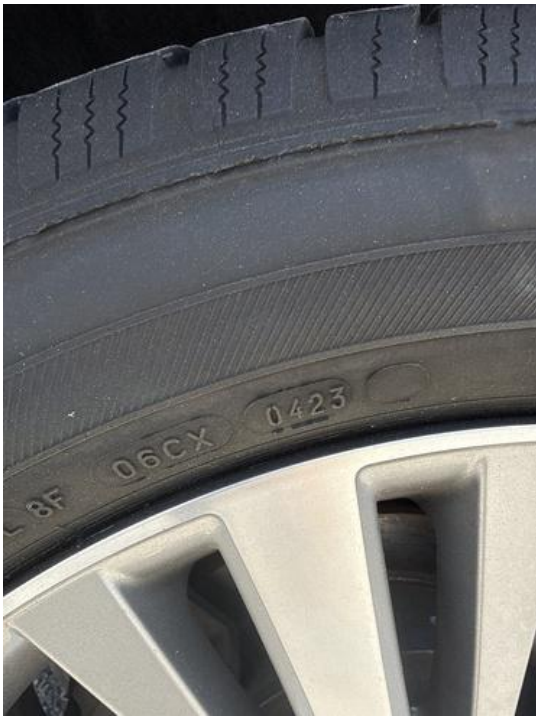
Photo 95

50-75% remaining

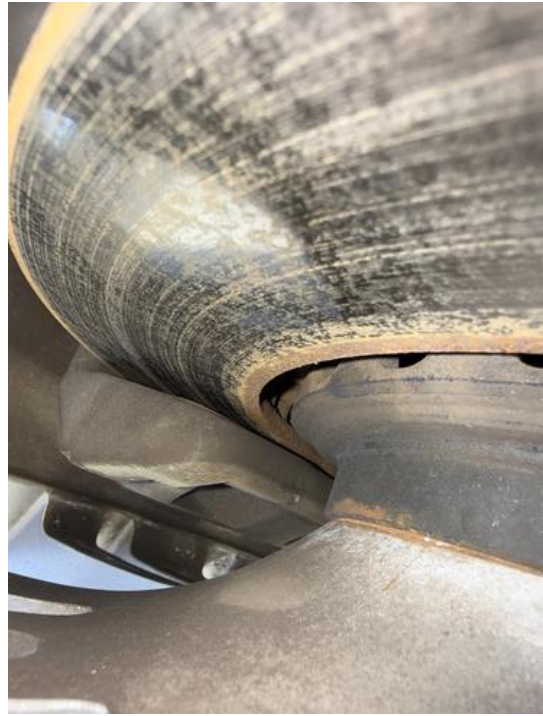
Photo 134

| Braking system condition | |
|---|---|
| <b>Front brake pad life remaining</b><br>Recent service to both the front and rear brake system | 75-100% remaining |

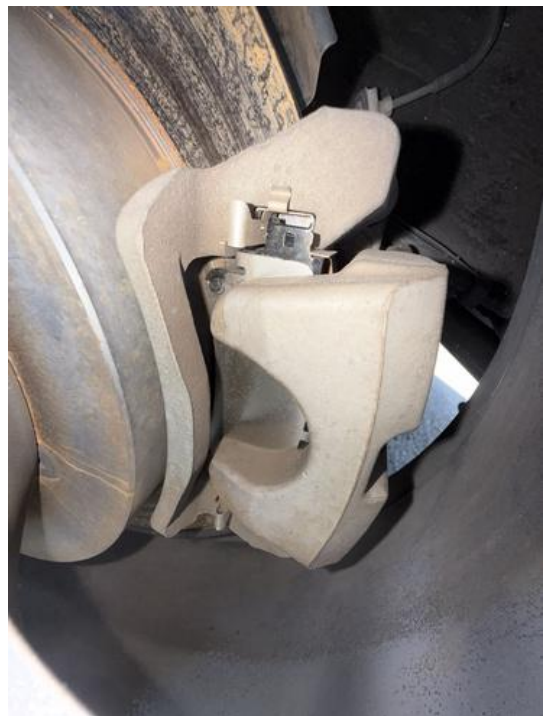
Photo 136

| Braking system condition | |
|---|---|
| <b>Rear brake pad life remaining</b> | 75-100% remaining |
