# Peace of Mind Automotive Inspection Report.

Score	4 / 4 (100%)	Flagged items	0	Actions	0
<b>Site conducted</b>					Unanswered
<b>Customer name</b>					Lmj auto motor sales
<b>Date / Time</b>					May 18th
<b>Payment method</b>					Invoice
<b>Inspection cost</b>					Fleet account
<b>Vehicle Year / Make / Model / Color</b>					2015 Lexus RX
<b>VIN</b>					55719 last 5

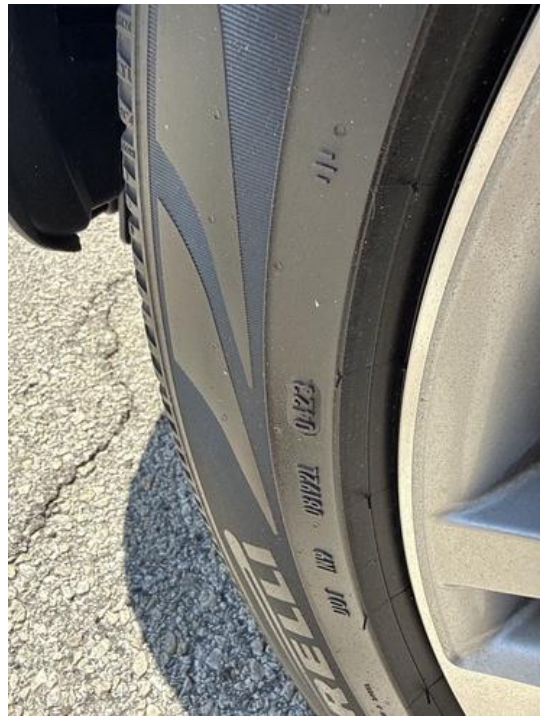
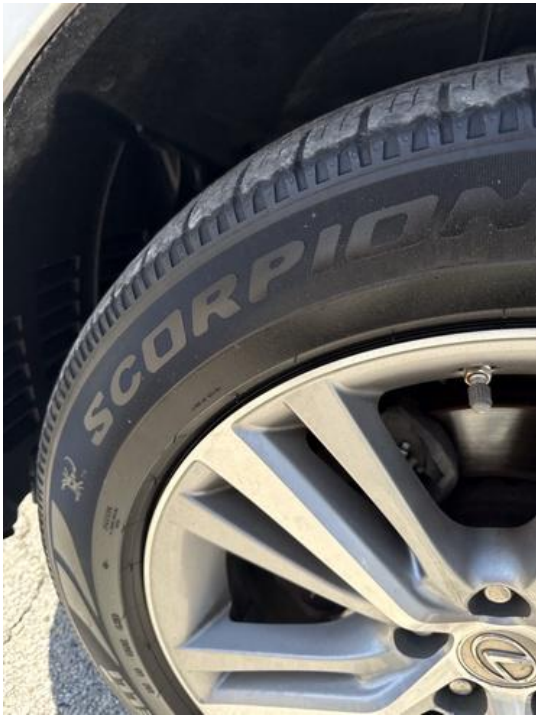
50-75% remaining

Both front tires have right about 55% tread life remaining

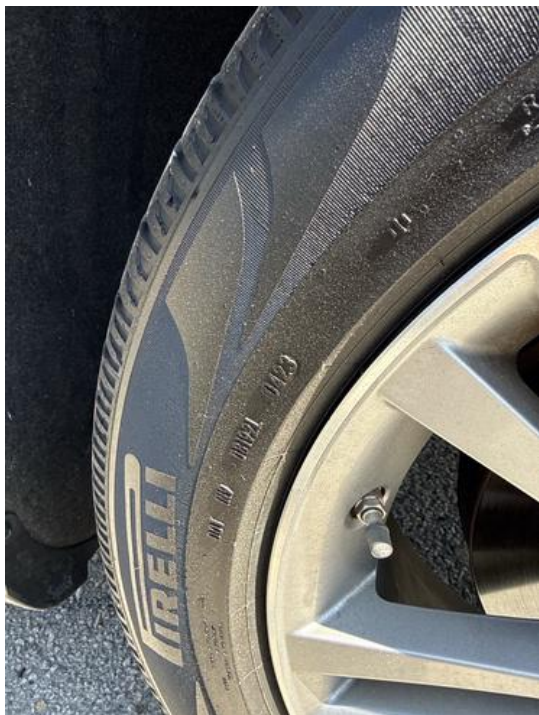
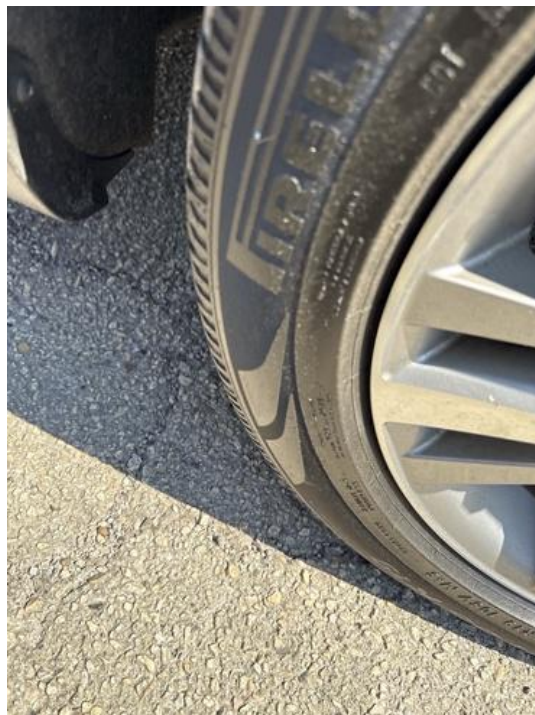
50-75% remaining

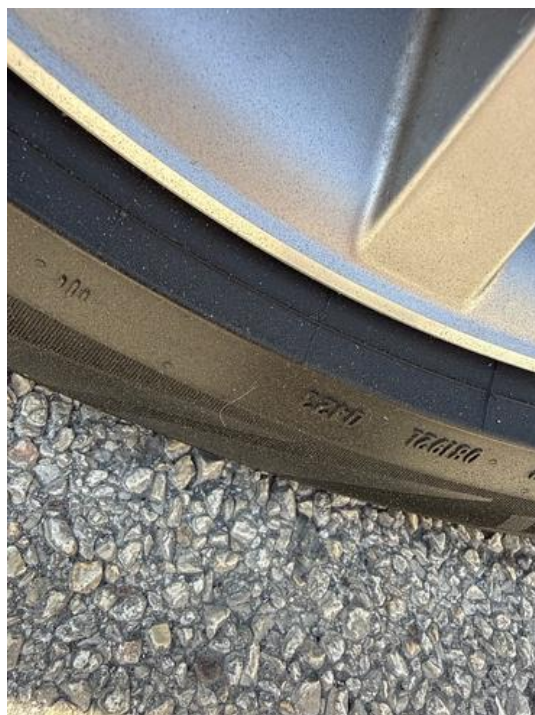
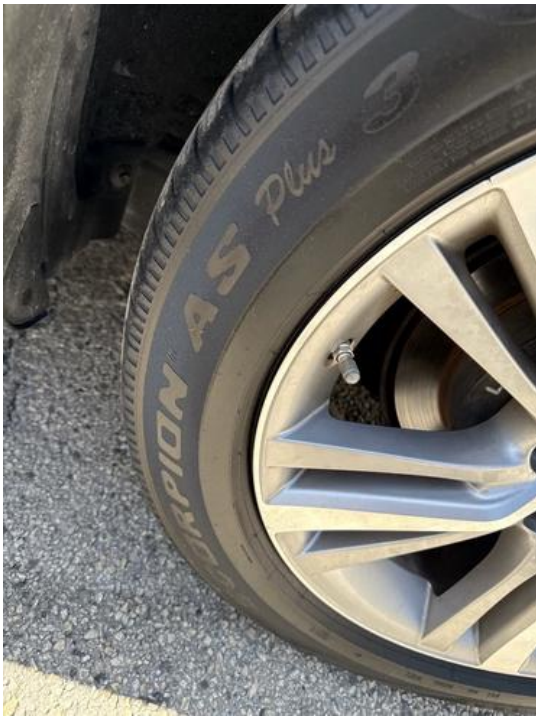
25-50% remaining

Both rear tires have right around 40% tread life remaining

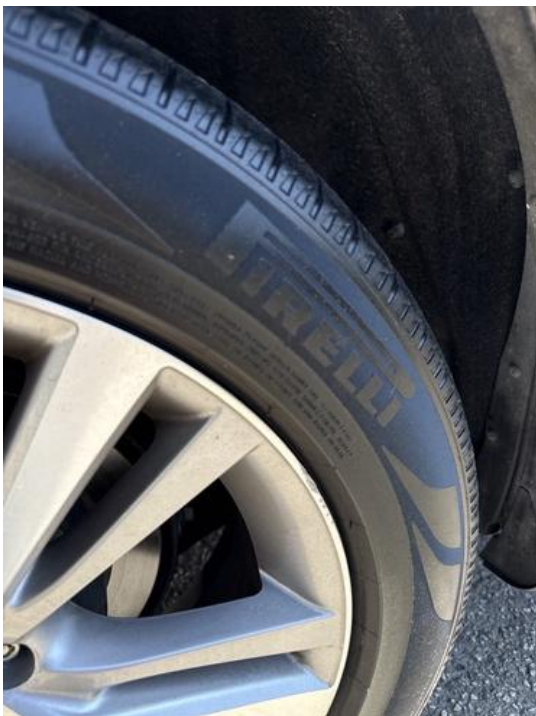
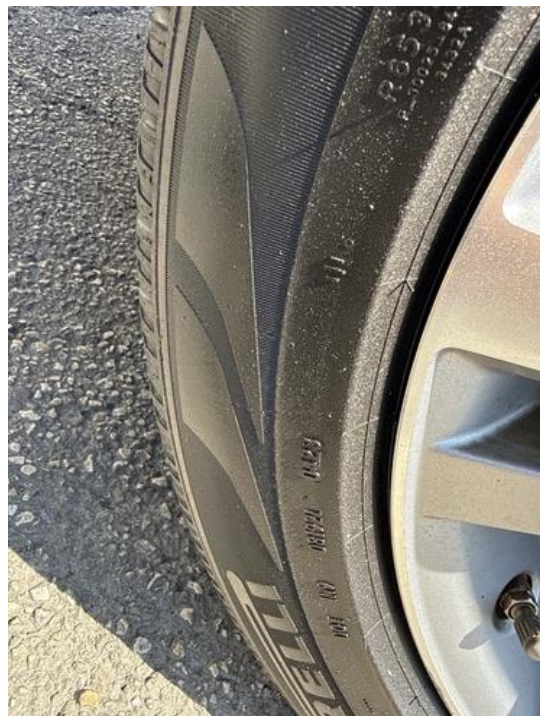
25-50% remaining

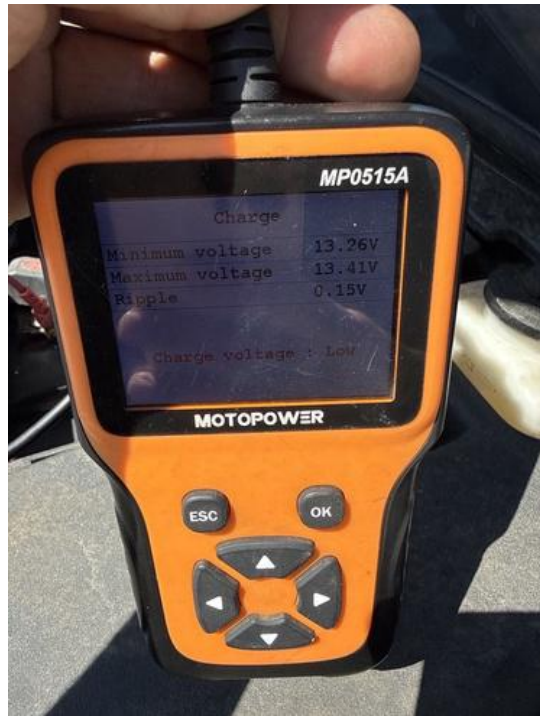
**Standing voltage** 12.7

**Loaded voltage** 13.41

Battery is accepting the charge from the alternator and the alternator charge output is correct

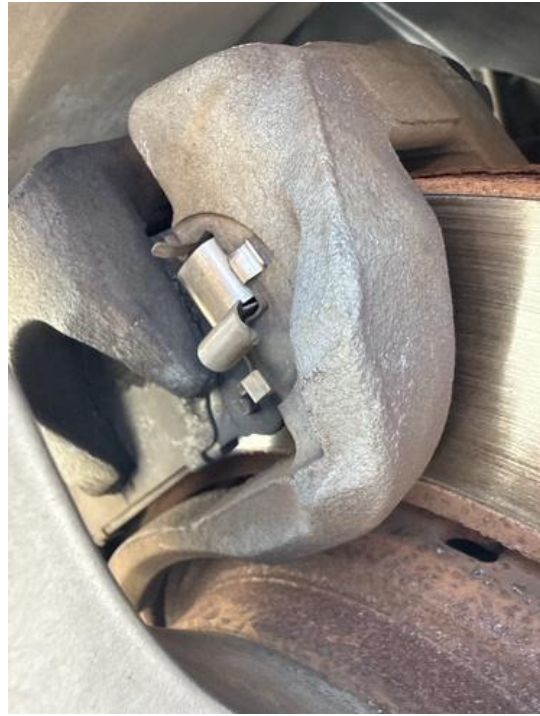
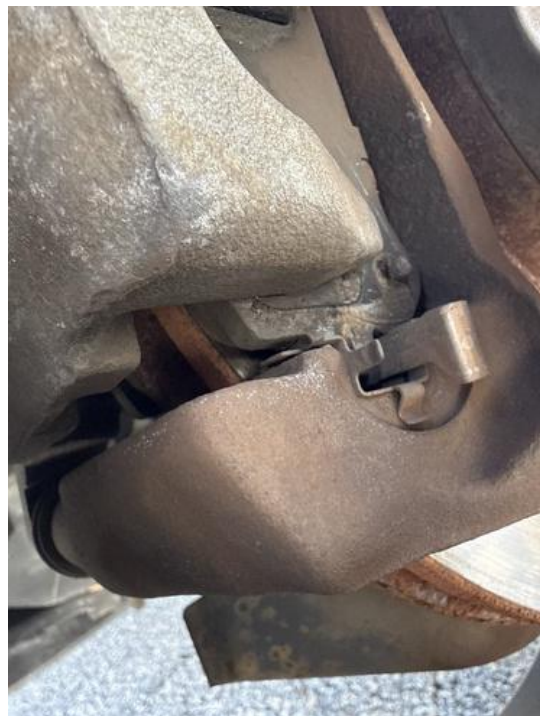
Braking system condition	
Brake fluid condition	Healthy
Brake fluid level	Healthy
Brake fluid leaks	None
Moisture content in brake fluid	None
Brake lines	Healthy
Brake calipers front	Healthy
Brake calipers rear	Healthy
Brake drums rear	N/A
Brake rotors front	Healthy
<p>Very subtle pulse noticed in the brakes when braking from high speeds the front brake pads were likely replaced without the front brake rotors being resurfaced</p>	
Brake rotors rear	Healthy
Front brake pad life remaining	50-75% remaining
<p>Right around 60% brake pad life remaining</p>	
<div style="display: flex; justify-content: space-around;"> <div style="text-align: center;">

Very subtle pulse noticed in the brakes when braking from high speeds
