Peace of Mind Automotive Inspection Report.

Site conducted	Unanswered
Customer name	Luis LMJ auto motor sales
Date / Time	Jan 21st
Payment method	Invoice
Inspection cost	199
Vehicle Year / Make / Model / Color	2016 Honda civic
VIN	11871 last 5

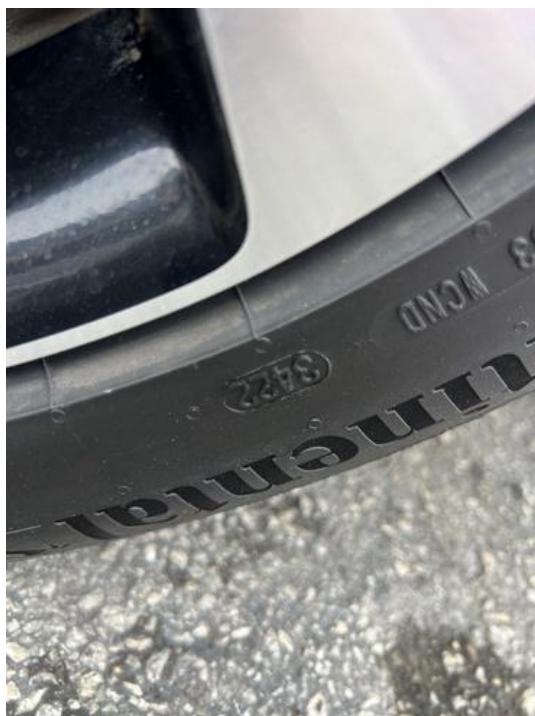
Photo 113

All four tires are matching and in healthy condition. Tires are dated from late 2022 and I'll have right around 75% tread life remaining.

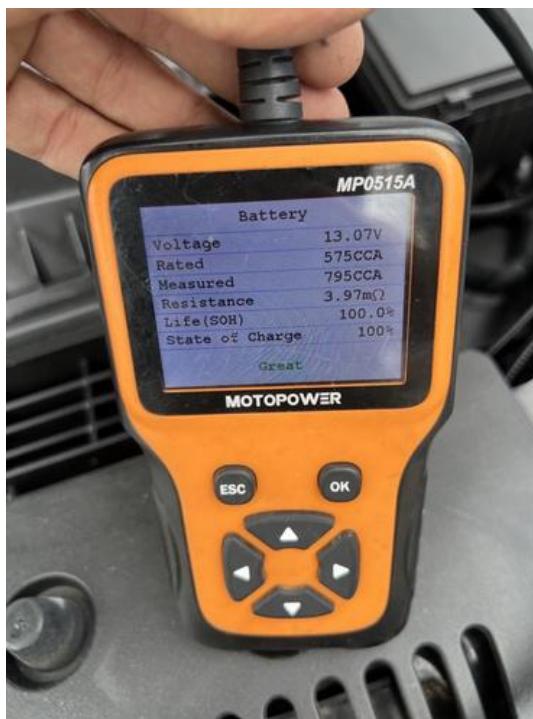
Photo 125

Battery is accepting the charge from the alternator and the alternator charge output is correct

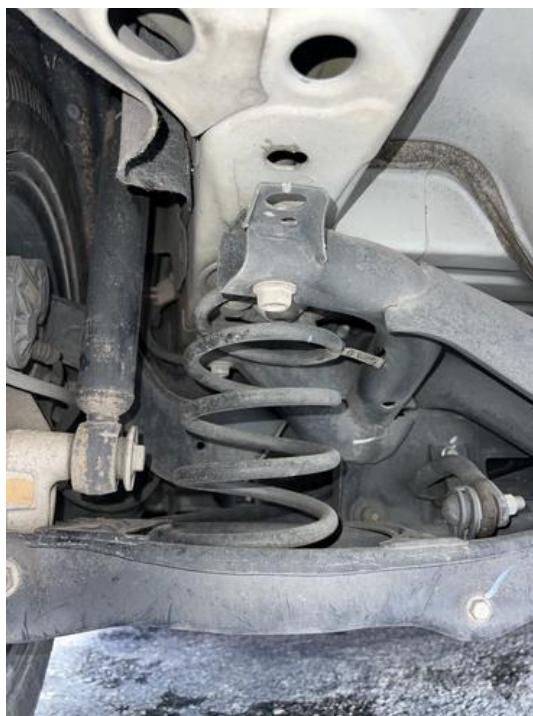
Photo 163

Normal fatigue notice to the suspension components. All of the suspension components seem to be original. None of the suspension components are blown out and due form the replacement. The No excessive surface rust on the exposed metal. No abnormal noise or feedback from the suspension while out on the road. All of the rubber in relation to the mounts, joints and bushings has decent texture.

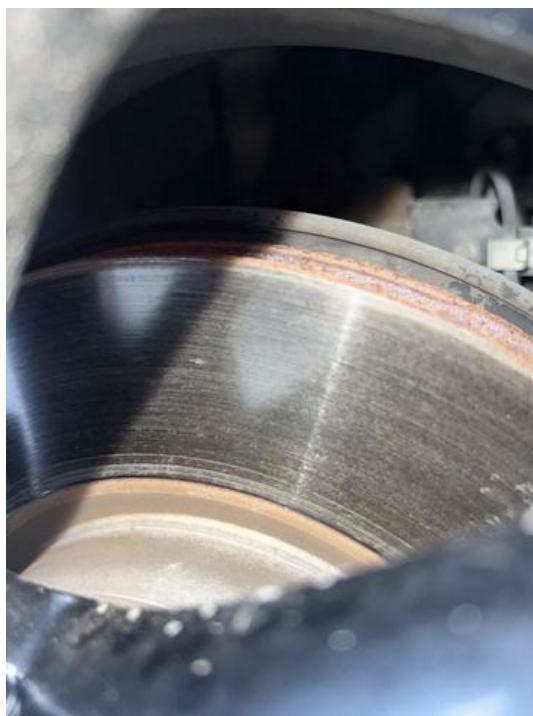
Photo 167

Right around 70% brake pad life remaining

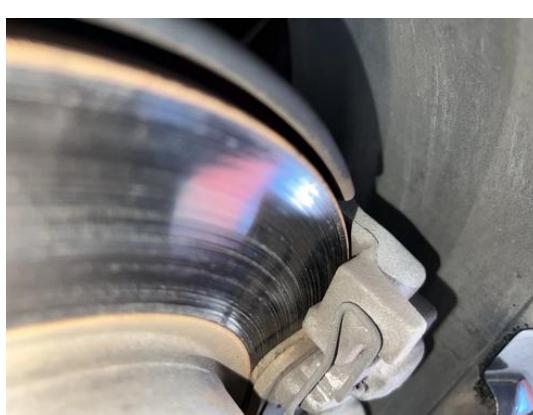
Photo 169

Only around 35% brake pad life remaining
