Peace of Mind Automotive Inspection Report.

Site conducted	Unanswered
Customer name	Luis LMj auto motor sales
Date / Time	Dec 30th
Payment method	Invoice
Inspection cost	Fleet
Vehicle Year / Make / Model / Color	2016 Honda CRv

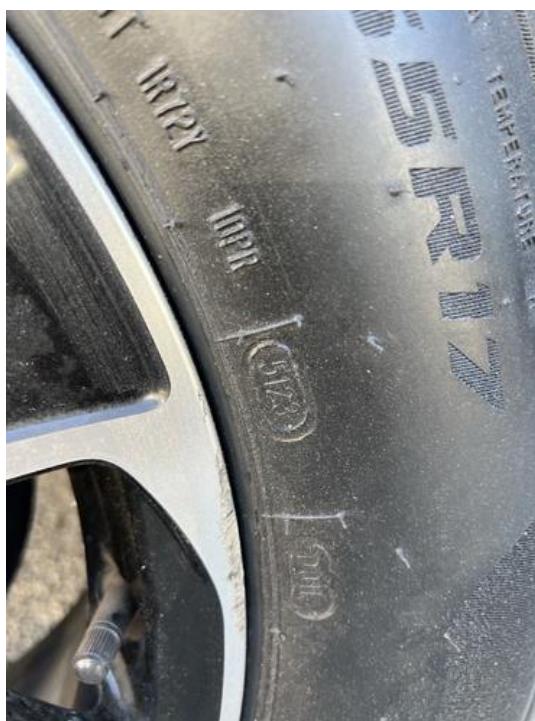
Photo 115

All four tires are matching. All four tires are dated from 2023. Tires are in healthy condition with right around 65% tread life remaining all around.

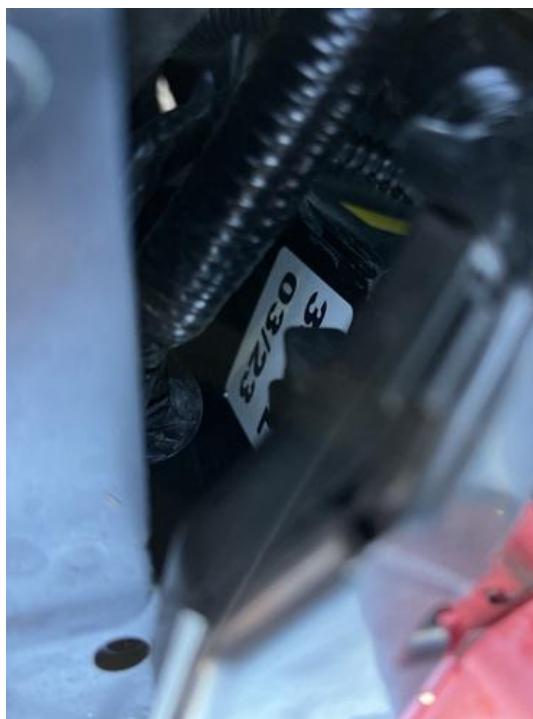
Photo 127

Battery is dated from March 2023,

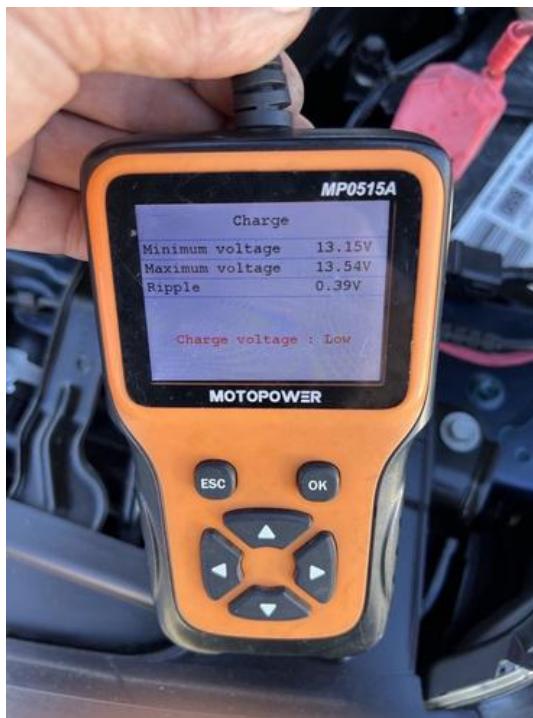
Photo 129

Battery is accepting the charge from the alternator and the alternator charge output is correct

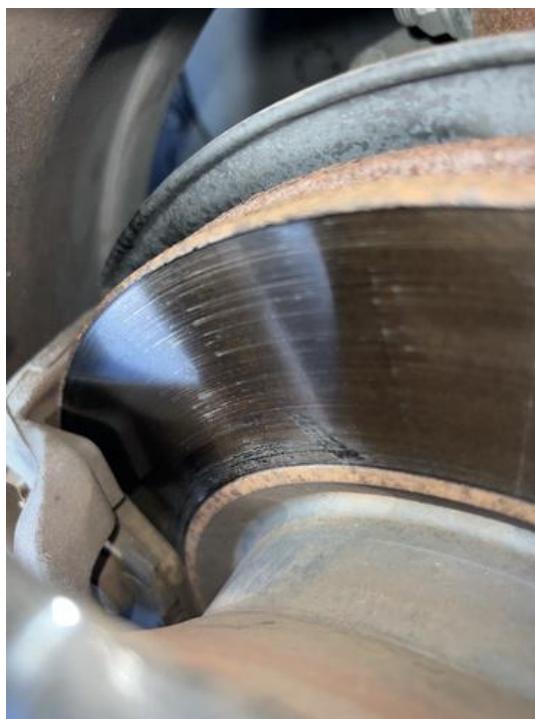
Photo 169

Right around 50% brake pad life remaining

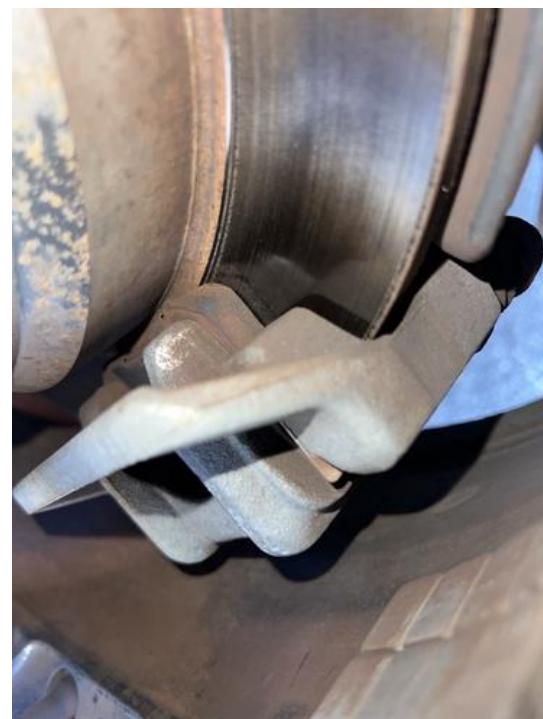
Photo 174

Right around 35% brake pad life remaining

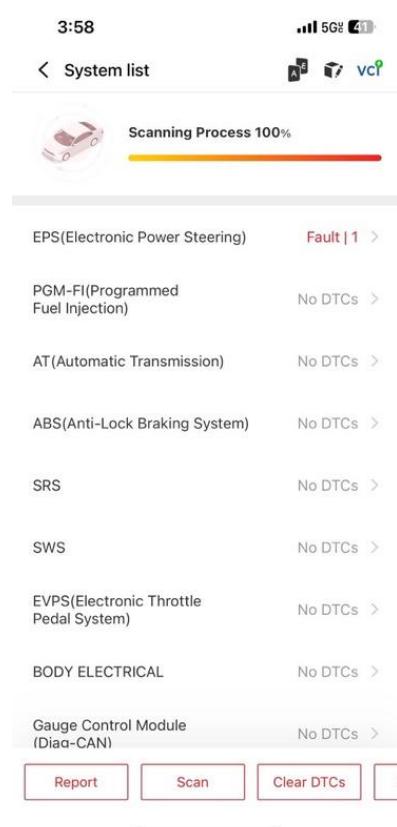
Photo 176

All of the control modules are free of any live/active diagnostic fault codes. All live feed diagnostic testing was successfully passed.

There was one historical diagnostic fault code present, this code is not live or active, and no attention is needed.
