Peace of Mind Automotive Inspection Report.

Score	4 / 4 (100%)	Flagged items	0	Actions	0
Site conducted					Unanswered
Customer name					Luis LMj auto motor sales
Date / Time					April 6th
Payment method					Invoice
Inspection cost					Fleet
Vehicle Year / Make / Model / Color					2016 Volkswagen Tig
VIN					03693 last 5
license plate					Dealer
Mileage					81516
Color					White

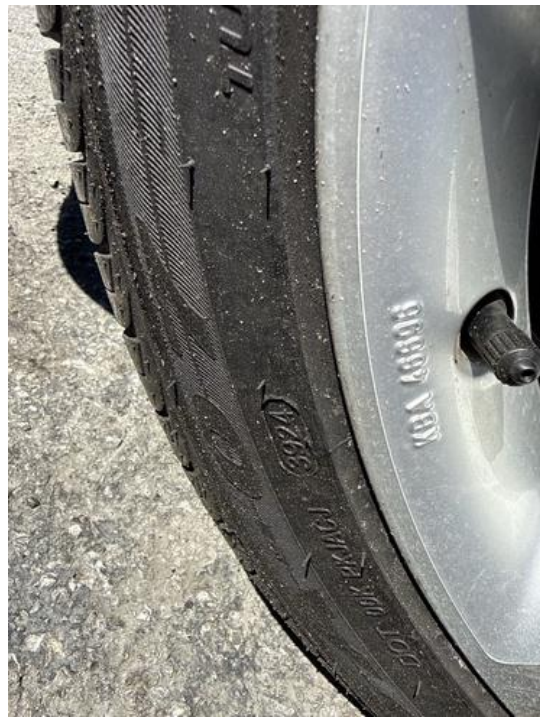
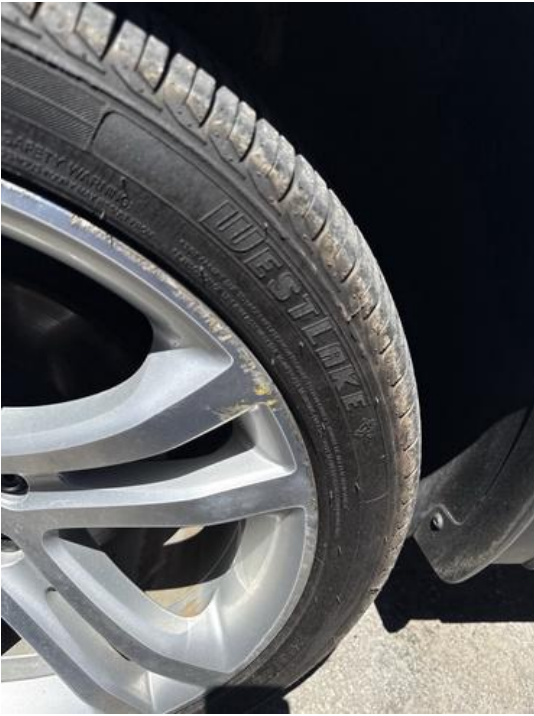
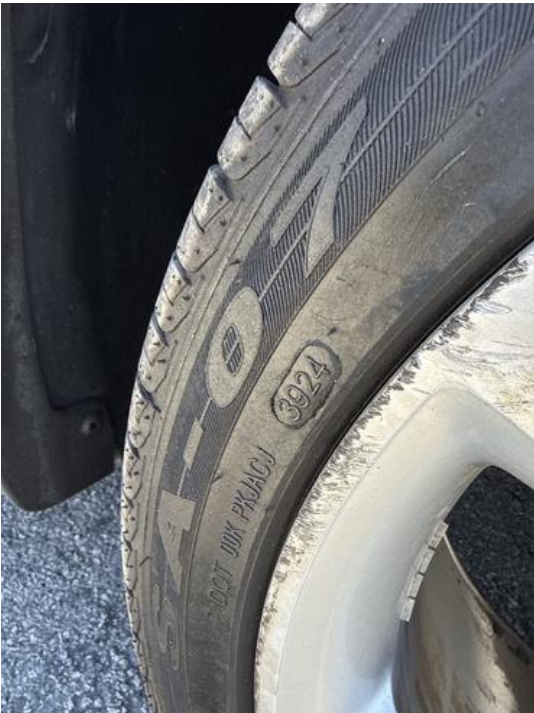
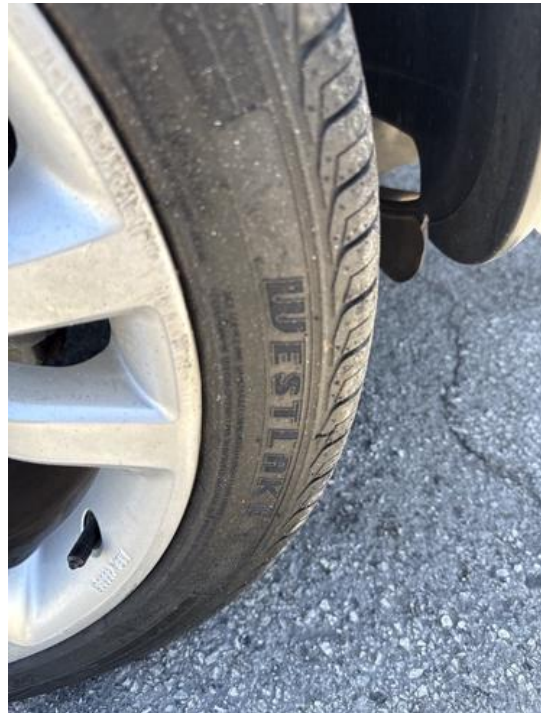
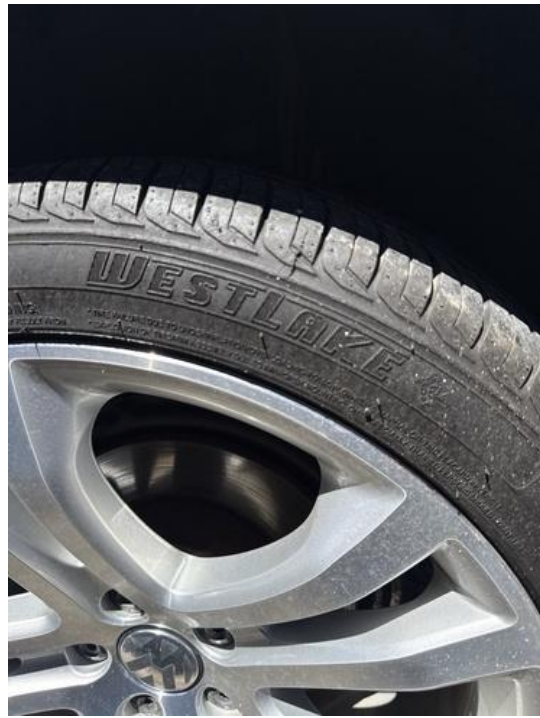
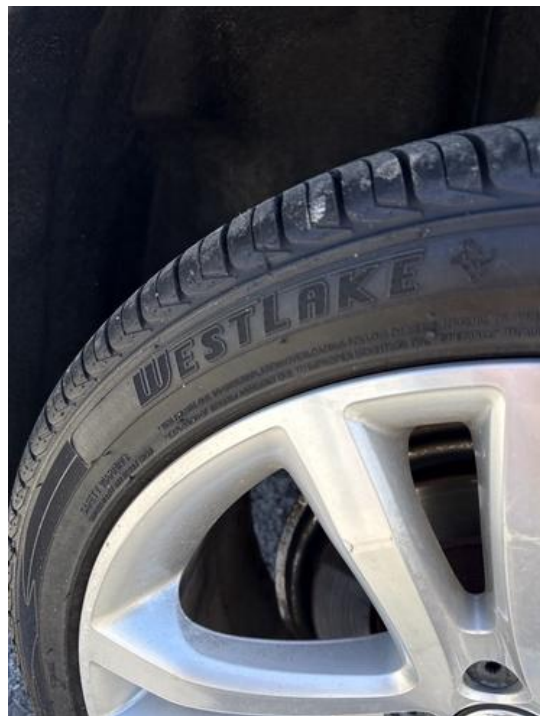
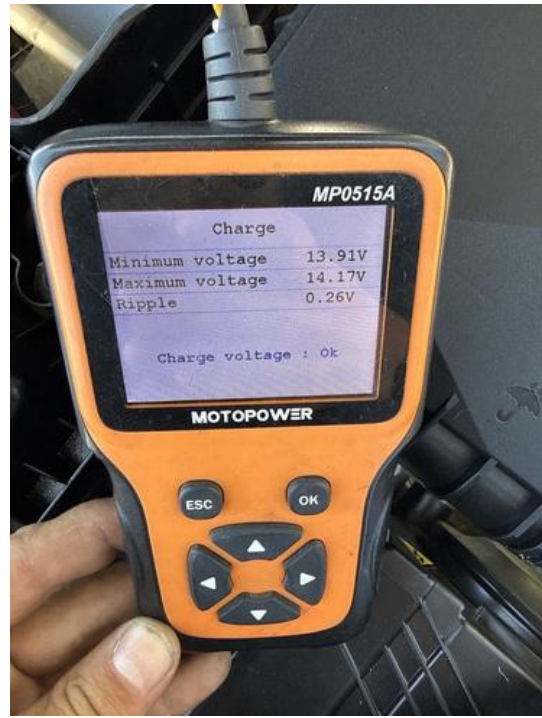
All four tires are matching, all four tires are dated from 2024. Tires are evenly worn and in decent condition with right around 65% tread life remaining.

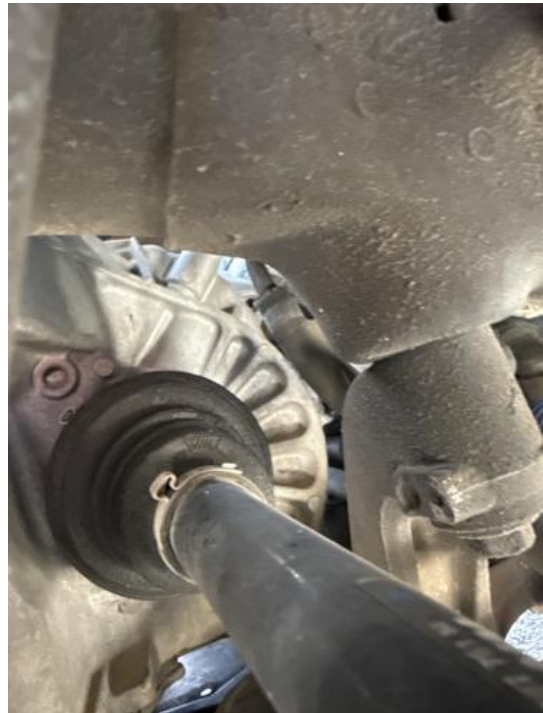
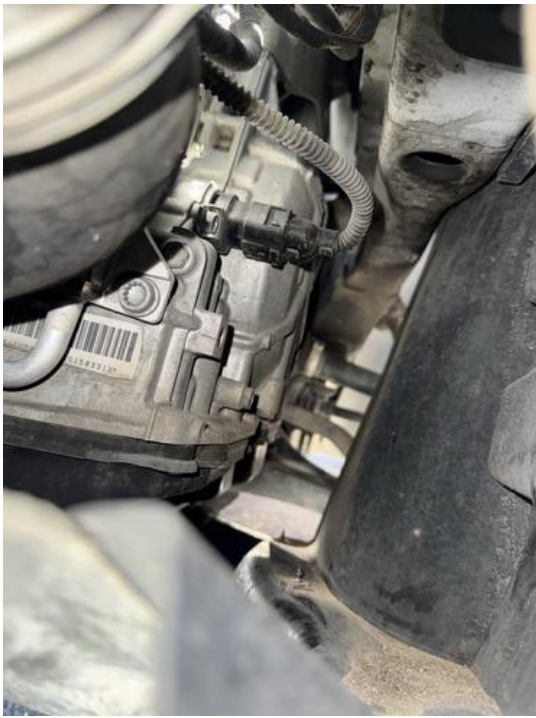
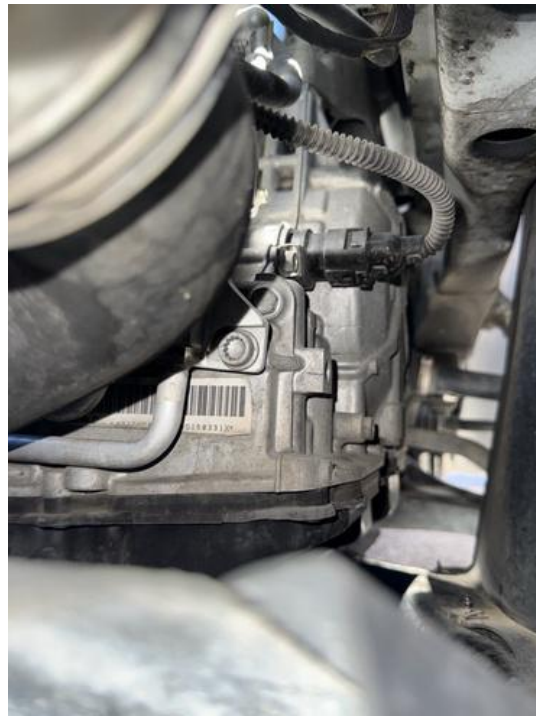
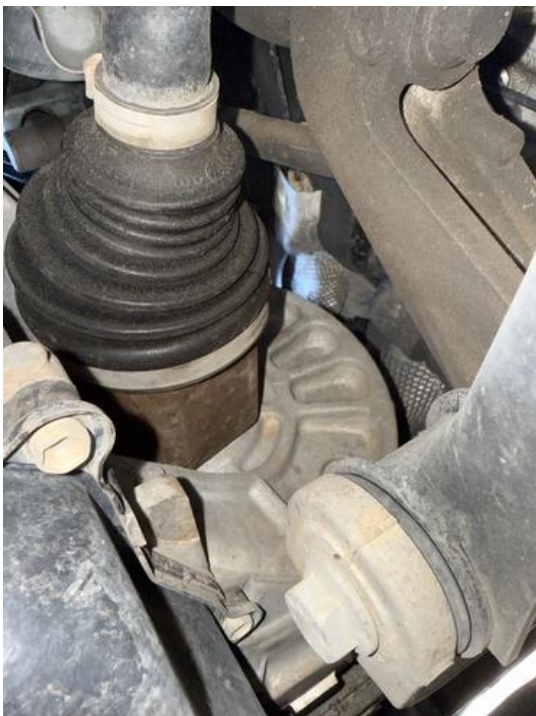
There's a very small amount of fluid residue noticed around the front differential near the passenger side. Axle seal, there was no fresh fluid able to be collected however, a future repair to expect may be replacement of the axle seal.

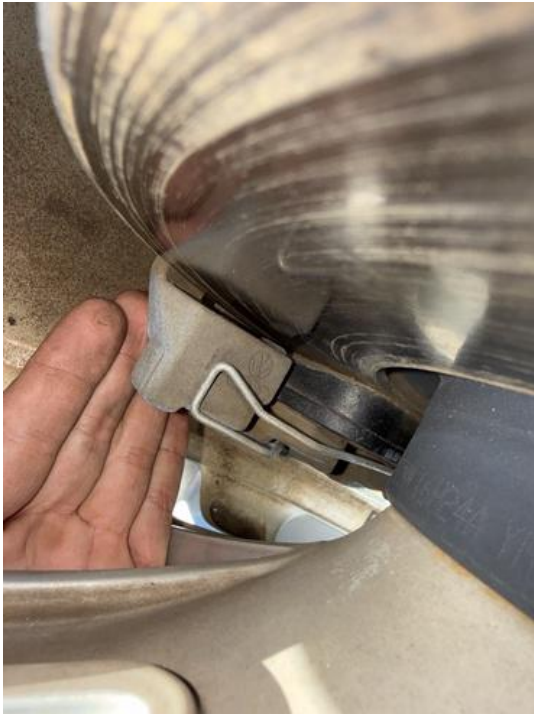
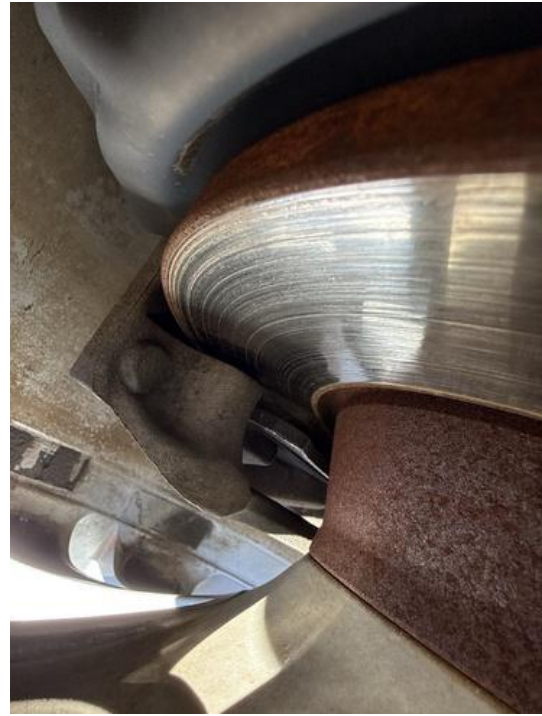
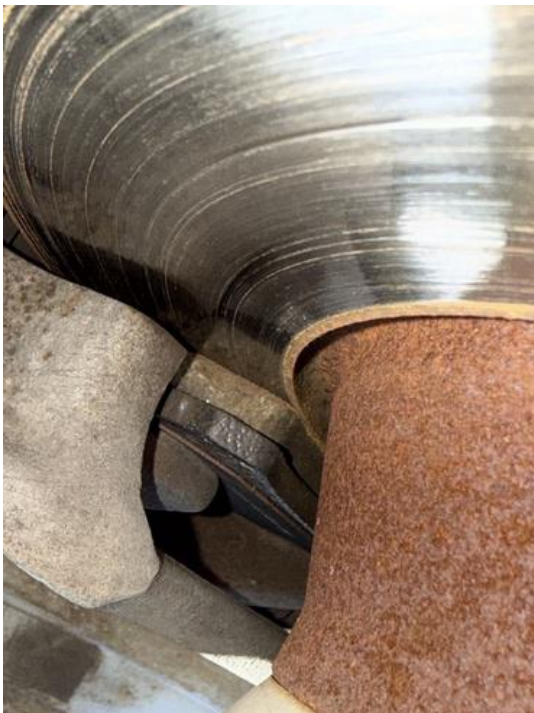
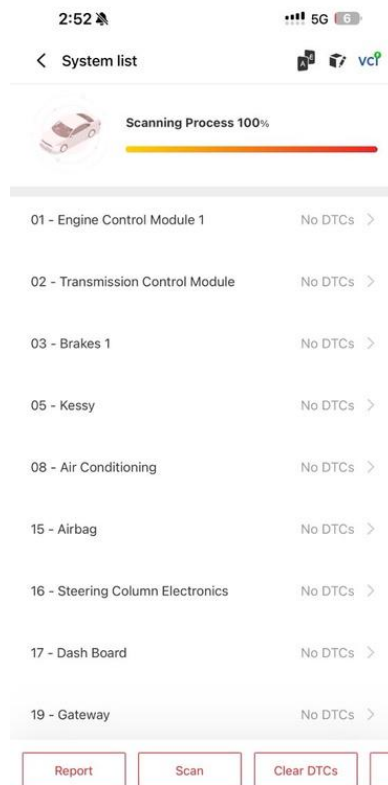
Braking system condition	
Brake fluid condition	Healthy
Brake fluid level	Healthy
Brake fluid leaks	None
Moisture content in brake fluid	None
Brake lines	Healthy
Brake calipers front	Healthy
Brake calipers rear	Healthy
Brake drums rear	N/A
Brake rotors front	Healthy
Brake rotors rear	Healthy
Front brake pad life remaining	75-100% remaining
<p>There seems to have been relatively recent service to both the front and rear brake system. Brake pads have been recently replaced on both the front and rear and have over 85% pad life remaining.</p>

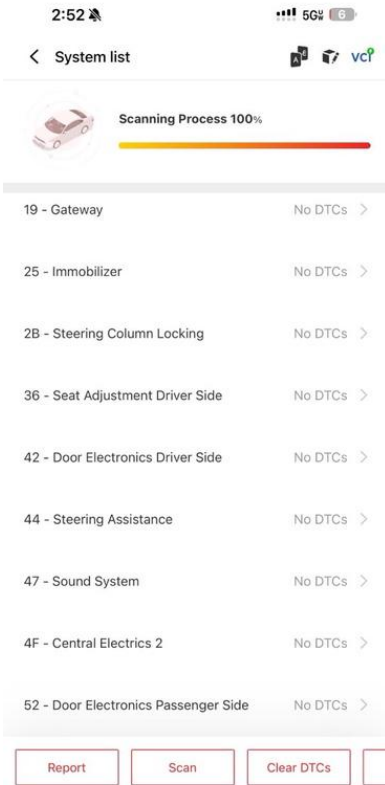
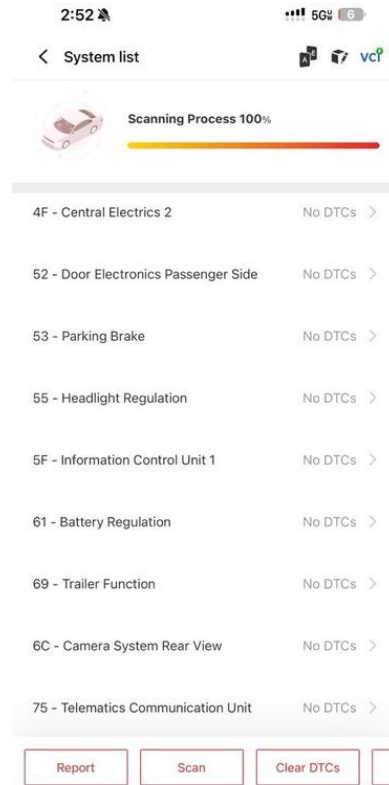
All of the main control modules on the vehicle were free of any new live/active diagnostic fault codes. All of the live feed diagnostic test testing was successfully passed. At the time of the inspection there were no active warning lights present.
