Peace of Mind Automotive Inspection Report.

Score	4 / 4 (100%)	Flagged items	0	Actions	0
Site conducted					Unanswered
Customer name					Luis Imj auto motor sales
Date / Time					June 2nd
Payment method					Invoice
Inspection cost					Fleet
Vehicle Year / Make / Model / Color					2017 Lexus RC 350
VIN					016903 last 6

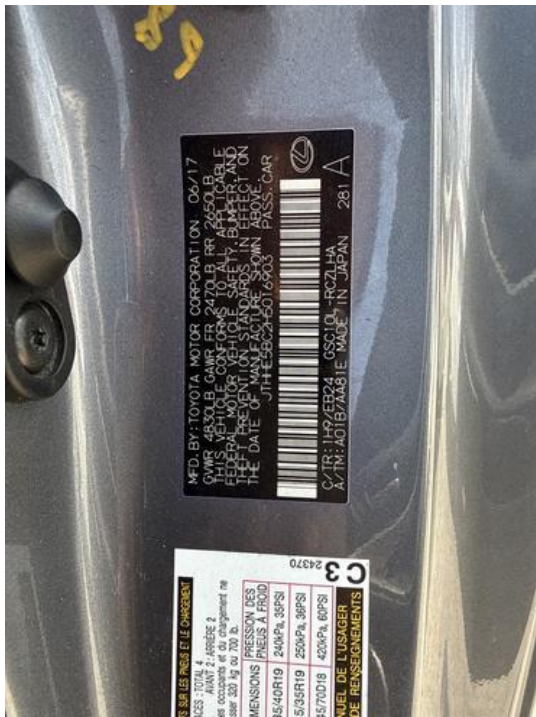
Photo 1					
license plate					Dealer
Mileage					147214
Color					Grey

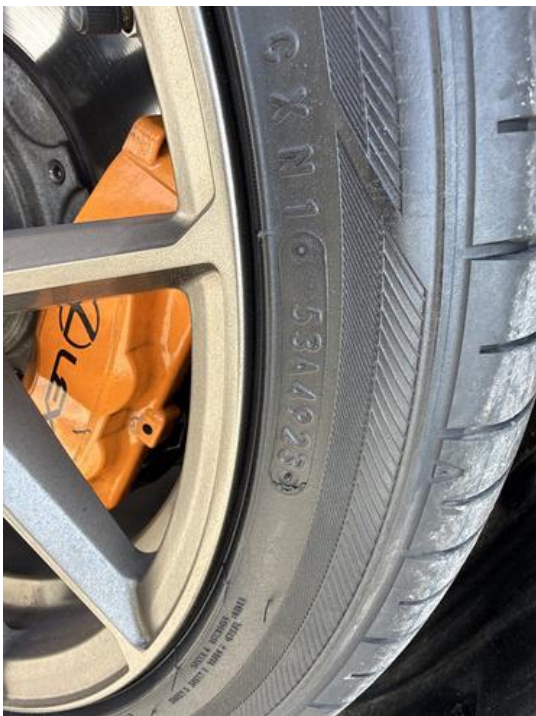
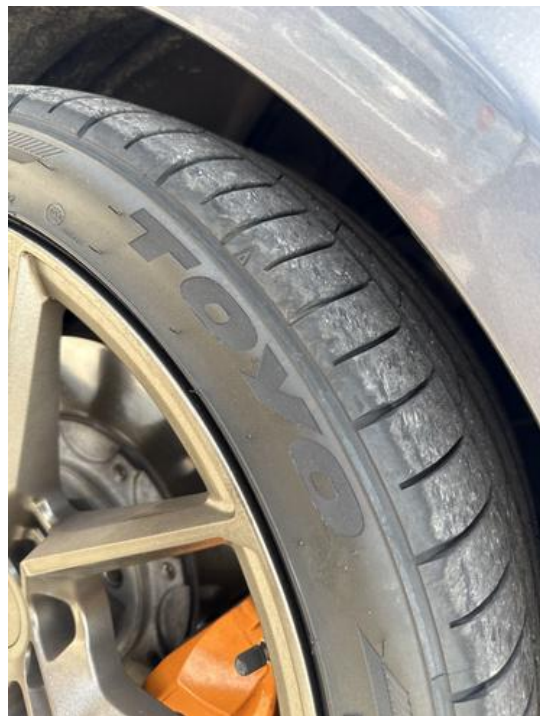
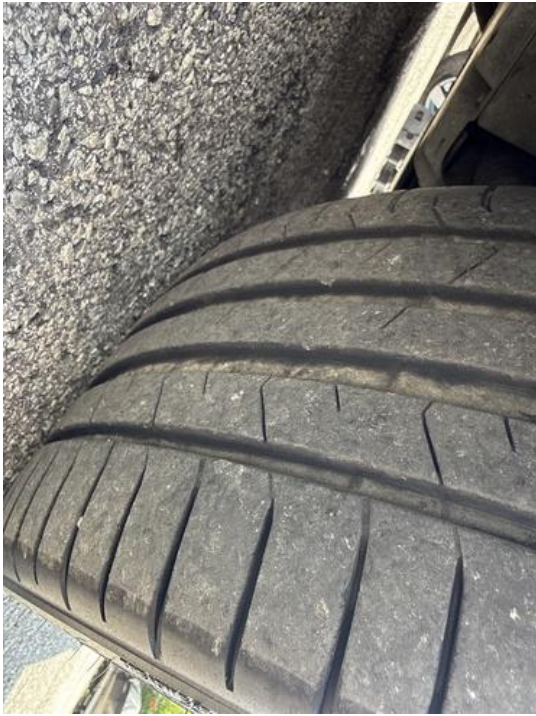
Front driver side tire

75-100% remaining

All four tires are matching in and healthy condition. Tires have been recently replaced and have over 85% tread life remaining all around.

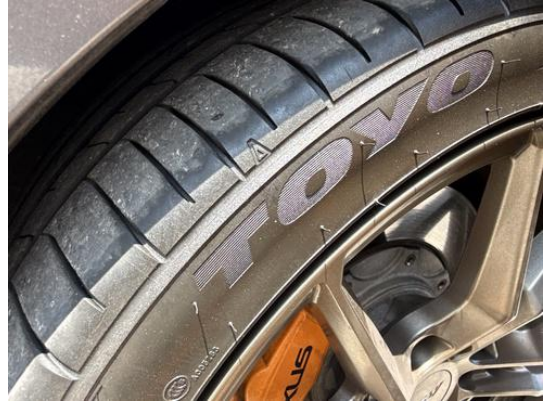
Photo 114

Front passenger side tire

75-100% remaining

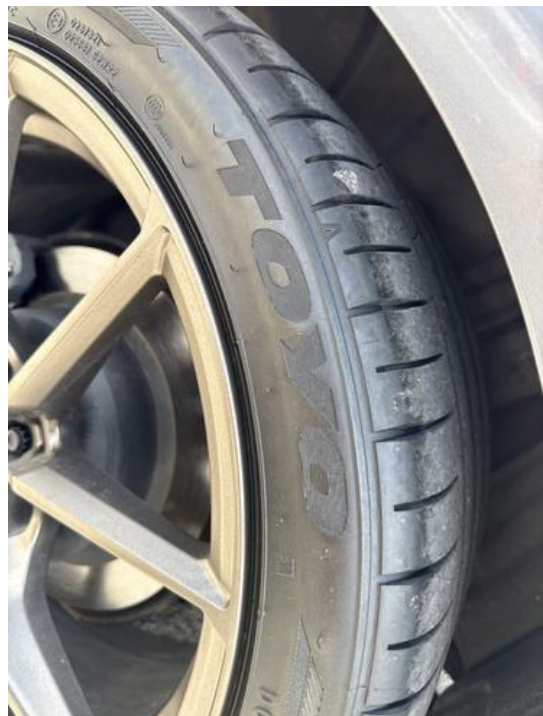
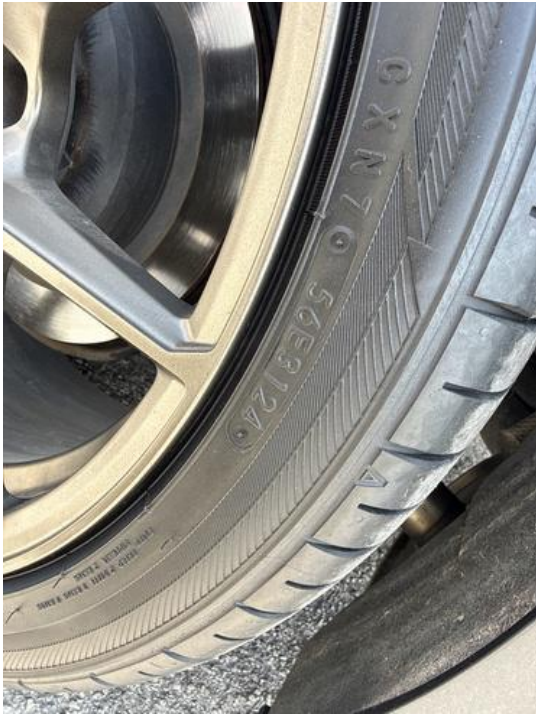
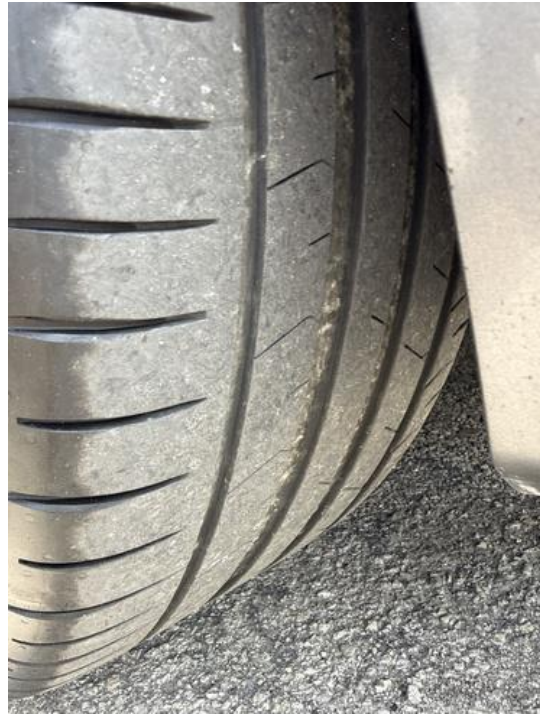
Rear driver side tire

75-100% remaining

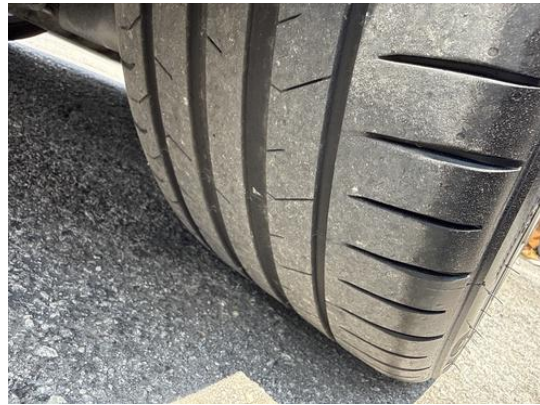
Photo 120

Rear passenger side tire

75-100% remaining

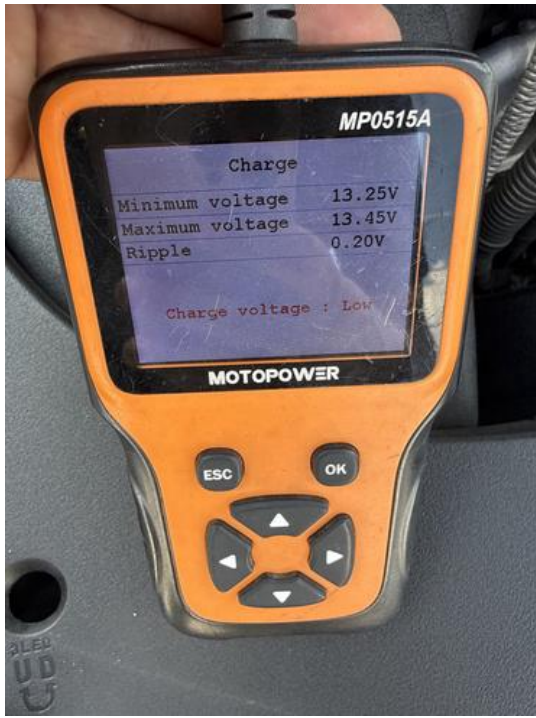
Photo 121

Battery date 08/24

Standing voltage 12.8

Loaded voltage 14.1

Battery is accepting the charge from the alternator and the alternator charge output is correct

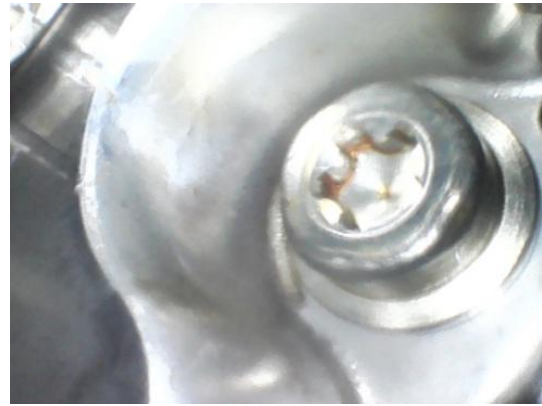
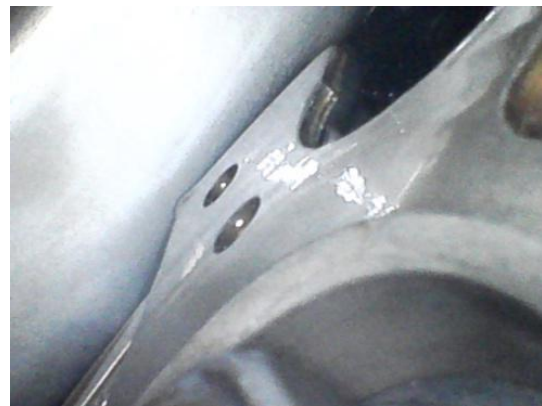
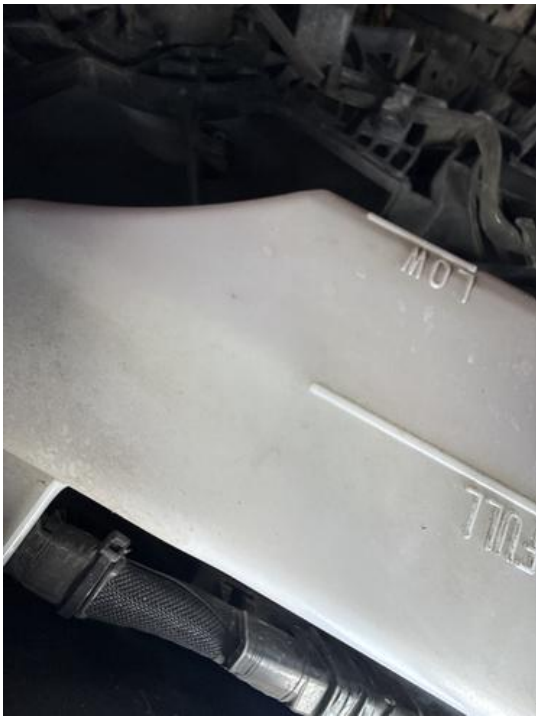
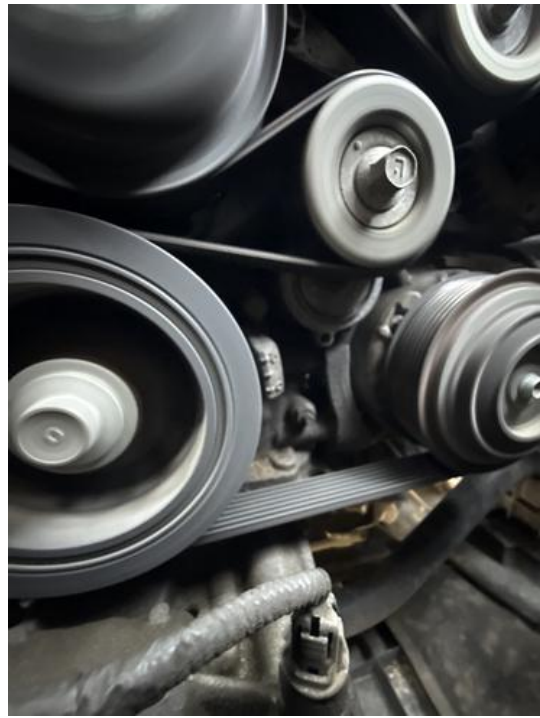
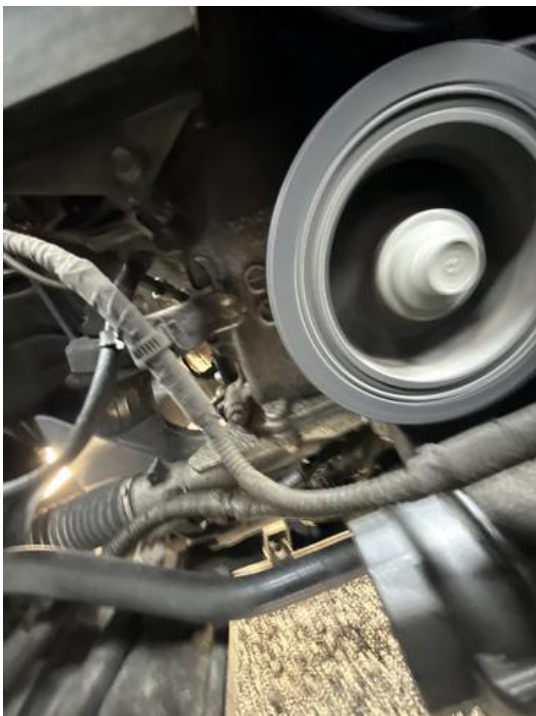
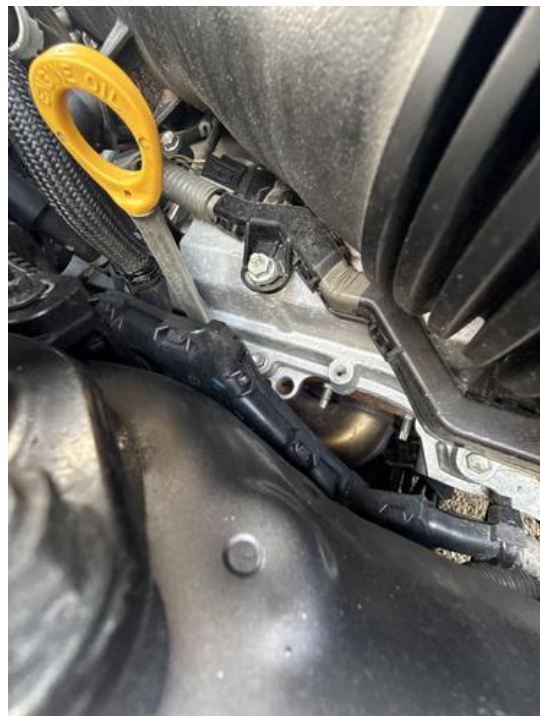
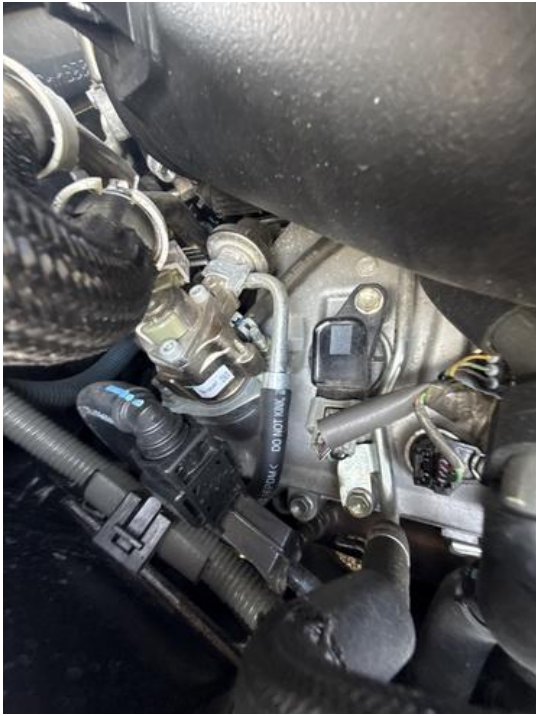
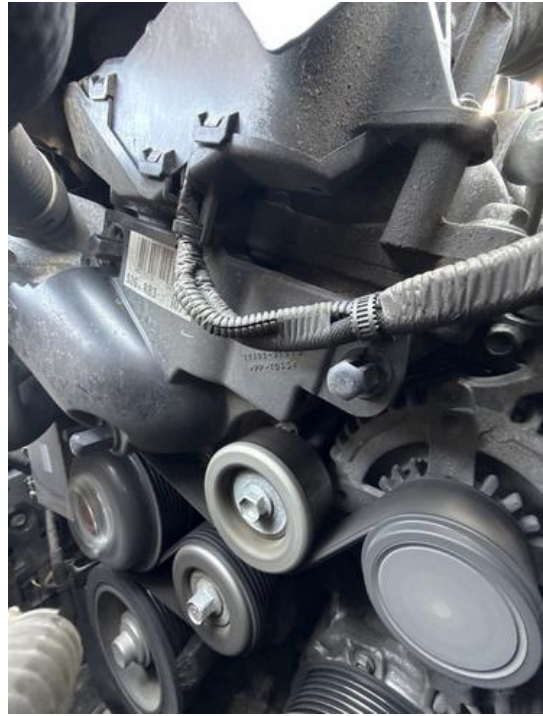
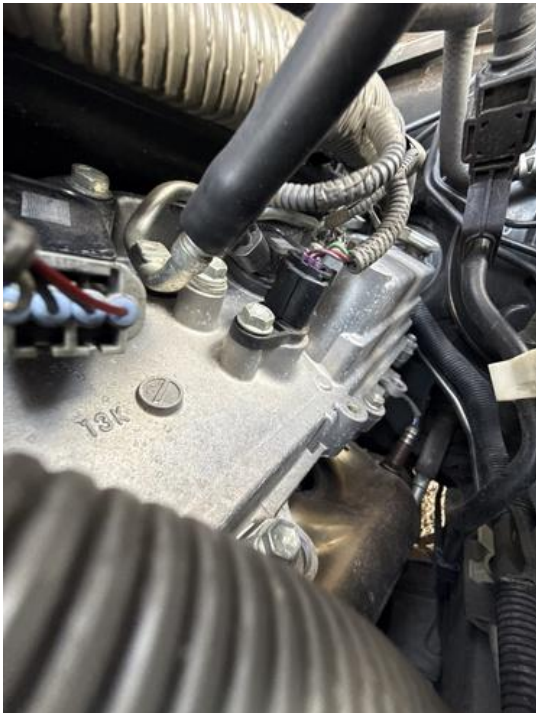
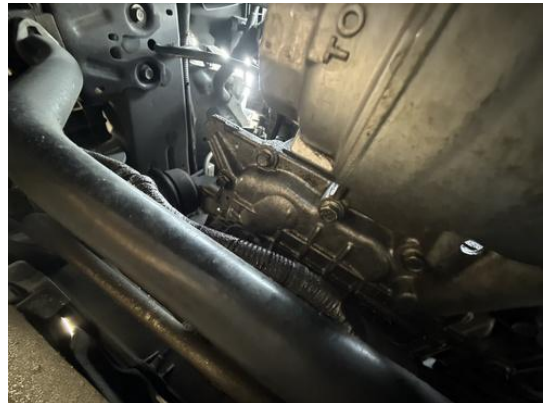
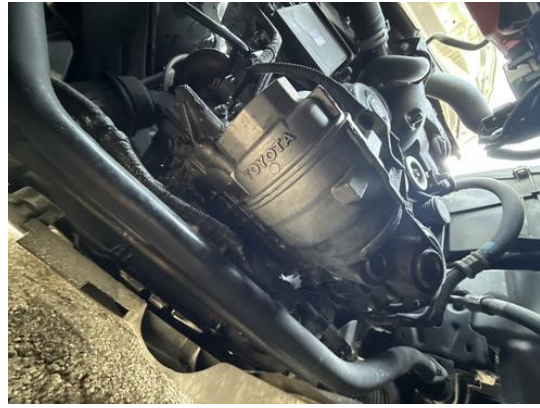
Internal engine inspection w/ borescope camera

Engine clean internally, no gunk or sludge presents. Proper signs of maintenance present. Block test passed, no internal combustion leak out. Coolant mixture correct and cooling system functionality is healthy. All external engine accessories in good working. No leaks or seepage from anywhere on the engine. External drive belts in decent condition. Currently no concern in mechanical issues present in relation to the engine or related accessories.

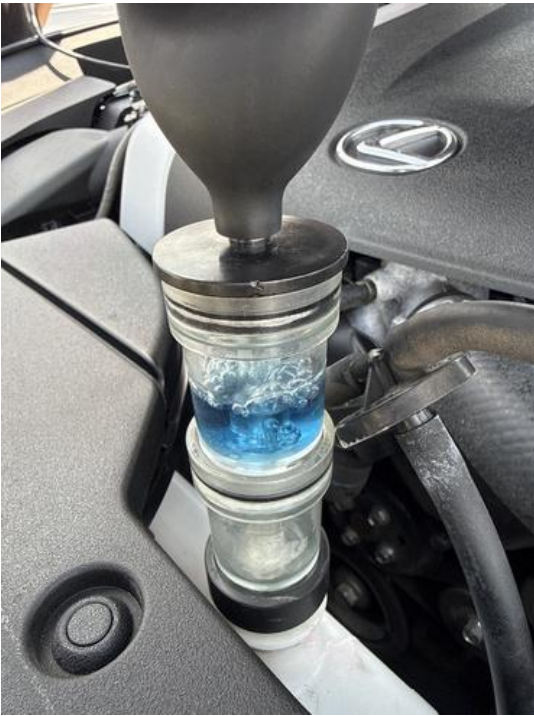
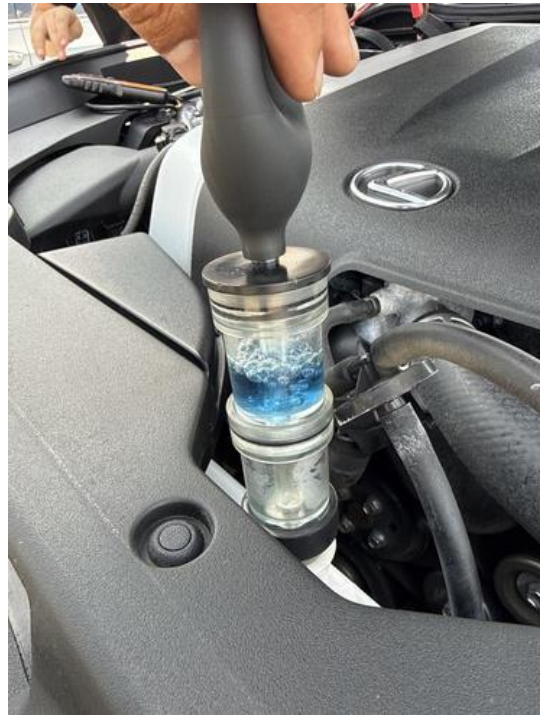
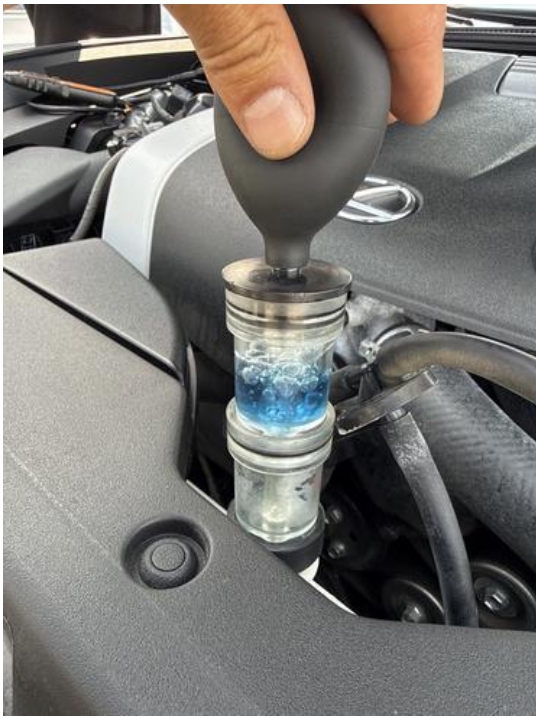
Engine block test

Pass

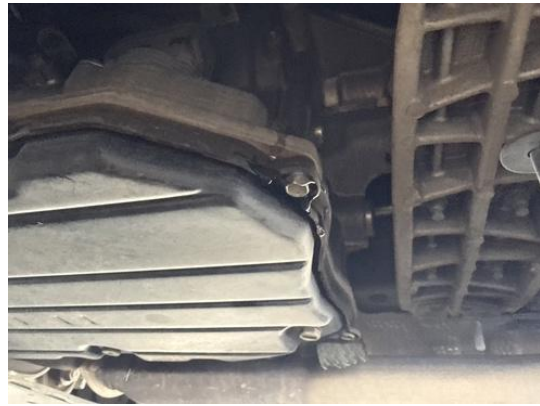
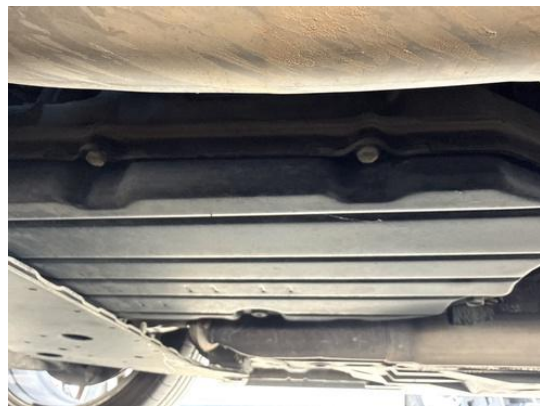
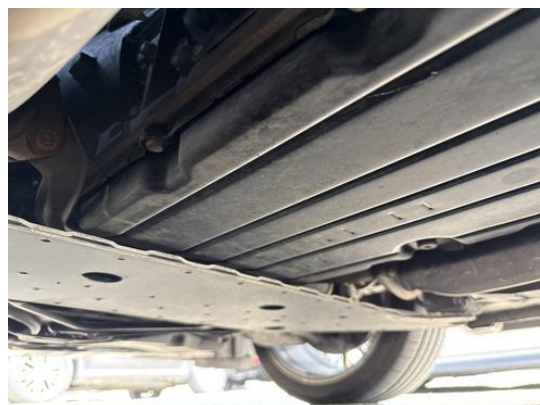
No transmission fluid leaks from the transmission casing or the transmission pan area. The tail shaft seal is free of any fluid leaks. The driveshaft is in healthy condition. Shift transitions out on the road are correct across the board. No fluid leak out from the rear differential.

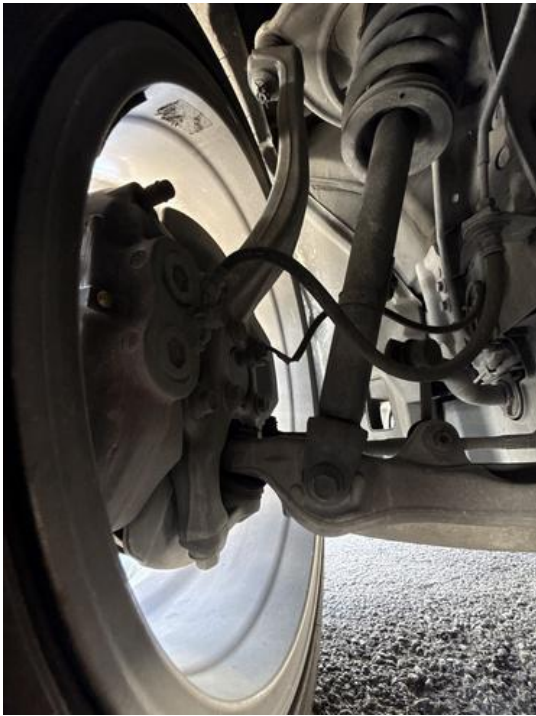
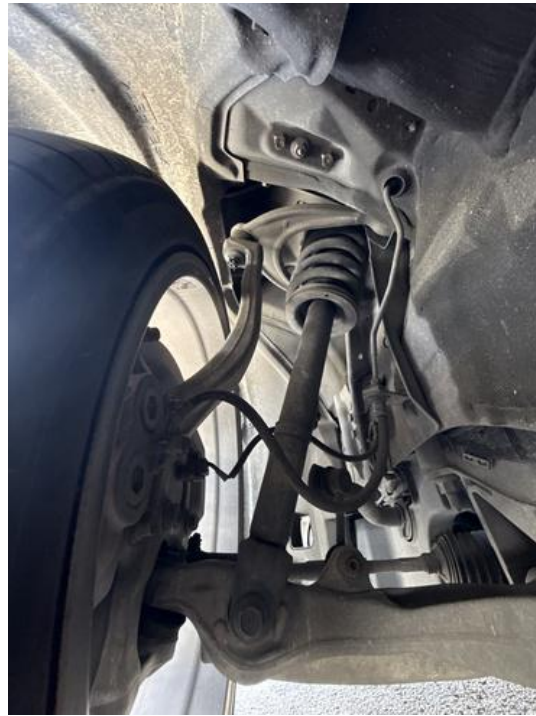
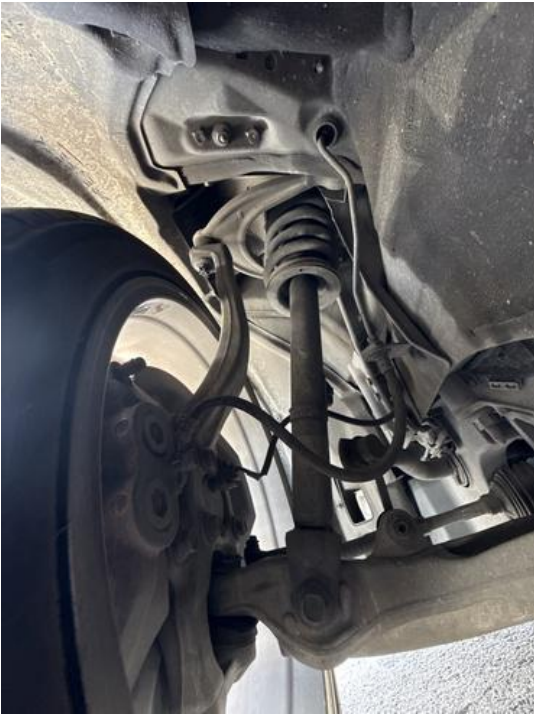
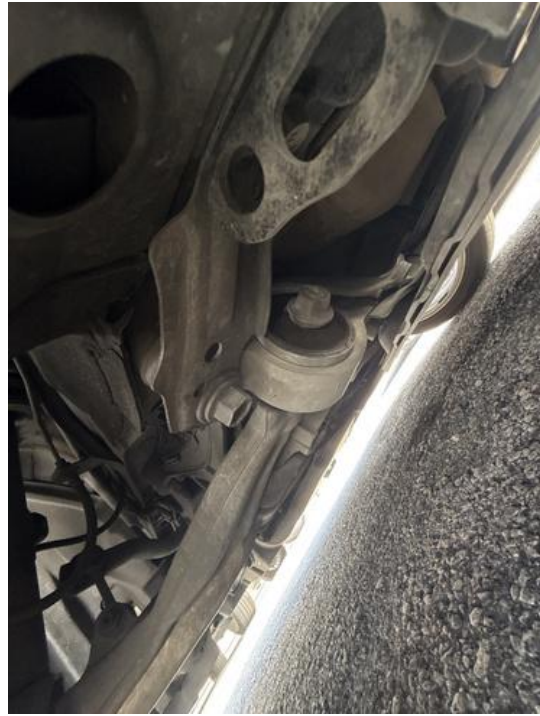
Front shocks / struts

Healthy

Normal fatigue notice to the suspension components. All of the suspension components seem to be original. None of the suspension components are blown out and due form the replacement. The No excessive surface rust on the exposed metal. No abnormal noise or feedback from the suspension while out on the road. All of the rubber in relation to the mounts, joints and bushings has decent texture.

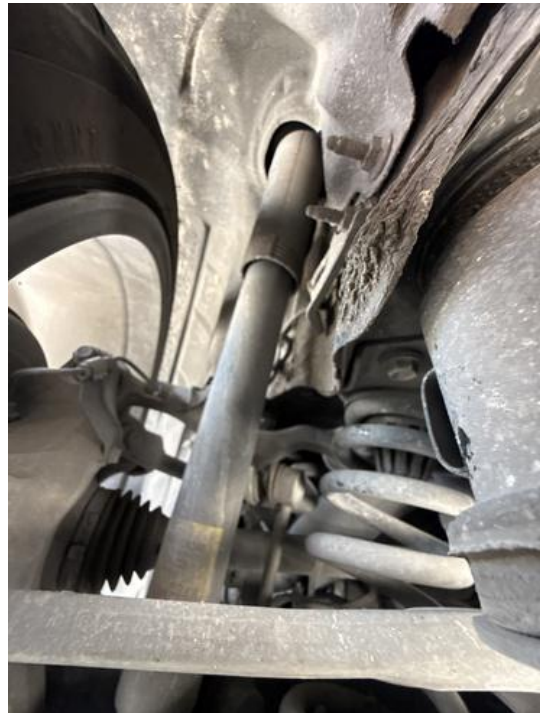
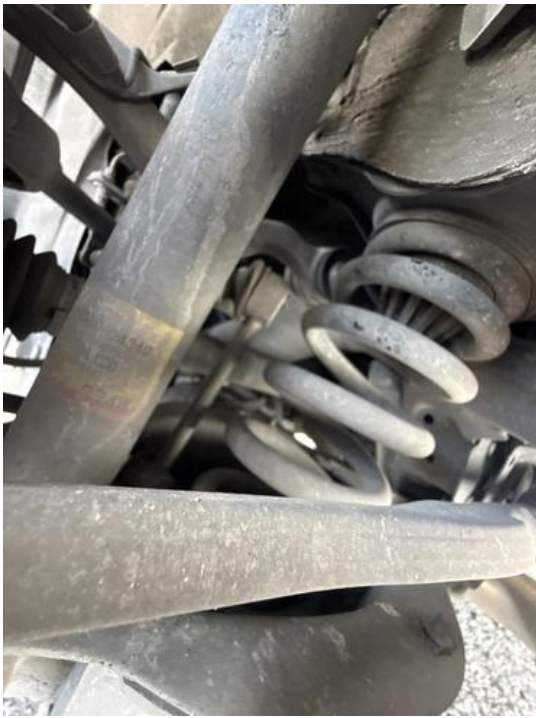
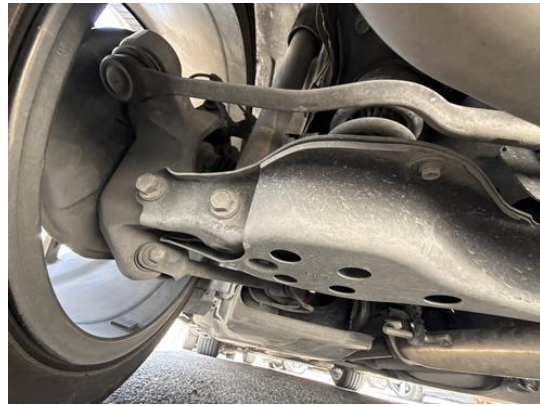
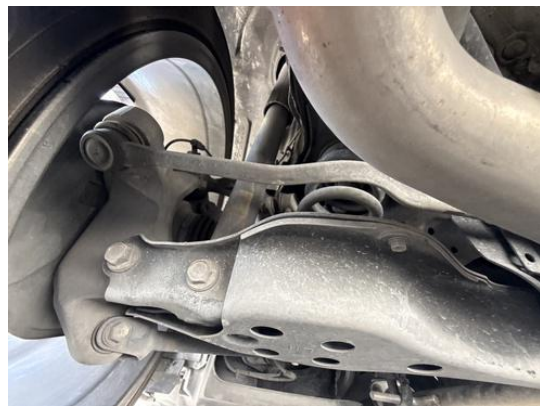
Rear shocks / struts

Healthy

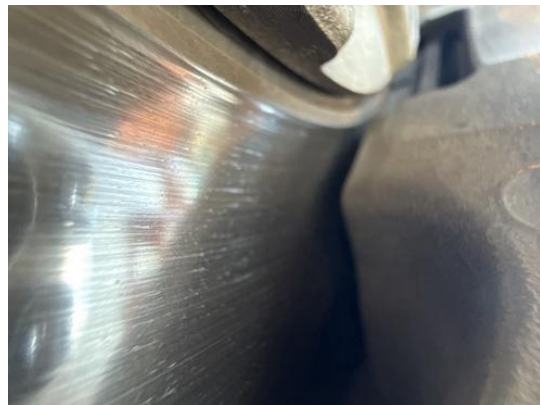
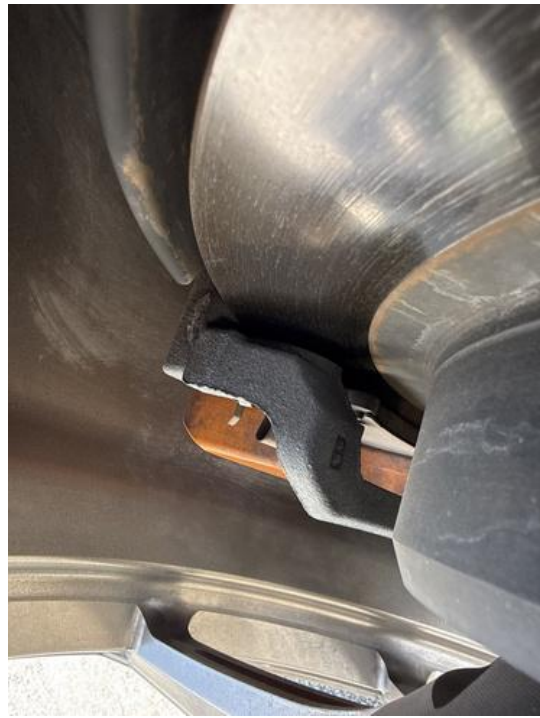
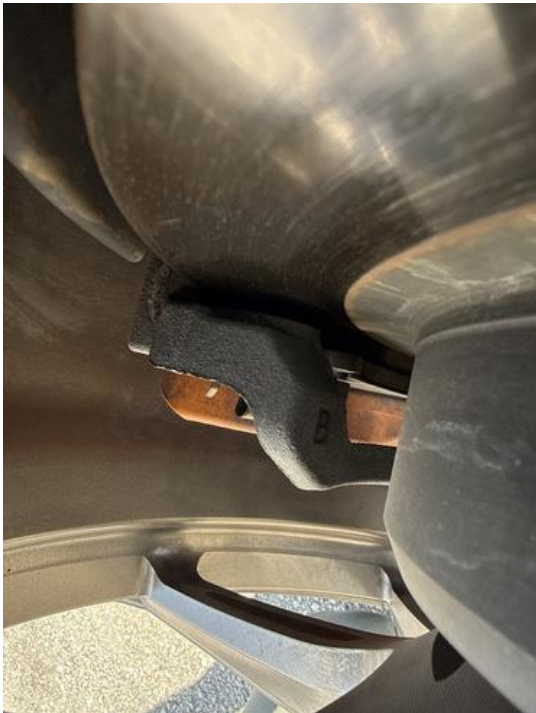
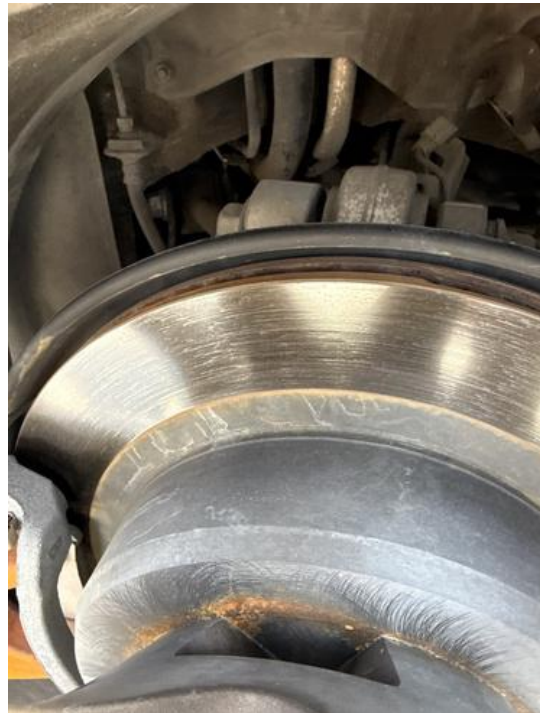
Braking system condition		
Brake fluid condition	Healthy	
Brake fluid level	Healthy	
Brake fluid leaks	None	
Moisture content in brake fluid	None	
Brake lines	Healthy	
Brake calipers front	Healthy	
Brake calipers rear	Healthy	
Brake drums rear	N/A	
Brake rotors front	Healthy	
Brake rotors rear	Healthy	
Front brake pad life remaining	50-75% remaining	
<p>Right around 65% brake pad life remain remaining on the front brake system and right around 75% brake pad. Life remain remaining on the rear brake system.</p>

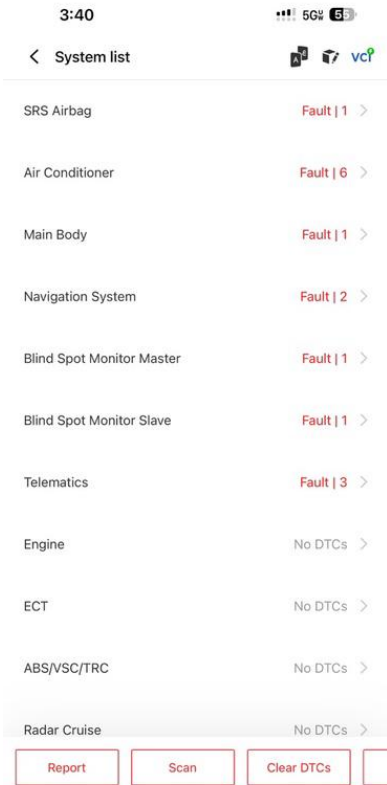
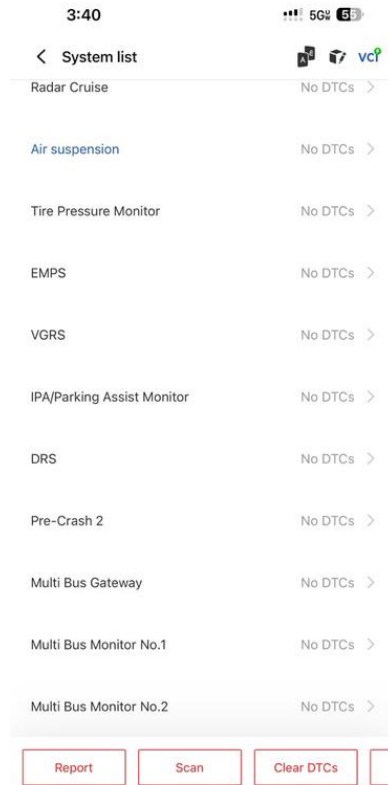
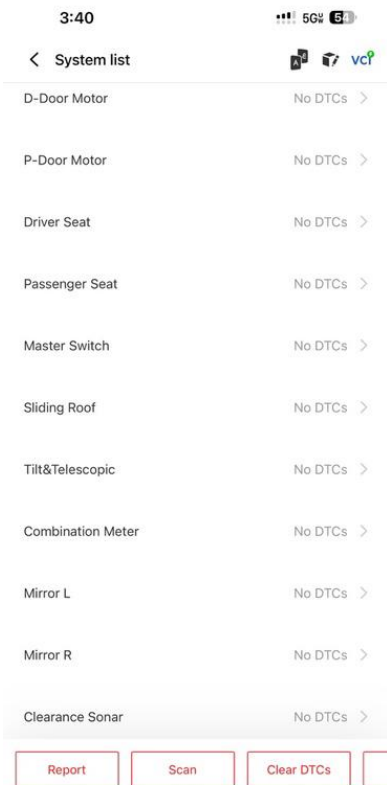
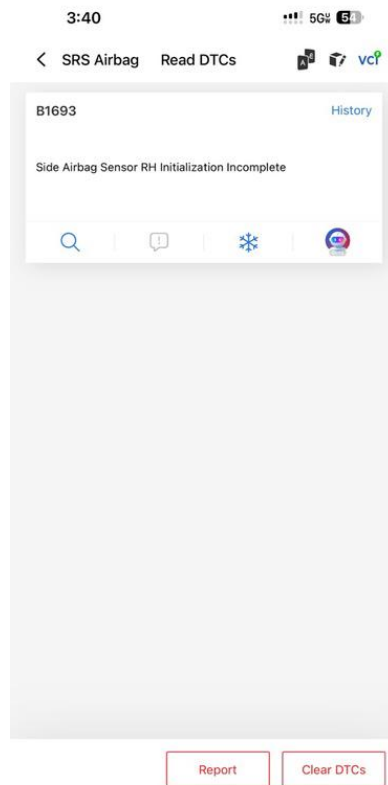
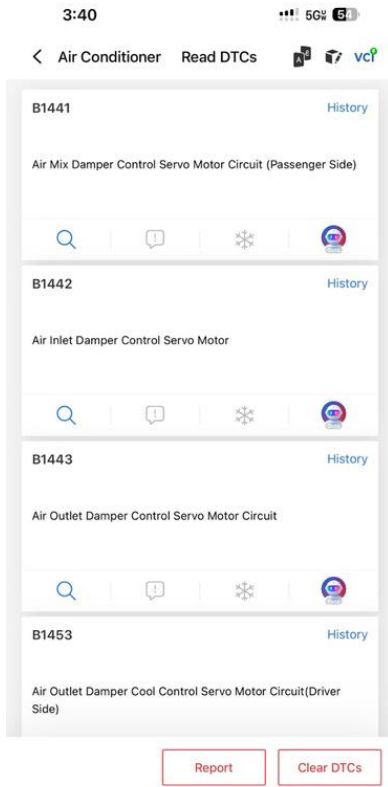
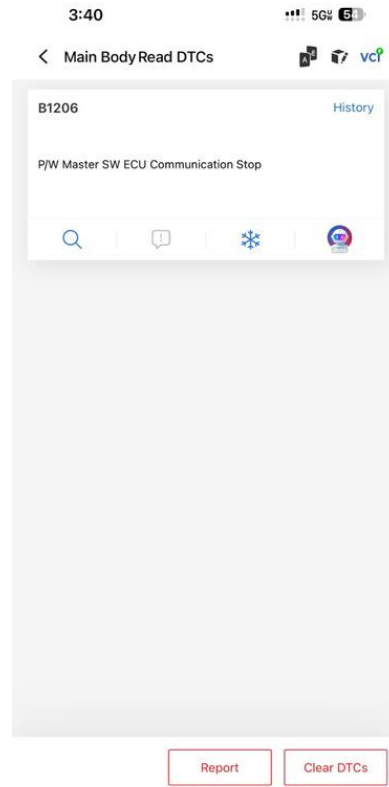
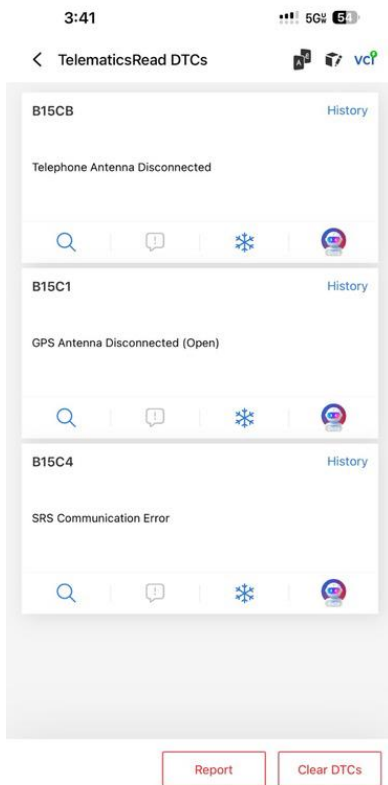
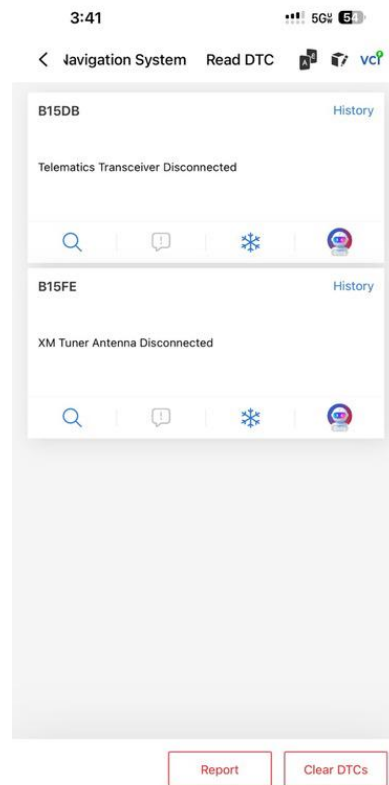
Engine control module

Healthy

All of the main control modules on the vehicle were free of any live/active diagnostic fault code. At the time of the inspection there were no active warning lights present. All of the live feed diagnostic test testing was successfully passed. There were a few different historical diagnostic fault codes that were present however, with these fault codes being inactive, there is no attention needed. This is just evidence of fault codes that have popped up in the past.
