Peace of Mind Automotive Inspection Report.

Site conducted	Unanswered
Customer name	LMJ Auto motor sales
Date / Time	Dec 10th
Payment method	Invoice
Inspection cost	199
Vehicle Year / Make / Model / Color	2017 Ford F150

VIN	90662 last 5

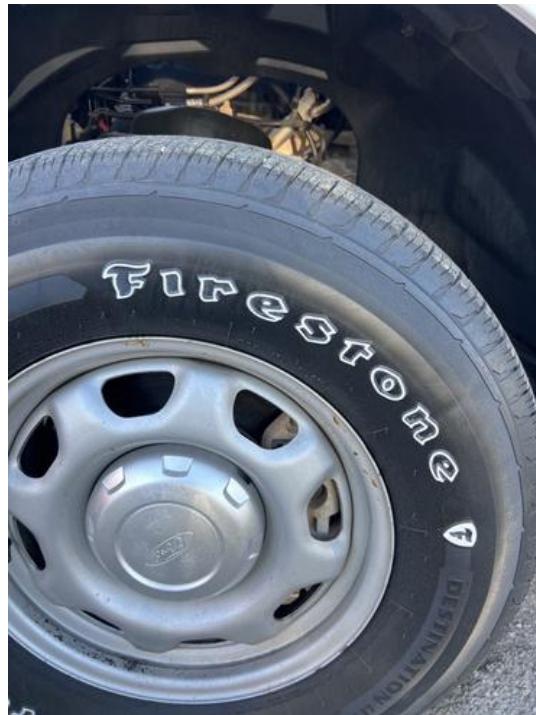
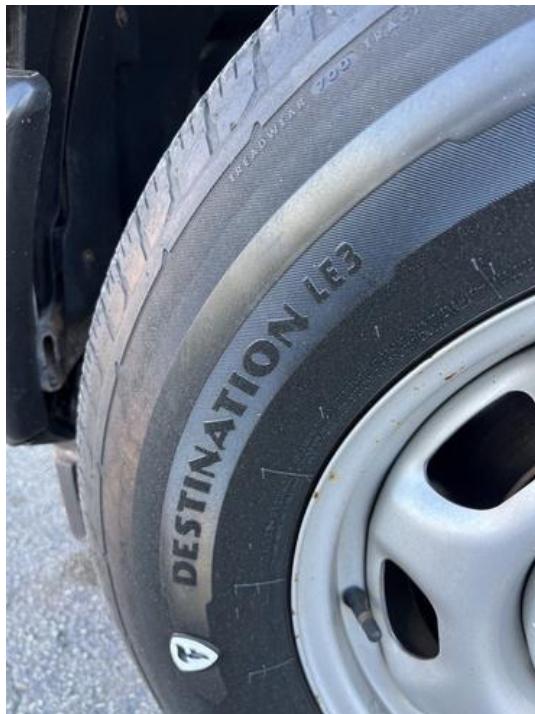
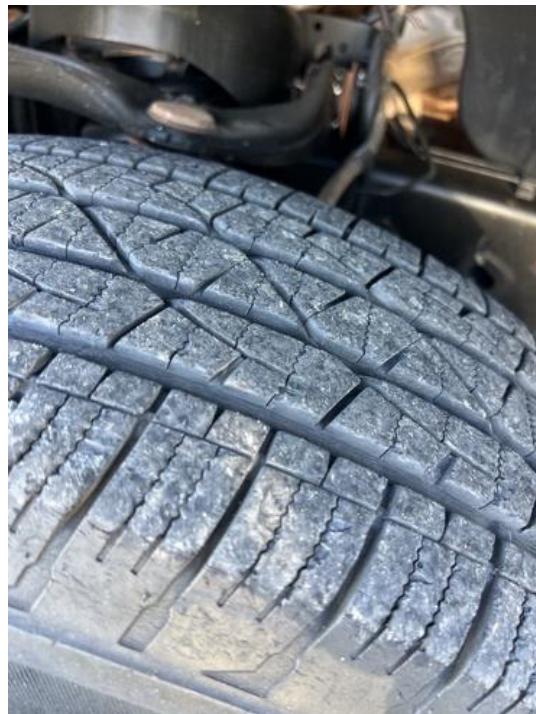
Front driver side tire

50-75% remaining

This tire has right around 50% tread life remaining, there are three different types of tire installed on the truck. All of the tires are road safe and the correct size.

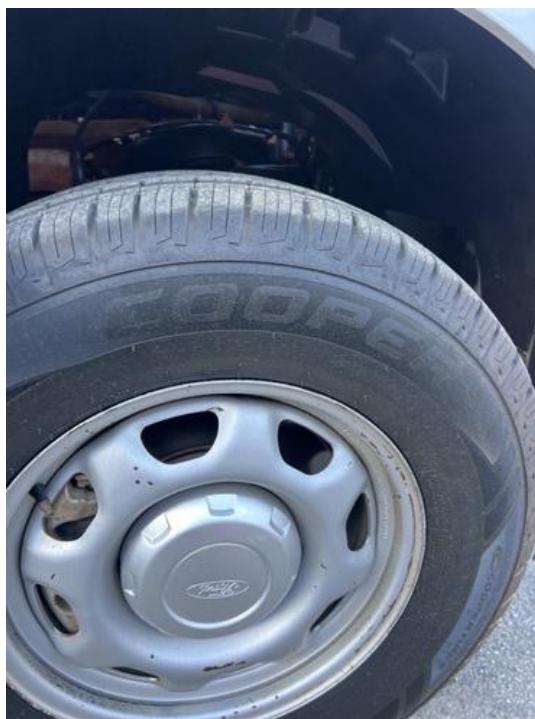
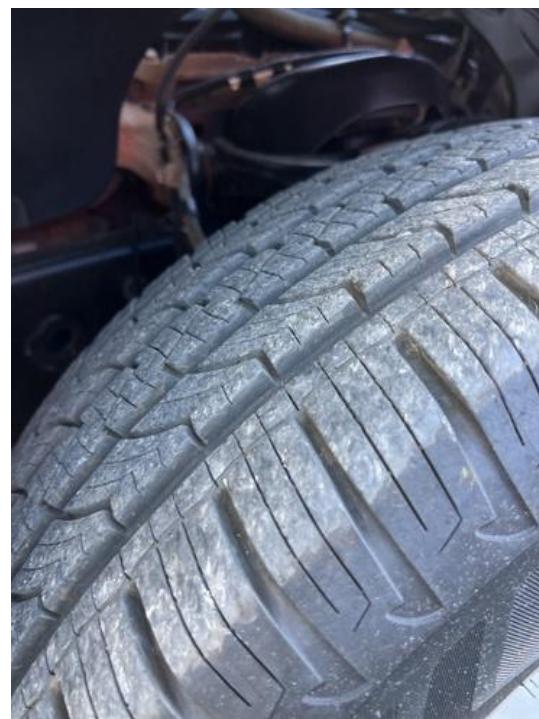
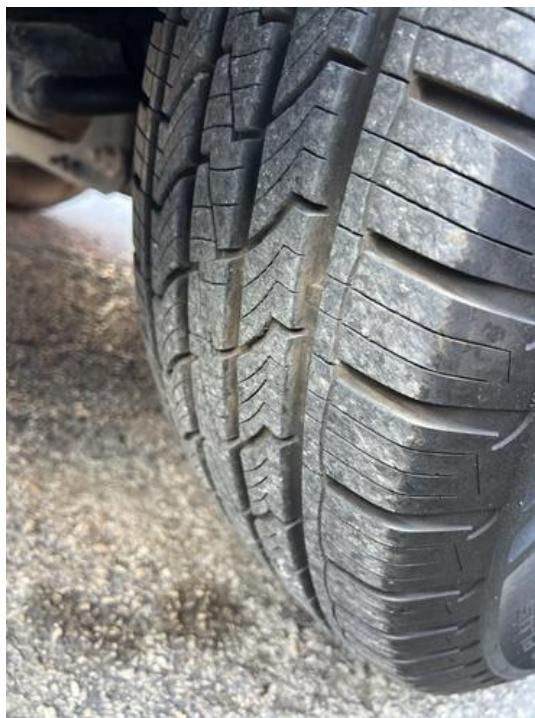
Front passenger side tire

75-100% remaining

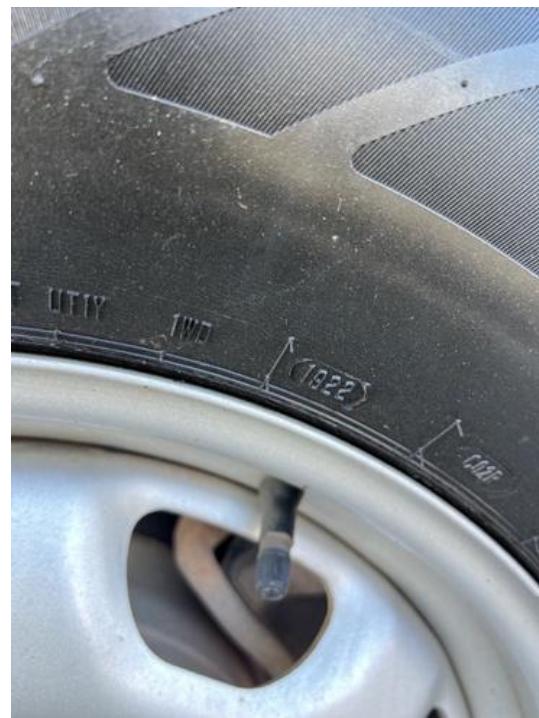
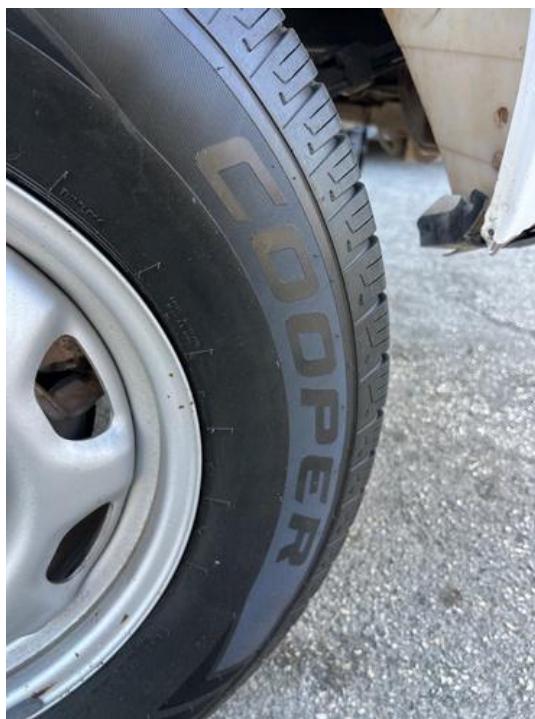
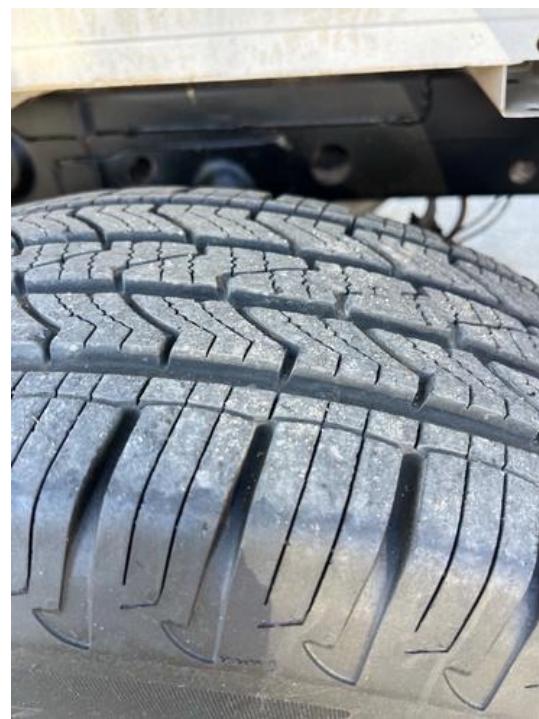
Rear driver side tire

75-100% remaining

This tire is dated from 2022 and has over 80% tread life remaining

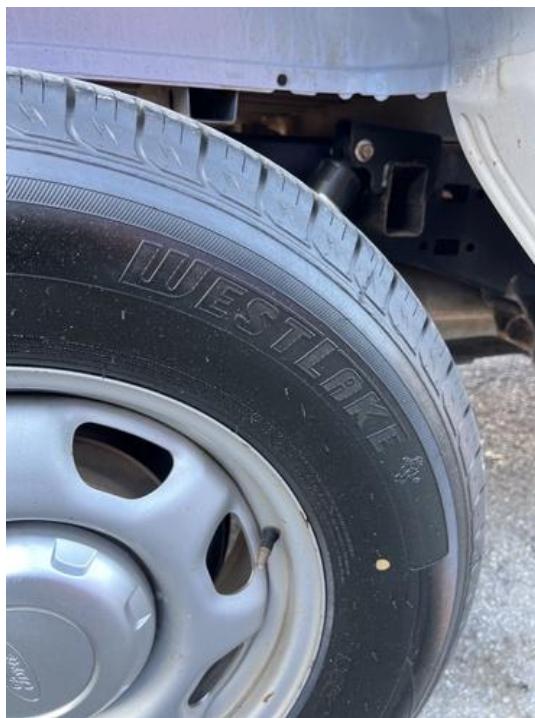
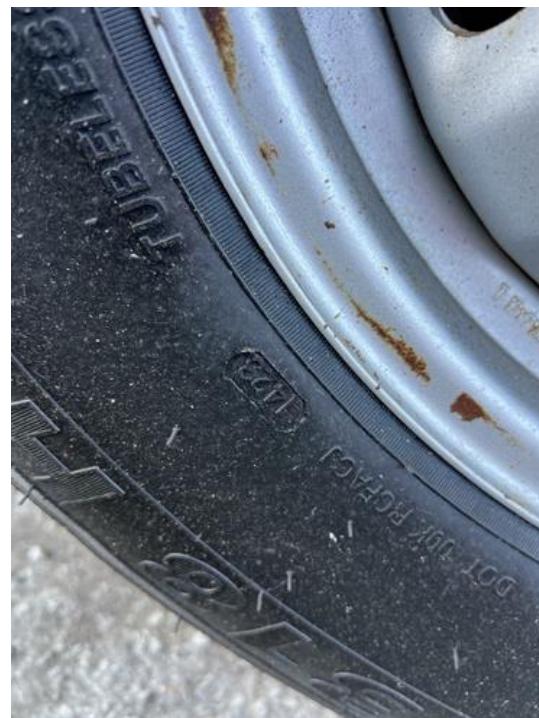
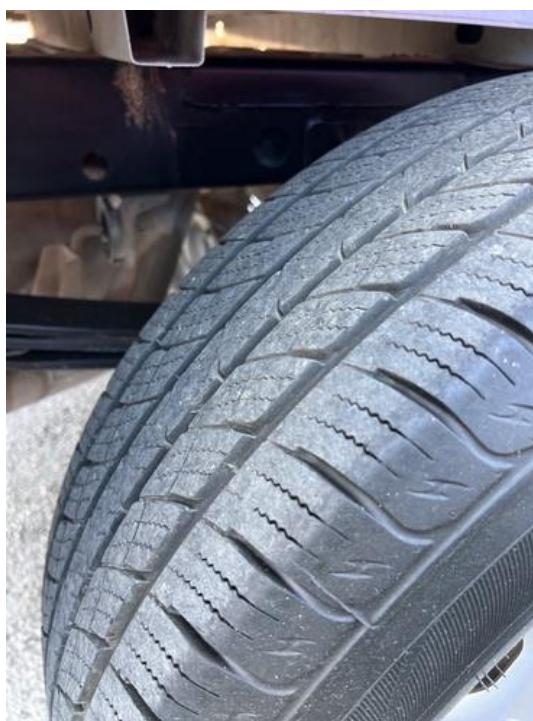
Rear passenger side tire

50-75% remaining

This tire has right around 60% tread life remaining

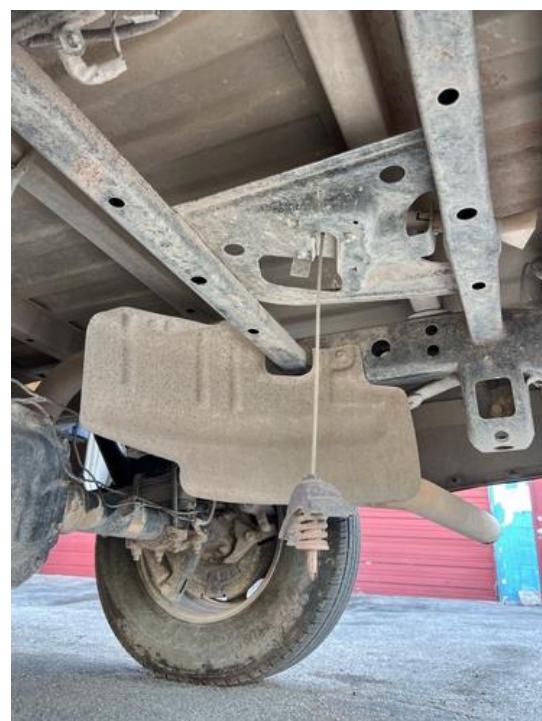
Photo 118

Spare tire and equipment

Missing spare / tools

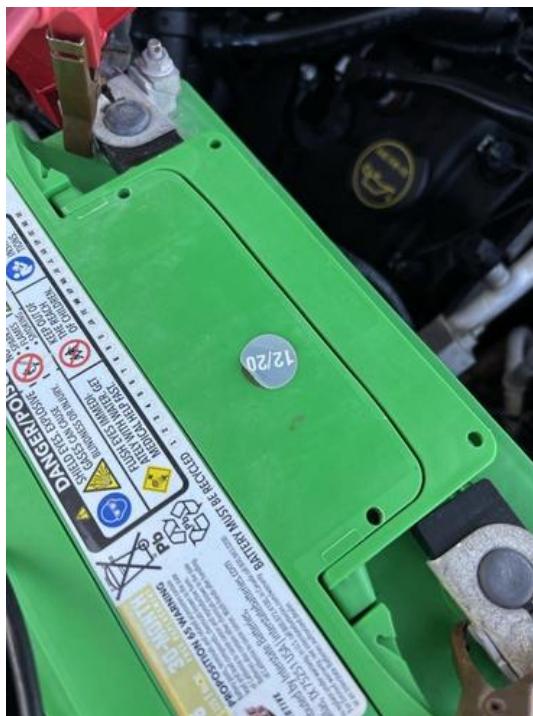
Photo 119

Battery date

Battery is aged and dated from December 2020

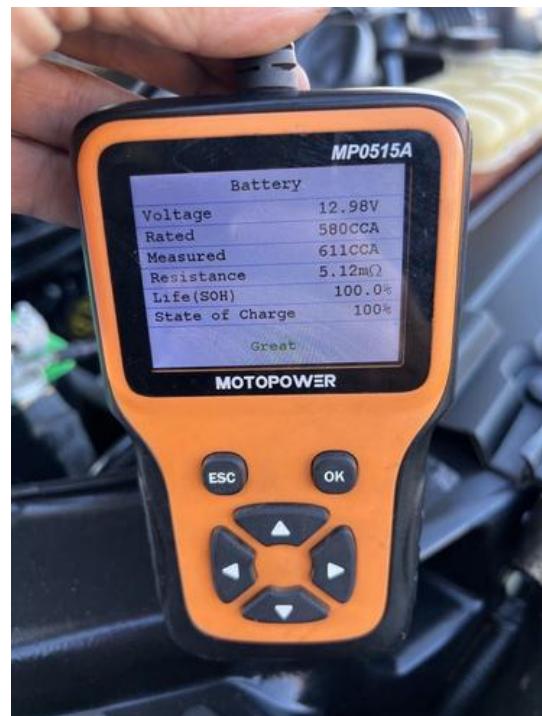
Photo 120

Standing voltage

12.98

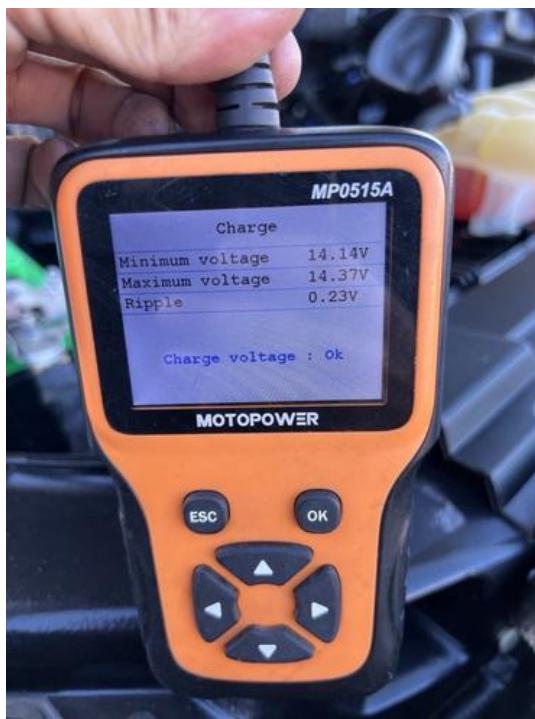
Photo 121

Loaded voltage

14.37

Battery is accepting the charge from the alternator and the alternator charge output is correct

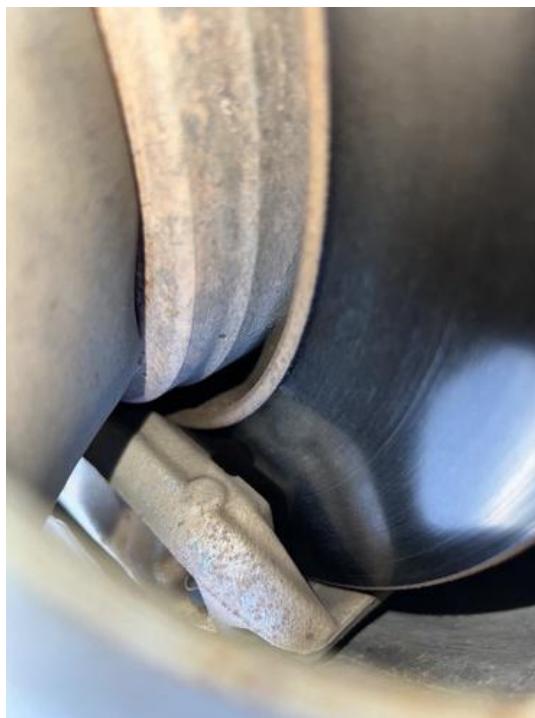
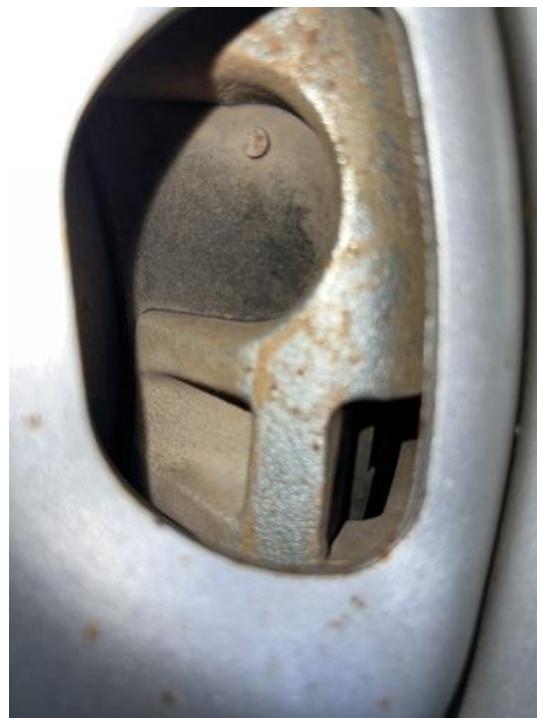
Brake fluid condition	Healthy
Brake fluid level	Healthy
Brake fluid leaks	None
Moisture content in brake fluid	None
Brake lines	Healthy
Brake calipers front	Healthy
Brake calipers rear	Healthy
Brake drums rear	N/A
Brake rotors front	Healthy
Brake rotors rear	Healthy
Front brake pad life remaining	50-75% remaining

Right about 55% brake pad life remaining

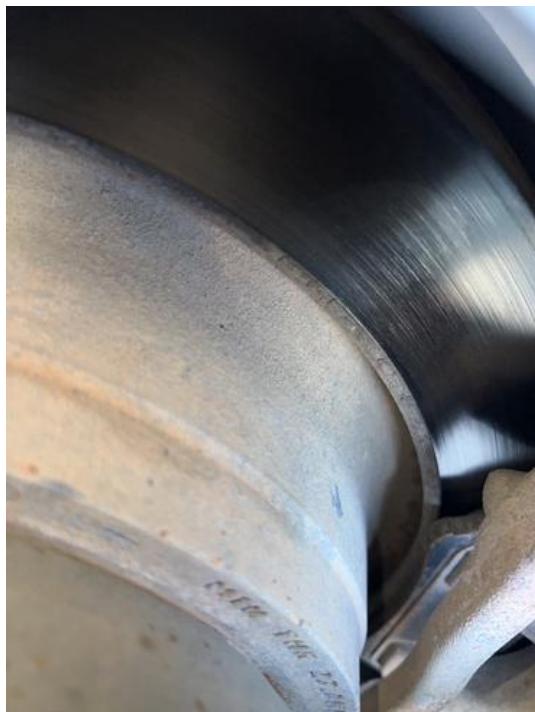
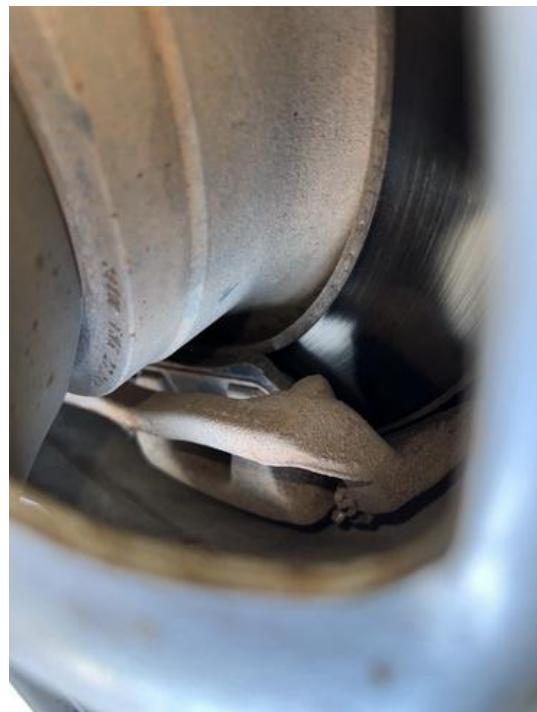
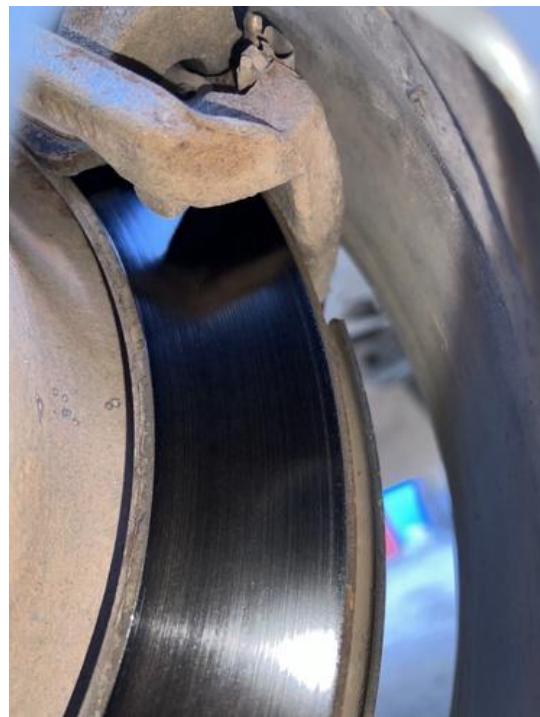
Rear brake pad life remaining

25-50% remaining

Right about 45% brake pad life remaining

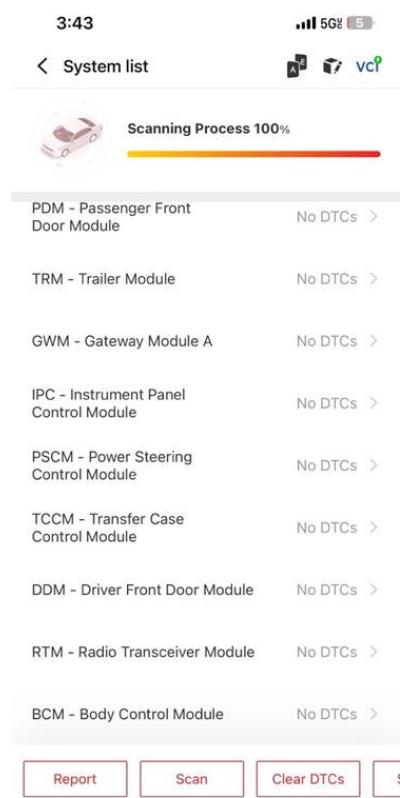
Photo 181

All of the control modules on the vehicle are free of any live/active diagnostic fault codes. All live feed diagnostic testing was successfully passed. All live feed emissions testing was successfully passed. There are no active warning lights present on the vehicle.
