Peace of Mind Automotive Inspection Report.

Site conducted	Unanswered
Customer name	Luis LMJ auto motor sales
Date / Time	Dec 30th
Payment method	Invoice
Inspection cost	Fleet
Vehicle Year / Make / Model / Color	2017 Honda accord
VIN	29878 last 5

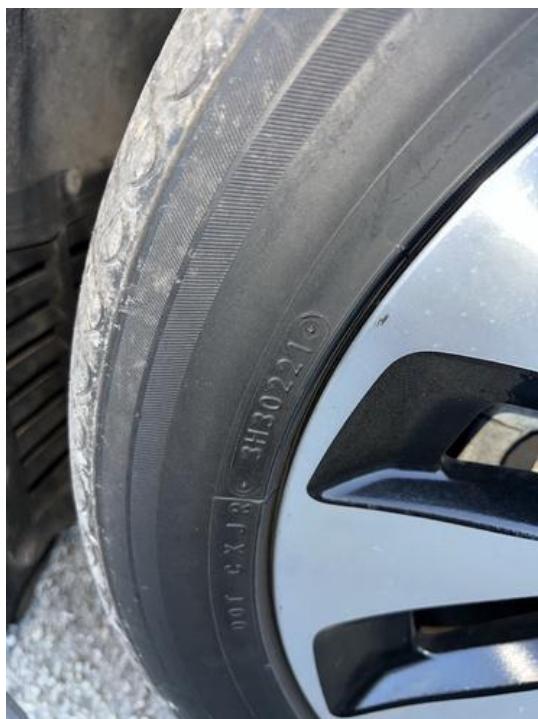
Photo 121

Both front tires are mismatched, the front driver side tire has Edgeware present and only around 35% tread life remaining. The front passenger side tire is in a little bit better condition and has right around 60% tread remaining. Neither of the front tires match the rear tires. There are three different tires installed on the vehicle.

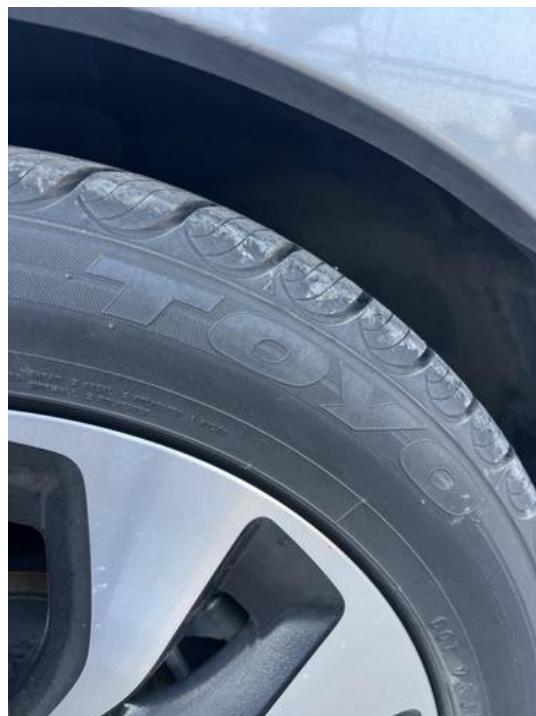
Photo 128

Both rear tires are matching from 2020, there is light dry rot noticed on the tread. Tires have right around 55% tread life remaining.

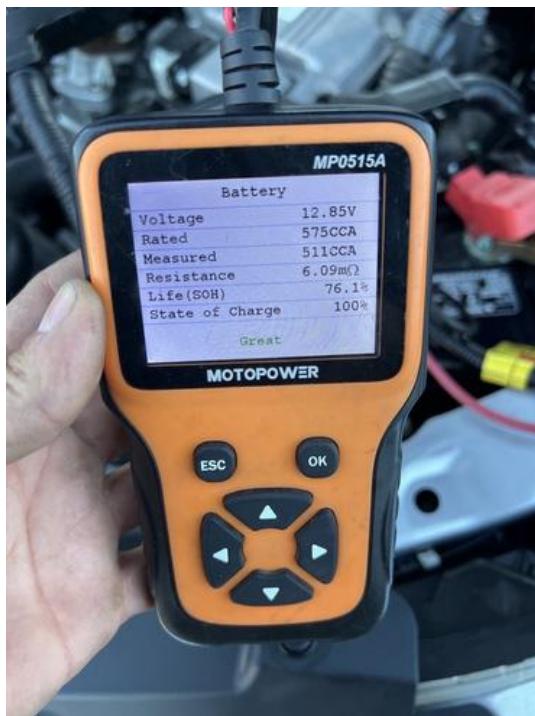
Photo 135

Battery is accepting the charge from the alternator and the alternator charge output is correct

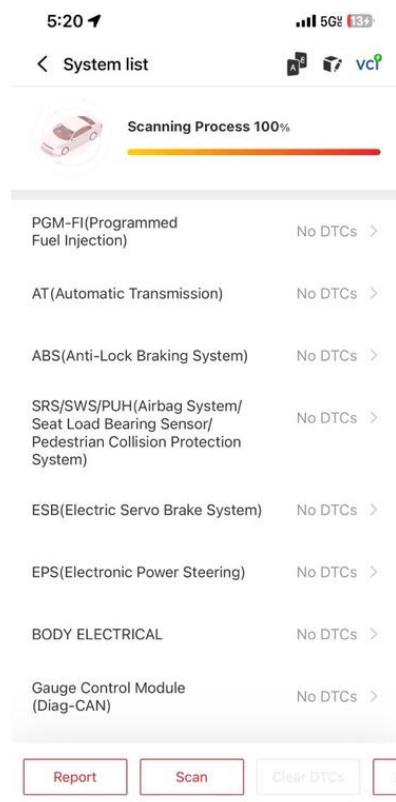
Photo 181

All of the control modules are free of any live/active diagnostic fault codes. All live feed diagnostic testing was successfully passed. All live feed emissions testing was successfully passed. There are no active warning lights present on the vehicle. Within the hybrid control module I was able to verify all of the battery cells Were within proper tolerance.
