Peace of Mind Automotive Inspection Report.

Score	4 / 4 (100%)	Flagged items	0	Actions	0
Site conducted					Unanswered
Customer name					Luis LMJ auto motor sales
Date / Time					April 6th
Payment method					Invoice
Inspection cost					Fleet
Vehicle Year / Make / Model / Color					2017 Nissan versa
VIN					66814 last 5

license plate					Dealer
Mileage					67666
Color					White

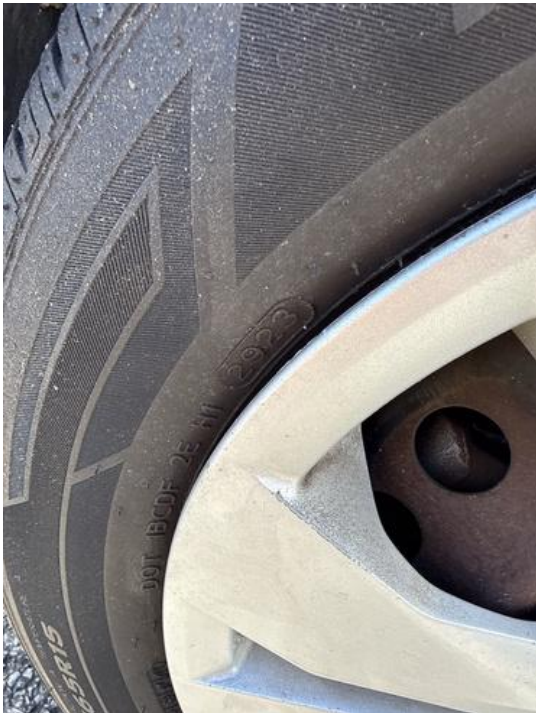
Photo 103

All four tires are matching. Tires are dated from 2023. Tires have right around 70% tread life remaining all around on both the front and rear. All four tires are road safe.

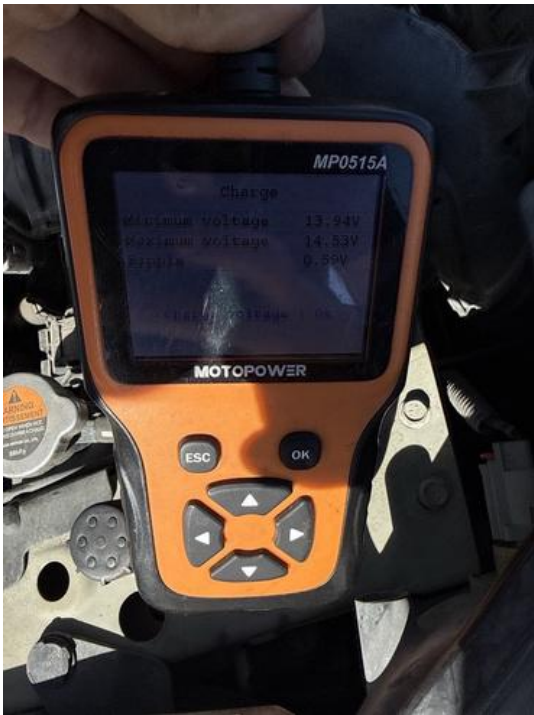
Photo 113

Battery is accepting the charge from the alternator and the alternator charge output is correct

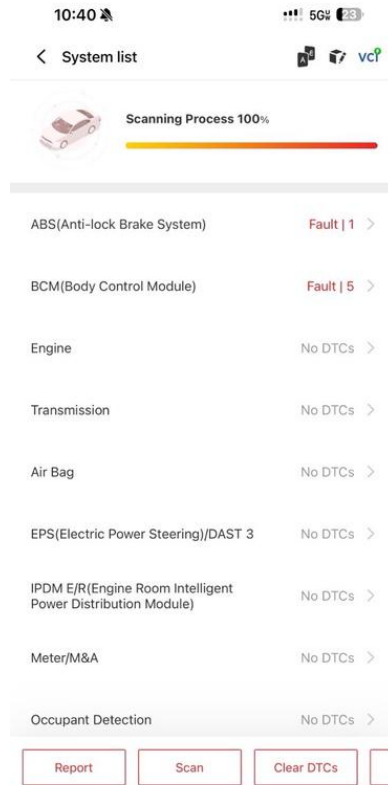
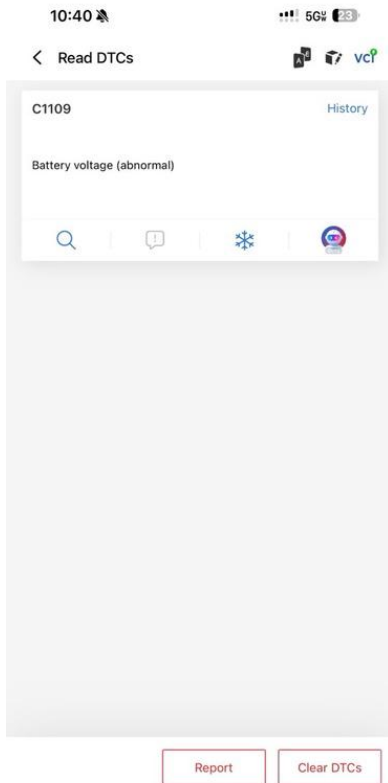
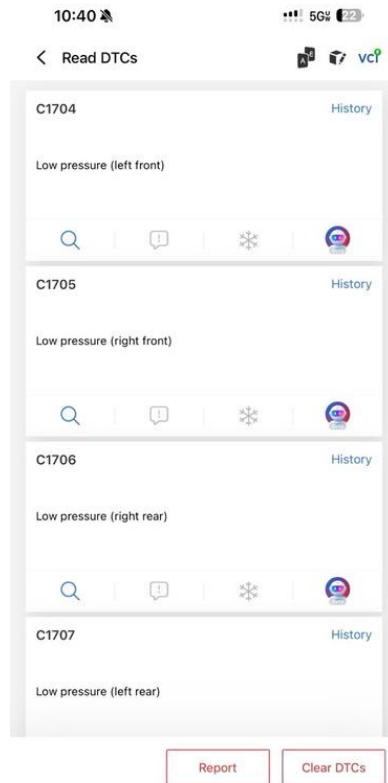
All of the main control modules on the vehicle were free of any live/active diagnostic fault codes. All of the live feed diagnostic testing was successfully passed. At the time of the inspection there were no active warning lights present.
