Peace of Mind Automotive Inspection Report.

Score	4 / 4 (100%)	Flagged items	1	Actions	0
Site conducted				Unanswered	
Customer name				Luis LMJ auto motor sales	
Date / Time				Jan 21st	
Payment method				Invoice	
Inspection cost				199	
Vehicle Year / Make / Model / Color				2017 dodge ram 1500	
VIN				14562 last 5

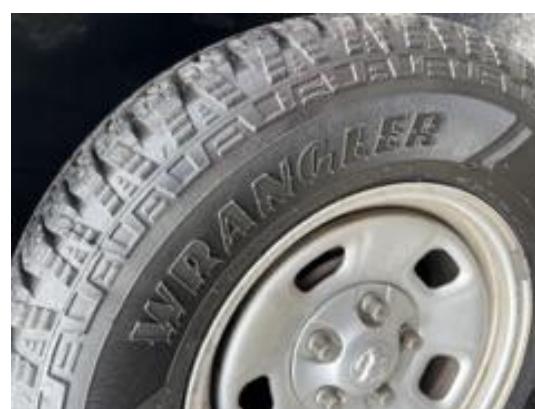
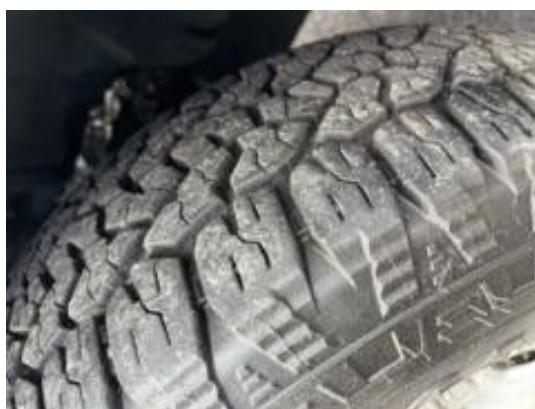
All four tires are matching. All four tires are in healthy condition. Tires have right around 75% tread life remaining all around.

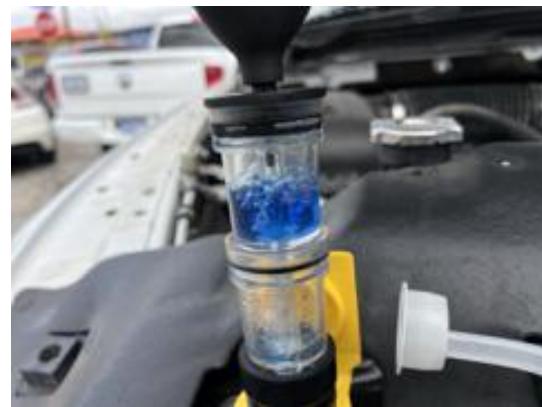
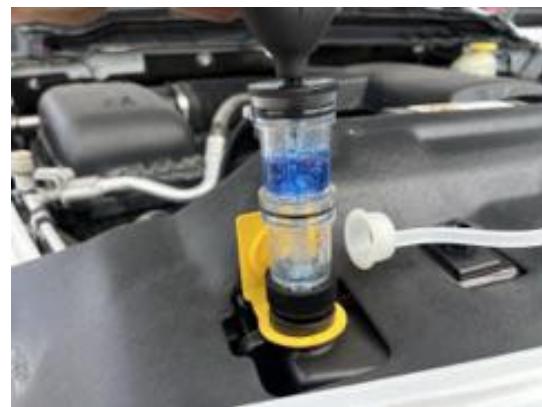
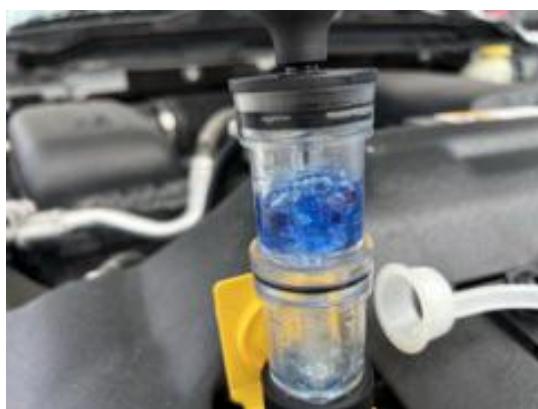
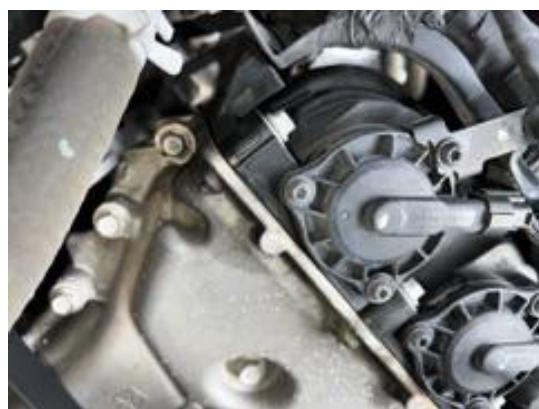
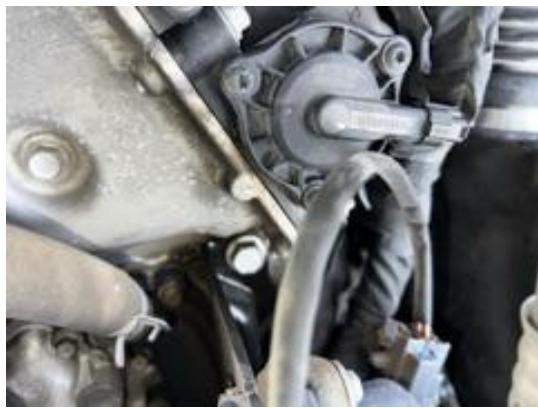
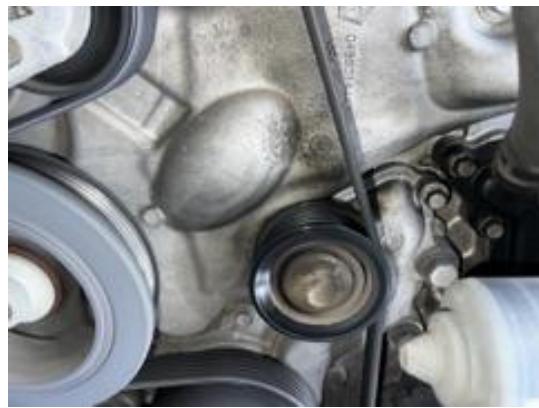
Engine clean internally, no gunk or sludge presents. Proper signs of maintenance present. Block test passed, no internal combustion leak out. Coolant mixture correct and cooling system functionality is healthy. All external engine accessories in good working. No leaks or seepage from anywhere on the engine. External drive belts in decent condition. Currently no concern in mechanical issues present in relation to the engine or related accessories.

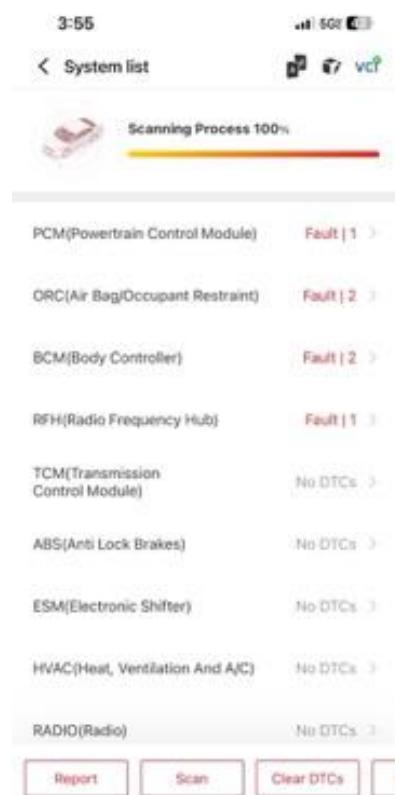
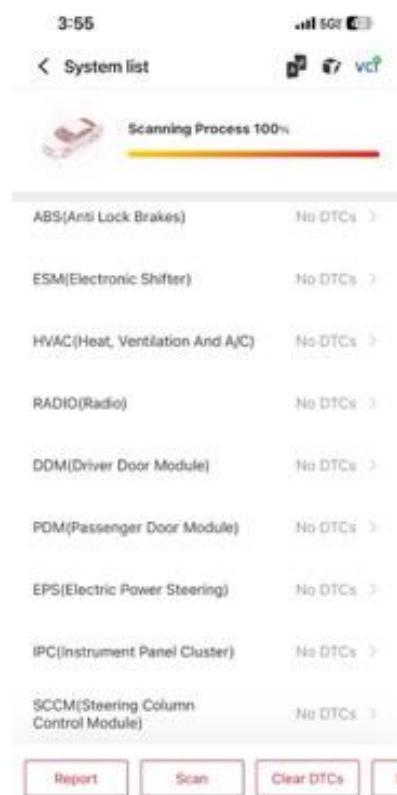
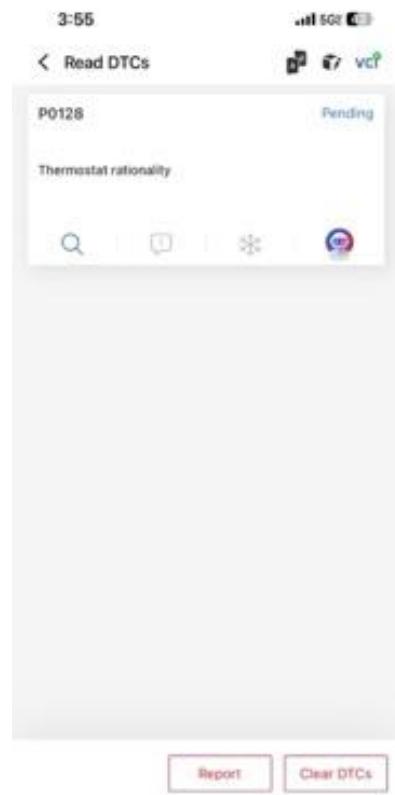
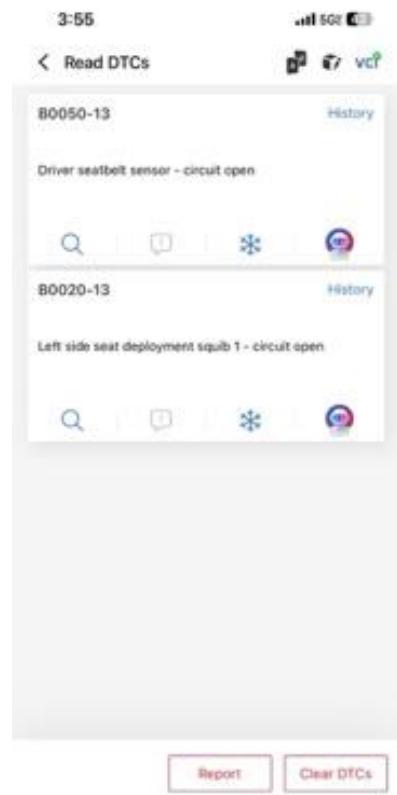
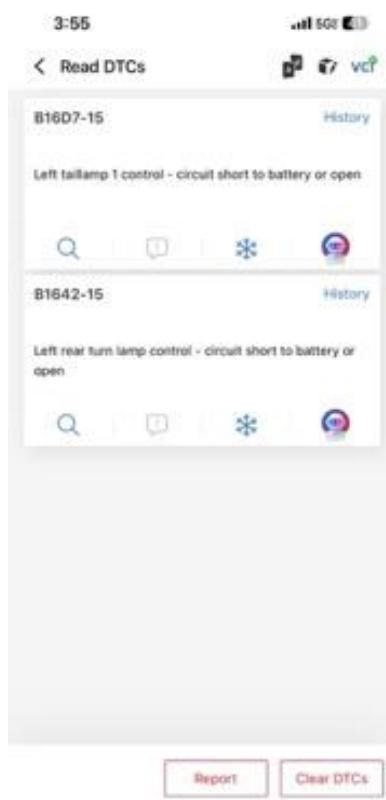
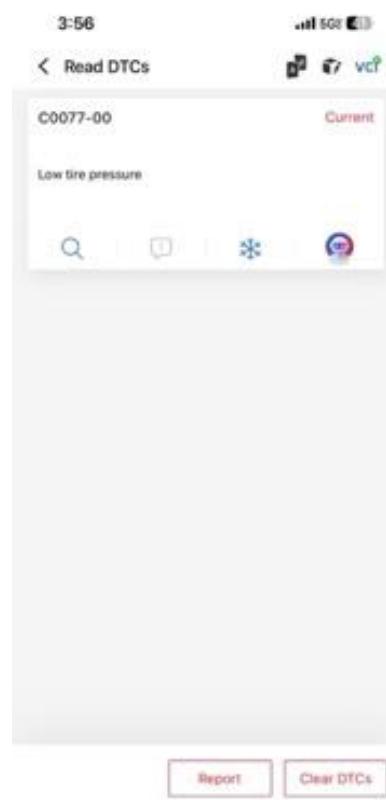
All of the control modules on the vehicle were free of any live/active diagnostic fault codes. All live feed diagnostic testing was successfully passed. All live feed emissions testing was successfully passed. There were a few historical diagnostic fats. None of these codes were live/active and not of any concern.
