## Peace of Mind Automotive Inspection Report.

<b>Site conducted</b>	Unanswered
<b>Customer name</b>	Luis LMJ Auto motor sales
<b>Date / Time</b>	Jan 21st
<b>Payment method</b>	Invoice
<b>Inspection cost</b>	199
<b>Vehicle Year / Make / Model / Color</b>	2017 dodge ram 1500

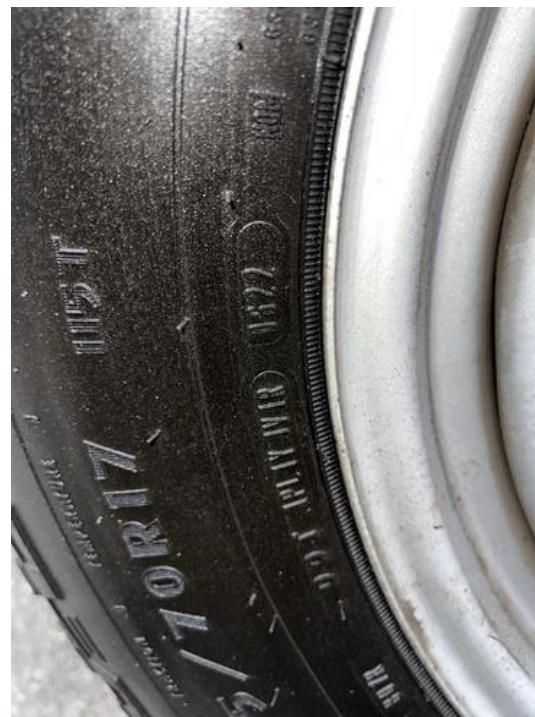
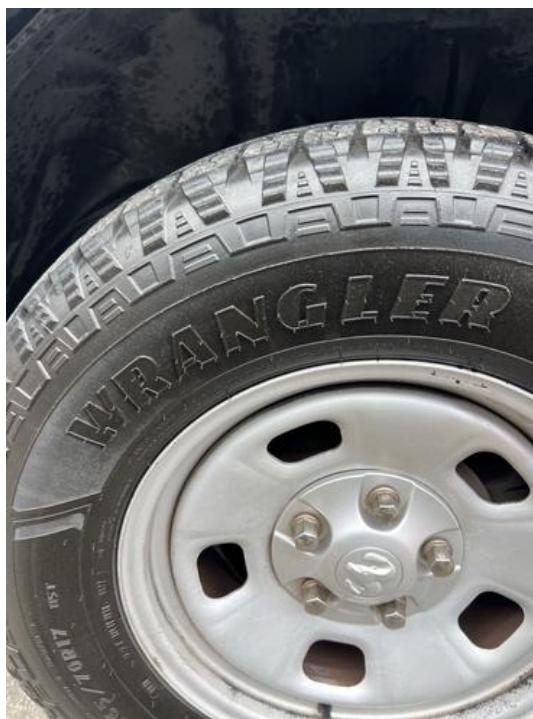
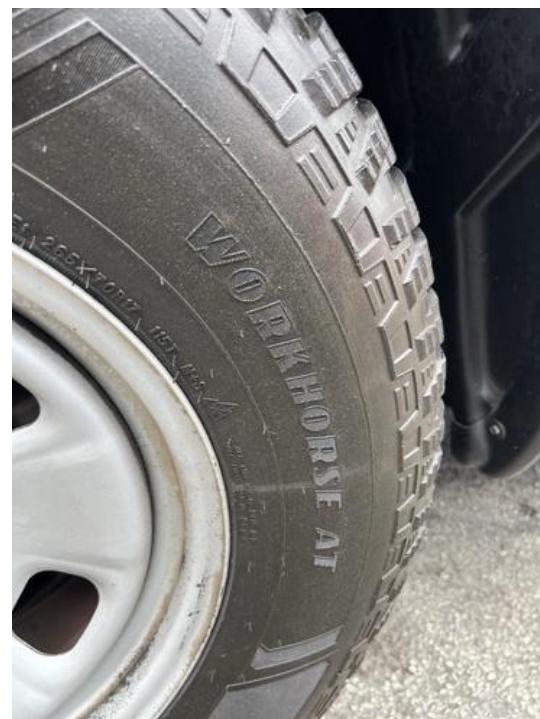
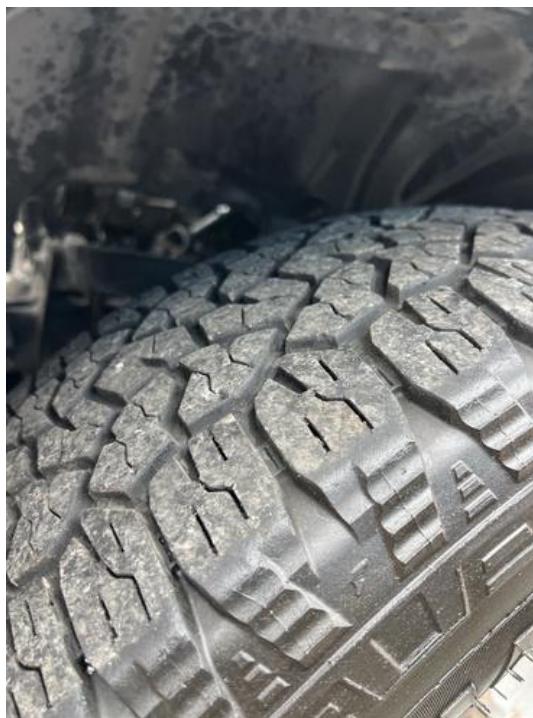
Both front tires are from 2022, front tires have right about 55% tread life remaining

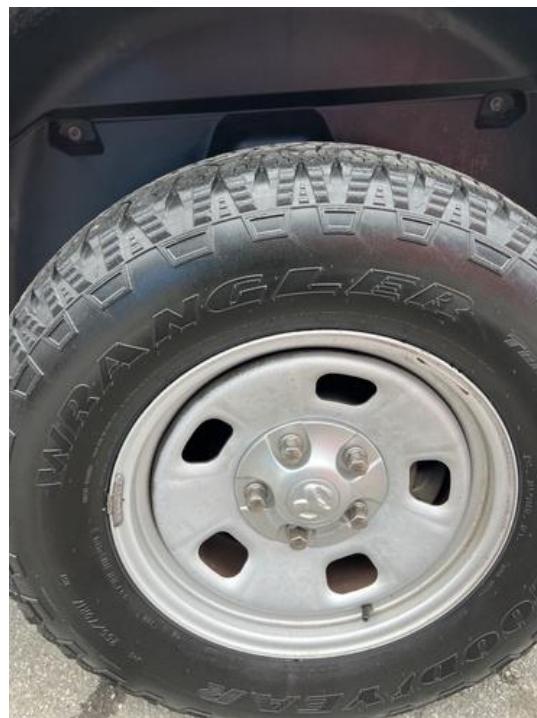
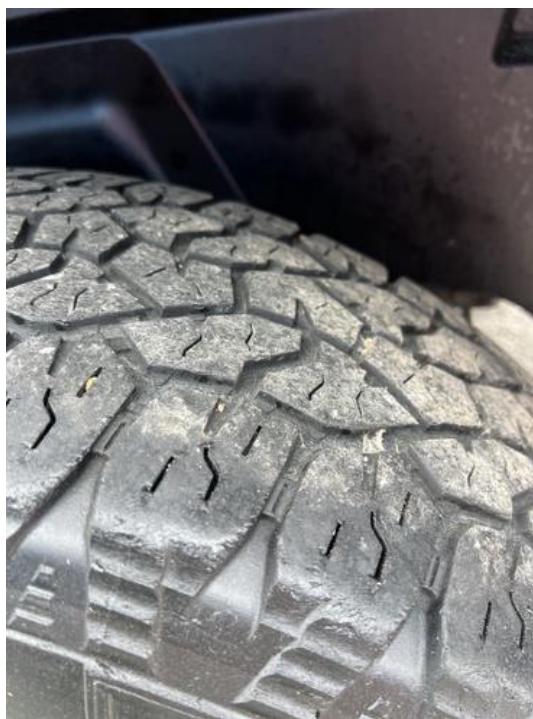
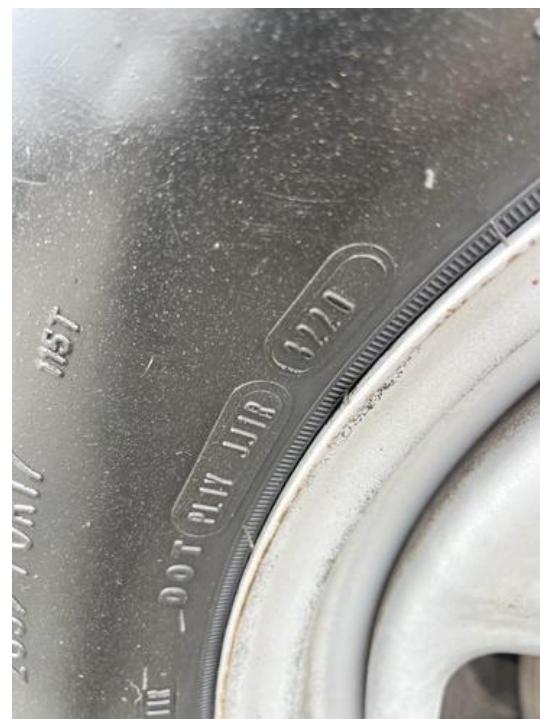
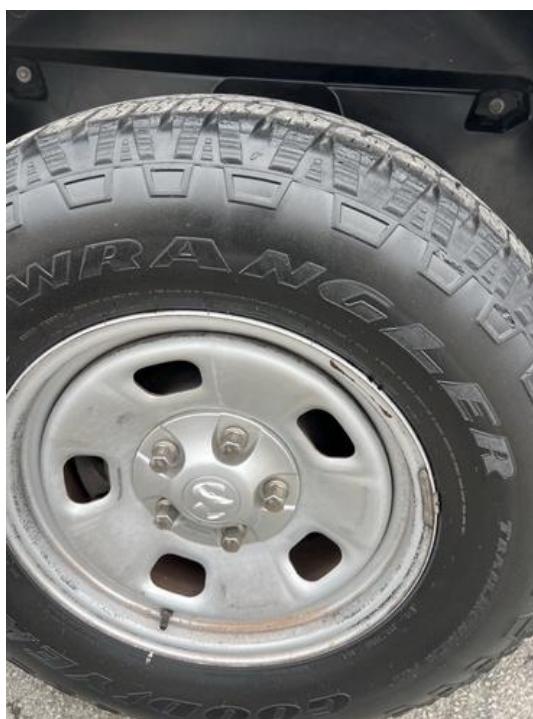
Both rear tires are a matching set from 2020 and 2021, rear tires have right about 40% tread life remaining

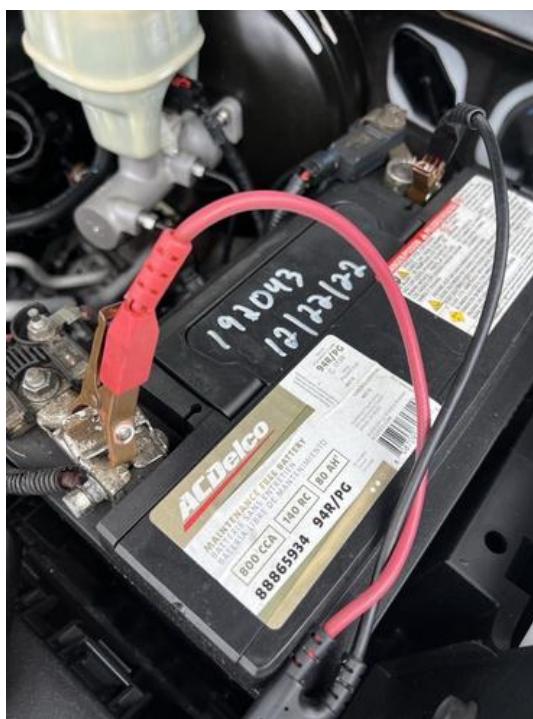
12/22

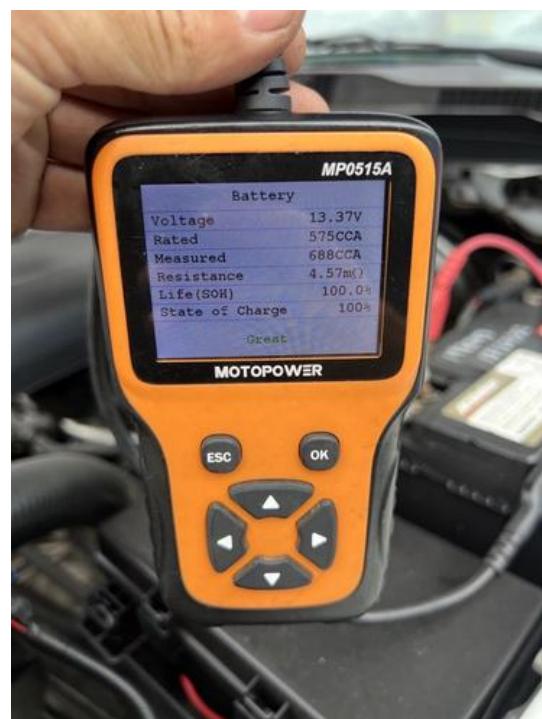
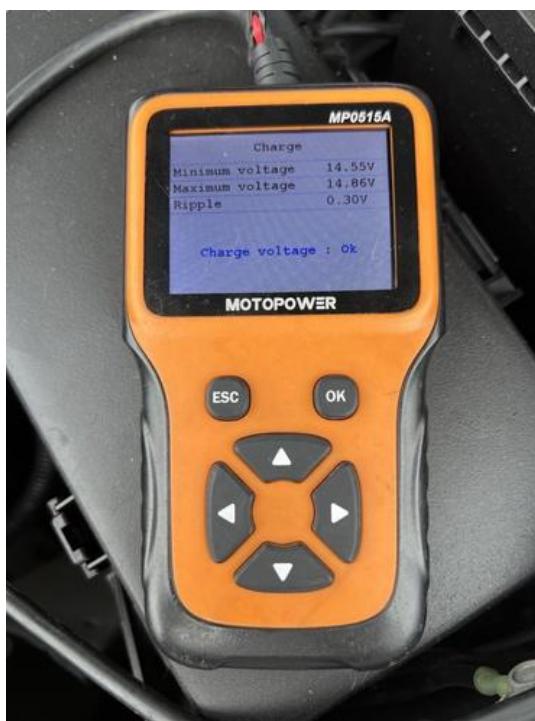
Battery is accepting the charge from the alternator and the alternator charge output is correct

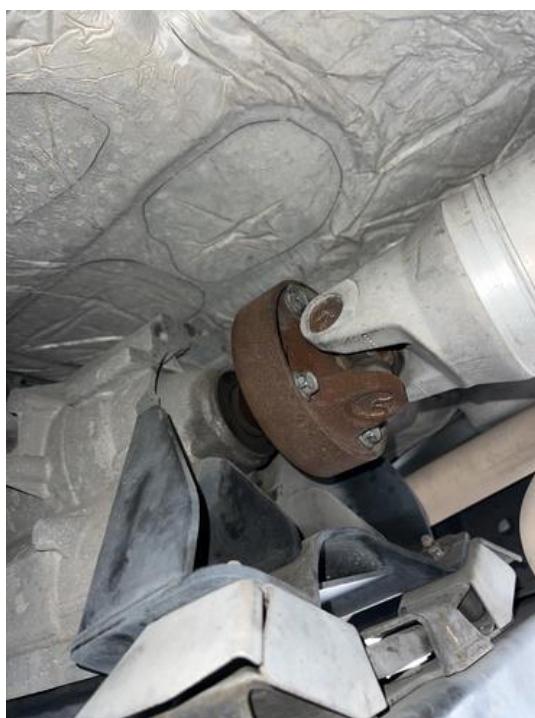
No transmission fluid leak out from the transmission casing or the transmission pan area. Drive shaft and seal is free of any fluid leaks. The rear differential is free of any fluid leak out. Shift transitions out on the road are correct across the board.

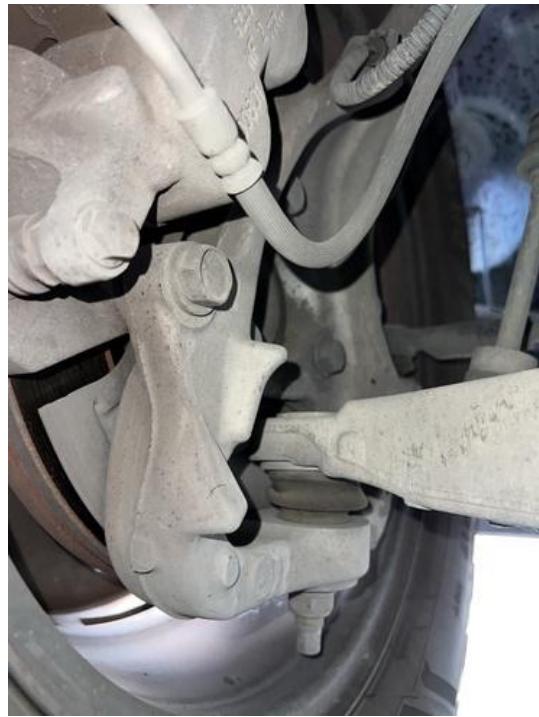
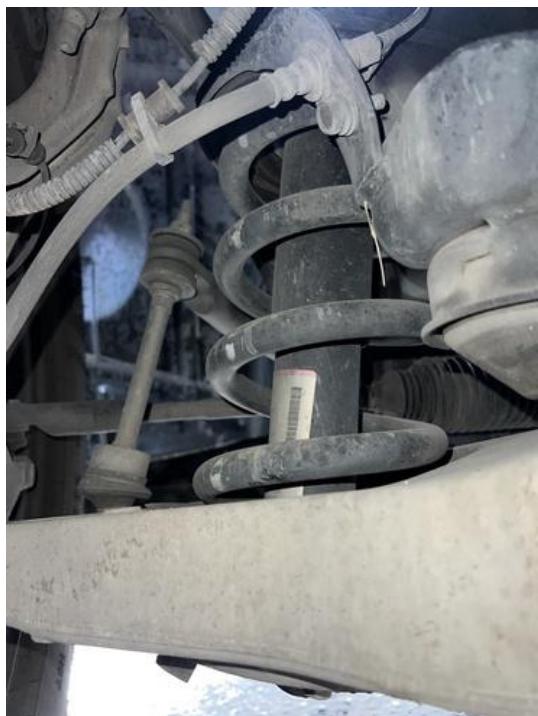
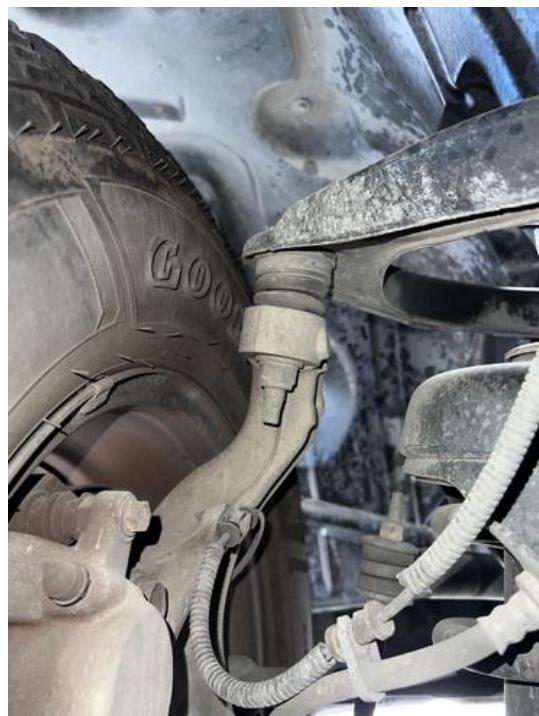
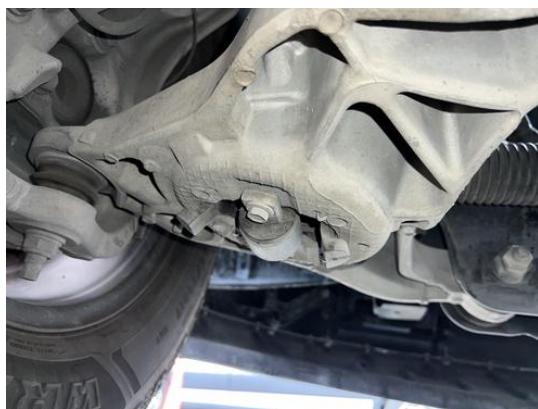
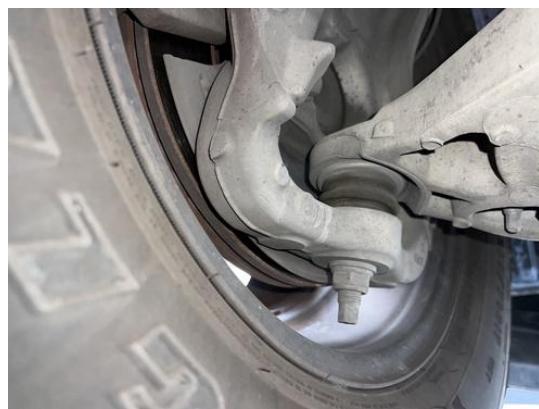
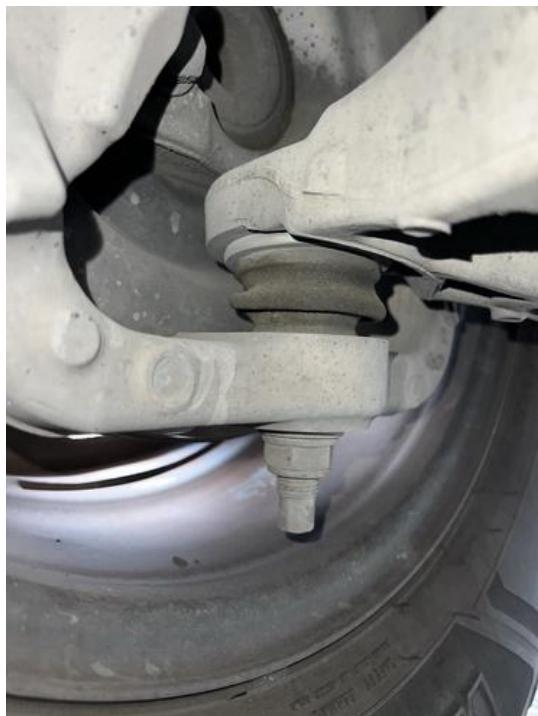
Normal fatigue notice to the suspension components. All of the suspension components seem to be original. None of the suspension components are blown out and due form the replacement. The No excessive surface rust on the exposed metal. No abnormal noise or feedback from the suspension while out on the road. All of the rubber in relation to the mounts, joints and bushings has decent texture.

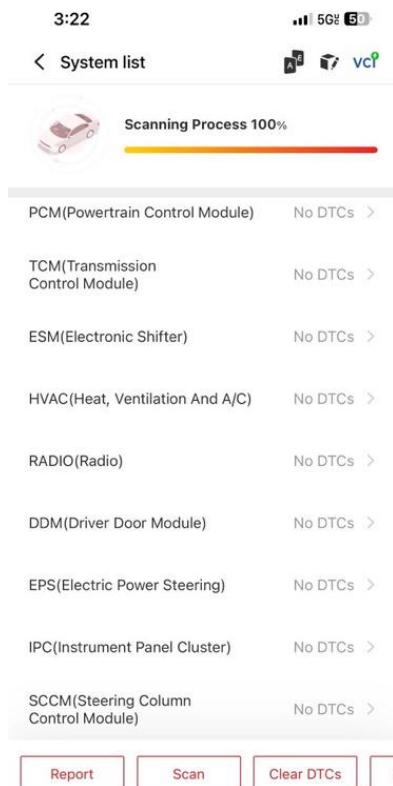
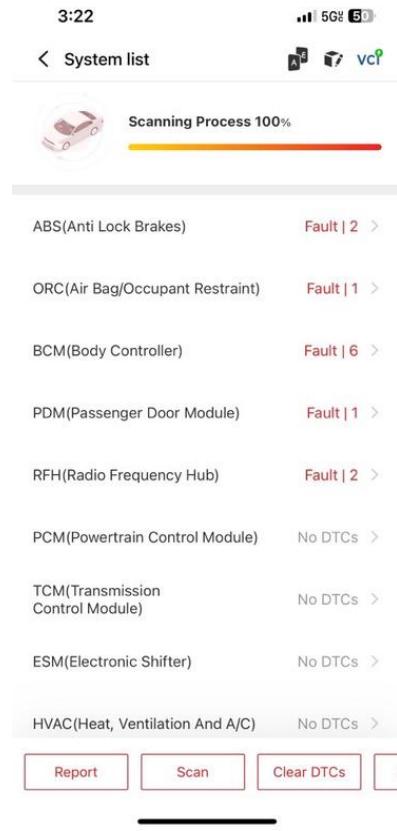
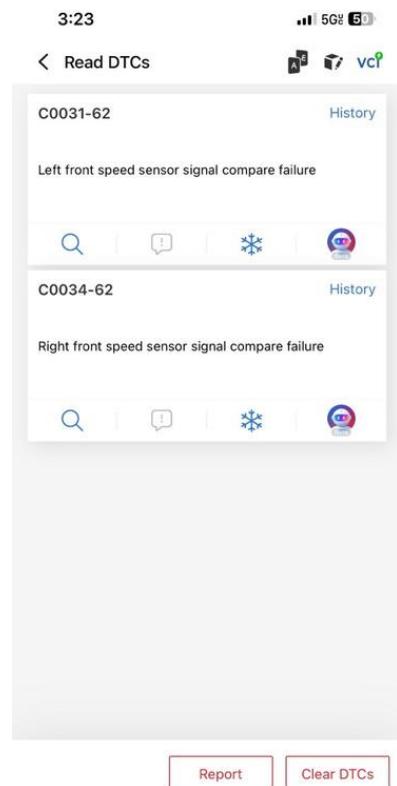
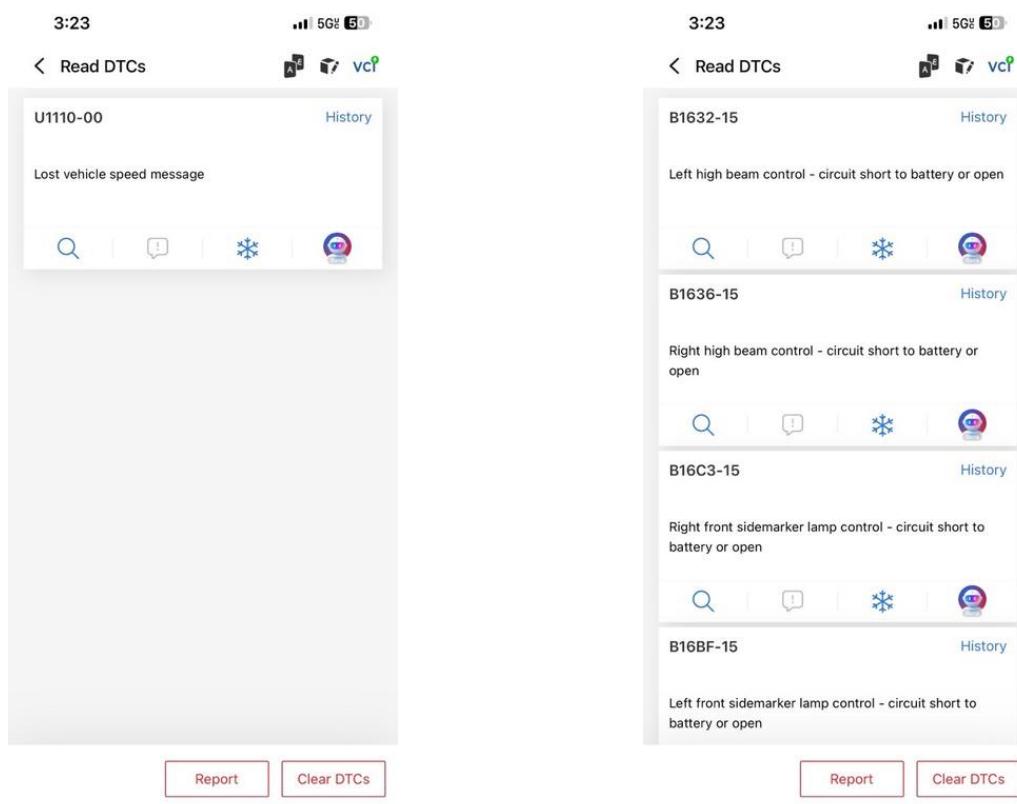
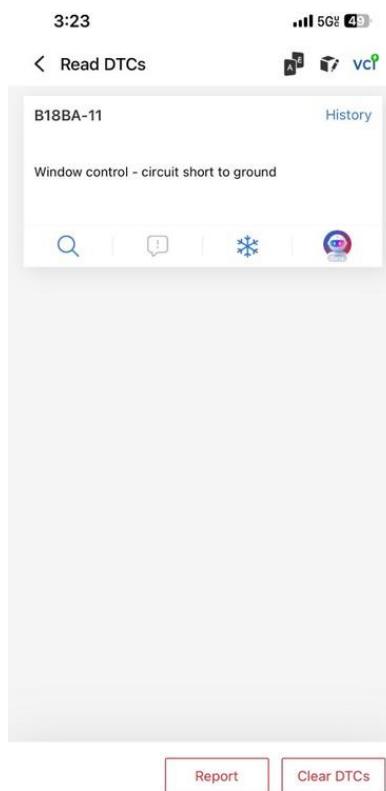
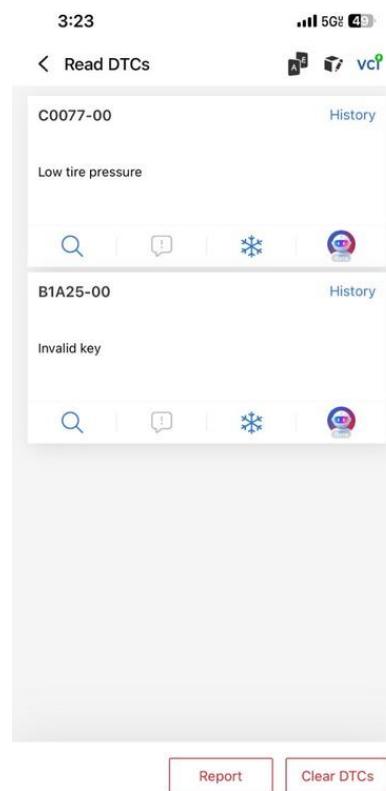
All of the main control modules on the vehicle were free of any live/active diagnostic fault codes. All live feed diagnostic testing was successfully passed. All live feed emissions testing was successfully passed. There were a few historical diagnostic fault coats present across various control modules on the vehicle. None of these codes were live/active and are not of any current concern. No attention is needed.
