Peace of Mind Automotive Inspection Report.

Score	4 / 4 (100%)	Flagged items	0	Actions	0
Site conducted					Unanswered
Customer name					Lmj auto motor sales
Date / Time					May 19th
Payment method					Invoice
Inspection cost					199
Vehicle Year / Make / Model / Color					2018 jeep wrangler sport
VIN					76442 last 5

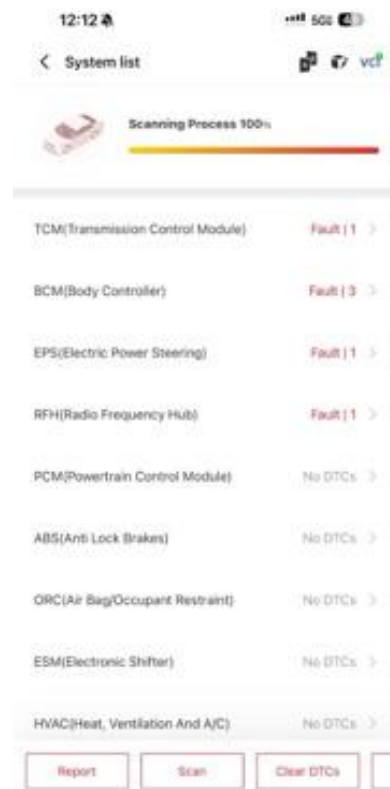
Photo 162

At the time of the inspection, there were no active warning lights present. All of the live feed diagnostic testing was successfully passed. All of the live feed emission testing was successfully passed. There was a couple of fault coats in relation to the tail lights, this is due to the aftermarket tail lights installed on the vehicle, the functionality of the tail lights is correct.
