## Peace of Mind Automotive Inspection Report.

<b>Site conducted</b>	Unanswered
<b>Customer name</b>	LMJ Auto motor sales
<b>Date / Time</b>	Dec 10th
<b>Payment method</b>	Invoice
<b>Inspection cost</b>	199
<b>Vehicle Year / Make / Model / Color</b>	2019 Chevy Colorado

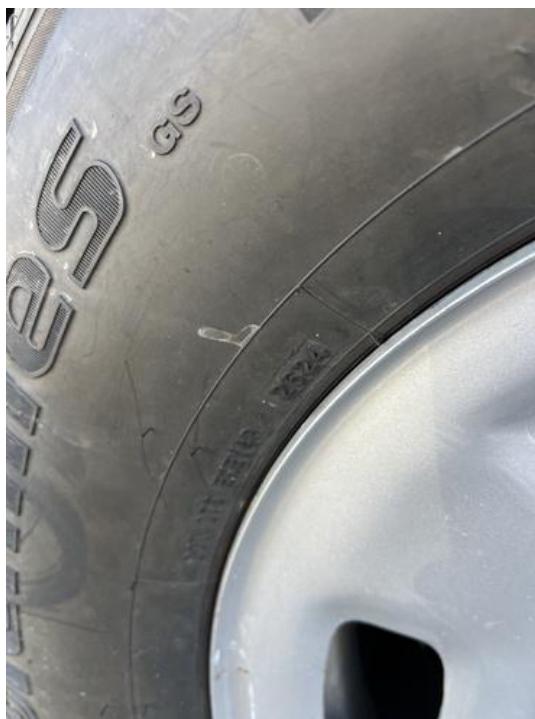
Photo 109

This specific tire does not match the other three tires, this tire is dated from 2024 and has a ride around 65% tread life remaining.

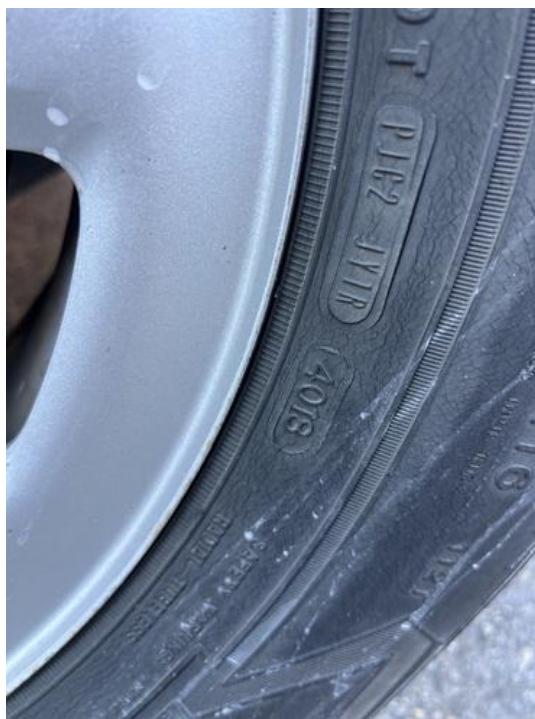
Photo 113

The other three tires are matching, tires are dated from 2018 and have only around 35% tread life remaining.

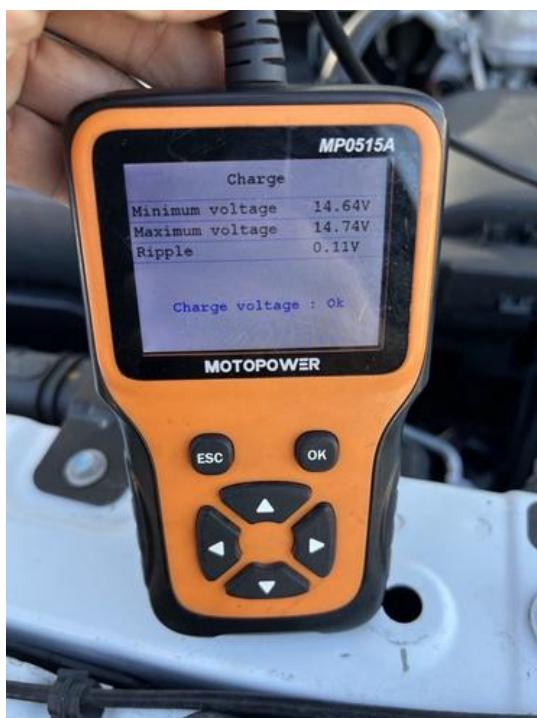
Photo 125

Battery is accepting the charge from the alternator and the alternator charge output is correct

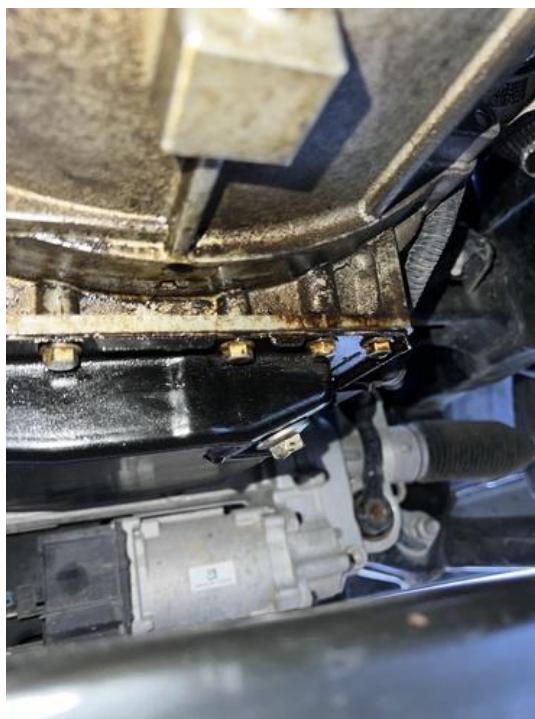
Photo 145

Small amount of oil residue/oil seepage noticed at the backside of the oil pan gasket area, a future repair to expect will be a replacement of the oil pan gasket
