## Peace of Mind Automotive Inspection Report.

| Score | 4 / 4 (100%) | Flagged items | 0 | Actions | 0 |
|---|---|---|---|---|---|
| Vehicle Year / Make / Model / Color | | | | | 2019 ford fiesta |
| Mileage | | | | | 99824 |

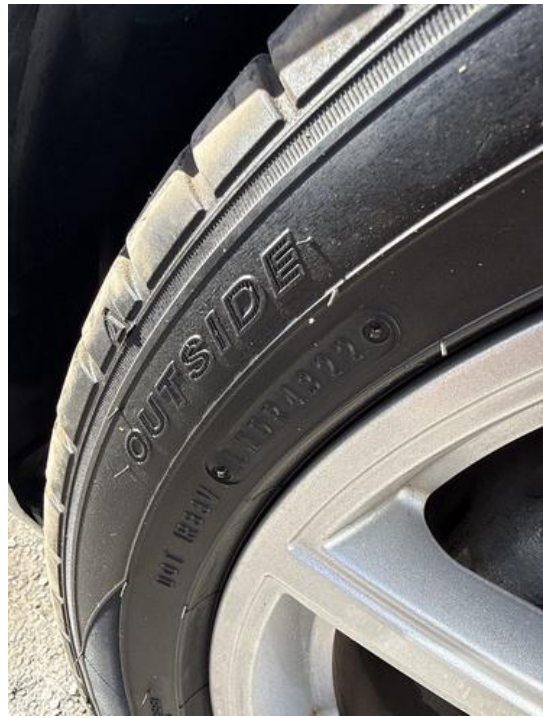
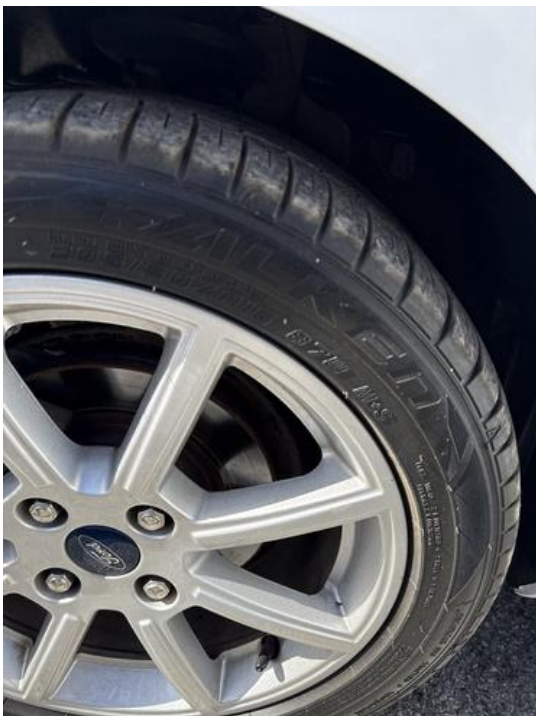
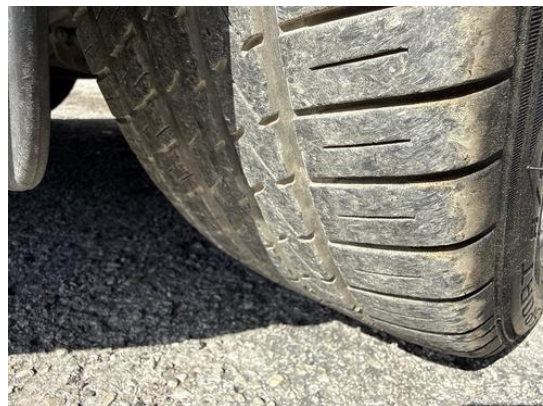
50-75% remaining

Three matching tires have right around 70% tread life remaining

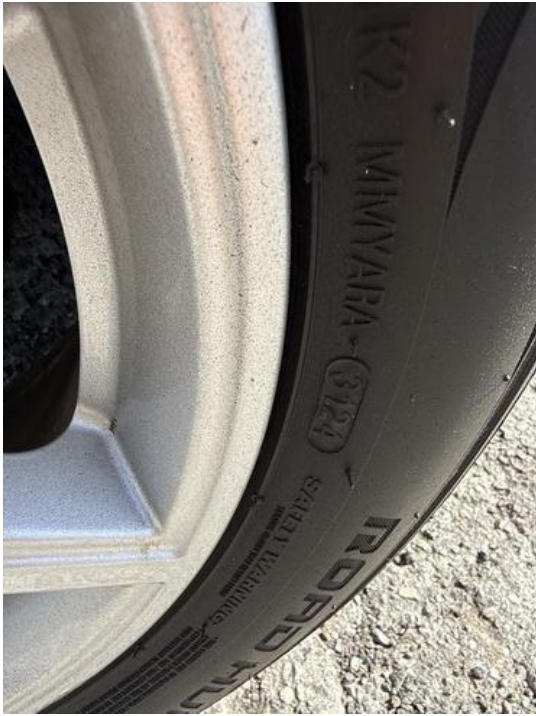
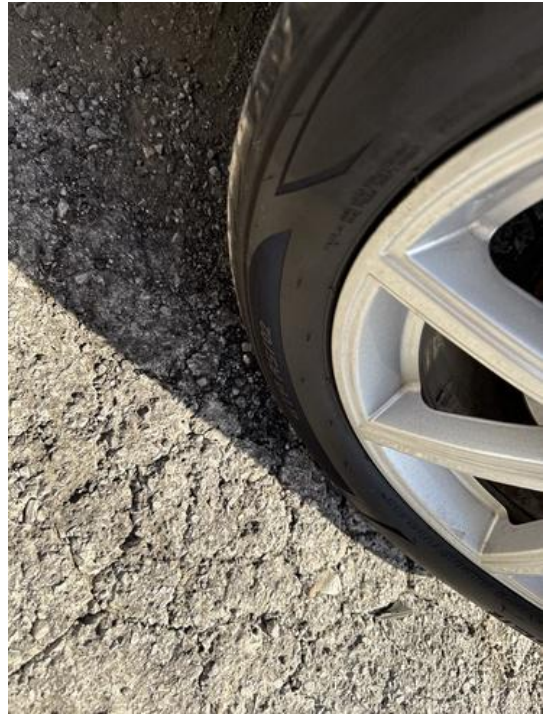
50-75% remaining

This tire does not match the other three

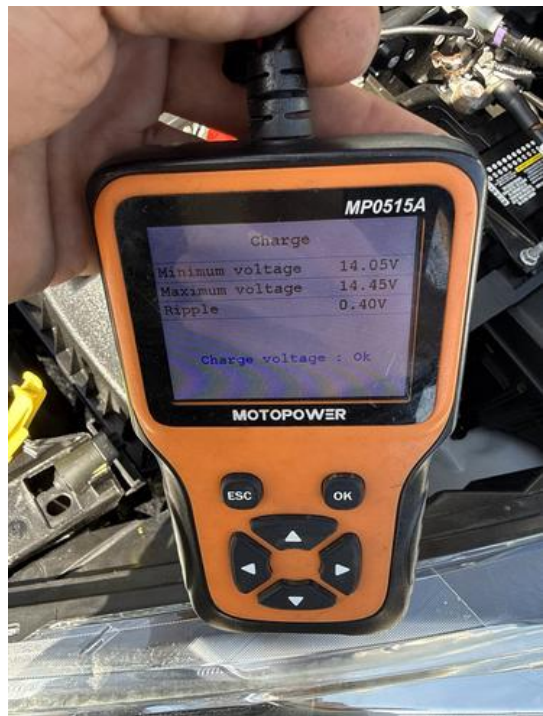
Photo 112

Battery is accepting the charge from the alternator and the alternator charge output is correct
