Peace of Mind Automotive Inspection Report.

Score	3 / 4 (75%)	Flagged items	1	Actions	0
Site conducted					Unanswered
Customer name					Lmj auto motor sales
Date / Time					May 19th
Payment method					Invoice
Inspection cost					199
Vehicle Year / Make / Model / Color					2019 ford expedition max
VIN					22443 last 5

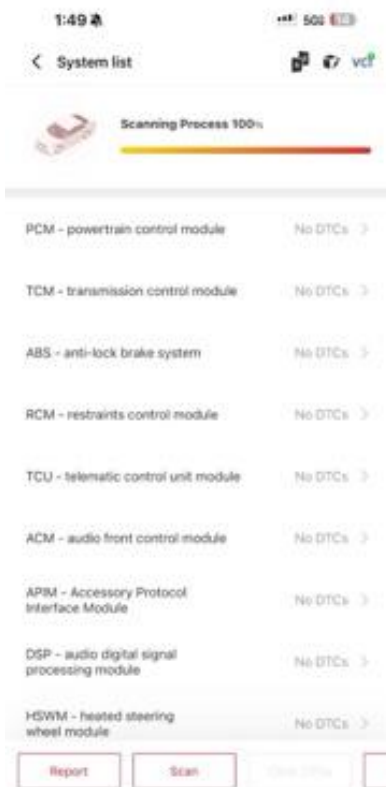
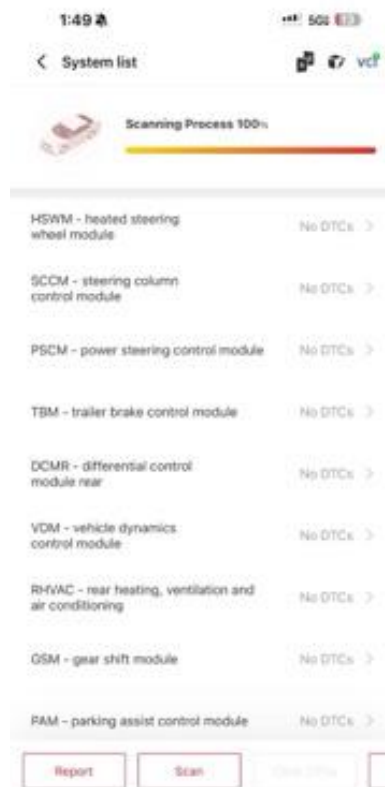
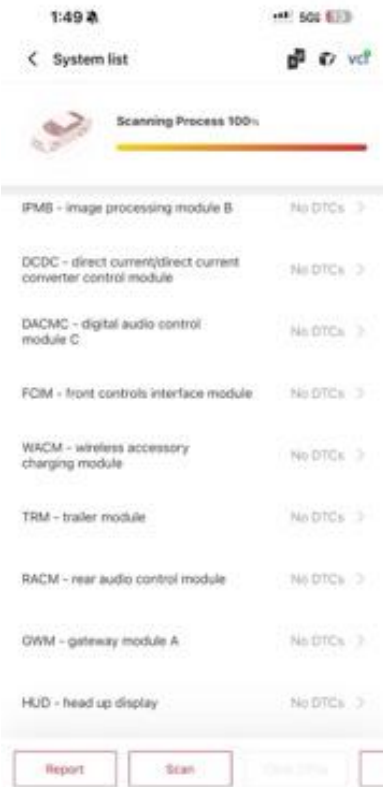
At the time of the inspection, there were no active warning lights presents. All of the live feed diagnostic testing was successfully passed. All of the live feed emission testing was successfully passed.
