# Peace of Mind Automotive Inspection Report.

Score	4 / 4 (100%)	Flagged items	0	Actions	0
<b>Site conducted</b>					Unanswered
<b>Customer name</b>					Lmj auto motor sales
<b>Date / Time</b>					May 19th
<b>Payment method</b>					Invoice
<b>Inspection cost</b>					199
<b>Vehicle Year / Make / Model / Color</b>					2019 ford expedition max
<b>VIN</b>					22443 last 5

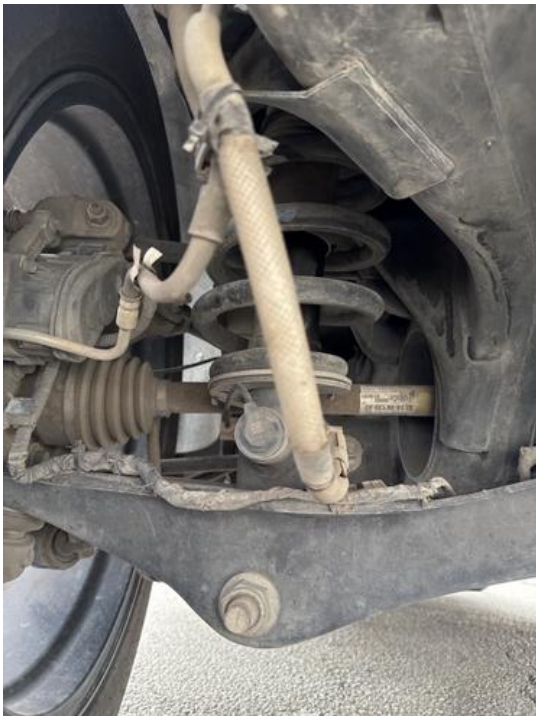
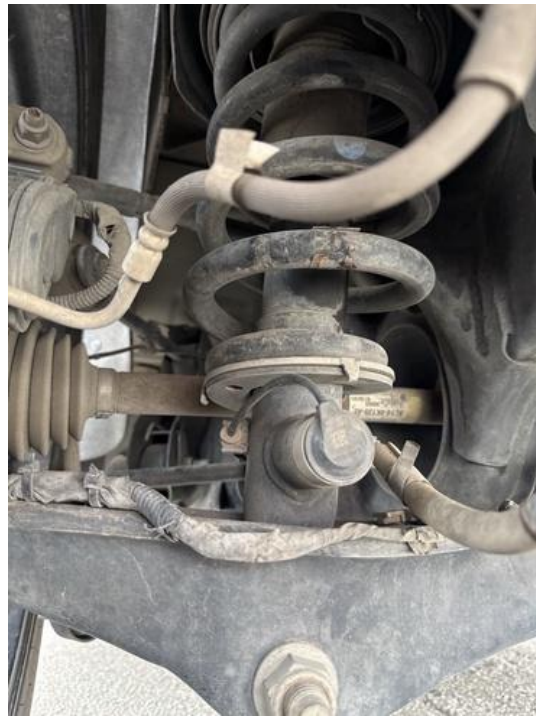
Small amount of leak out notice from the rear driver, side strut, no immediate attention is needed however, eventually the strut may need to be replaced

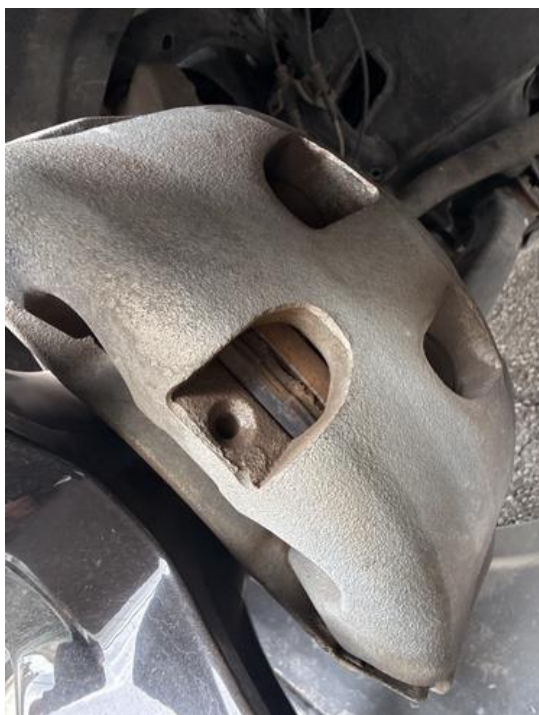
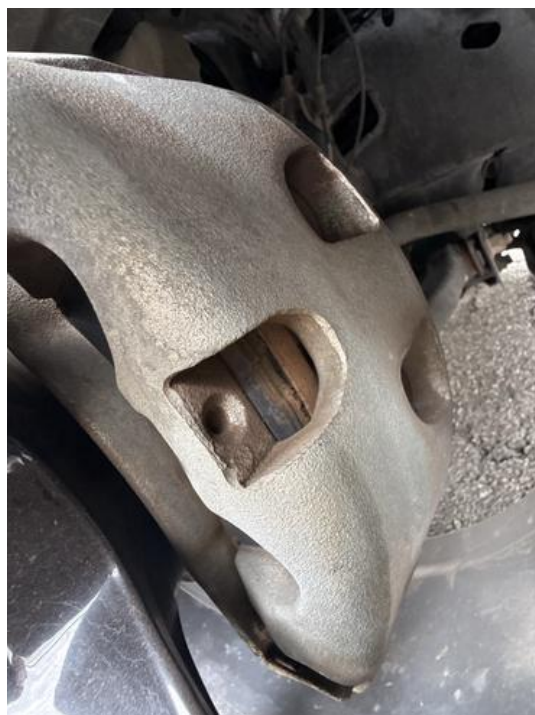
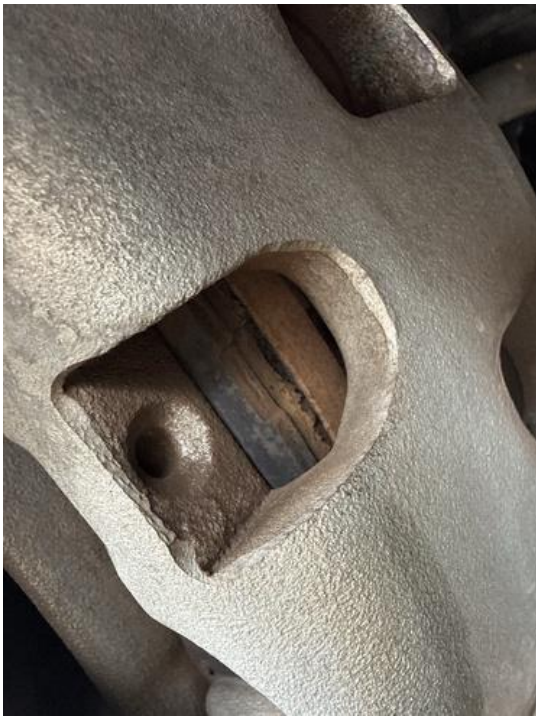
Braking system condition		
Brake fluid condition	Healthy	
Brake fluid level	Healthy	
Brake fluid leaks	None	
Moisture content in brake fluid	None	
Brake lines	Healthy	
Brake calipers front	Healthy	
Brake calipers rear	Healthy	
Brake drums rear	N/A	
Brake rotors front	Healthy	
Brake rotors rear	Healthy	
<b>Front brake pad life remaining</b>	<b>25-50% remaining</b>	
Only around 35% brake pad life remaining
