Peace of Mind Automotive Inspection Report.

Site conducted	Unanswered
Customer name	Luis LMJ auto motor sales
Date / Time	Jan 21st
Payment method	Invoice
Inspection cost	199
Vehicle Year / Make / Model / Color	2021 ford escape
VIN	25892 last 5
	Photo 1
license plate	Dealer
Mileage	115669
Color	Silver

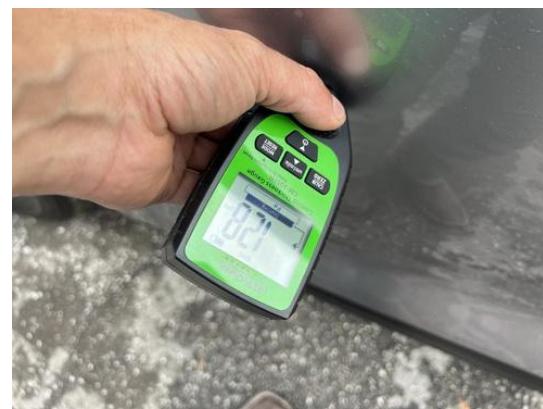
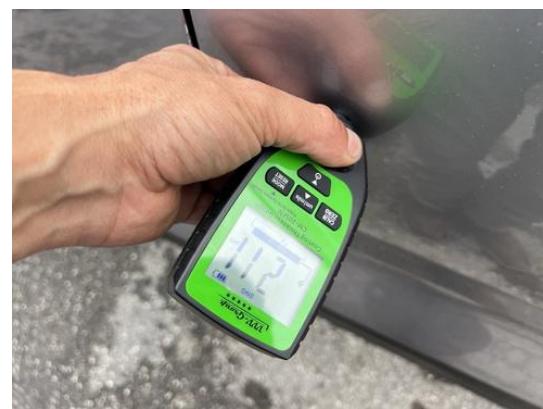
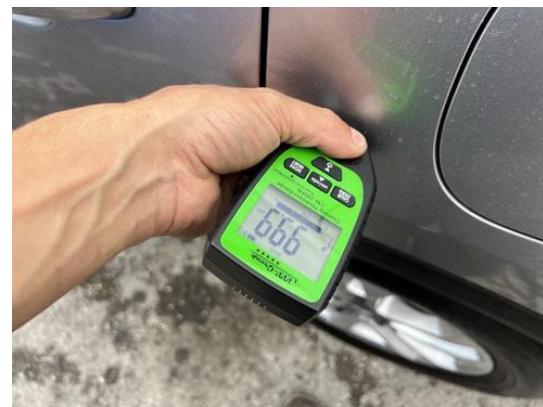
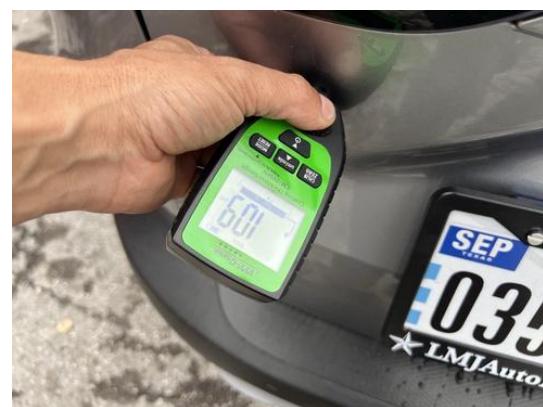
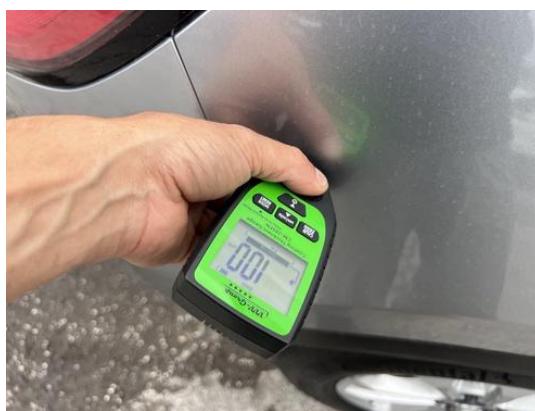
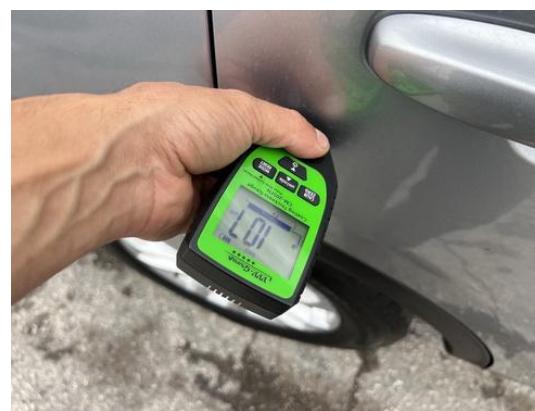
There is some paint and bodywork noticed on the vehicle, the majority of the repaint work is consolidated to the driver side. The front driver side fender has been repainted, the driver side door has been repainted, the rear driver side door has been repainted, the front passenger side fender has been repainted. All of the other metal body panels are showing factory paint depth. The front windshield has been replaced with a non-OEM replacement. There is no structural damage present nor any structural damage repair work done. Normal wear to the exterior as expected for the age and mileage on the vehicle, including chips, scrapes, scratches and dings. See all exterior photos for evidence of current condition.

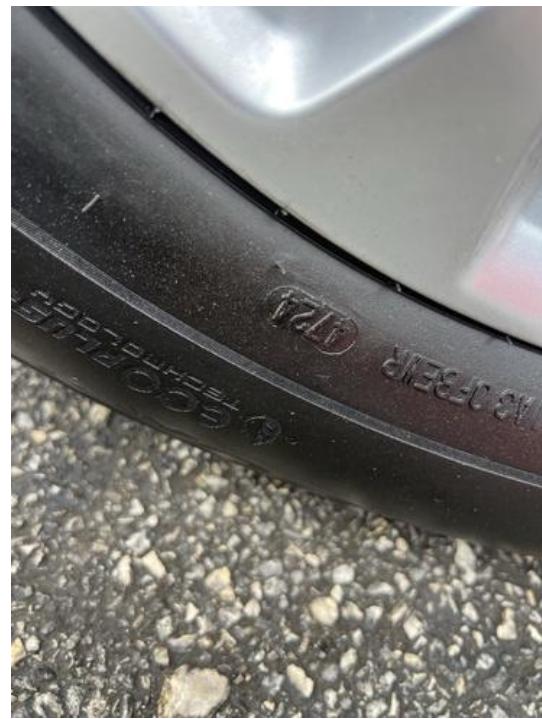
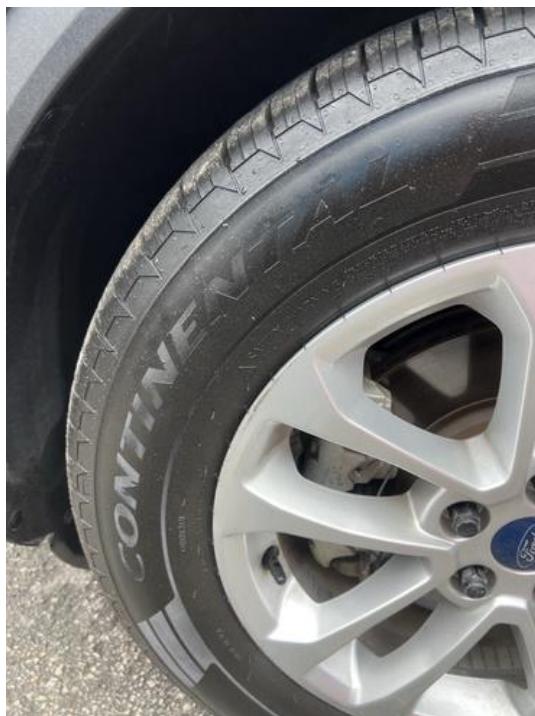
Photo 136

All four tires are in healthy condition, tires are evenly worn and all road safe with right around 75% tread life remaining.

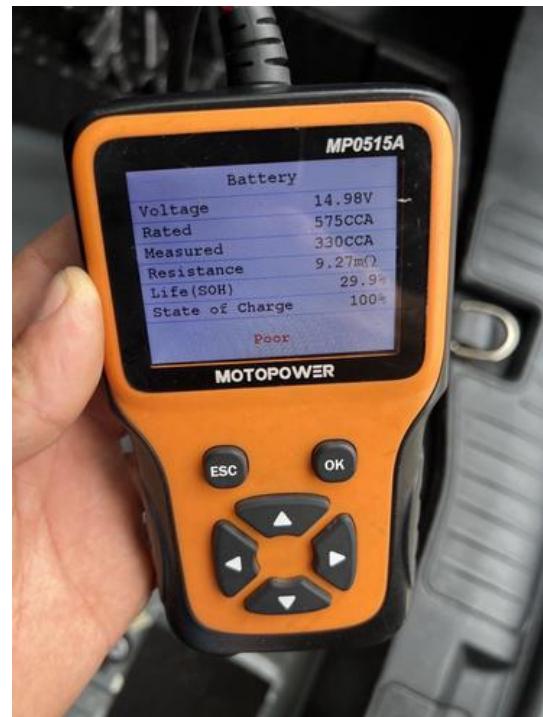
Photo 148

Battery is accepting the charge from the alternator and the alternator charge output is correct

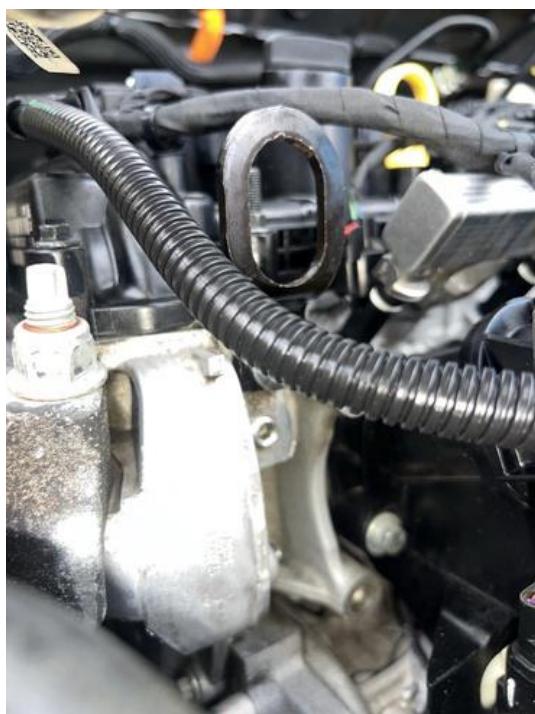
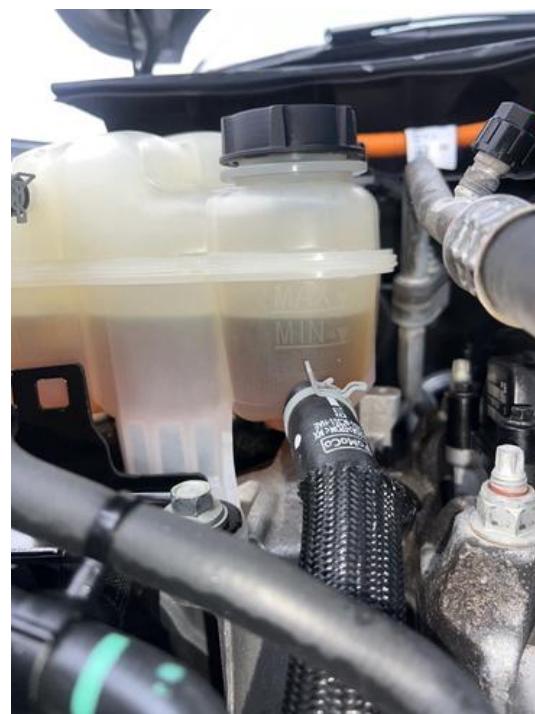
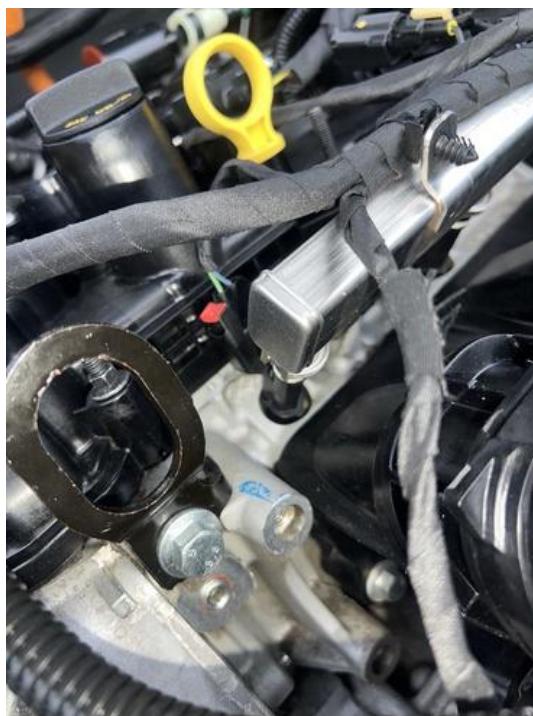
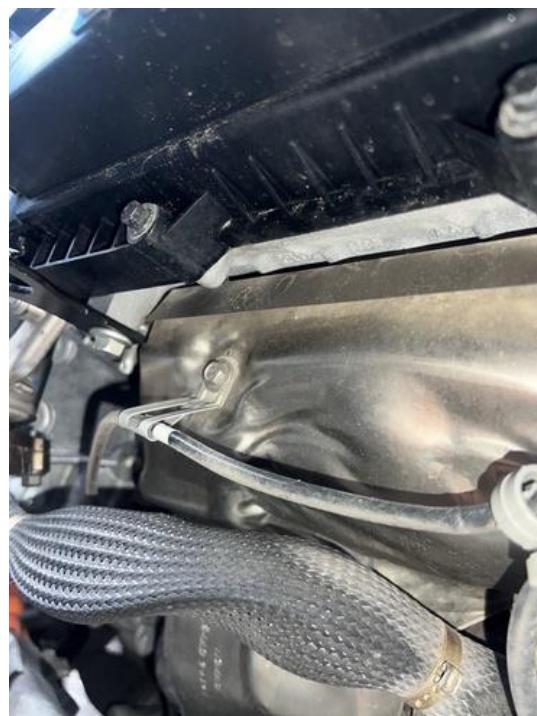
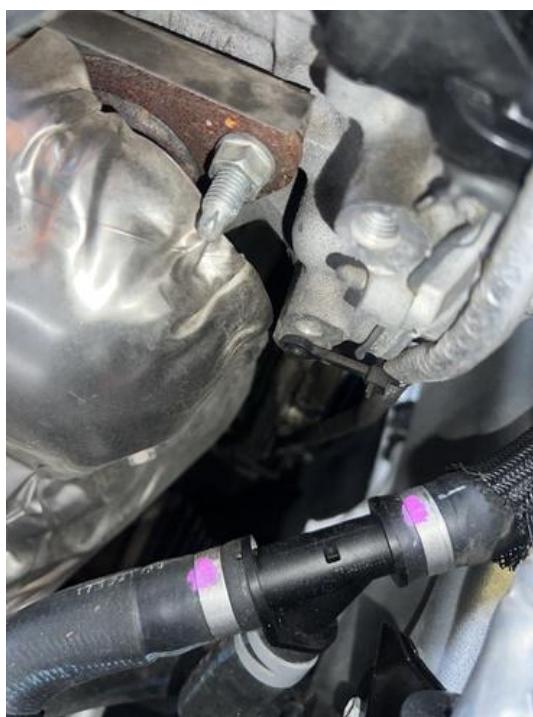
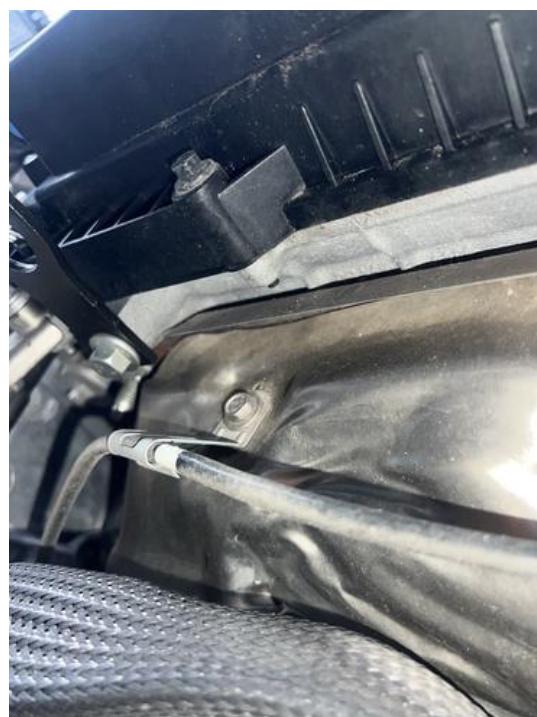
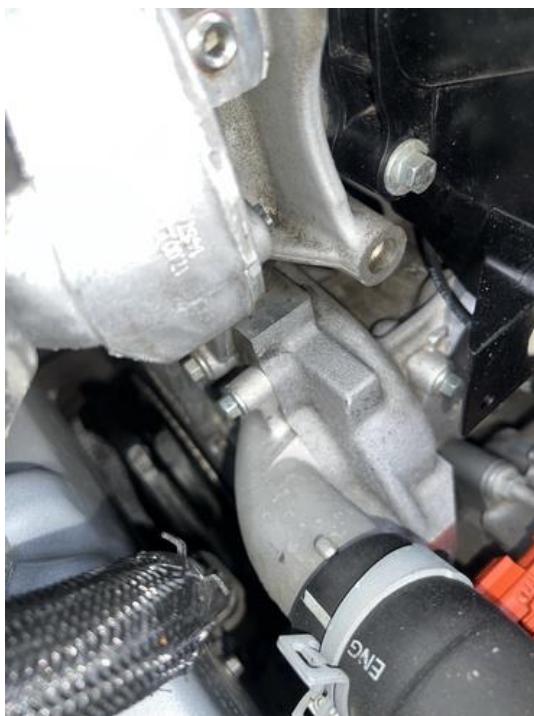
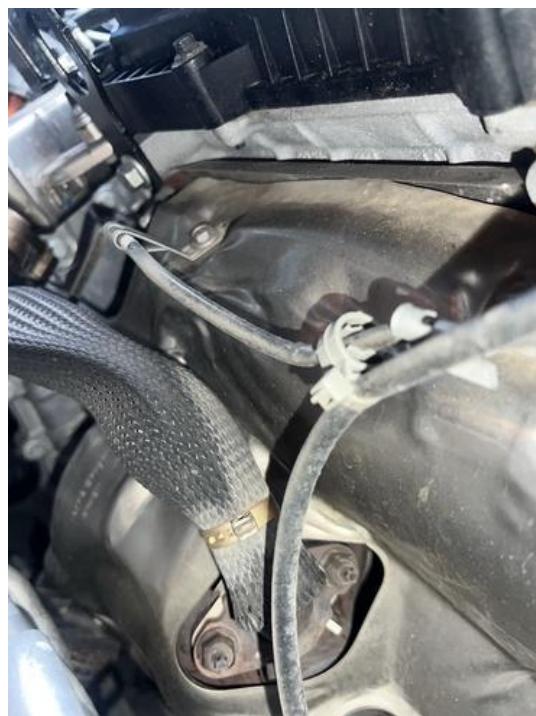
Engine clean internally, no gunk or sludge presents. Proper signs of maintenance present. Block test passed, no internal combustion leak out. Coolant mixture correct and cooling system functionality is healthy. All external engine accessories in good working. No leaks or seepage from anywhere on the engine. External drive belts in decent condition. Currently no concern in mechanical issues present in relation to the engine or related accessories.

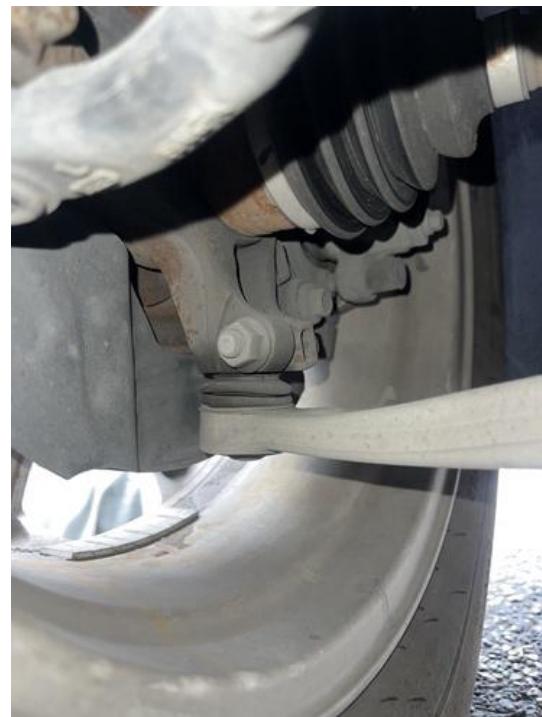
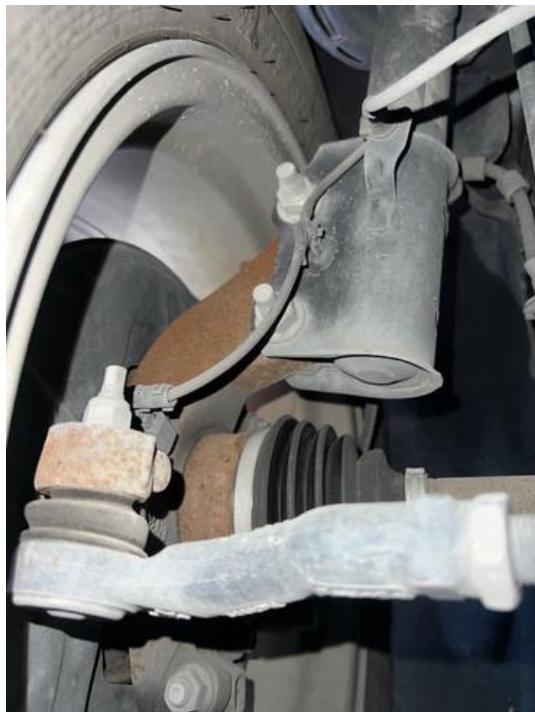
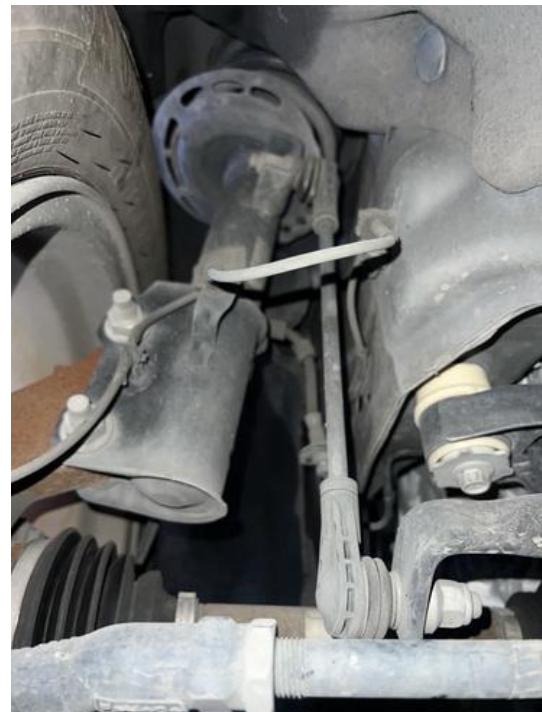
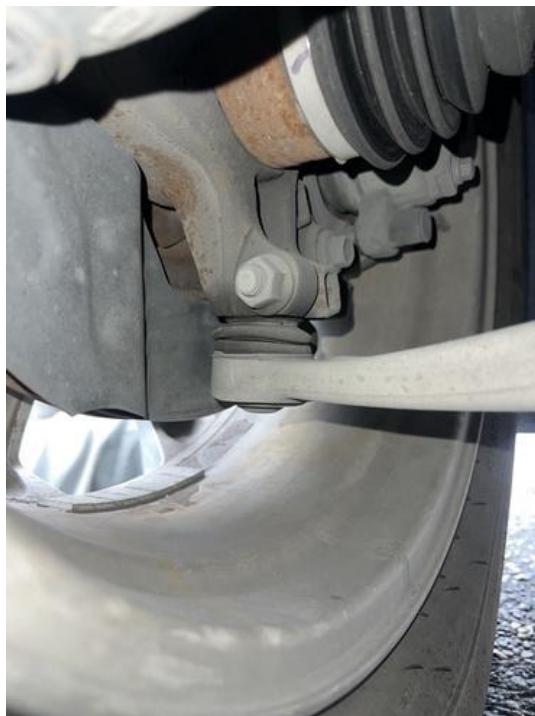
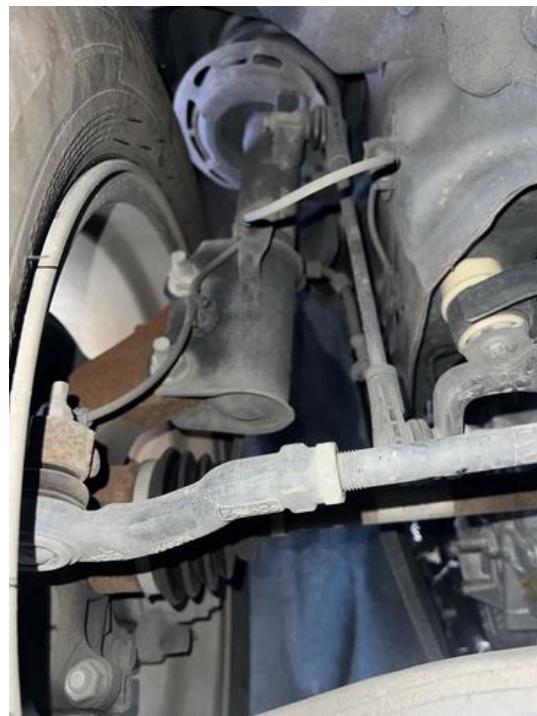
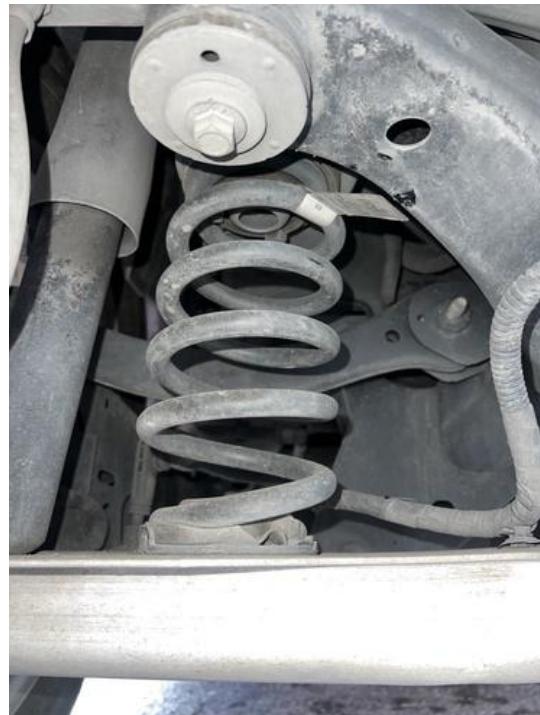
Normal fatigue notice to the suspension components. All of the suspension components seem to be original. None of the suspension components are blown out and due form the replacement. The No excessive surface rust on the exposed metal. No abnormal noise or feedback from the suspension while out on the road. All of the rubber in relation to the mounts, joints and bushings has decent texture.

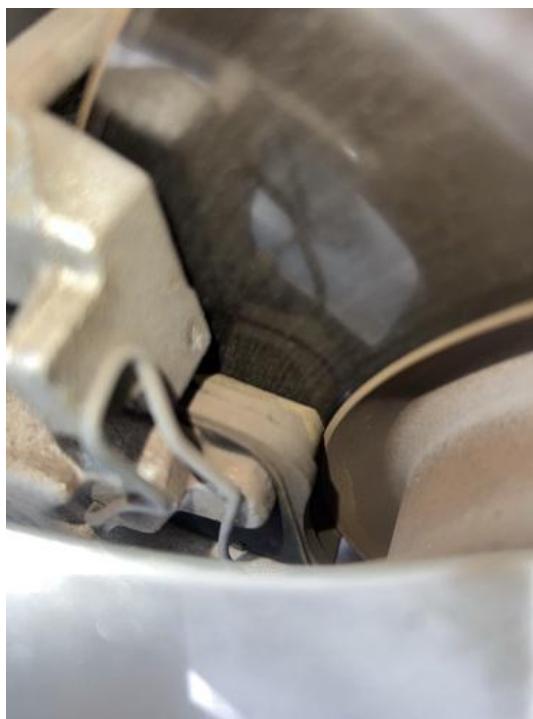
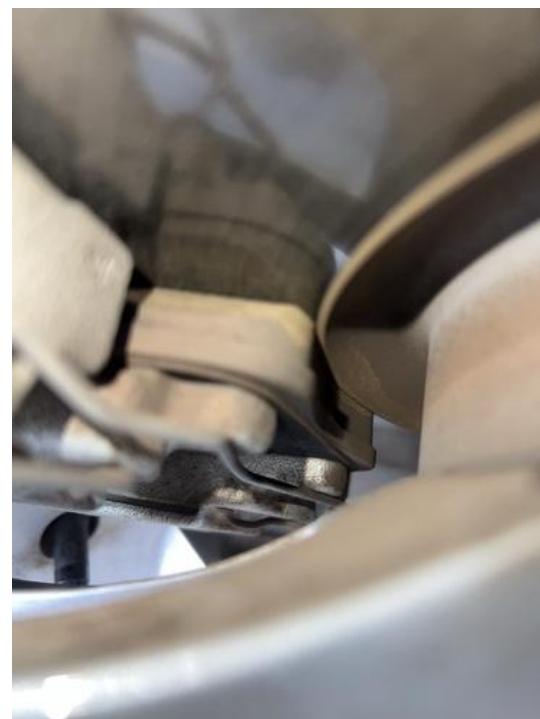
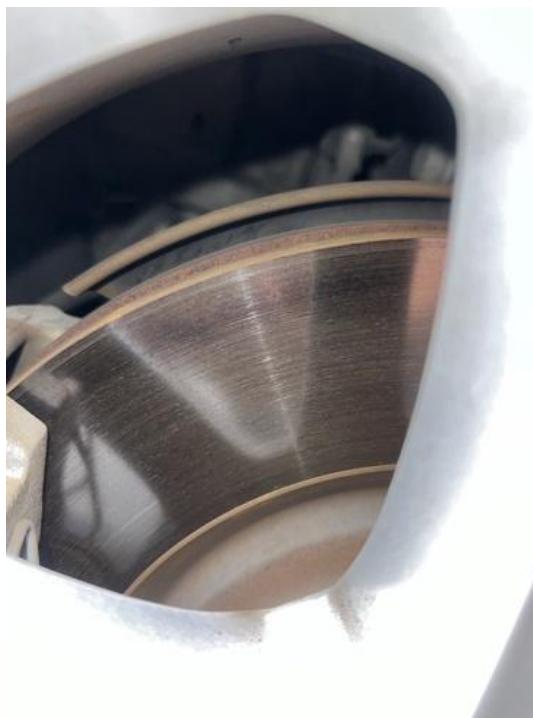
Right around 75% brake pad life remaining

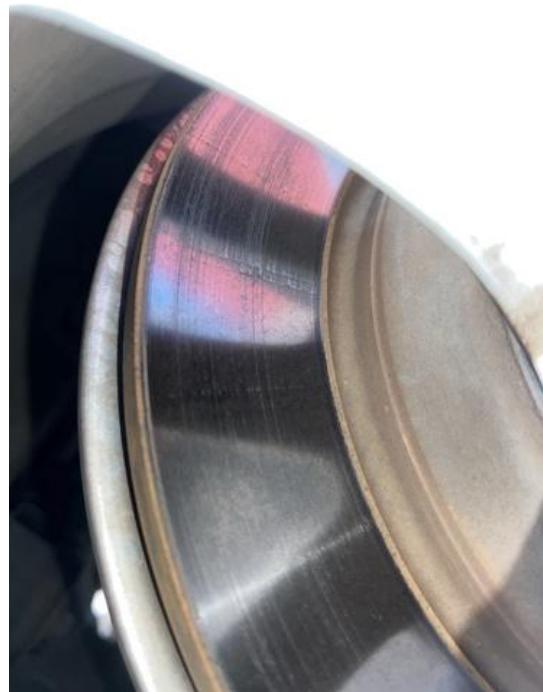
Photo 190

Right around 75% brake pad life remaining

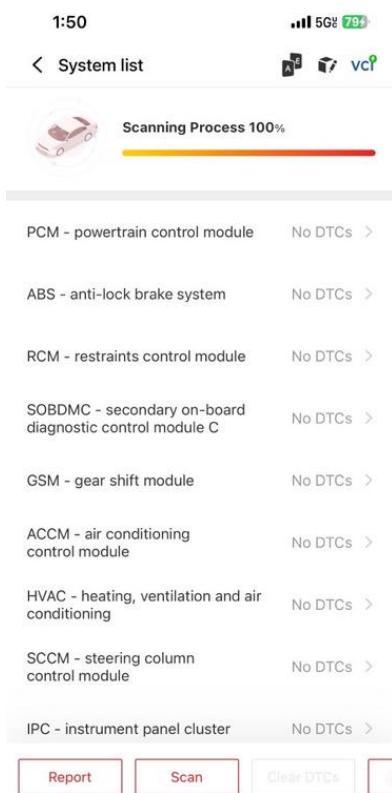
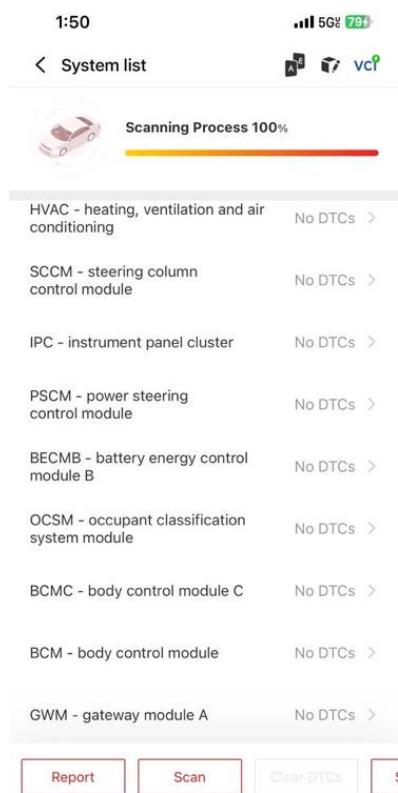
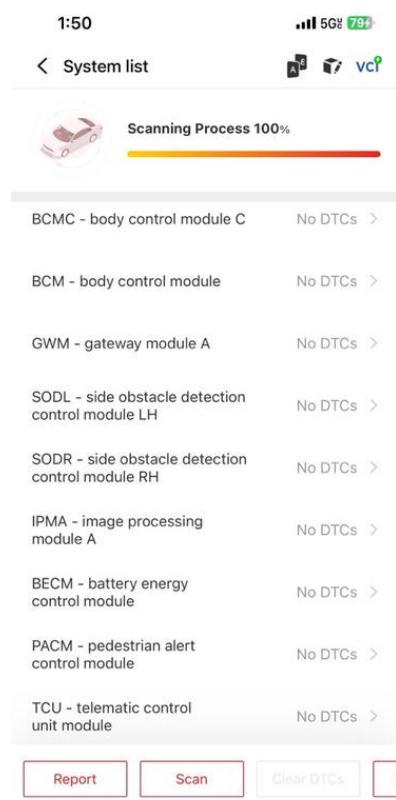
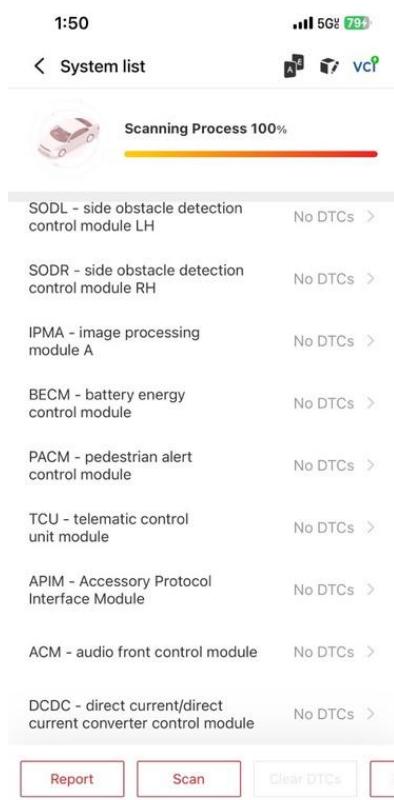
All of the control modules on the vehicle were free of any live/active diagnostic fault codes. All live feed diagnostic testing was successfully passed. All live feed emissions testing was successfully passed.
