# Village Park #4 Strong!

## Fire Assessment and Proposed Plan of Action

**Prepared for Village Park Recreational Community #4**

**By: Douglas Kent+ Associates**

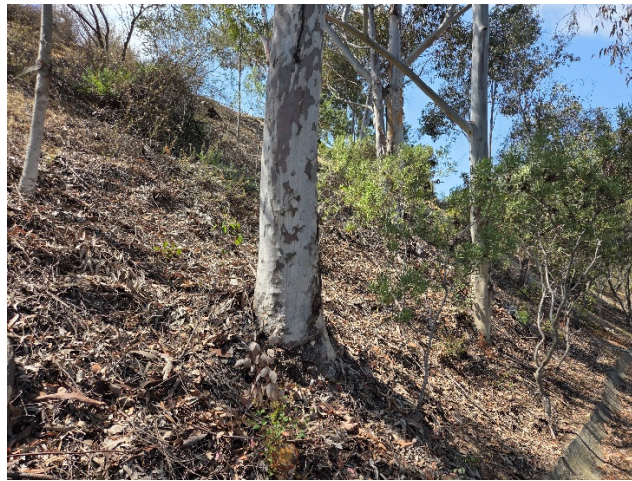
*A slope on the southwestern edge of the Open Space that shows good attention to fuel reduction while reducing erosion and topsoil loss.*

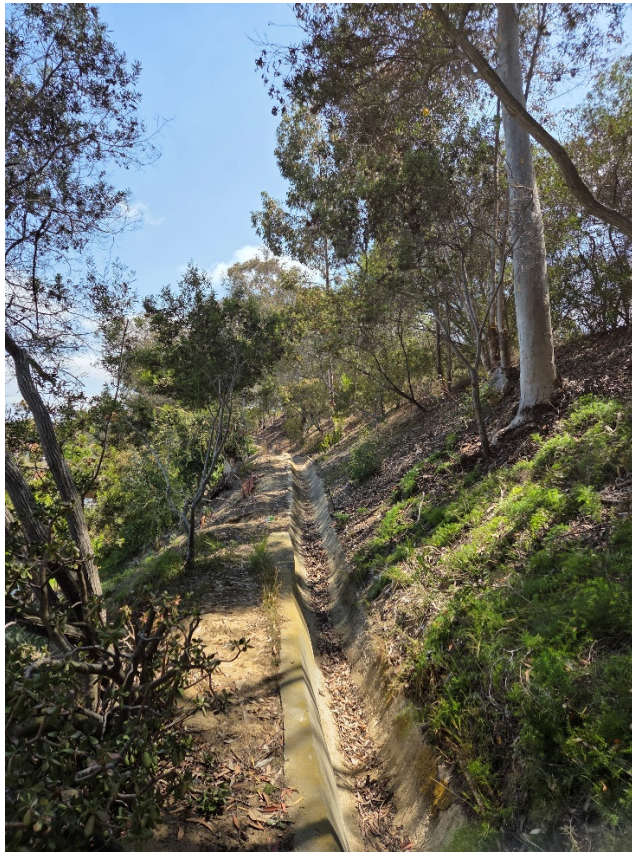
*Picture taken along the southwestern edge of the open space and it shows land care that will greatly reduce the severity of a wildfire. Excess vegetation and deadwood have been removed, ladder fuels have been reduced, and spacing between trees is being maintained.*

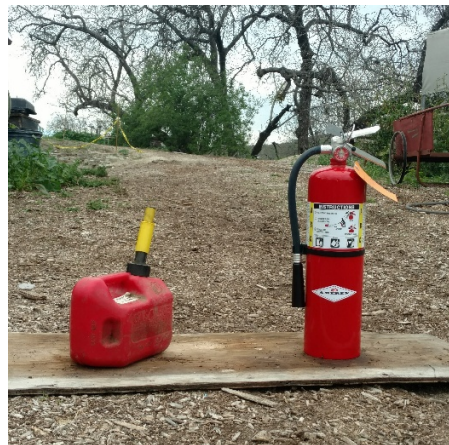
*All machine work in fire country must be accompanied by a fire extinguisher, board for hot equipment, and a no-spill refueling can.*

1. **Fuel Reduction:** In the Areas of Great Concern (see prior section) the dead wood must be removed. These fuels are both on the ground and in the canopies of the shrubs and trees. Importantly, anyone doing work in the open space must bring a fire extinguisher with them and a board to lay hot equipment on.

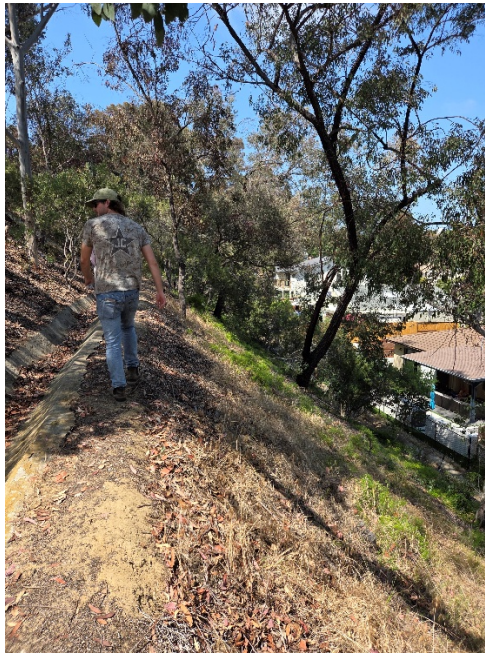
*Some parts of the Open Space have an irrigation system. It should be employed when rainfall is scant. Other areas of the Open Space would be more fire resistant with supplemental moisture as well.*

4. **Winter Water:** More so than any other time of year, California native and Mediterranean plants need late fall and winter moisture—it is when they stock up and prepare for the long, dry and hot months ahead. If average rainfall does not occur, the community should ensure winter moisture.

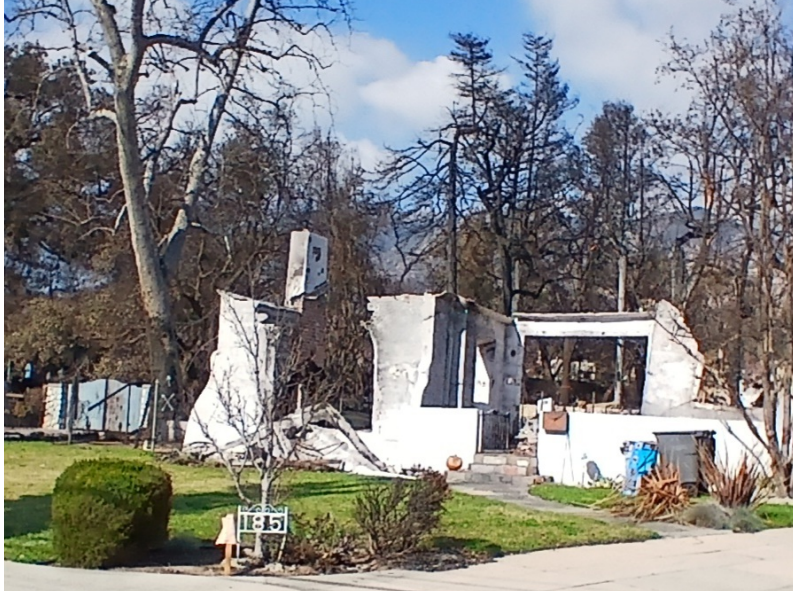
*Pictured is a common sight in every burn area I have toured—an immaculate landscape surrounding a pile of charred rubble. Always start with the heart and work outwards. Picture taken in Altadena*
