Lighthouse Home Inspections, LLC Home Inspection Report

1234 Happy Street, Cleveland, OH 44000 Inspection prepared for: I.M. Client Date of Inspection: 1/1/2020 Time: 1:00 PM Age of Home: 1915 Size: 1020 Order ID: XXX

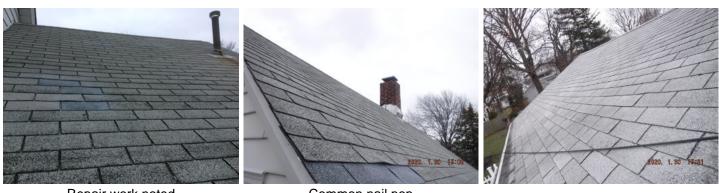
3.2. Shingles are older and nearing end of life. Common nail pops/lifting sections, exposed nails and holes noted. Recommend contacting a roofing contractor to perform a roofing tune up, evaluate, give remaining life expectancy, and repair / seal all flashings, holes where dish satellite was attached, exposed nail heads and lifting shingles at needed locations.

Lifting sections

Repair work noted

Common nail pop

Multiple layers observed

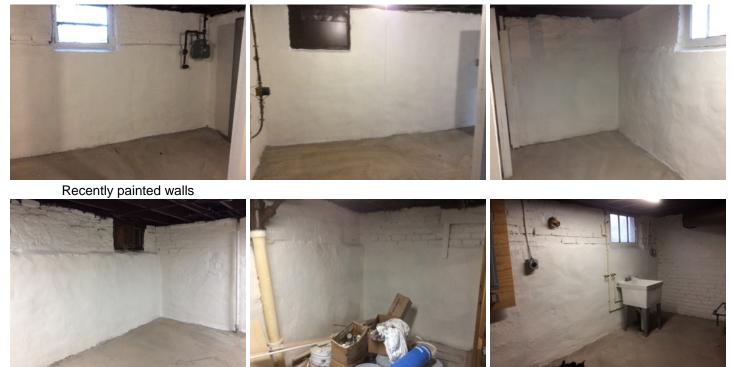
Excessive amount of dirt

Water stains on floor suggests water seepage

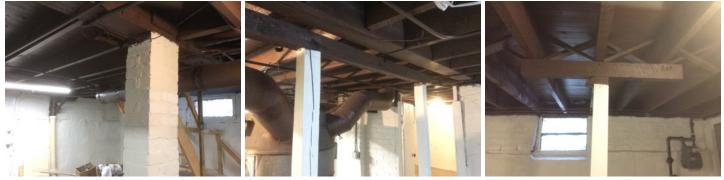
3.1. Additional bracing is not secured / permanent which means it could be moved or shifted. Recommend a professional contractor evaluate and repair / secure.

Bracing added to try to relevel floor

Additional bracing added

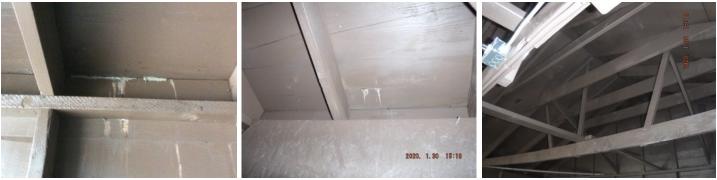
3.2. Be advised ceiling/ structure was recently painted. Sections show leaks since painting. Roof is older with multiple layers

Leaking roof section

Minor leak
