Inspection

██████████ Dr, Houston, TX ██████████

Date of Inspection: 6/3/2020 Time: 9:00 AM

PROPERTY INSPECTION REPORT

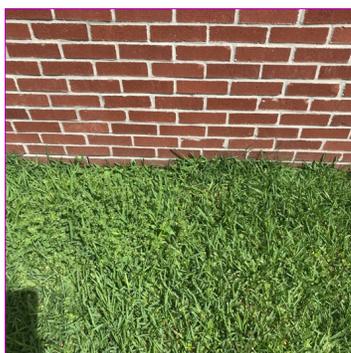
Soil height close to the exterior facade on part of the structure. This is a path for insects & moisture to travel to enter the home.

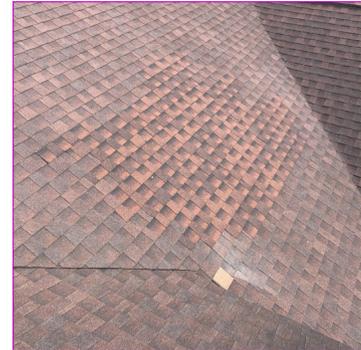
Evidence of patching and/or repair at time of inspection. Monitor these areas. Keep up with proper maintenance & corrective measures when needed.

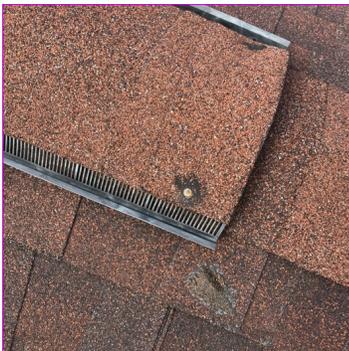
There were exposed fasteners at the time of inspection

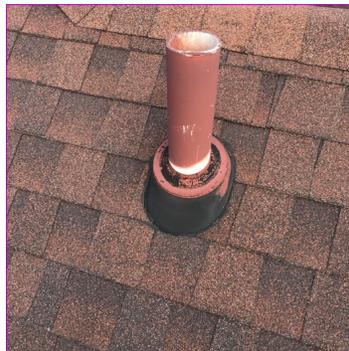
Some flashings were incorrectly installed & do not fully serve their intended purpose.

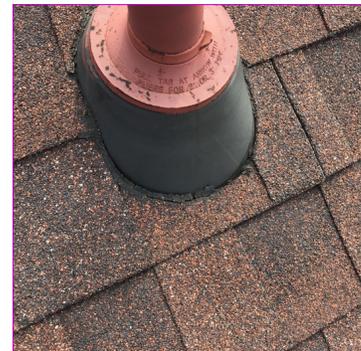
One or more flashing were not properly sealed at the time of inspection

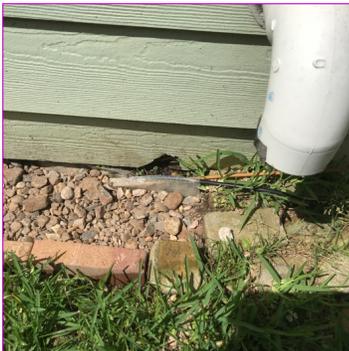
Sections of the hardboard siding were damaged

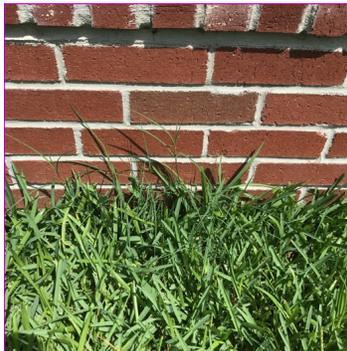
Foliage is in contact with masonry walls

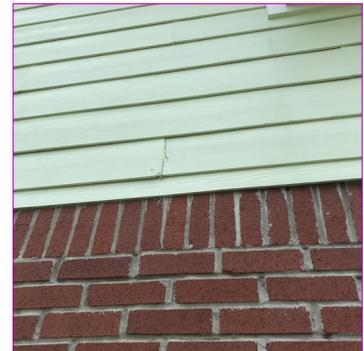
There were unsealed joints in the hardboard siding. We recommend the joints be caulked or sealed. This is a part of routine homeowner maintenance. Monitor yearly

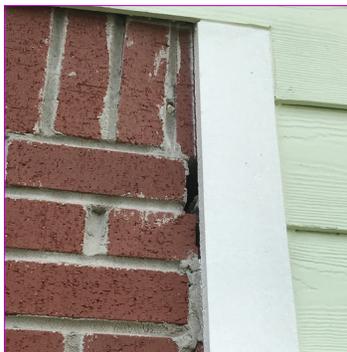
Gaps in the hardboard siding were observed at one or more of the pipe and/or vent penetrations. We recommend all such gaps be sealed or plugged in the course of routine property maintenance

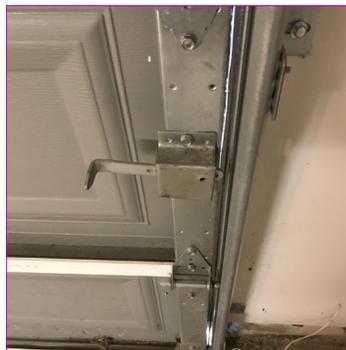
The overhead garage door lock has not been disabled. This is considered an entrapment hazard based on the state regulated standards of practice

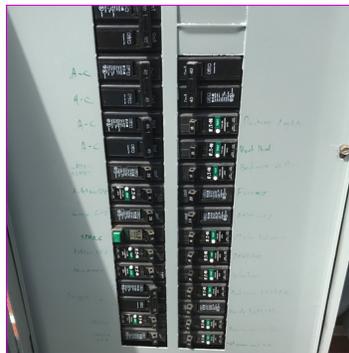
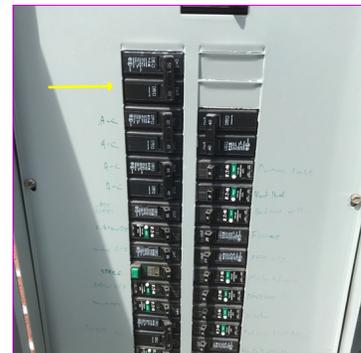
Breaker panel was not labeled or was partially labeled. This is a deficiency

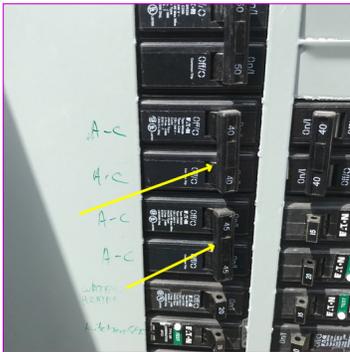
The breaker(s) pictured appear to be rated for greater amperage than allowed by the wire size present

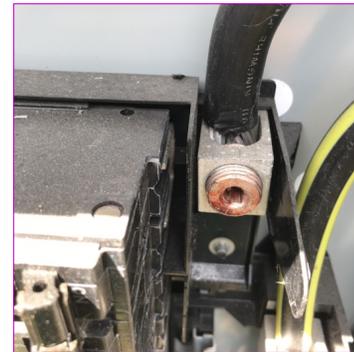
Aluminum wiring lacks anti oxidant coating. This is a deficiency

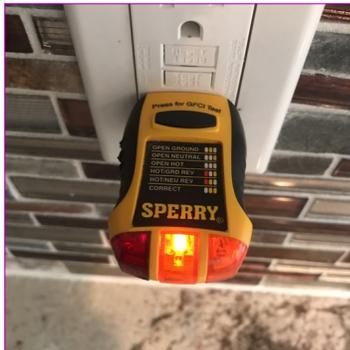
Three prong receptacles were ungrounded. Based on wiring found in the panel and/or sub panel(s), portions of the structure possibly contains what is called a "two wire" electrical system present. This is indicated by the age of the structure & the fact that some or all receptacles were ungrounded. Though it was installed properly, for its time. These are no longer up to date with modern construction practices because they do not possess an earth ground therefore rendering all receptacles & appliances ungrounded. This should be discussed with an electrician if this is of a concern

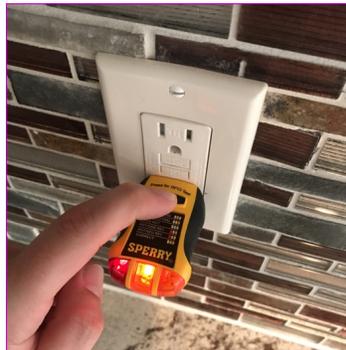
Though the kitchen was equipped with GFCI style receptacles, when tested some of the receptacles did not trip, and therefore, lack GFCI protection

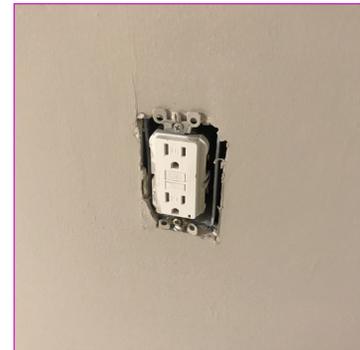
Some cover plates were missing

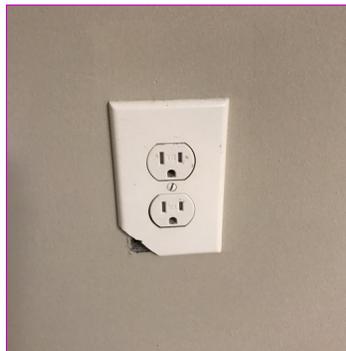
Some cover plates were damaged

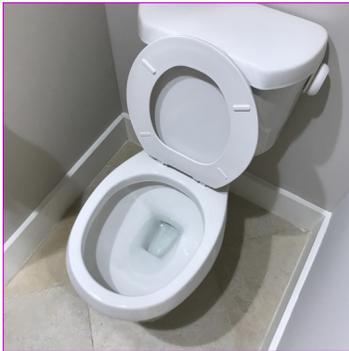
Master bathroom toilet would not flush using normal operating procedures

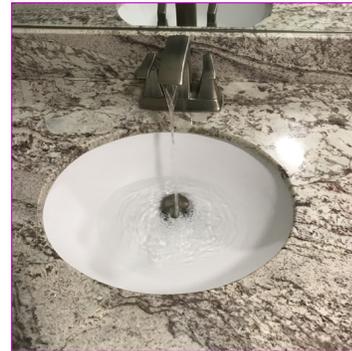
Upstairs Hall bathroom sink drains slowly
