Condition Assessment and Report of Findings

Town of Holden Beach

Holden Beach Pier

Holden Beach, North Carolina April 7, 2025

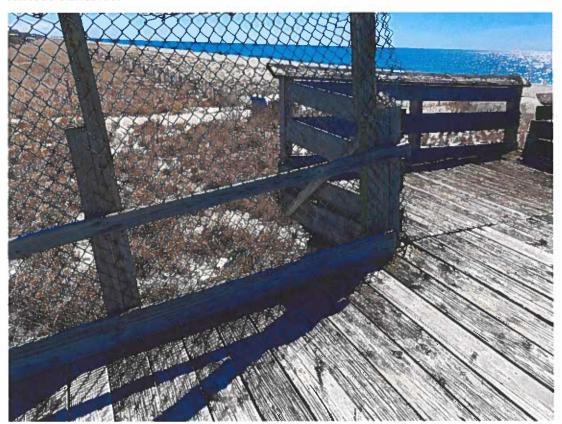
Figure 5 - Balcony Area Between Sta 0+75 and 0+90

At the end of the access ramp or start of the main pier, there is a balcony area that acts as an overlook for the beach (Figure 5). The balcony superstructure is in CRITICAL condition overall. Deficiencies observed include:

- Railing detachment and failure (Photo 5)
- Loose and soft deck boards
- Split rail posts (Photos 3 and 6)
- Corroded steel hardware (Photo 6 and 67)
- Hollow pile (Photos 4).

While timber piles are a substructure element, the pile top was observed from the balcony as hollowed. Individually, the railing is in CRITICAL condition while the deck boards and hollowed pile are in POOR to SERIOUS condition. The hardware is heavily corroded with sections of failed timber railing and therefore insufficient in transferring or supporting the required OSHA rail load standards.

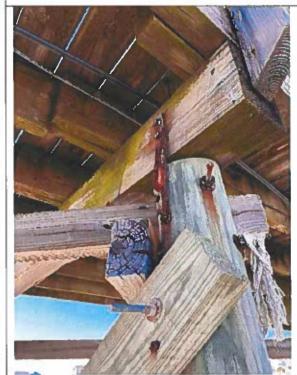
Pile caps were observed to generally be 10x10 members and piles were typically field measured as 12-in in diameter. The SERIOUS elements include the corroded/failed pile to pile cap connections and the disconnected and split bracing members which are no longer structurally effective.

Photo 75: Corroded and Failed Pile / Pile Cap Connection near station 2+50

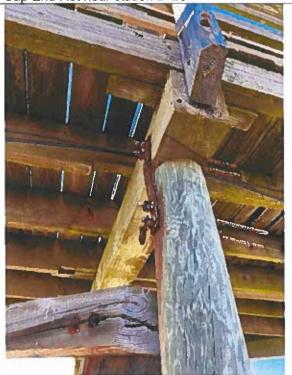
Photo 76: Corroded Pile / Pile Cap Connection and Cross Bracing Connection near station 2+50

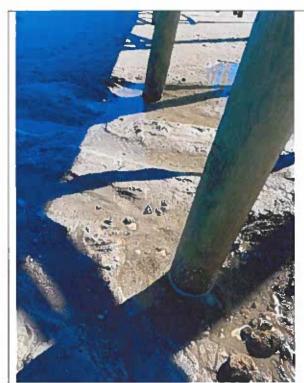
Photo 77: Typical Pile Marine Growth and Localized Scour in the Tidal Zone near station 2+75

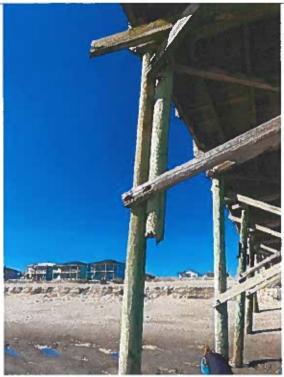
Photo 78: Typical Pile Sistering Repair near station 2+75

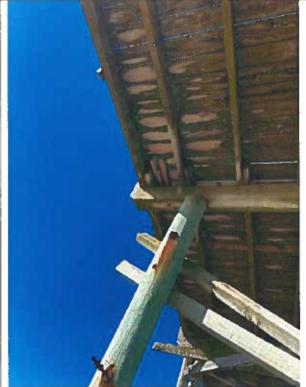
Photo 79: Typical Pile with Missing Cross Bracing and Missing Pile / Pile Cap Connection near station 3+00

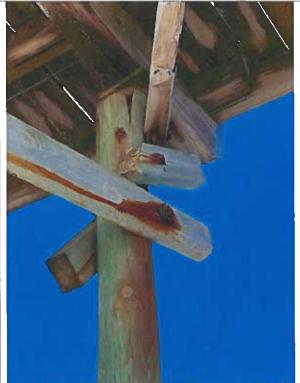
Photo 80: Split Pile Head with missing Pile / Pile Cap Connection Tie near station 3+50

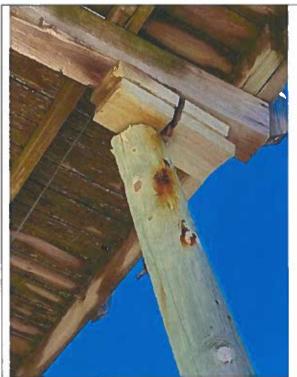
Photo 81: Misaligned Pile Missing Pile / Pile Cap Connection and Missing Bracing near station 3+75

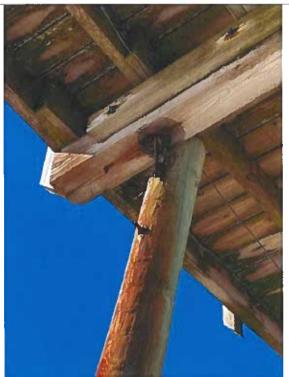
Photo 82: Misaligned Pile Missing Pile / Pile Cap Connection and Missing Bracing near station 3+75
