Town of Holden Beach Summary Report

Town Pier Preliminary Reconstruction

HDR Engineering, Inc. of the Carolinas
Project No. 10426190

August 4, 2025

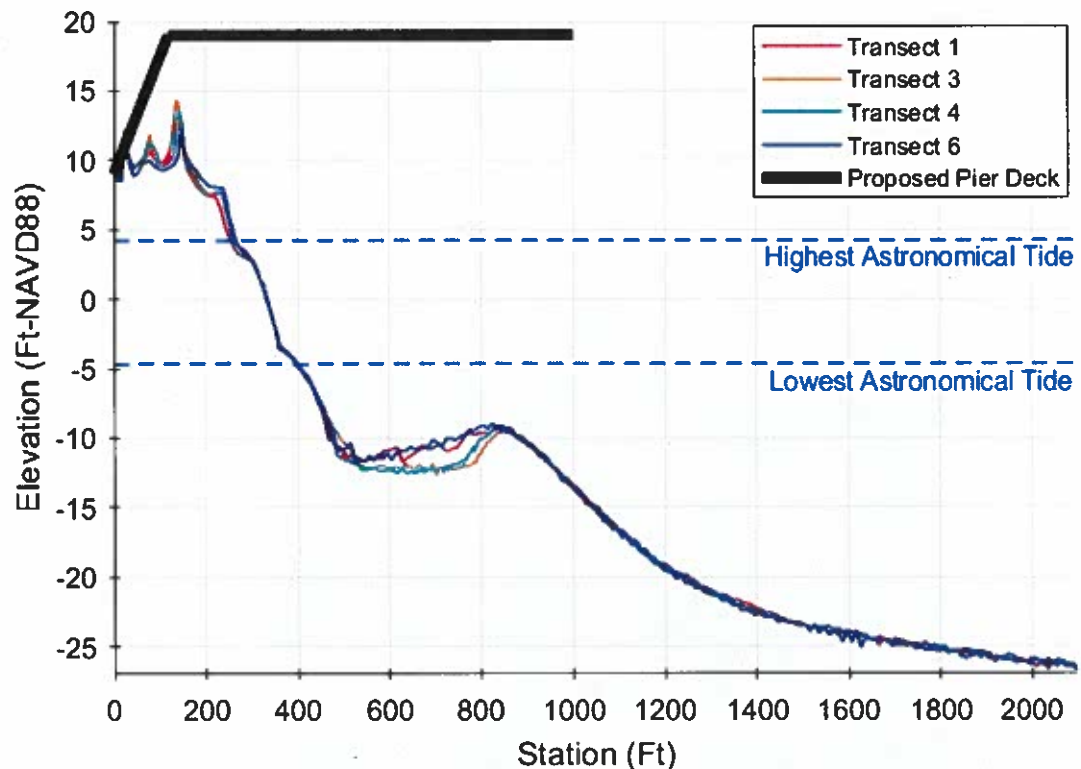
Figure 2-2. Beach Profiles Including the Proposed Pier Deck Elevation

From Figure 2-2, the effects of the pier on local scour can be observed in the offshore bar located between Stations 4+50 and 8+00. The bed within the immediate vicinity of the pier is about three feet deeper compared to the bed located approximately 200 feet away. The deeper elevation was used in the scour analysis to account for impacts on pile stability from bedform variability.

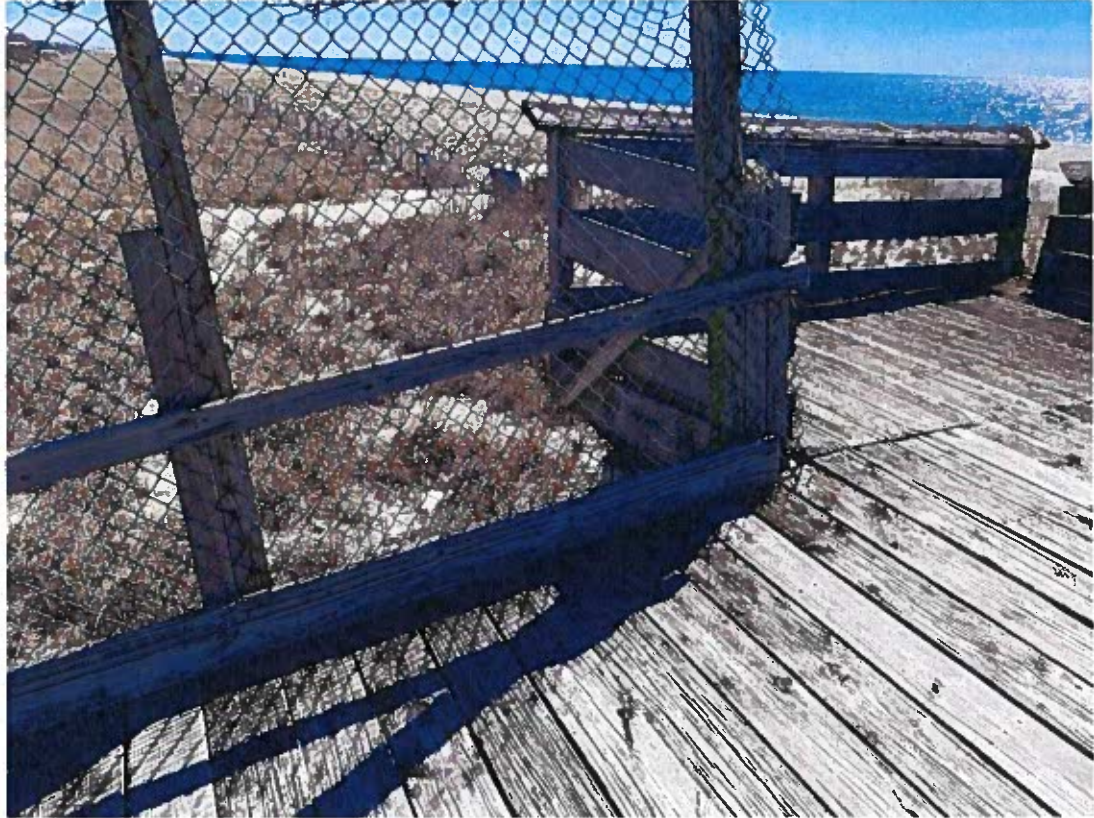
Figure 5 - Balcony Area Between Sta 0+75 and 0+90

While timber piles are a substructure element, the pile top was observed from the balcony as hollowed. Individually, the railing is in CRITICAL condition while the deck boards and hollowed pile are in POOR to SERIOUS condition. The hardware is heavily corroded with sections of failed timber railing and therefore insufficient in transferring or supporting the required OSHA rail load standards.

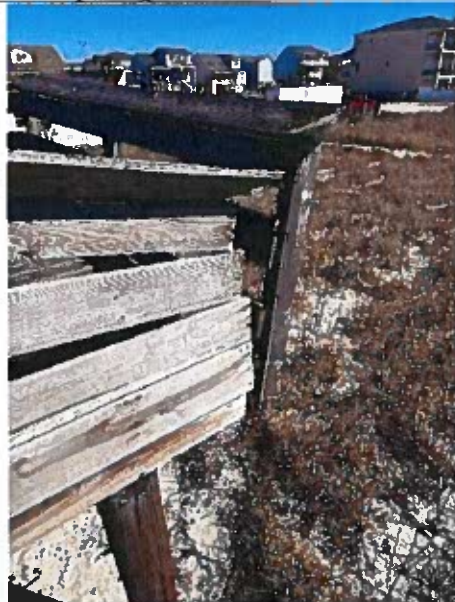
Photo 5: Typical Railing Detachment and Failure near station 0+90

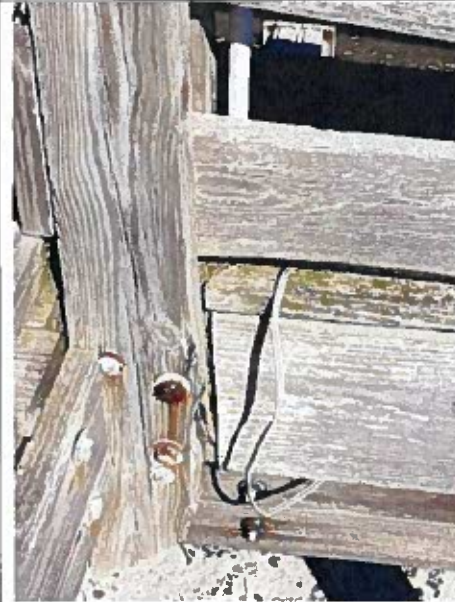
Photo 6: Typical Rail Post Gouging and Connection Bolt Corrosion near station 0+90

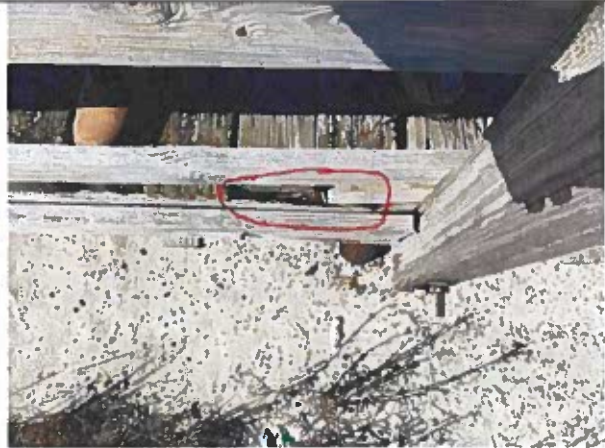
Photo 8: Typical Joist Deterioration near station 1+25

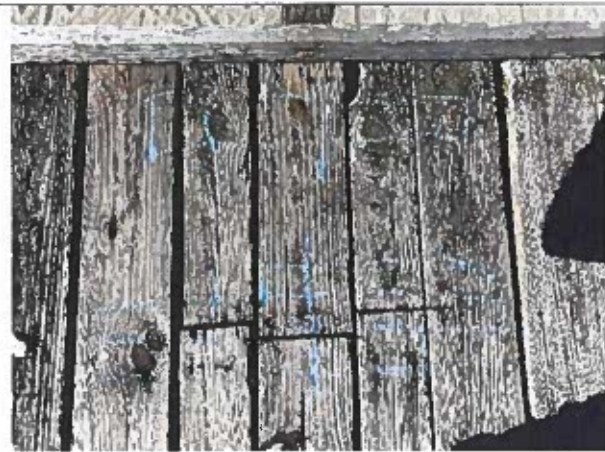
Photo 12: Typical Joist Replacement near station 2+25

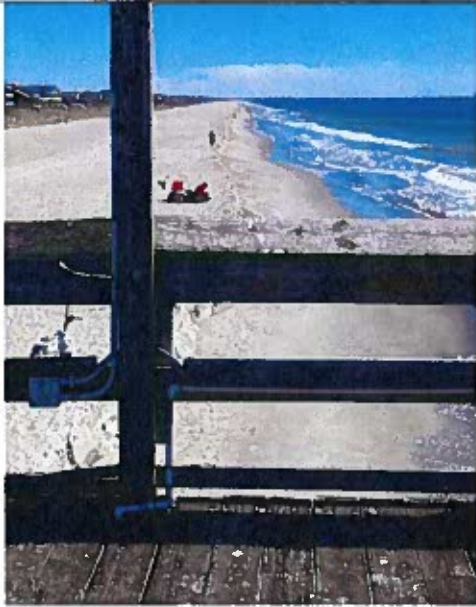
Photo 13: Top Rail Split and Conduit Running along Midrails near station 2+75

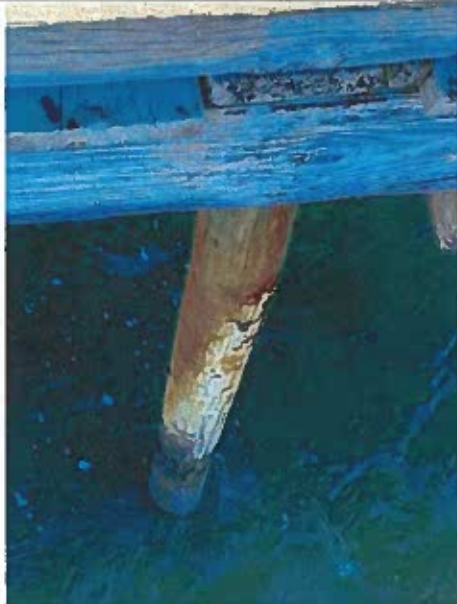
Photo 21: Typical Timber Pile Flaking and Gouging near station 3+75

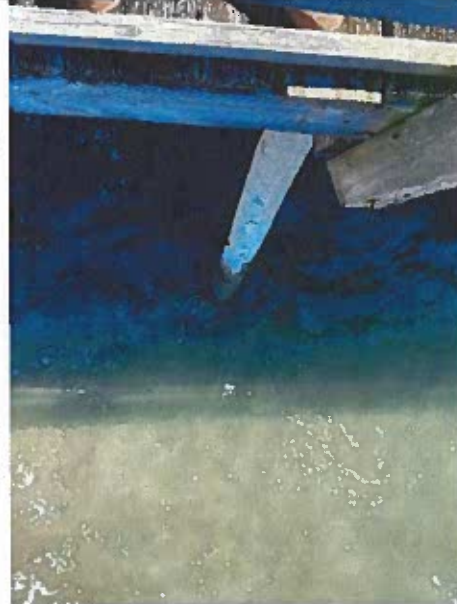
Photo 22: Rail Post Corroded Connection Bolt near station 3+75

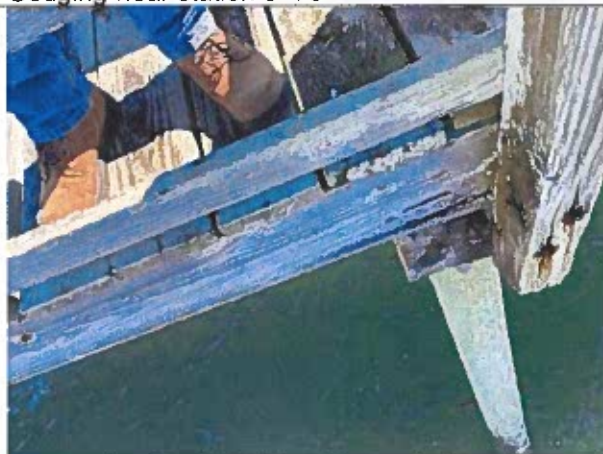
Photo 23: Corroded Connection and Checking at Rail Post and Timber Pile Cap Beam. Pile with Missing Brace and near station 4+00

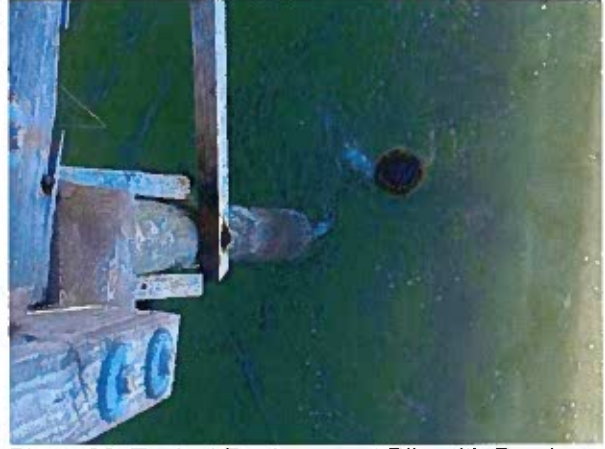
Photo 28: Typical Replacement Pile with Previous Cut-off Pile in Water near station 4+25

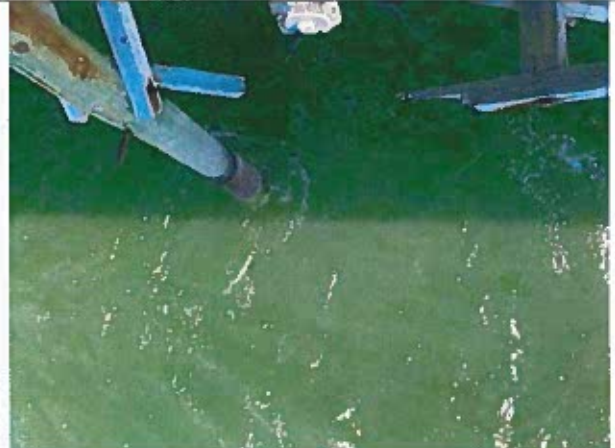
Photo 44: Typical Broken Bracing Member and Corroded Bolts near station 6+75

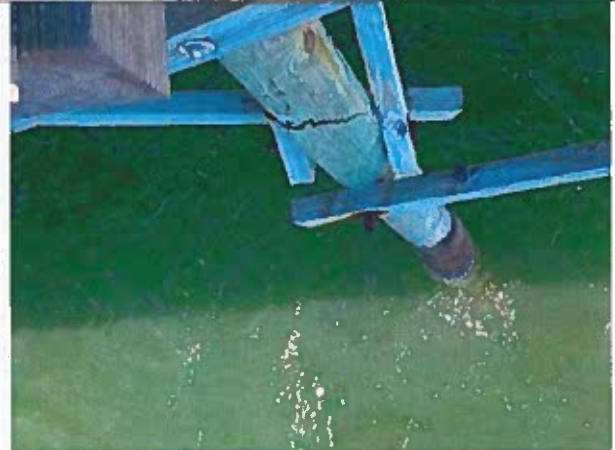
Photo 46: Cracked Pile near station 7+00

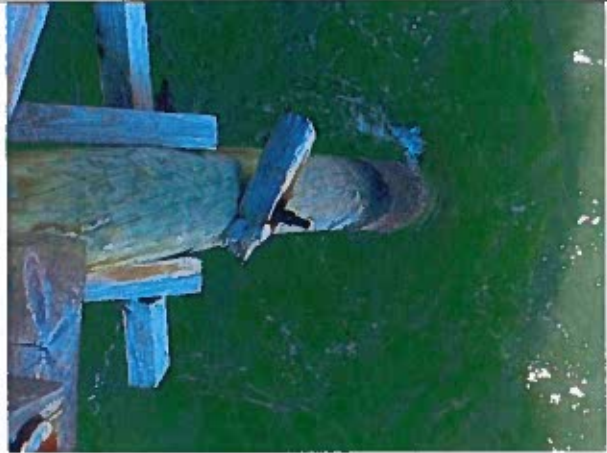
Photo 49: Typical Broken Bracing Member and Corroded Bolts near station 7+25

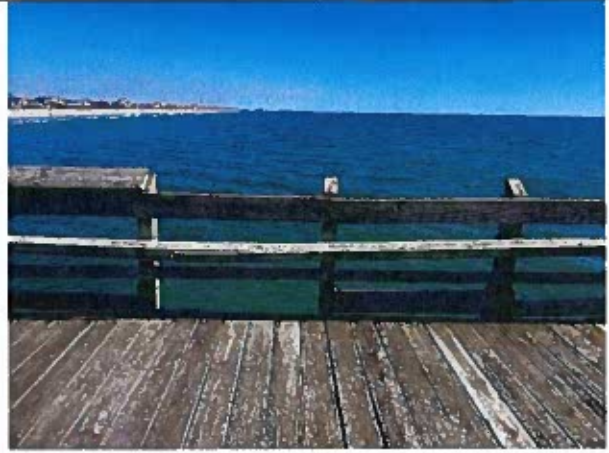
Photo 50: Typical Missing Top Rail and Toe Boards near station 7+25

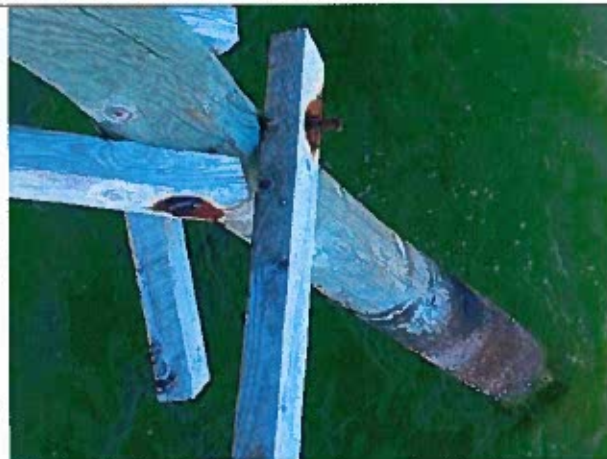
Photo 51: Typical Pile Gouging and Checking near station 7+25

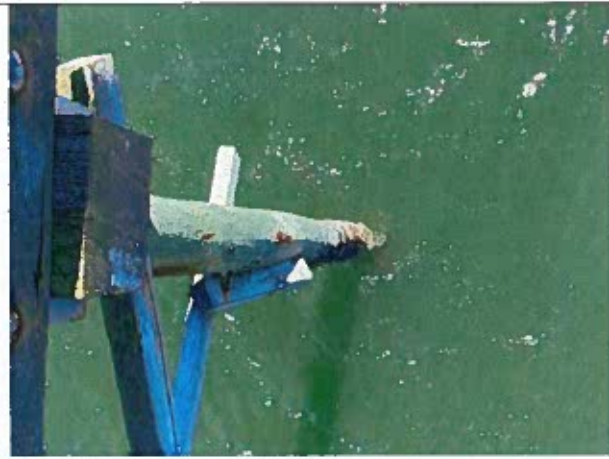
Photo 52: Typical Broken and Missing Bracing Member and Corroded Bolts near station 7+50

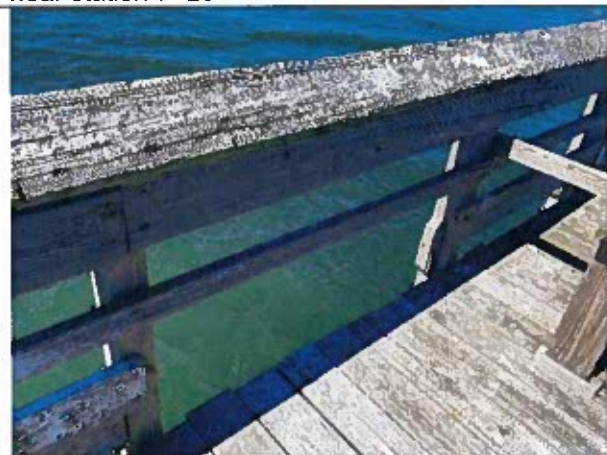
Photo 53: Typical Missing Midrail and Toe Board near station 7+50

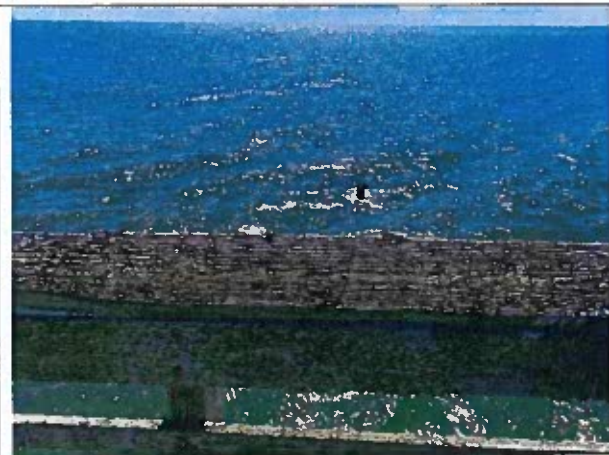
Photo 54: Broken Pile Beyond station 7+50

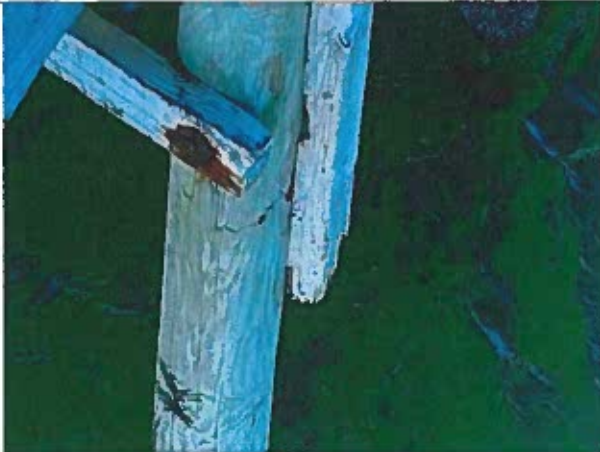
Photo 55: Typical Pile Gouging and Flaking near station 7+50

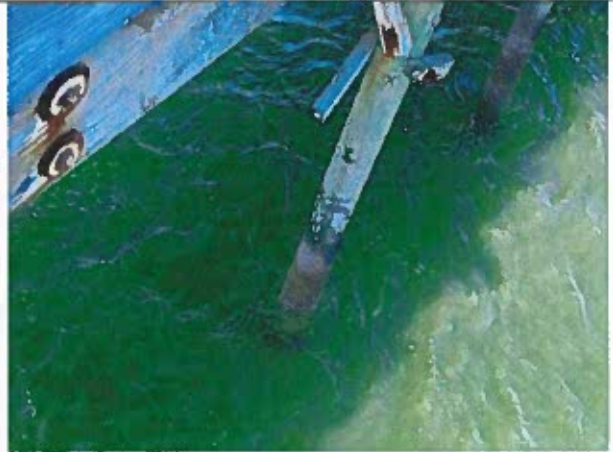
Photo 56: Typical Pile Gouging and Pitting with Broken Bracing near station 7+50

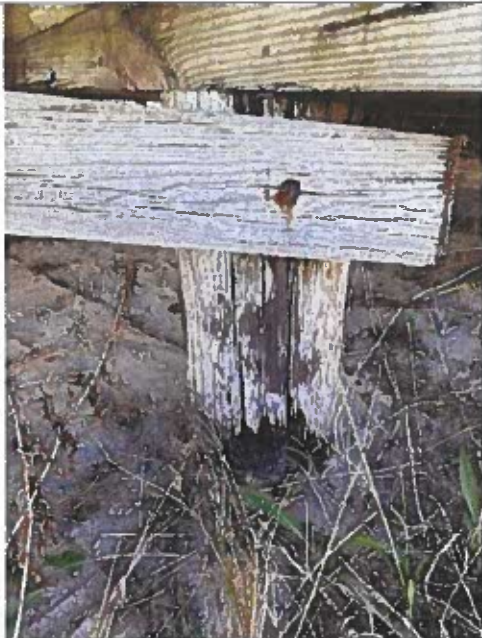
Photo 57: Typical Pile Exterior Rot Deterioration near station 0+00

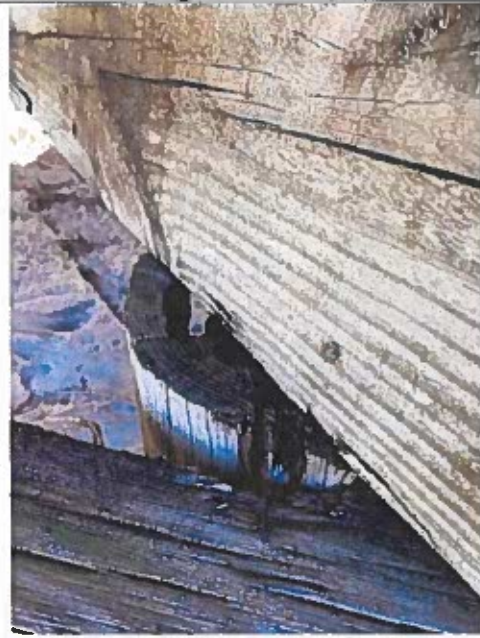
Photo 58: Typical Hollow Pile Deterioration near station 0+00

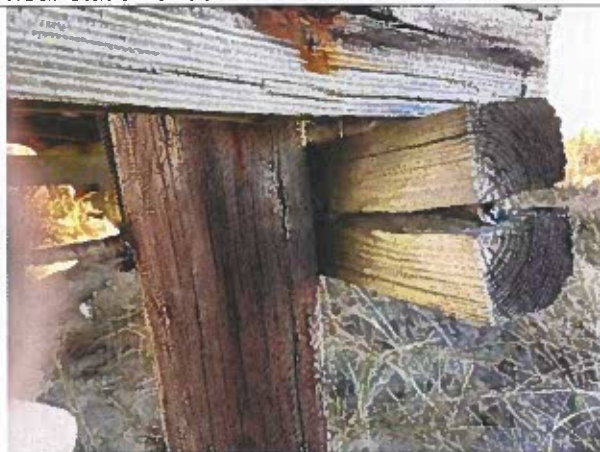
Photo 59: Typical Cross Bracing Checking and Splitting near station 0+50

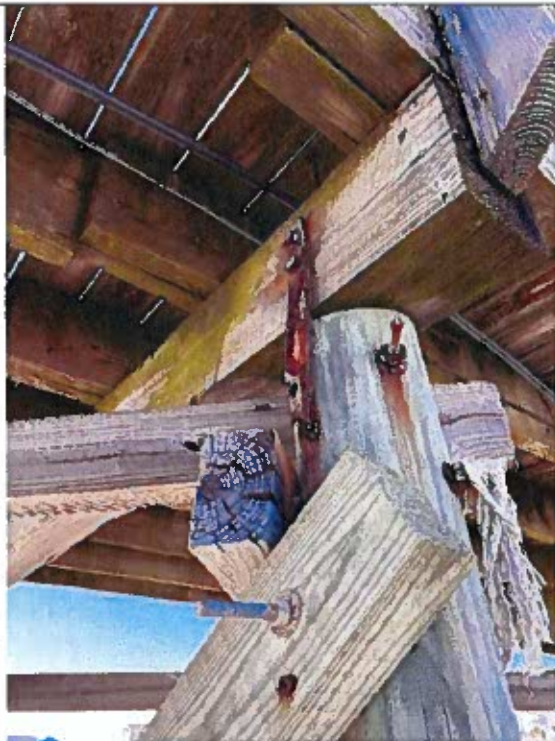
Photo 75: Corroded and Failed Pile / Pile Cap Connection near station 2+50

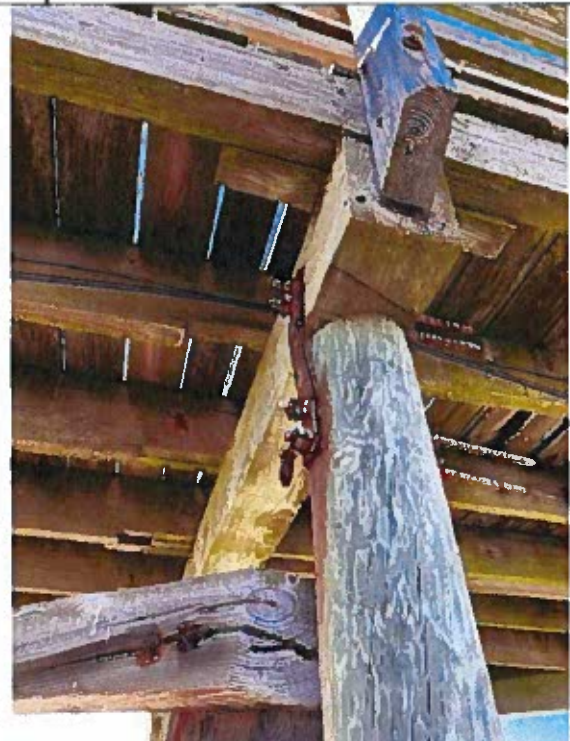
Photo 76: Corroded Pile / Pile Cap Connection and Cross Bracing Connection near station 2+50

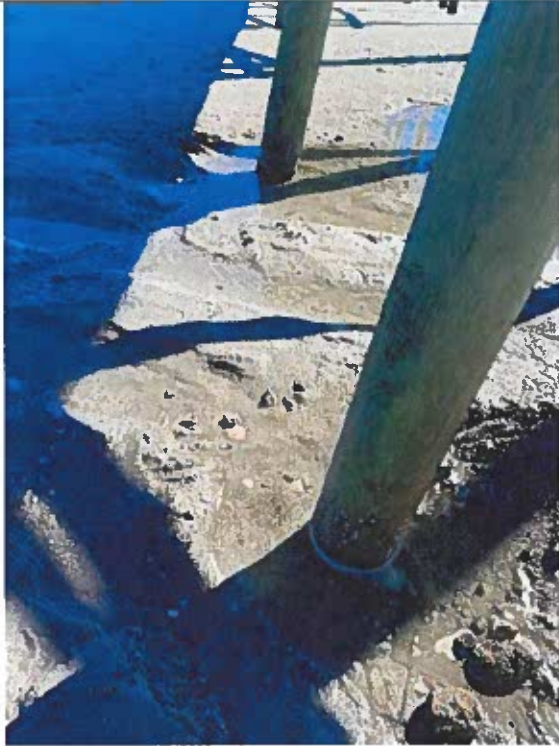
Photo 77: Typical Pile Marine Growth and Localized Scour in the Tidal Zone near station 2+75

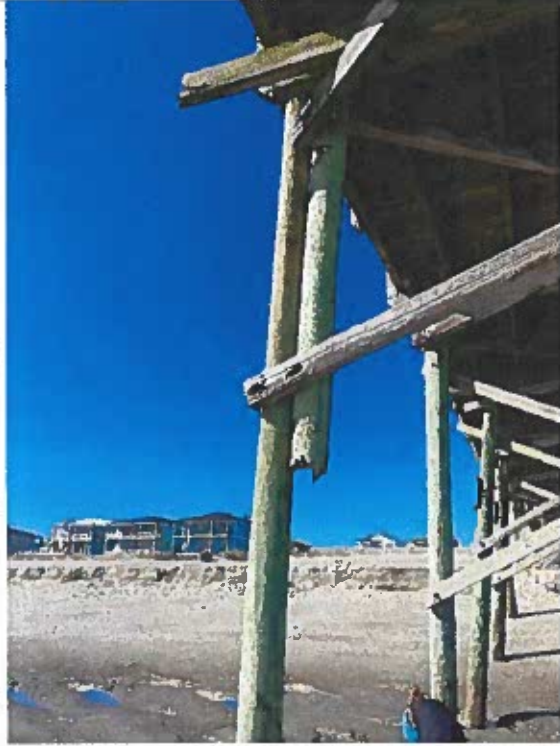
Photo 78: Typical Pile Sistering Repair near station 2+75

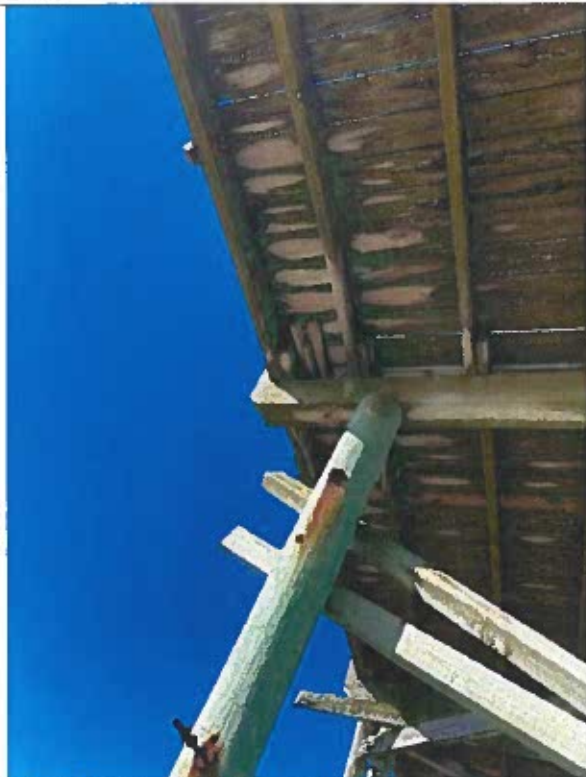
Photo 79: Typical Pile with Missing Cross Bracing and Missing Pile / Pile Cap Connection near station 3+00

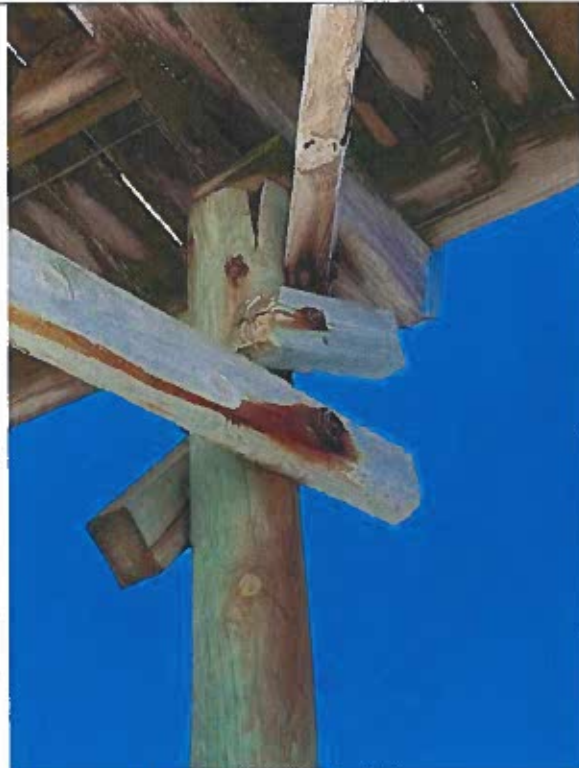
Photo 80: Split Pile Head with missing Pile / Pile Cap Connection Tie near station 3+50

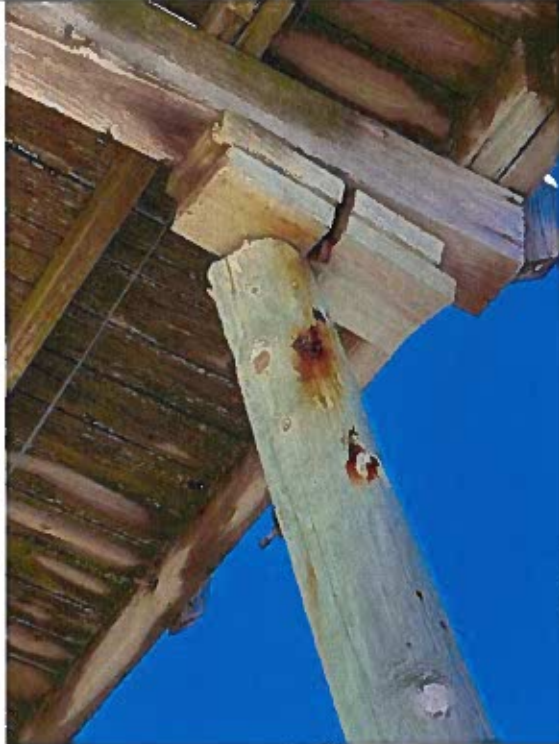
Photo 81: Misaligned Pile Missing Pile / Pile Cap Connection and Missing Bracing near station 3+75

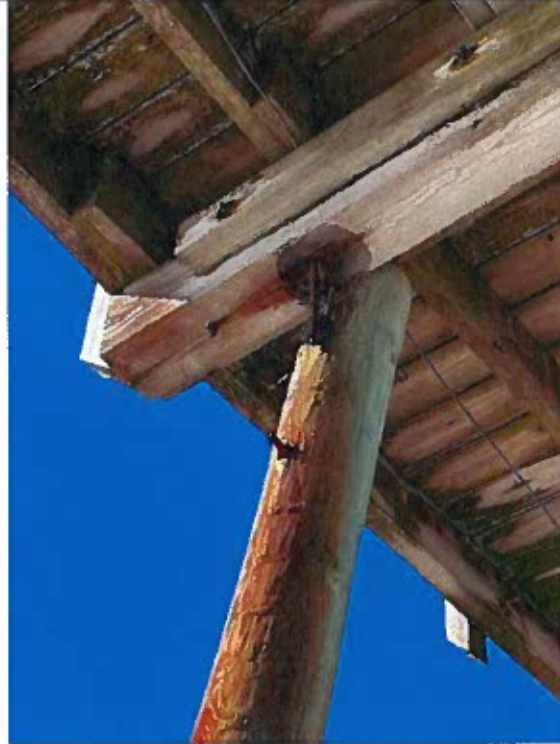
Photo 82: Misaligned Pile Missing Pile / Pile Cap Connection and Missing Bracing near station 3+75

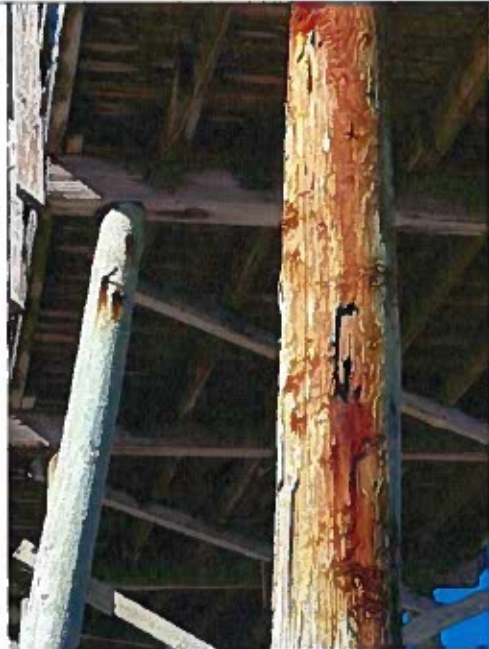
Photo 83: Pile Gouging and Flaking near station 3+75

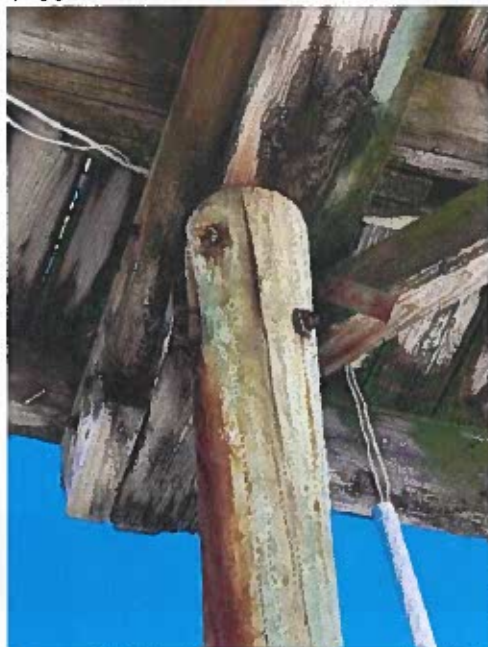
Photo 89: Pile / Pile Cap Connection Failure and Gouging at Pile Top near station 4+00

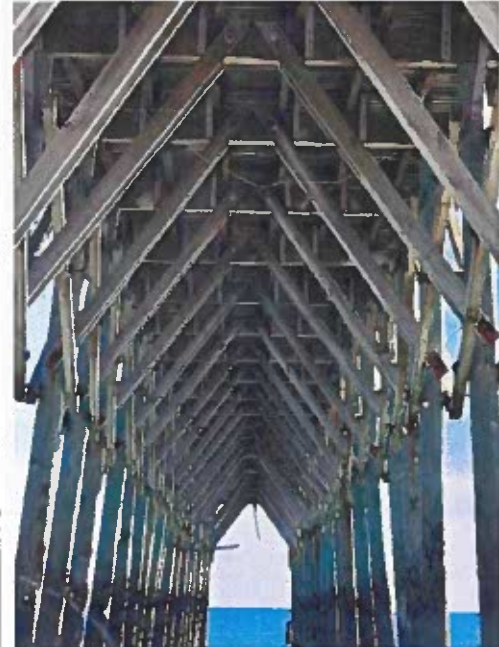
Photo 90: Broken Bracing and Corroded Connection Bolts Beyond station 4+00
