May 17, 2022

Project #: GES-2201

Reference: Holden Beach Fishing Pier – 2022 Due Diligence Inspection
Holden Beach, North Carolina

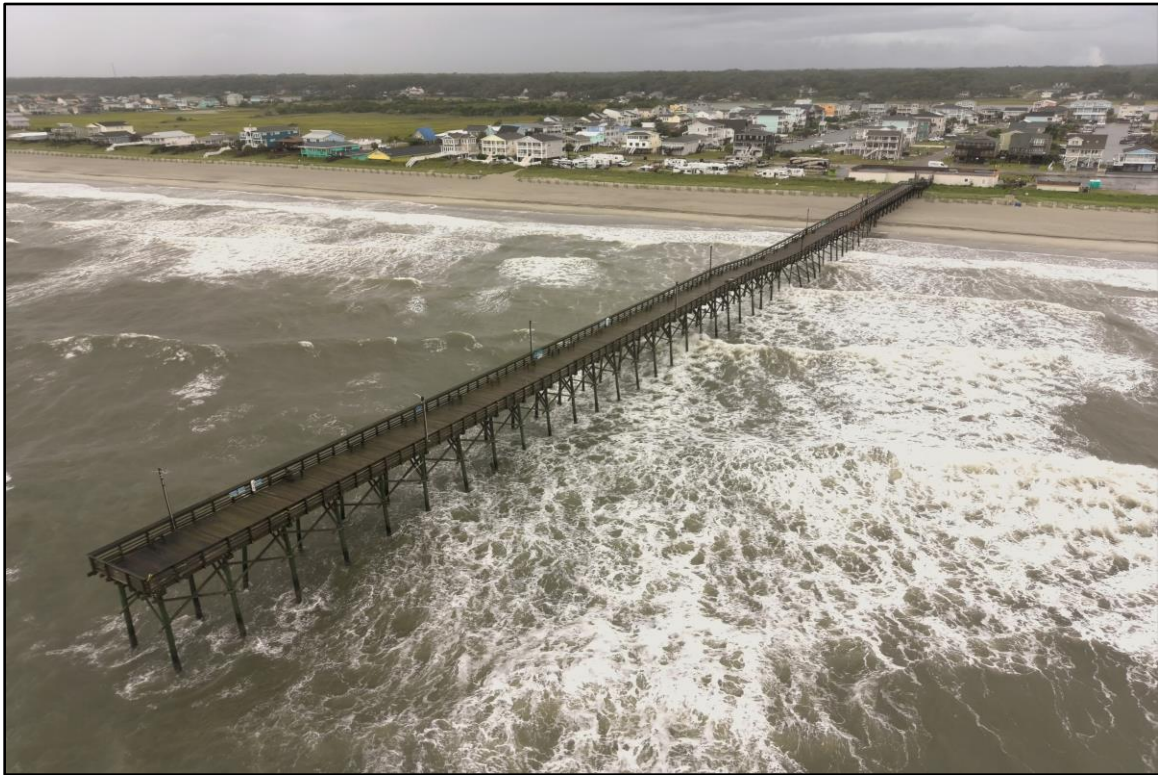
Photograph 1: Overall of Holden Beach Pier

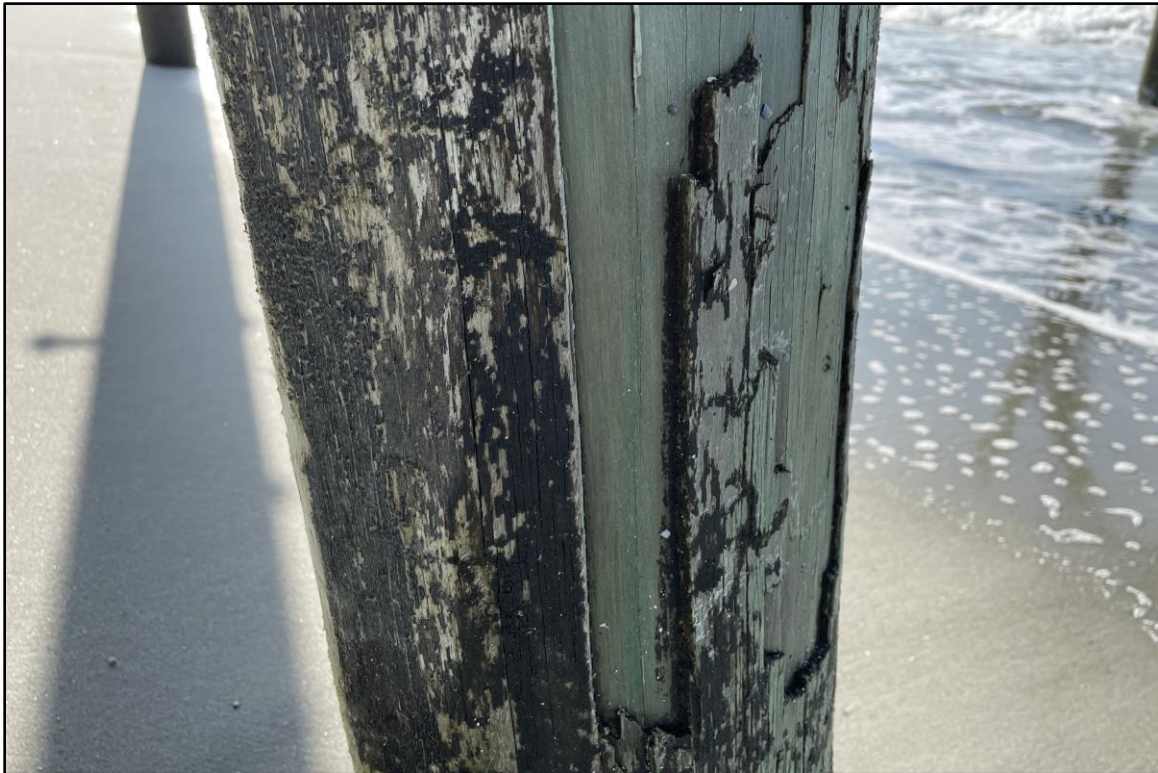
Photograph 2: Pile 25B – Typical shell peeling found on greenheart piles

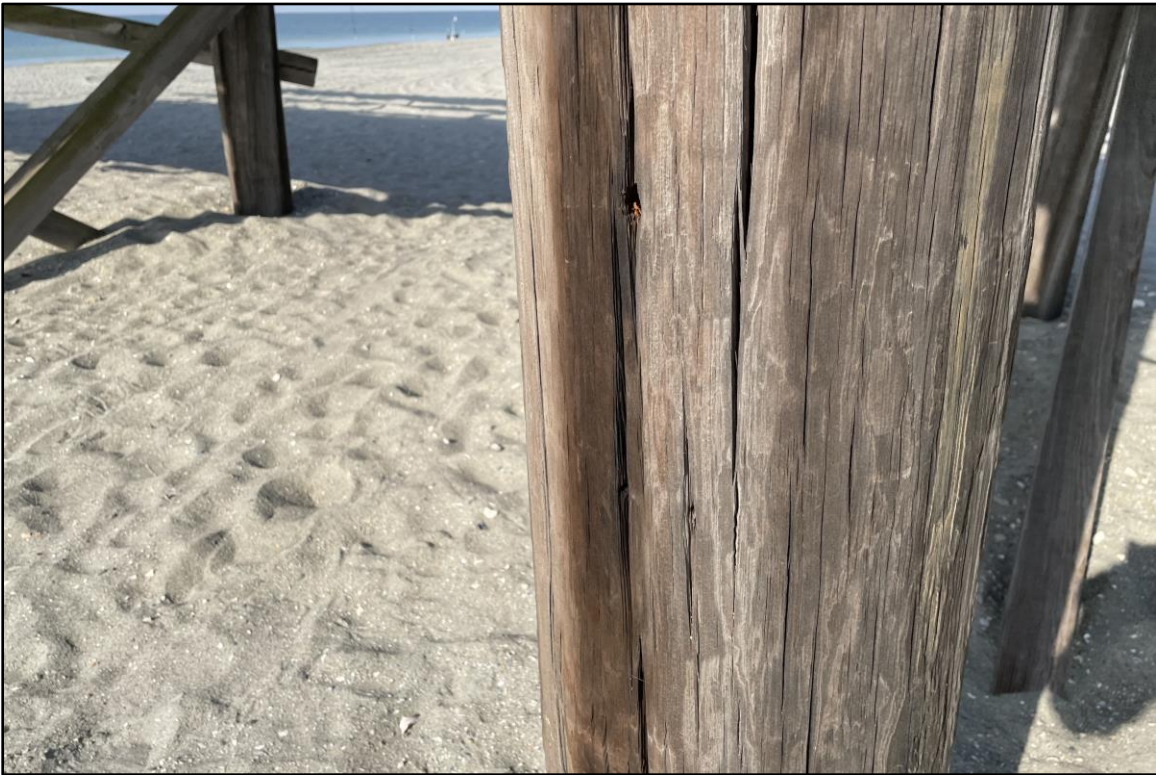
The inshore section of the pier from Bent -6 to Bent 10 are predominantly original vintage 10 - 12-inch diameter timber piles. The piles typically exhibited localized light checking/weathering (Photograph 2 and Photograph 3). The piles located between Bents 11 thru 52 are newer vintage greenheart timber piles 8 to 12-inch diameter. The piles located in between Bents 23 thru 52 have light marine growth consisting of light barnacles below mean low water (MLW) (Photograph 4) and typical have no defects above MLW. Isolate major to severe defects were identified at the top of some of the piles which are summarized in Table 2.

Photograph 3: Pile 7A – Typical checking and weathering found on original vintage piles

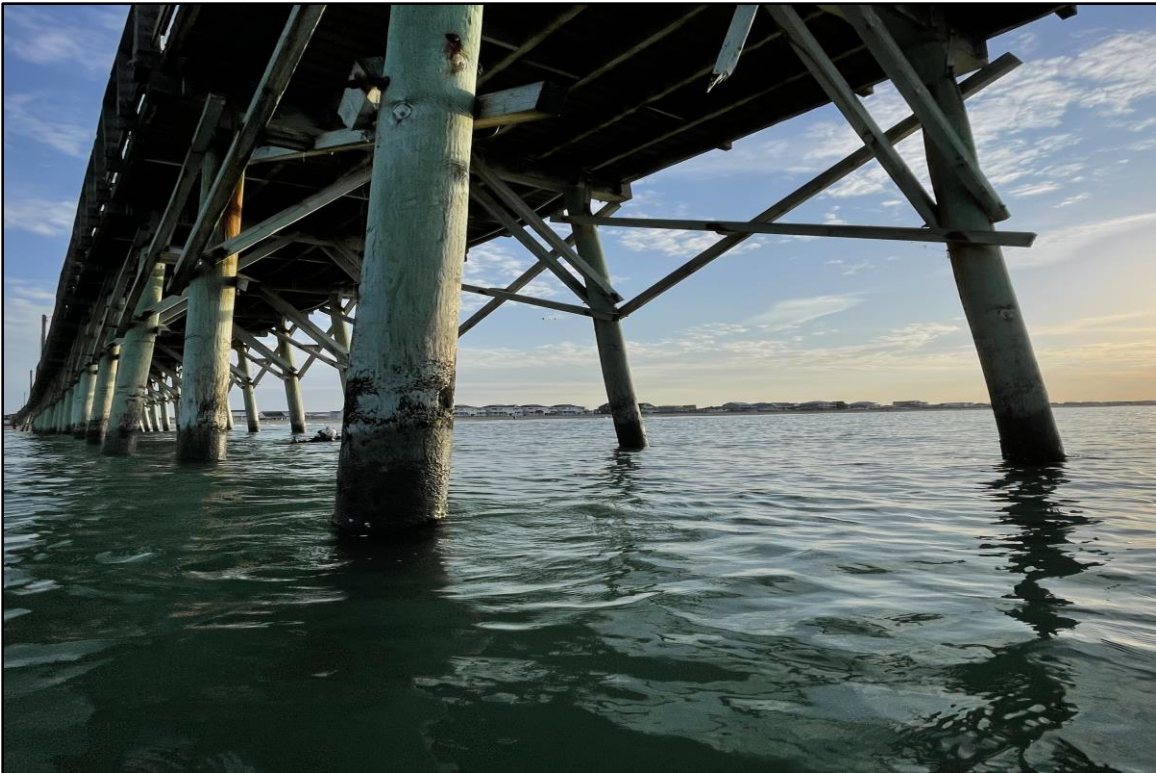
Photograph 4: Pile 52B – Typical marine growth found down length of pile

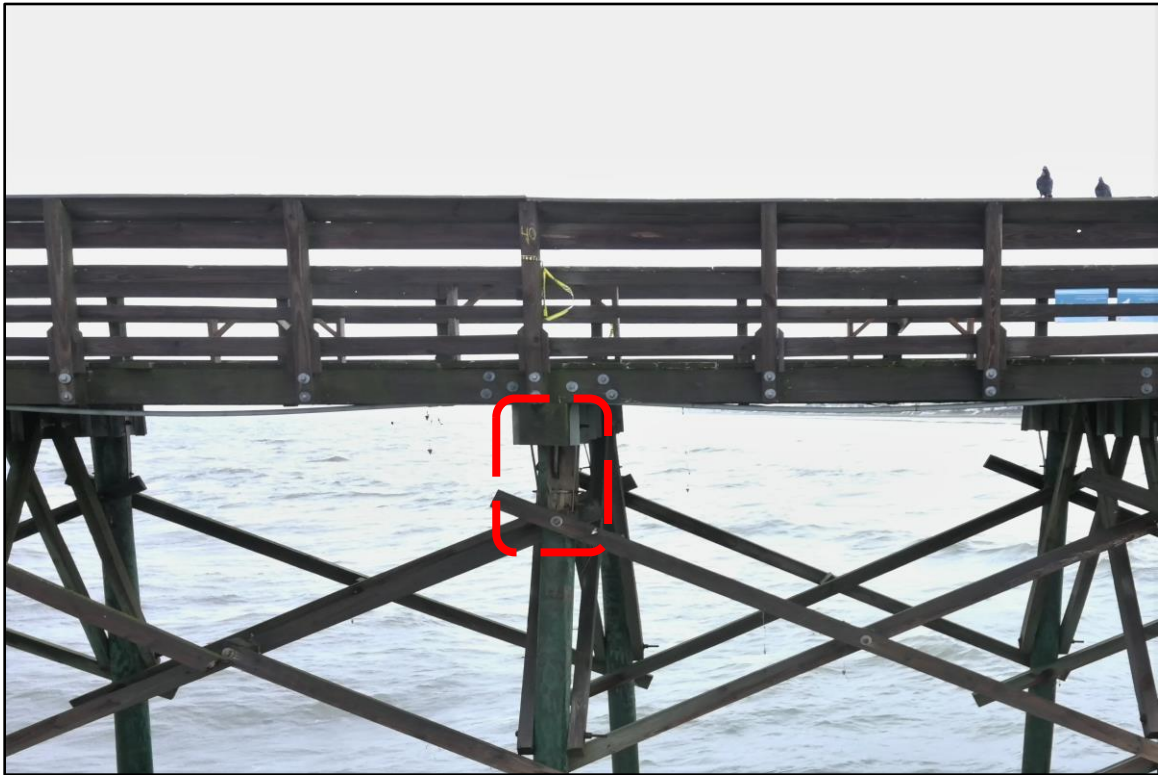
Photograph 9: Pile 40A - Top 18-inch pile is broke/overstressed

FISHING PIER	35	A	Pile	Round	Timber	MN	None	-	-	-	New greenheart pile	No	No	-	4/29/2022
FISHING PIER	35	B	Pile	Round	Timber	MN	None	-	-	-	New greenheart pile	No	No	-	4/29/2022
FISHING PIER	36	A	Pile	Round	Timber	MN	None	-	-	-	New greenheart pile	No	No	-	4/29/2022
FISHING PIER	36	B	Pile	Round	Timber	MN	None	-	-	-	New greenheart pile	No	No	-	4/29/2022
FISHING PIER	37	A	Pile	Round	Timber	MN	None	-	-	-	New greenheart pile	No	No	-	4/29/2022
FISHING PIER	37	B	Pile	Round	Timber	MN	None	-	-	-	New greenheart pile	No	No	-	4/29/2022
FISHING PIER	38	A	Pile	Round	Timber	MN	None	-	-	-	New greenheart pile -	No	No	-	4/29/2022
FISHING PIER	38	B	Pile	Round	Timber	MN	None	-	-	-	New greenheart pile	No	No	-	4/29/2022
FISHING PIER	39	A	Pile	Round	Timber	MN	None	-	-	-	New greenheart pile	No	No	-	4/29/2022
FISHING PIER	39	B	Pile	Round	Timber	MN	None	-	-	-	New greenheart pile - 10" Diameter pile	No	No	-	4/29/2022
FISHING PIER	40	A	Pile	Round	Timber	SV	Split	HVY	-	-	Top 18" of pile broke/overstressed	No	Yes	-	4/29/2022

ELEMENT	RECOMMENDATION	ESTIMATED COST
Timber Piles	Install timber pile shim (17A).	\$ 3,000
	Replace inkind timber pile shims (24A).	\$ 3,000
	Post/Structural pile repair to the top 2 feet of the ten (10) overstressed piles .	\$ 50,000
	Structural repair two(2) fractures piles (Bent 15B & 47B)	\$12,000
Timber Pile Cap	Replace inkind timber pile cap (Bent 27).	\$ 9,000
Timber Stringer	Replace inkind timber stringer (Bent 27 to 26).	\$ 7,000
Pier Wide	Perform structural analysis of piles, caps, stringers. Check slinderness ratio and strength against environmetal loads	\$32,000
Priority Recommendation Subtotal:		\$ 116,000

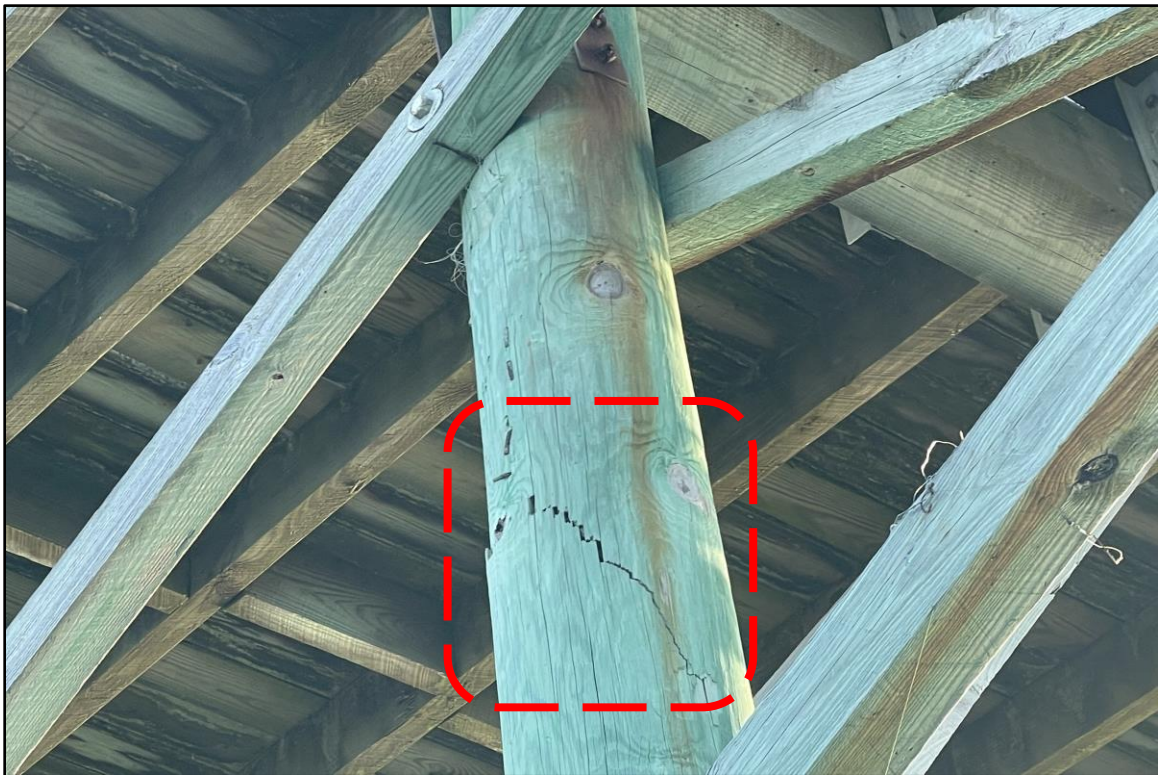
Photograph 10: Pile 47B - Pile is fractured 5feet down from top.

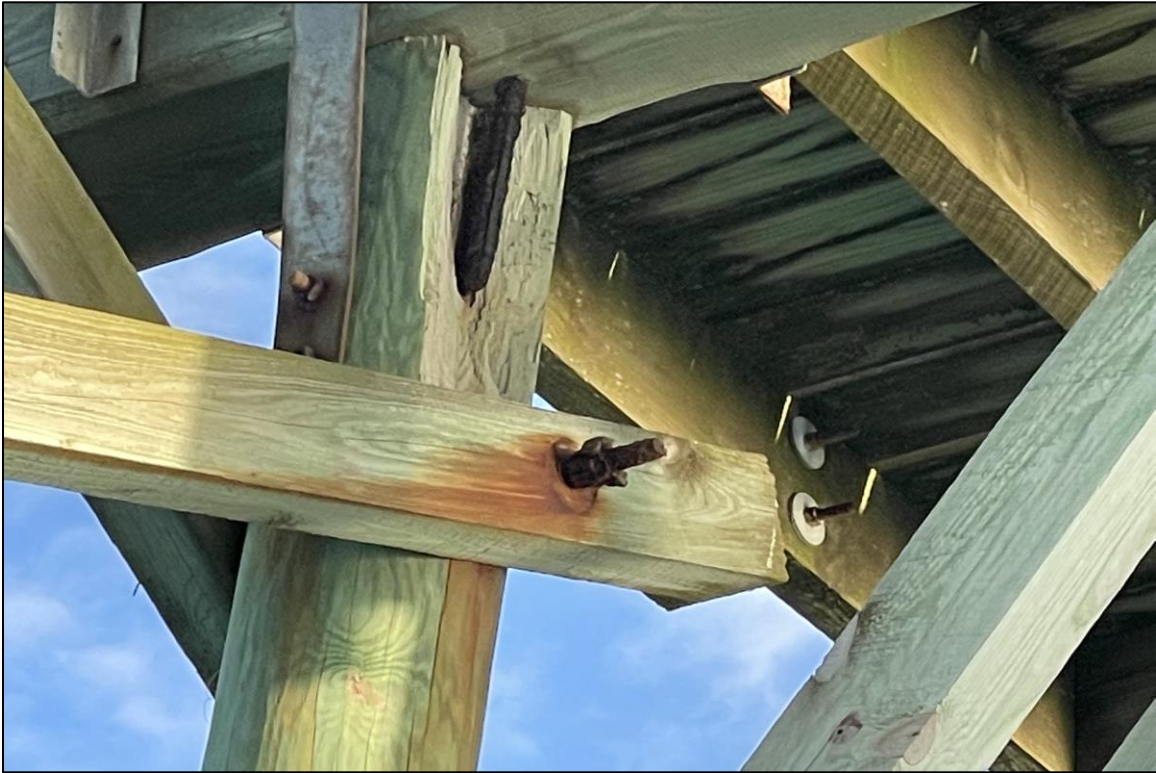
PILE LOCATION	ELEMENT RATING	REASON FOR RATING
15B	Severe	Pile is fractured at the cross-brace bolt (Photograph 5).
17A	Severe	100% Non-Bearing pile, timber cap is supported by steel fish plates (Photograph 6).
24A	Major	Pile is 50% bearing, due to displacement of pile shims (Photograph 7).
25B	Severe	Top 18-inch of the pile is broke/overstressed (Photograph 8).
40A	Severe	Top 18-inch of the pile is broke/overstressed (Photograph 9).
40B	Severe	Top 18-inch of the pile is broke/overstressed
41B	Severe	Top 18-inch of the pile is broke/overstressed
44B	Severe	Top 18-inch of the pile is broke/overstressed
46B	Severe	Top 18-inch of the pile is broke/overstressed
47B	Severe	5ft from top, pile has a fracture crack (Photograph 10)
48B	Severe	Top 18-inch of the pile is broke/overstressed
49B	Severe	Top 18-inch of the pile is broke/overstressed (Photograph 11)

Photograph 11: Bent 49B - Overstressed pile cap & stringer

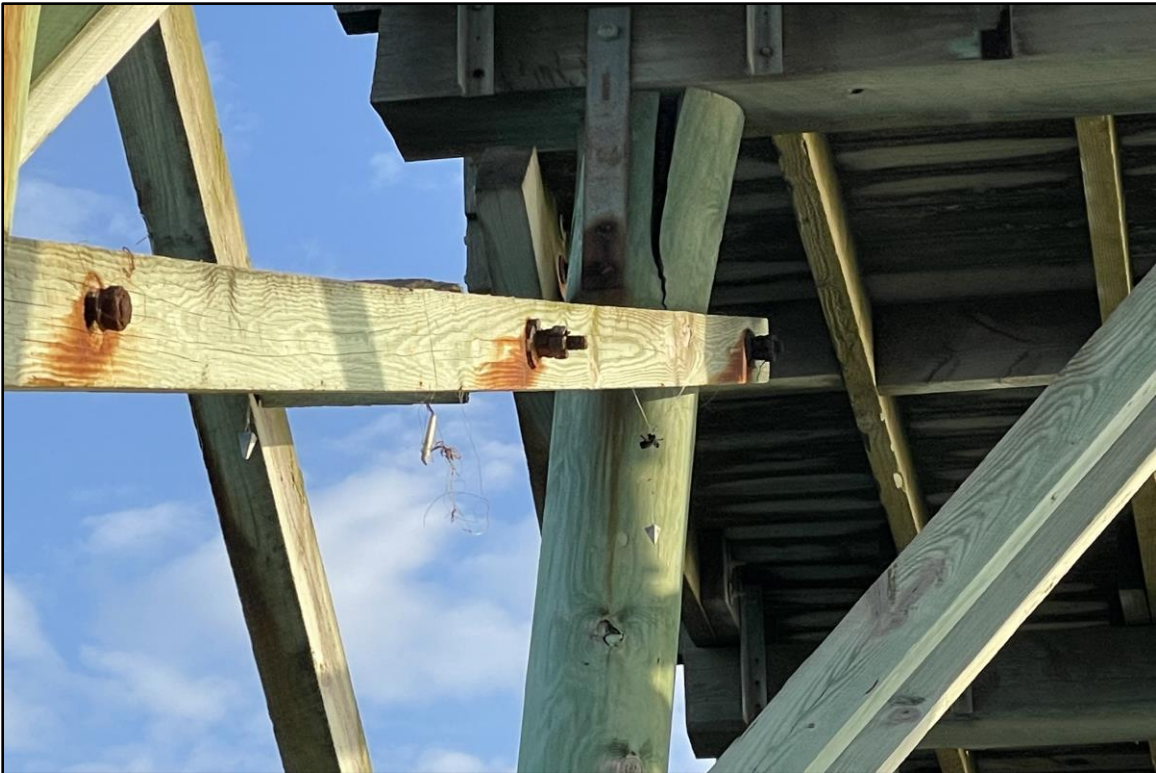
PILE LOCATION	ELEMENT RATING	REASON FOR RATING
50B	Severe	Top 18-inch of the pile is broke/overstressed (Photograph 12)
52A	Severe	Top 18-inch of the pile is broke/overstressed (Photograph 13).

Photograph 12: Pile 50B - Top 18-inch pile is broke/overstressed
