May 17, 2022

Project #: GES-2201

Reference: Holden Beach Fishing Pier – 2022 Due Diligence Inspection
Holden Beach, North Carolina

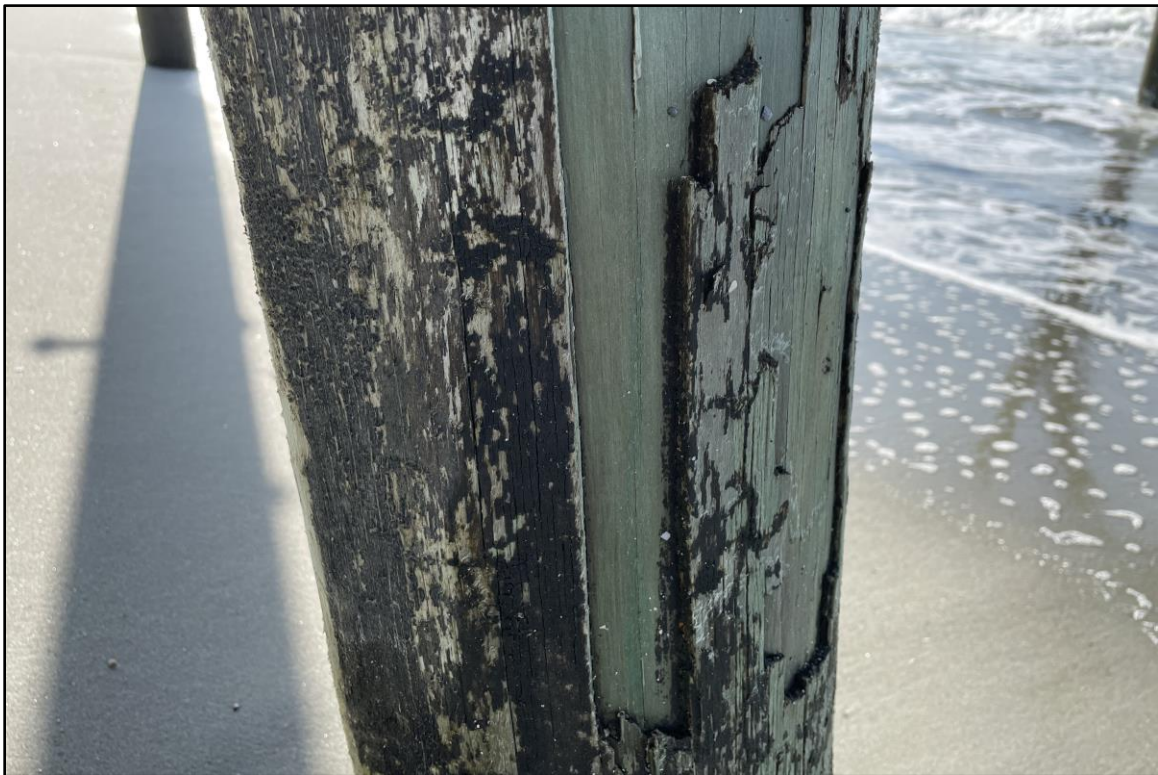
Photograph 2: Pile 25B – Typical shell peeling found on newer vintage piles

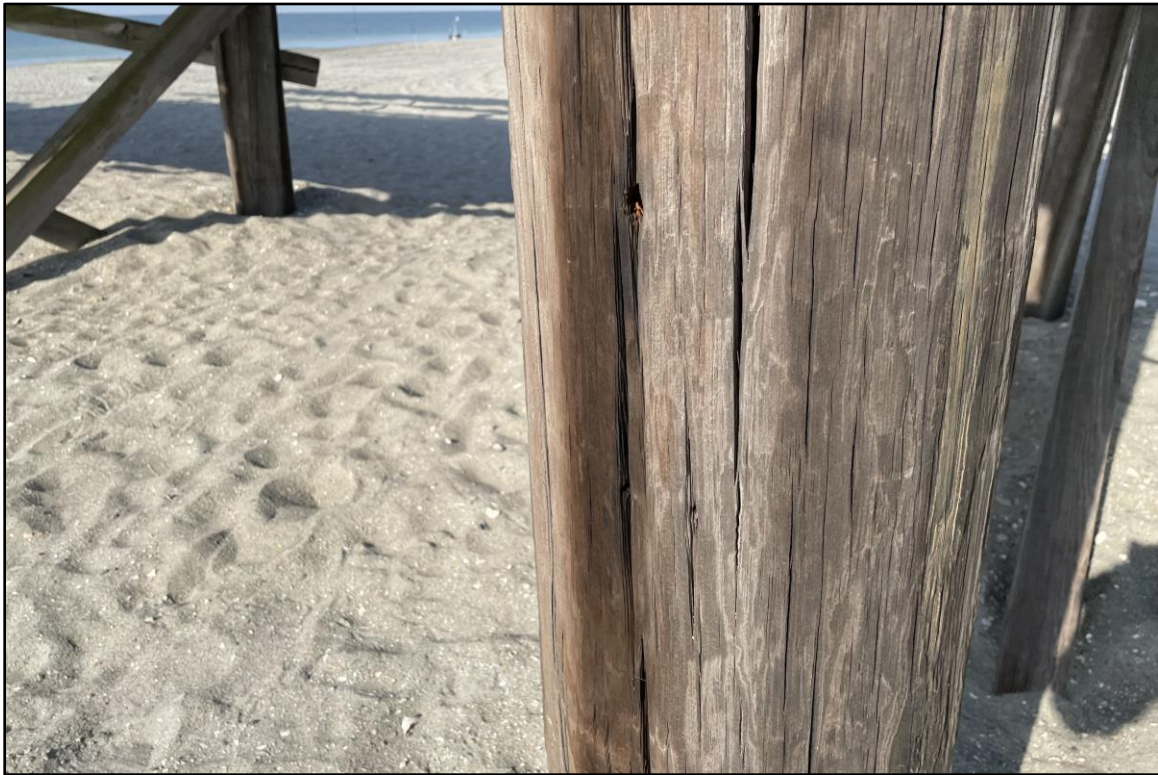
The inshore section of the pier from Bent -6 to Bent 10 are predominantly original vintage 10 - 12-inch diameter timber piles. The piles typically exhibited localized light checking/weathering (Photograph 2 and Photograph 3). The piles located between Bents 11 thru 52 are newer vintage timber piles 8 to 13-inch diameter. The piles located in between Bents 23 thru 52 have light marine growth consisting of light barnacles below mean low water (MLW) (Photograph 4) and typical have no defects above MLW. Isolate major to severe defects were identified at the top of some of the piles which are summarized in Table 2.

Photograph 3: Pile 7A – Typical checking and weathering found on original vintage piles

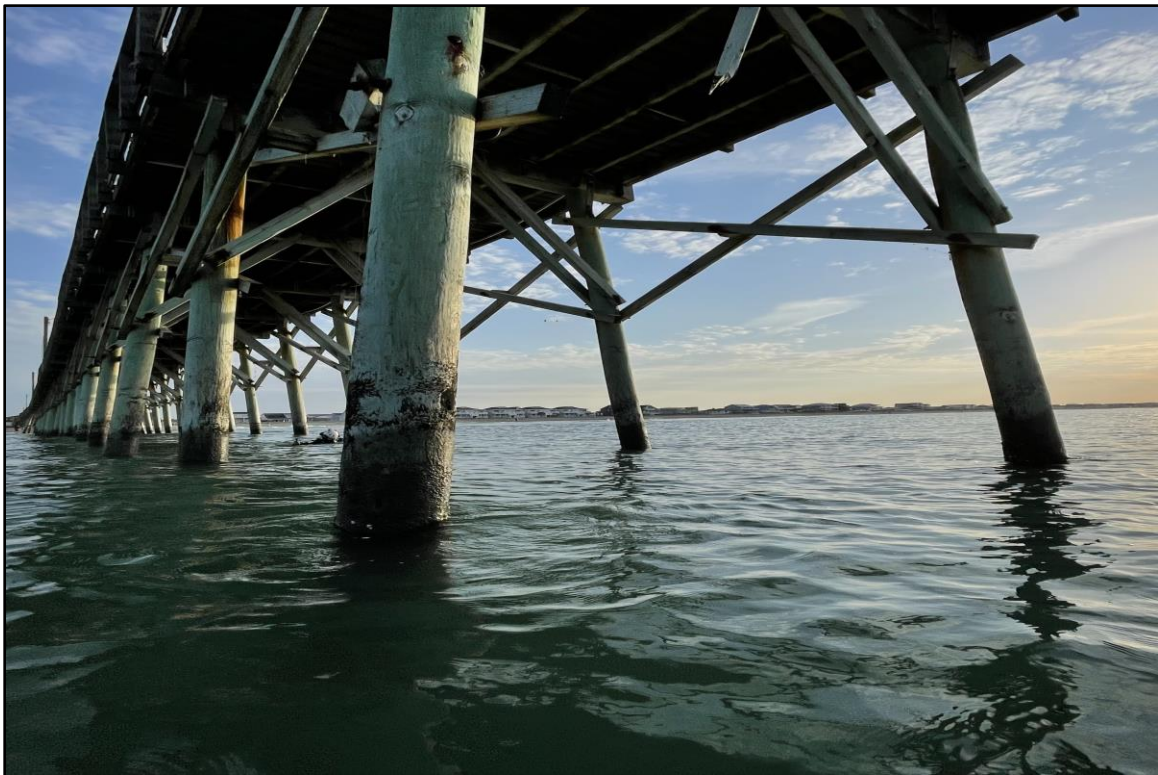
Photograph 4: Pile 52B – Typical marine growth found down length of pile

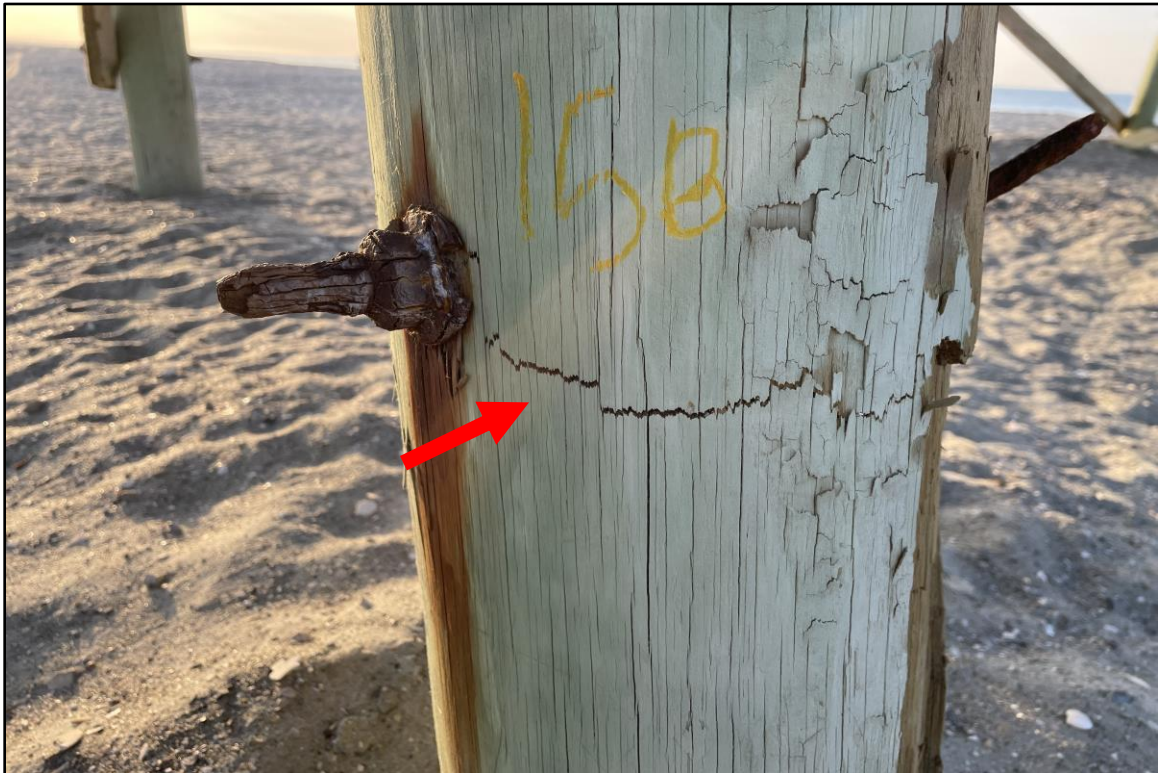
PILE LOCATION	ELEMENT RATING	REASON FOR RATING
15B	Severe	Pile is fractured at the cross-brace bolt (Photograph 5).
17A	Severe	100% Non-Bearing pile, timber cap is supported by steel fish plates (Photograph 6).
24A	Major	Pile is 50% bearing, due to displacement of pile shims (Photograph 7).
25B	Severe	Top 18-inch of the pile is broke/overstressed (Photograph 8).
40A	Severe	Top 18-inch of the pile is broke/overstressed (Photograph 9).
40B	Severe	Top 18-inch of the pile is broke/overstressed
41B	Severe	Top 18-inch of the pile is broke/overstressed
44B	Severe	Top 18-inch of the pile is broke/overstressed
46B	Severe	Top 18-inch of the pile is broke/overstressed
47B	Severe	5ft from top, pile has a fracture crack (Photograph 10)
48B	Severe	Top 18-inch of the pile is broke/overstressed
49B	Severe	Top 18-inch of the pile is broke/overstressed (Photograph 11)

Photograph 5: Pile 15B – Pile fractured

ELEMENT	RECOMMENDATION	ESTIMATED COST
Timber Piles	Install timber pile shim (17A).	\$ 3,000
	Replace inkind timber pile shims (24A).	\$ 3,000
	Post/Structural pile repair to the top 2 feet of the ten (10) overstressed piles .	\$ 50,000
	Structural repair two(2) fractures piles (Bent 15B & 47B)	\$12,000
Timber Pile Cap	Replace inkind timber pile cap (Bent 27).	\$ 9,000
Timber Stringer	Replace inkind timber stringer (Bent 27 to 26).	\$ 7,000
Pier Wide	Perform structural analysis of piles, caps, stringers. Check slinderness ratio and strength against environmetal loads	\$32,000
Priority Recommendation Subtotal:		\$ 116,000

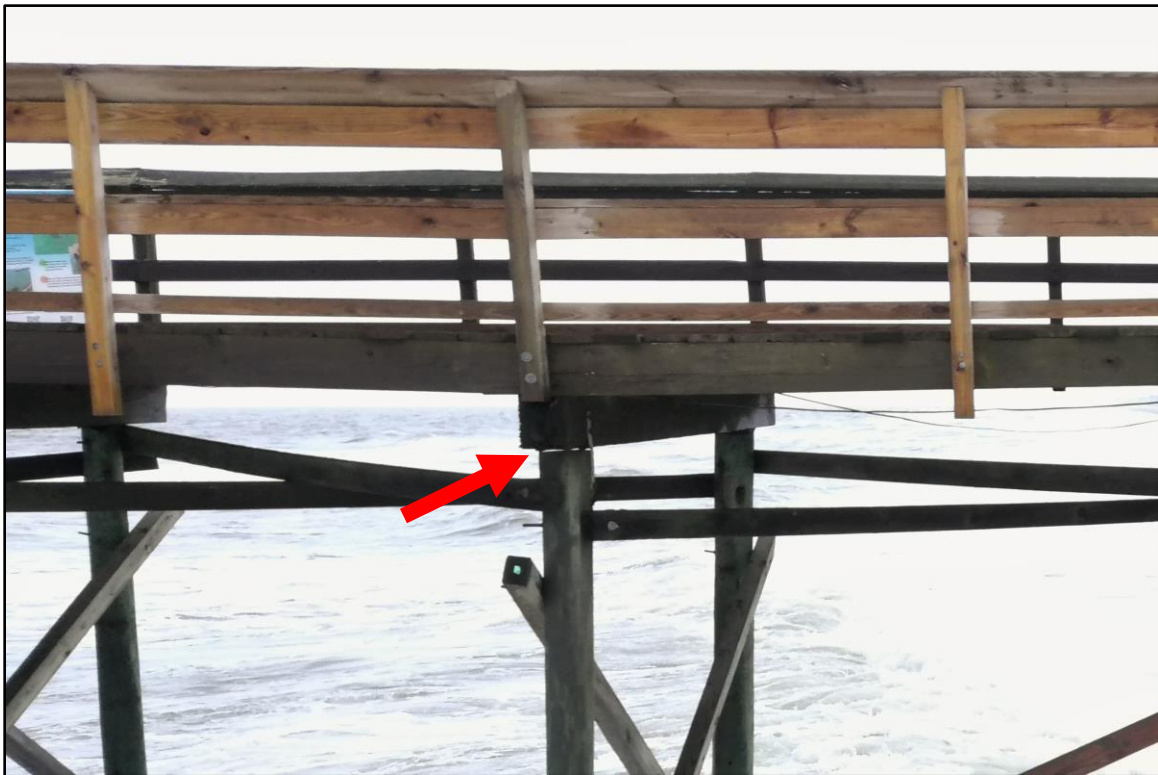
Photograph 6: Pile 17A - 100% Non-Bearing pile, timber cap supported by steel fish plates

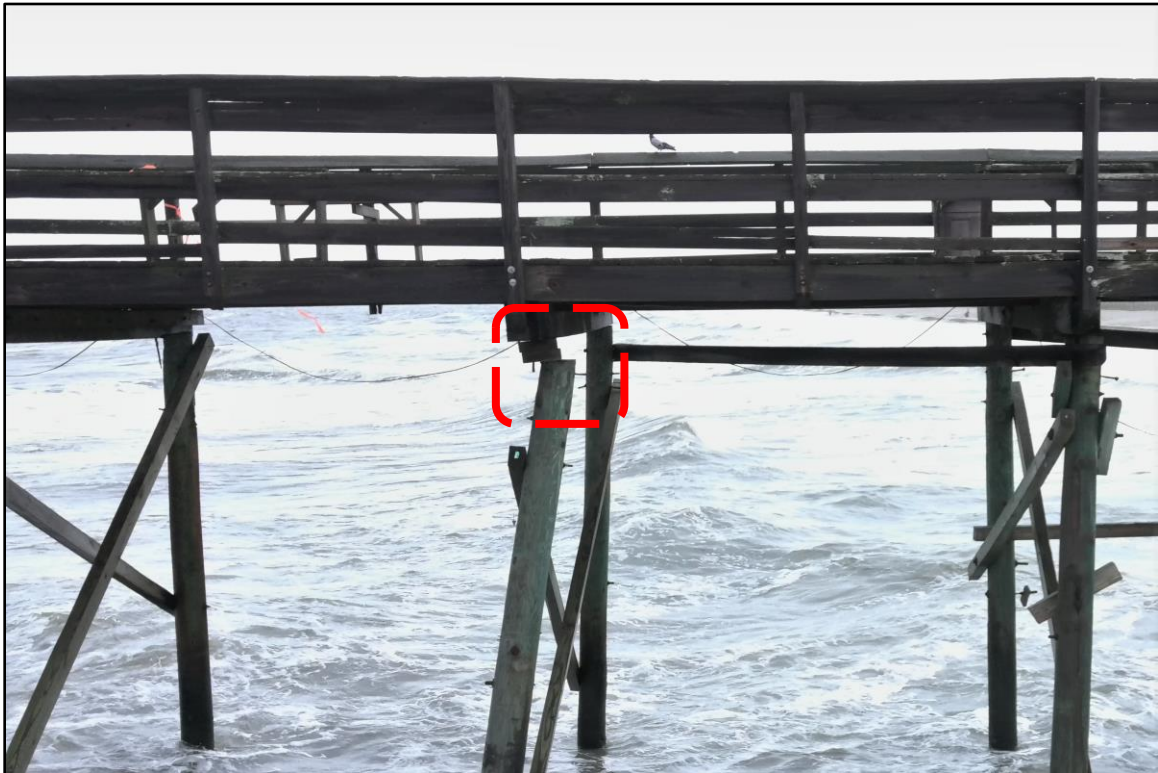
Photograph 7: Pile 24A - 50% Bearing due to displaced pile shims

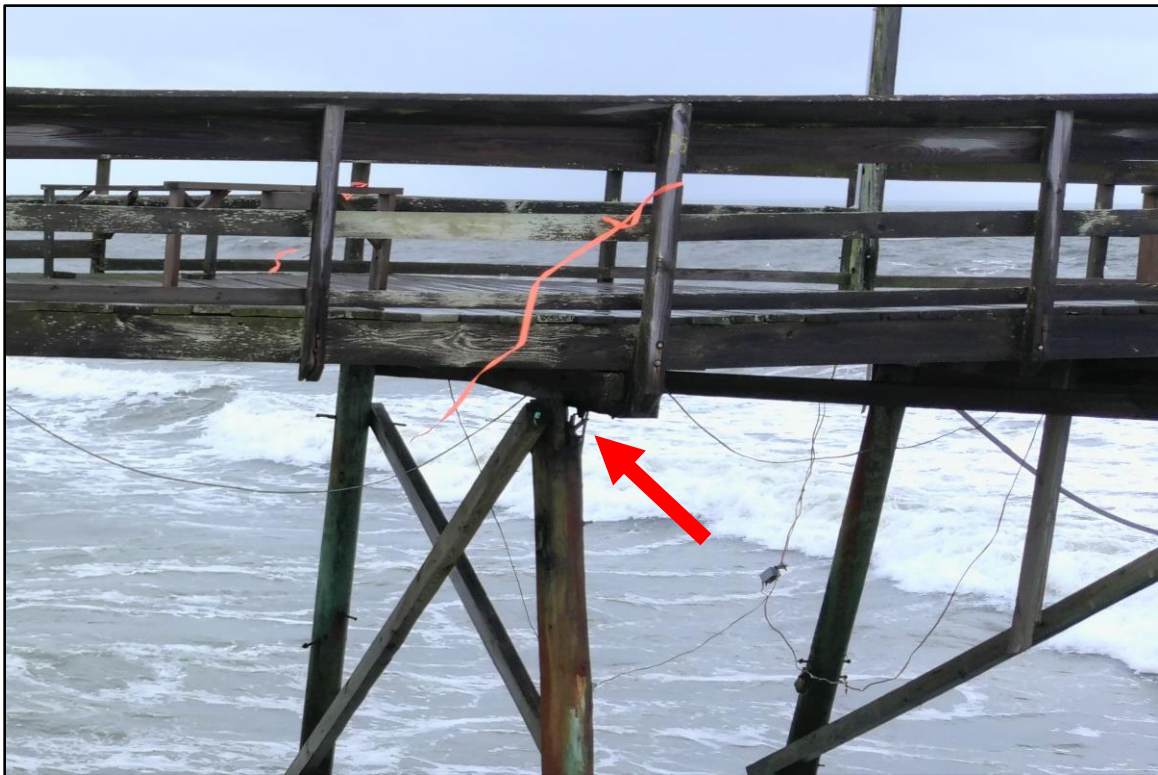
Photograph 8: Pile 25B - Top 18-inch pile is broke/overstressed

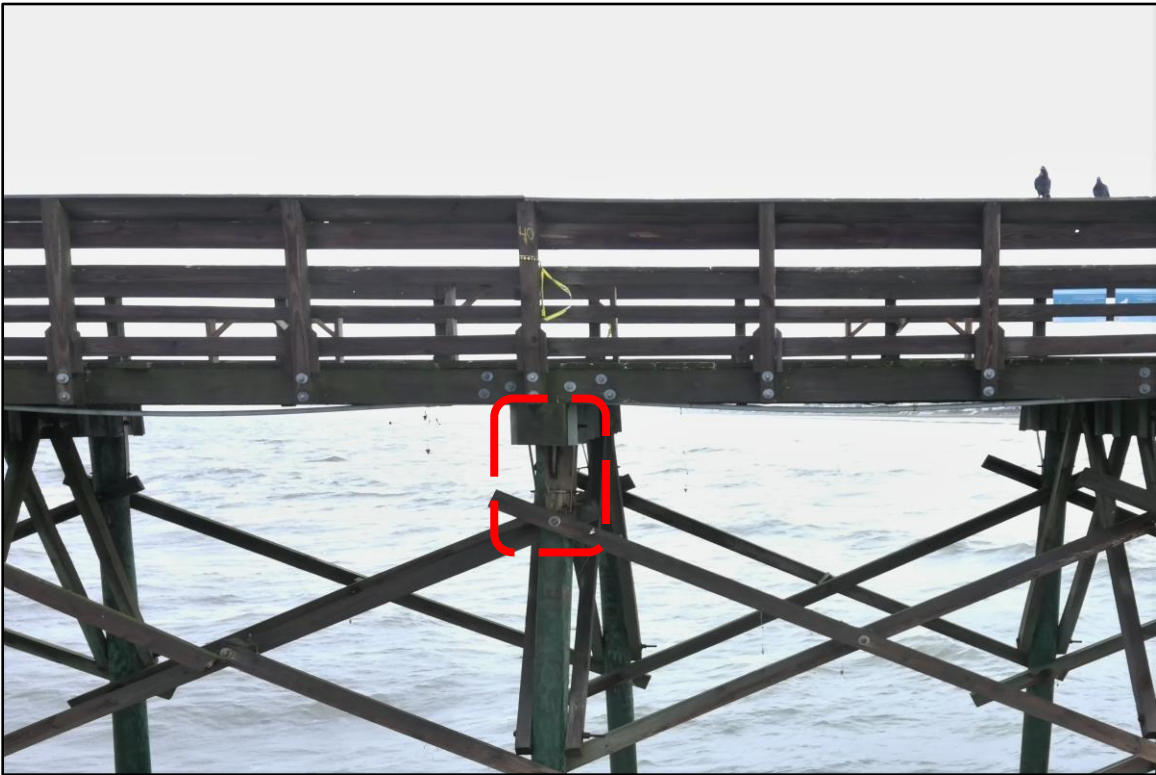
Photograph 9: Pile 40A - Top 18-inch pile is broke/overstressed

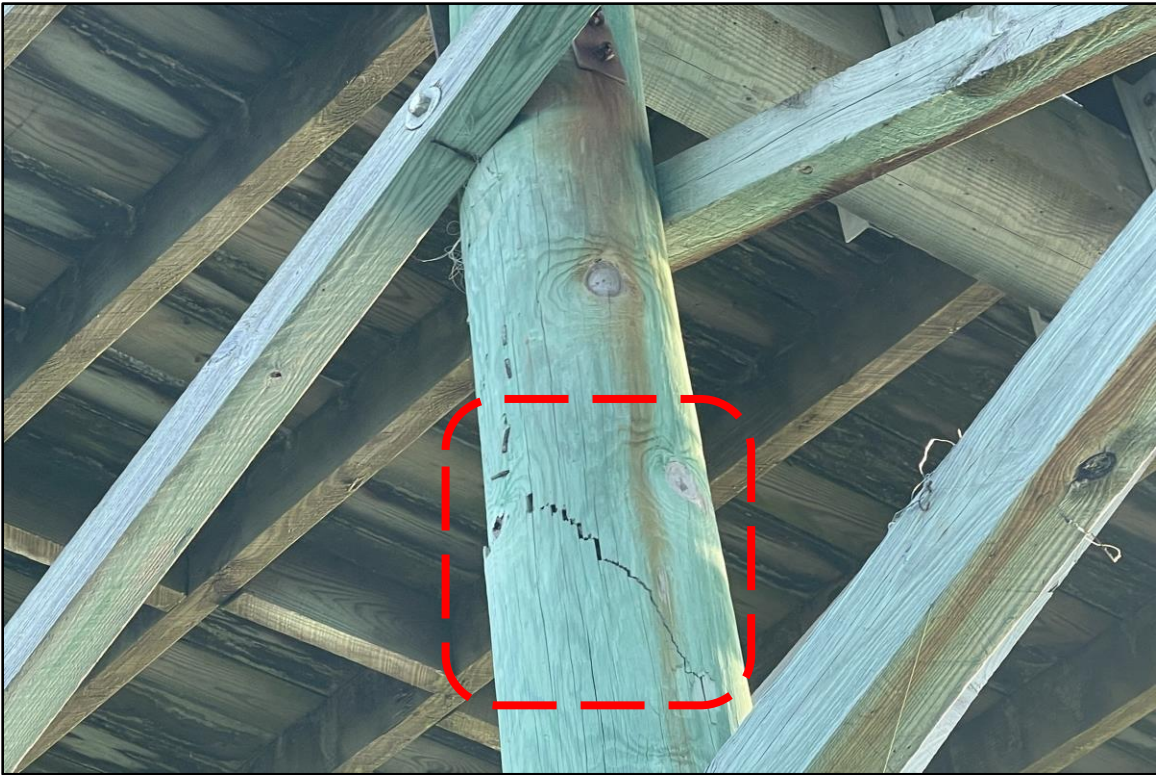
Photograph 10: Pile 47B - Pile is fractured 5feet down from top.

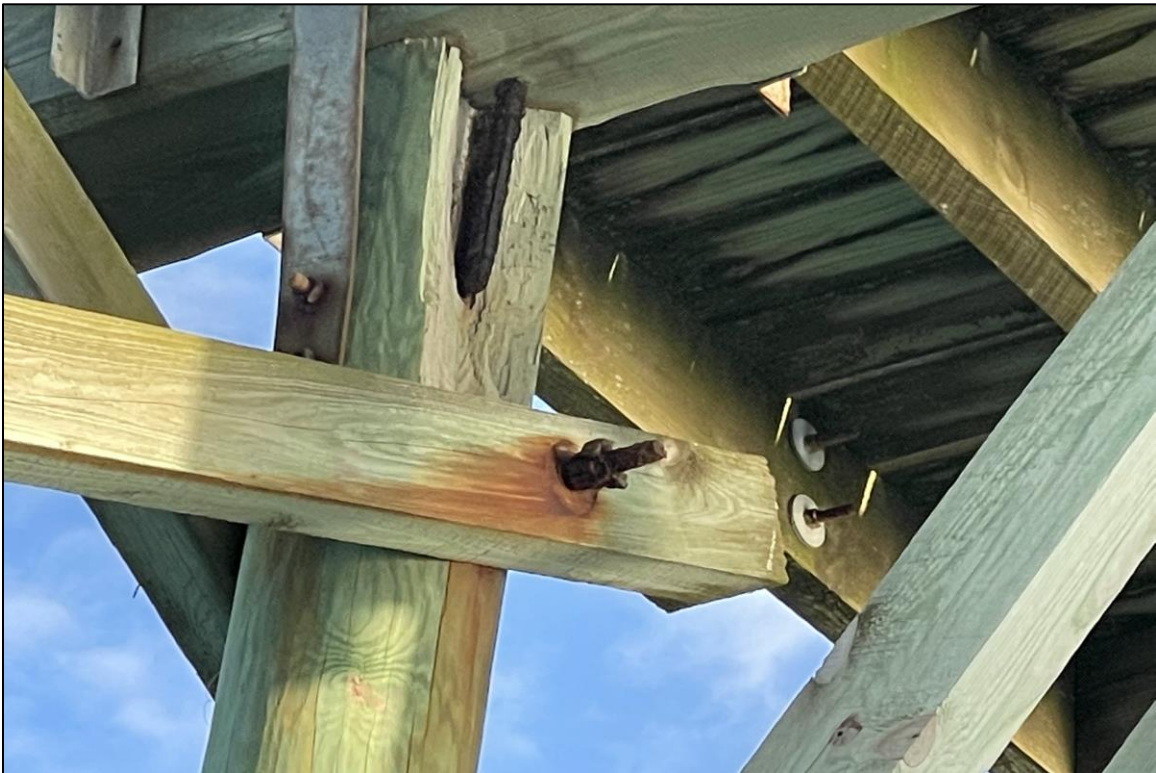
Photograph 11: Bent 49B - Overstressed pile cap & stringer

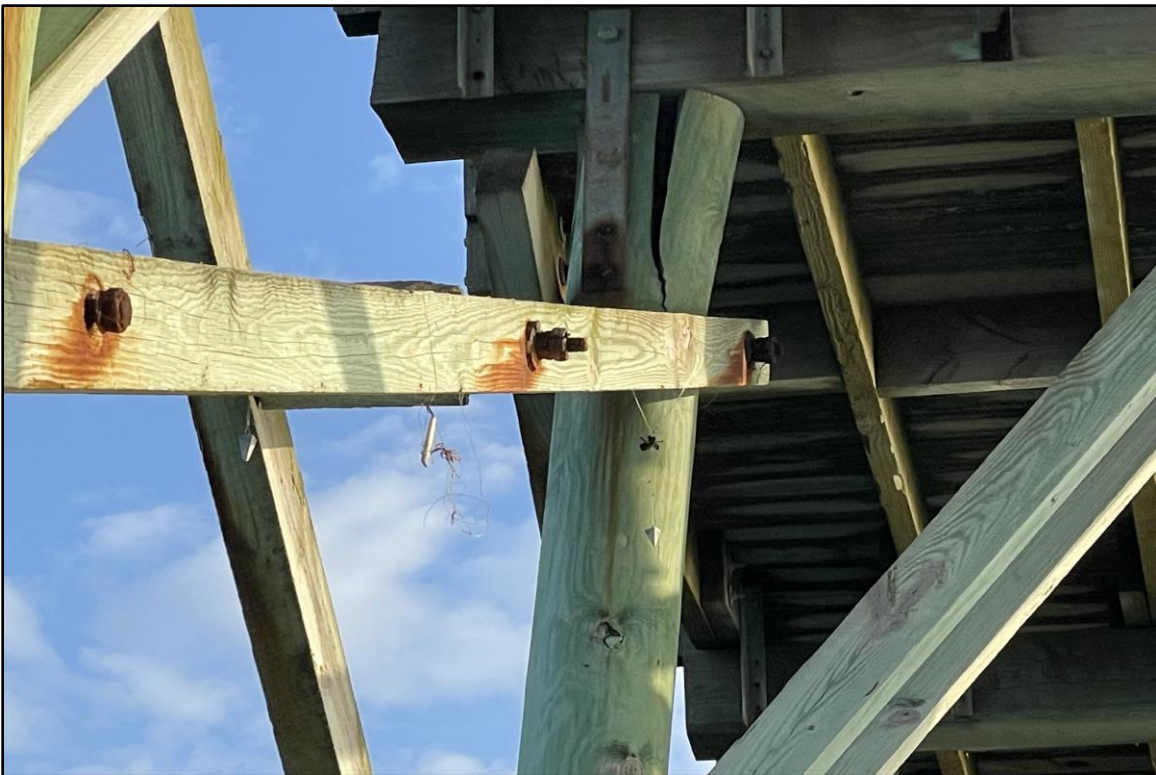
PILE LOCATION	ELEMENT RATING	REASON FOR RATING
50B	Severe	Top 18-inch of the pile is broke/overstressed (Photograph 12)
52A	Severe	Top 18-inch of the pile is broke/overstressed (Photograph 13).

Photograph 12: Pile 50B - Top 18-inch pile is broke/overstressed

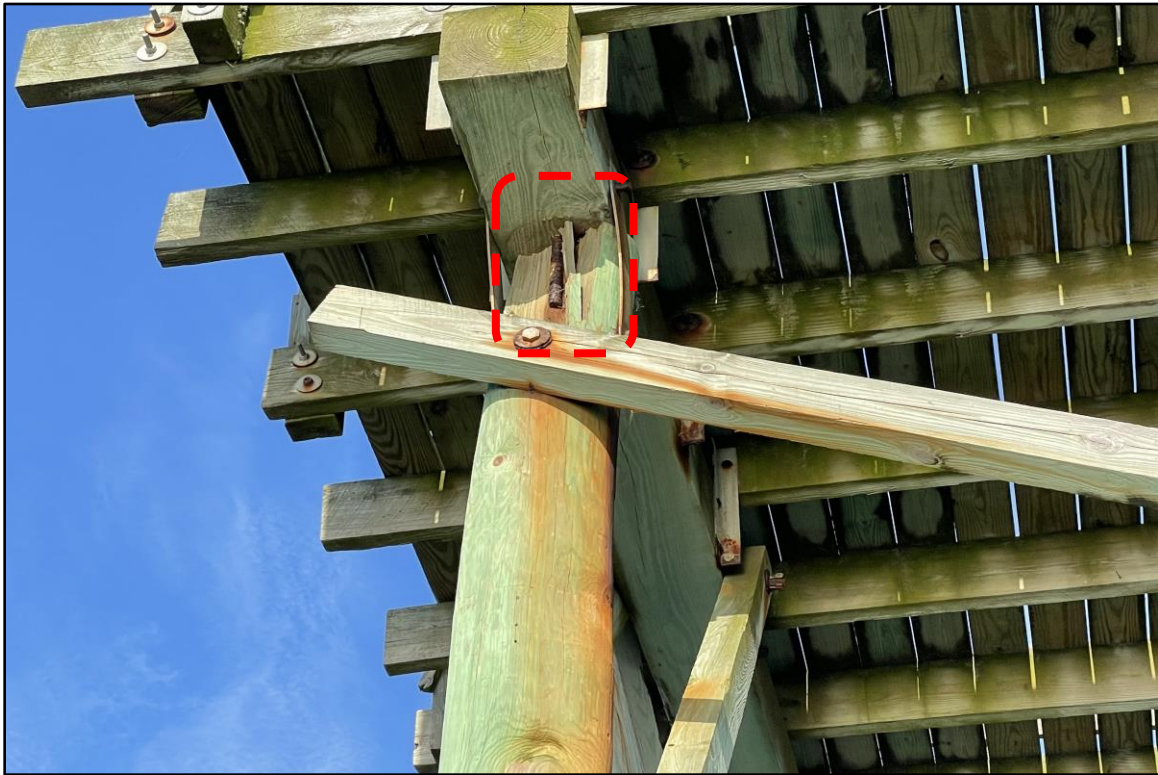
Photograph 13: Pile 52A - Top 18-inch pile is broke/overstressed

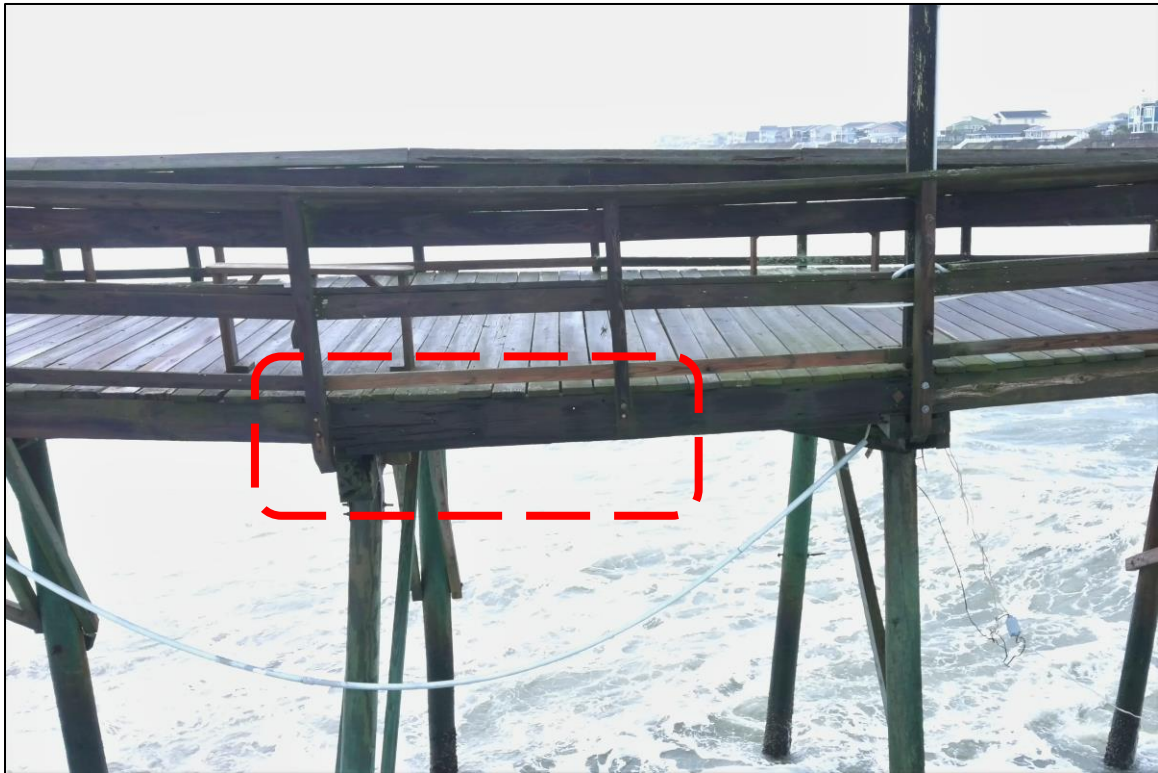
Additionally, between Bents 26 to 28 deflection and rotation was noted in the walking surface. The cause of this deflection appears to be overstressing in the pile cap of Bent 27 and the timber stringer from Bent 27 to 26 (Photograph 14). During the time of the inspection, the pier appears to be shutdown.

Photograph 14: Bent 27 - Overstressed pile cap & stringer
