MCPHERSON  
Engineering Design

September 20, 2021

RE: Report of Engineering Services - Building Assessment  
Holden Beach Fishing Pier  
441 Ocean Boulevard West, Holden Beach, NC 28462

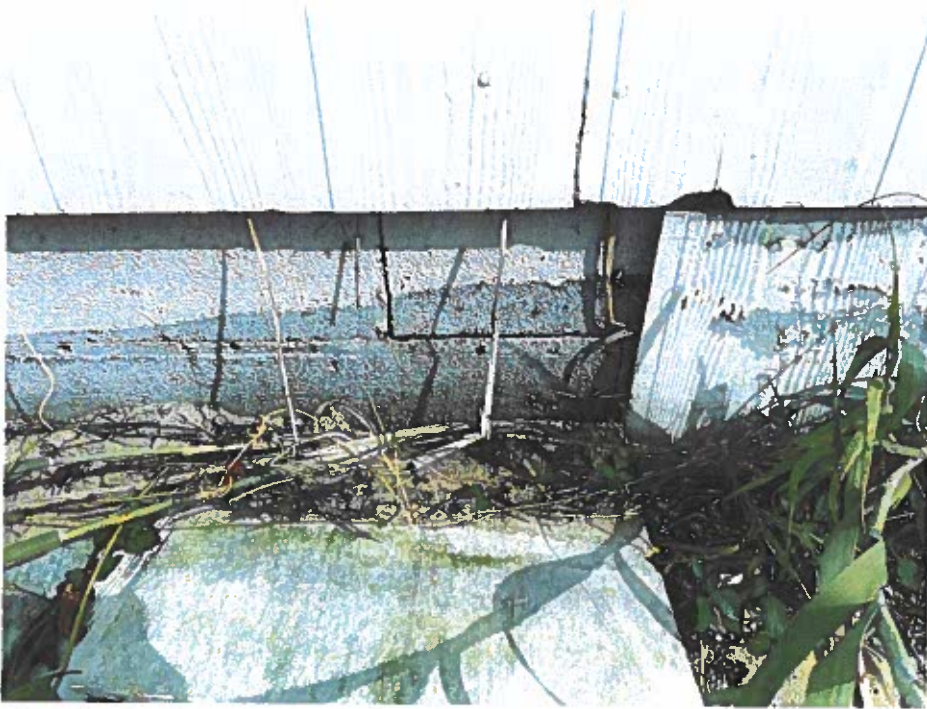
The cmu foundation walls are damaged in multiple locations. Cracks in the mortar, misaligned blocks, and cracks in the concrete floor slab were observed. See Figure 1, Figure 2, and Figure 3. The crawl space foundation in the original section of the building was not accessible because sand has inundated the space below the building. Excavation was not within the scope of this report, therefore concrete footings were not observed, if present.

Figure 1: Cracks in mortar at foundation wall

Based on my observations, the wood framed floor system in the original section of the building on the crawl space could not be repaired and may be demolished. It follows that the smaller east side addition may also be demolished.

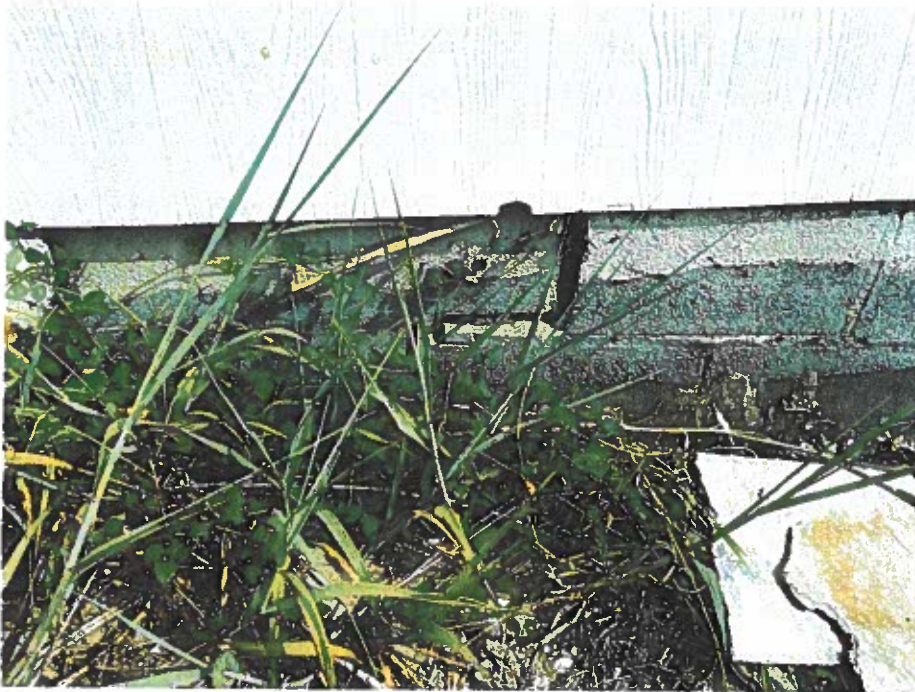
Figure 2: Misaligned blocks at foundation wall

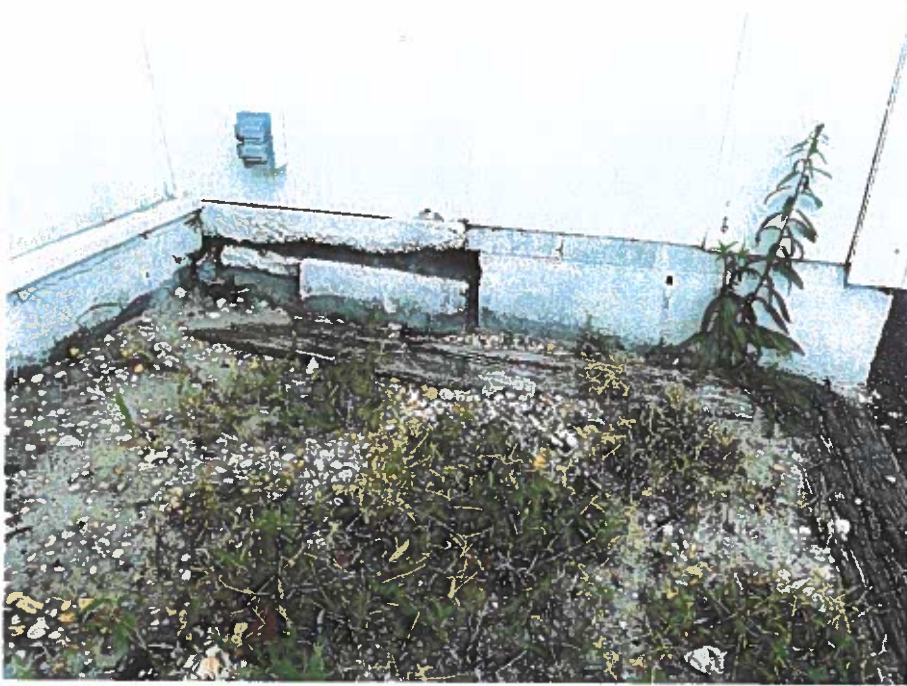
Figure 3: Damaged foundation wall

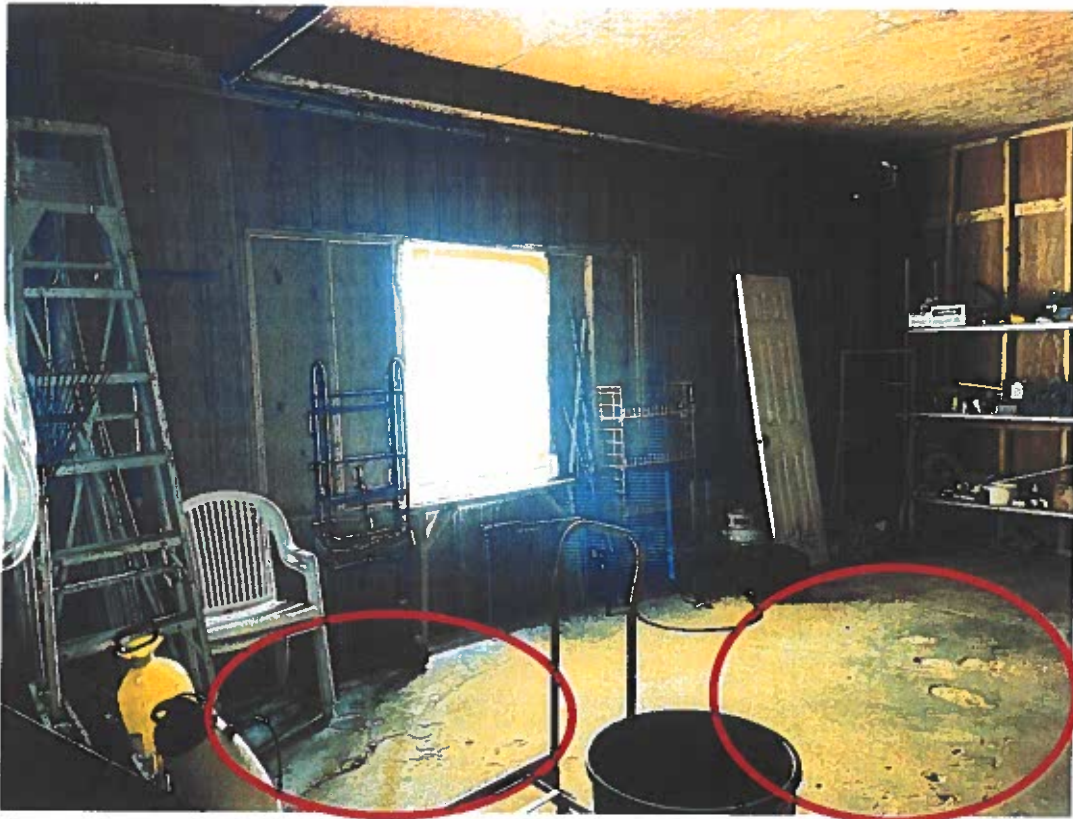
The condition of the wood framed floor system was not visually observed from the crawl space as noted above. However, the crawl space is not performing as intended, as sand has filled the space. The floor is not level, bowing in some locations, and soft spots were observed in at least one location that indicate the presence of deteriorated wood. See Figure 5. The concrete floor slab on grade is cracked and damaged in multiple locations. See Figure 4.

Figure 4: Cracks and damage to concrete slab on grade.

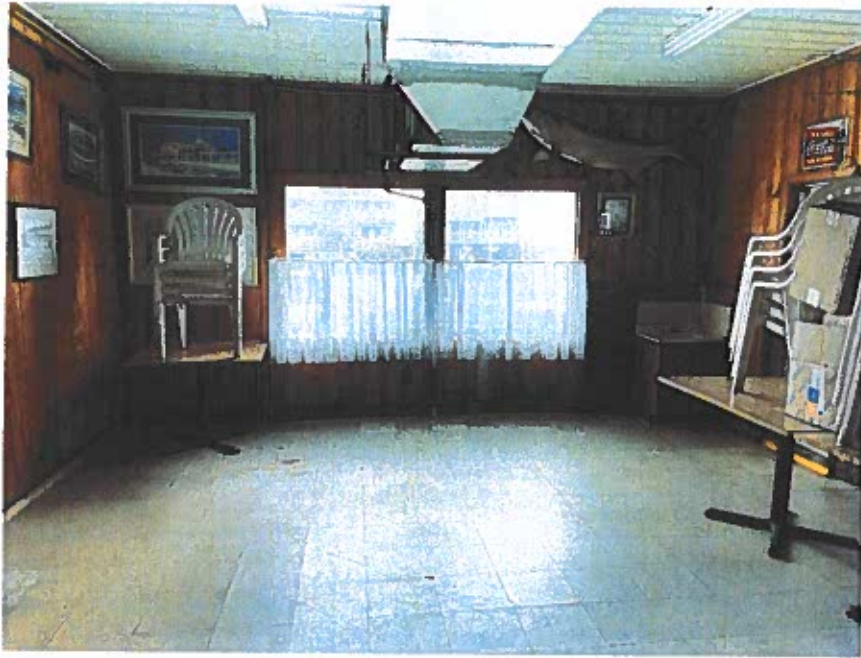
Figure 5: Bow in wood floor system.

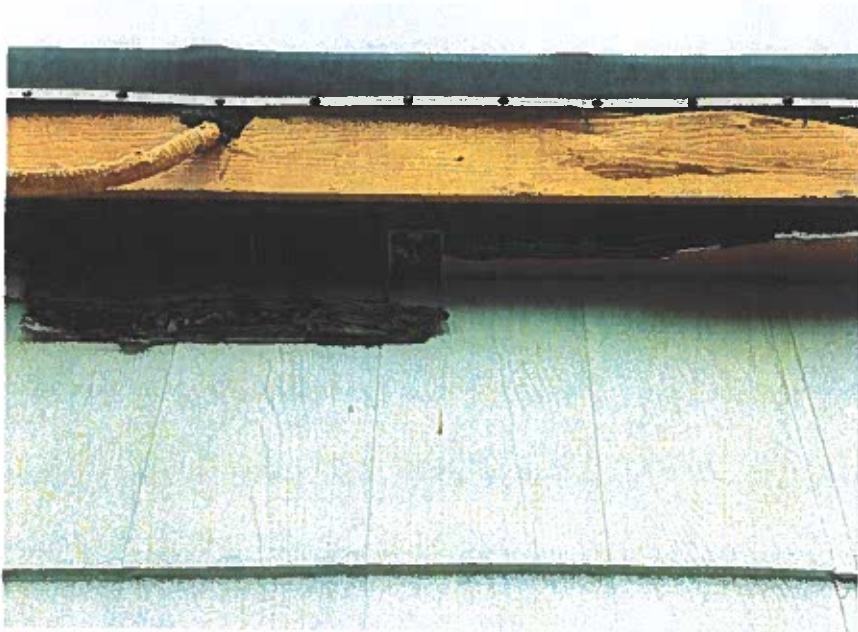
There is a small breach in the rear soffit of the building that shows the roof members in that location to be 2x wood framing (see Figure 6). The roof member attachment to the supporting beams is covered with finish materials and could not be observed. Further observation is needed to assess the structural integrity of the roof.

Figure 6: Damage to rear soffit

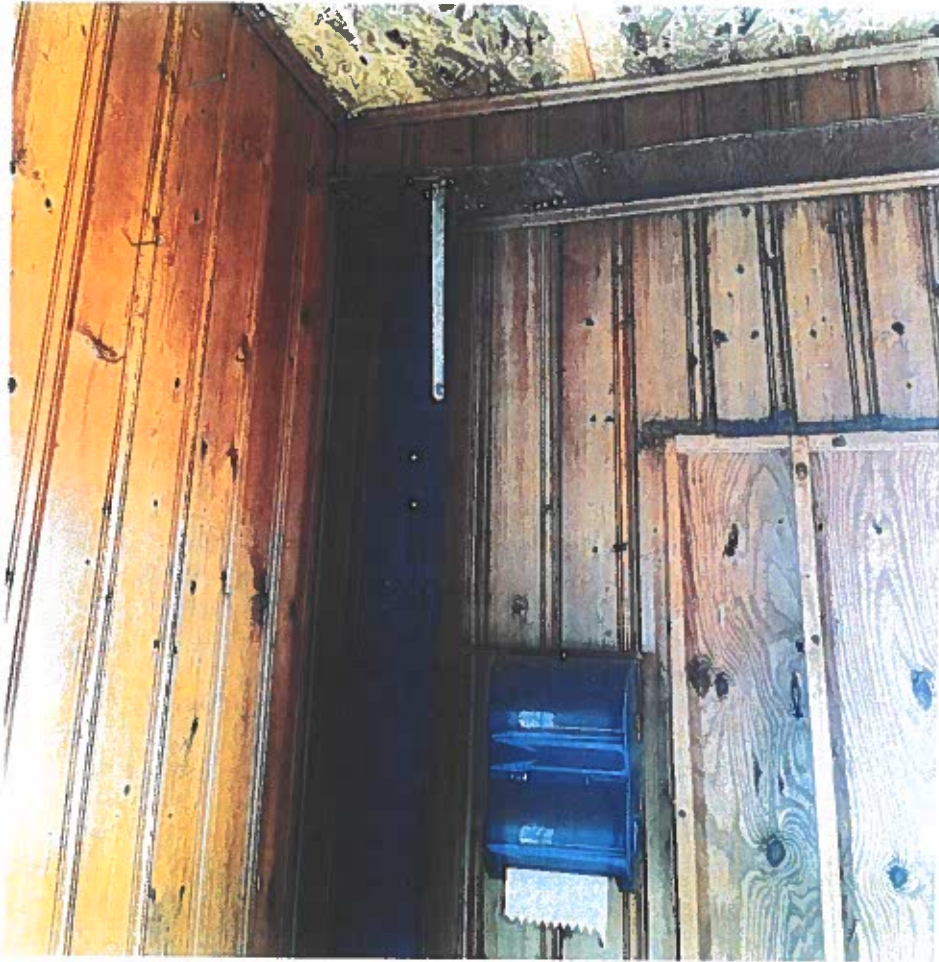
Figure 7: Wood piling and beam construction

The west side addition, which is supported by beams and pilings, may be able to be salvaged. This would require a pile study and further assessment and analysis of the beams and roof system to determine if the existing piles are adequate to support anticipated loading conditions.
