Town of Holden Beach Draft Summary Report

Town Pier Preliminary Reconstruction

HDR Engineering, Inc. of the Carolinas
Project No. 10426190

July 2, 2025

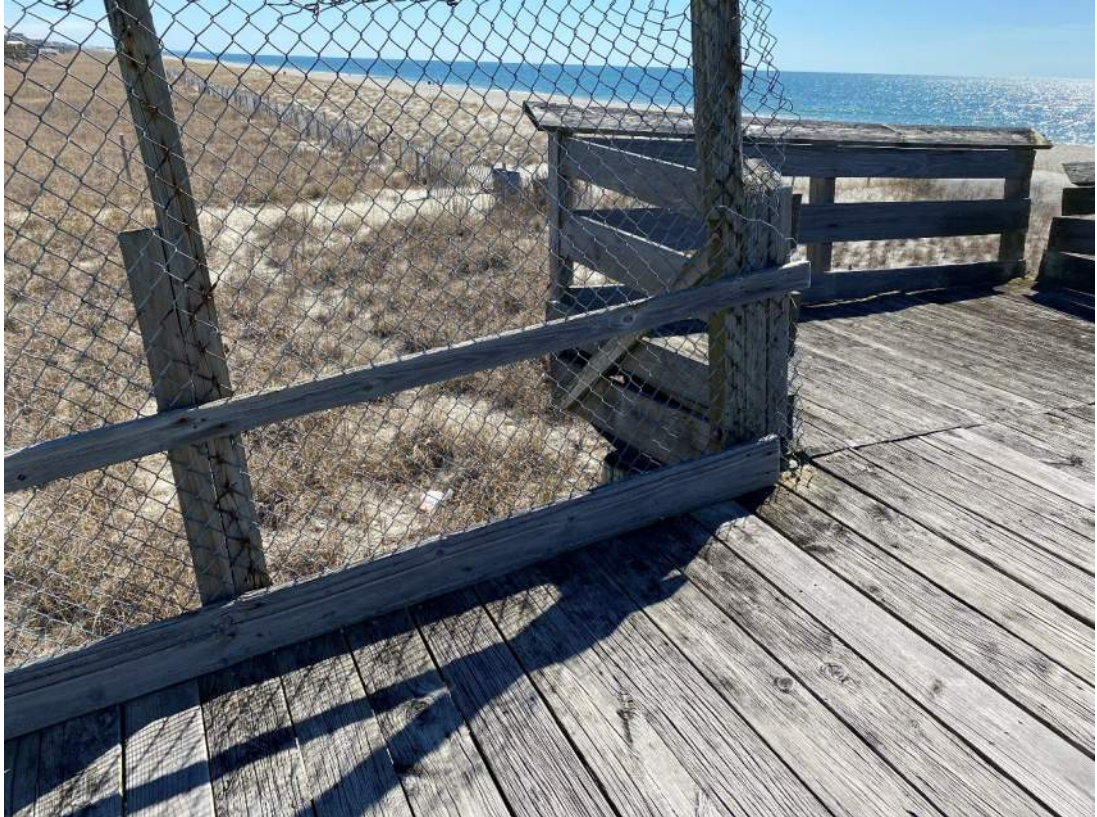
While timber piles are a substructure element, the pile top was observed from the balcony as hollowed. Individually, the railing is in CRITICAL condition while the deck boards and hollowed pile are in POOR to SERIOUS condition. The hardware is heavily corroded with sections of failed timber railing and therefore insufficient in transferring or supporting the required OSHA rail load standards.

Figure 5 - Balcony Area Between Sta 0+75 and 0+90

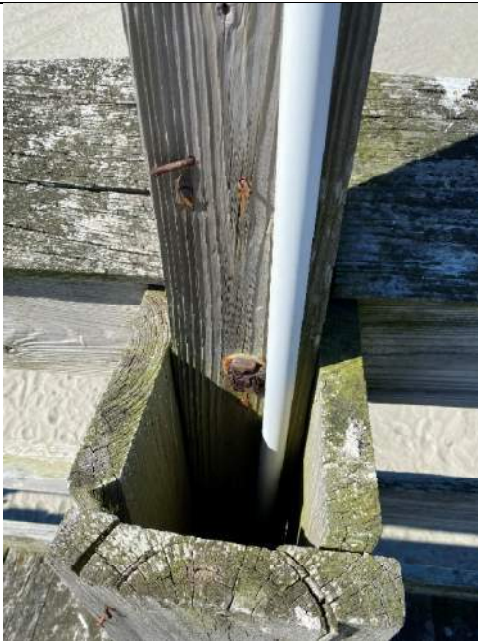
Photo 9: Typical Utility Conduit Timber Casing near station 2+00

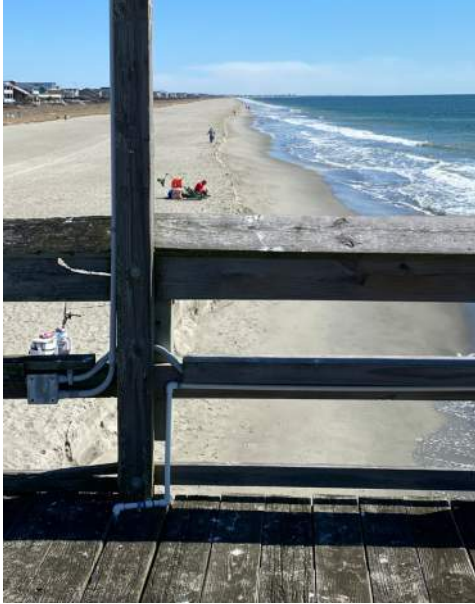
Photo 13: Top Rail Split and Conduit Running along Midrails near station 2+75

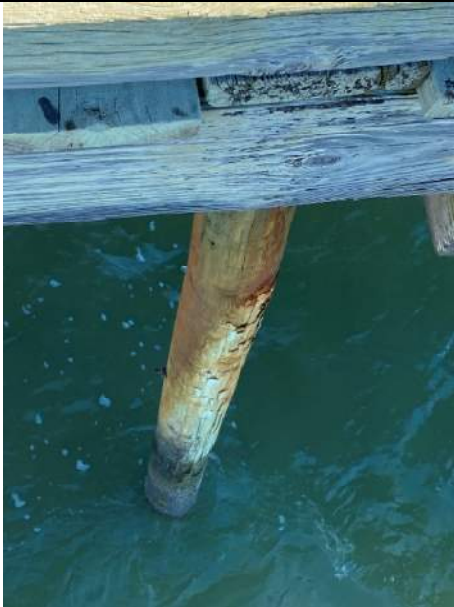
Photo 21: Typical Timber Pile Flaking and Gouging near station 3+75

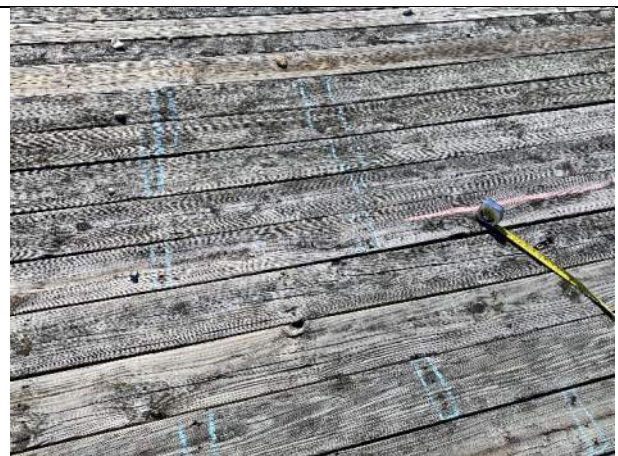
Photo 24: Typical Joist Replacement near station 4+00.

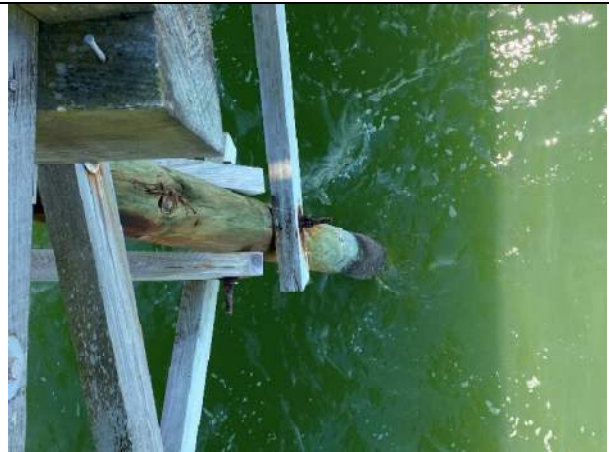
Photo 34: Typical Corroded Bracing Connection Bolts with Pile Gouging near station 5+50

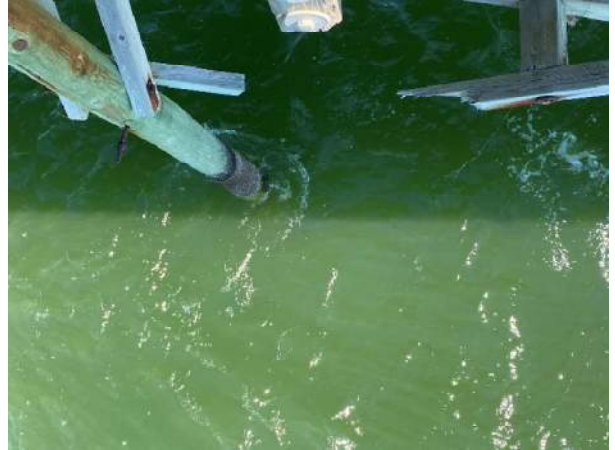
Photo 44: Typical Broken Bracing Member and Corroded Bolts near station 6+75

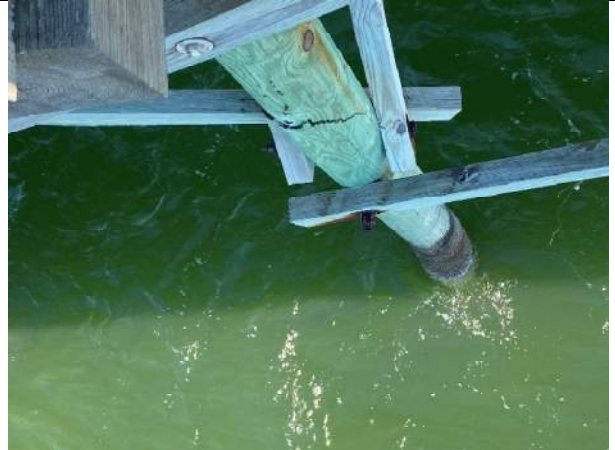
Photo 46: Cracked Pile near station 7+00

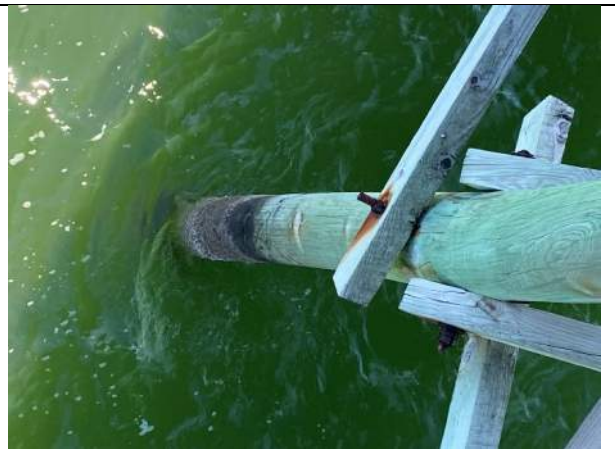
Photo 48: Typical Checking in Bracing near station 7+00

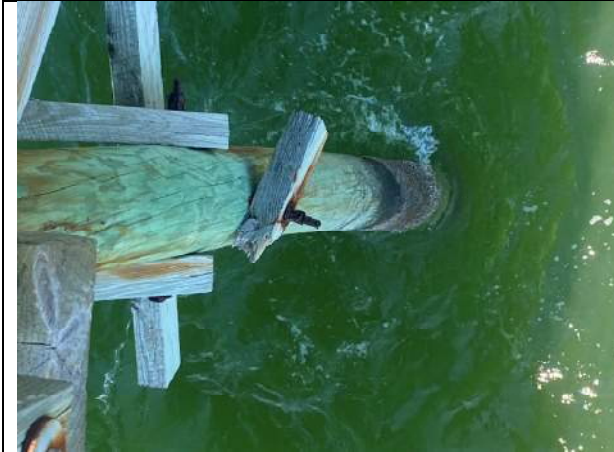
Photo 49: Typical Broken Bracing Member and Corroded Bolts near station 7+25

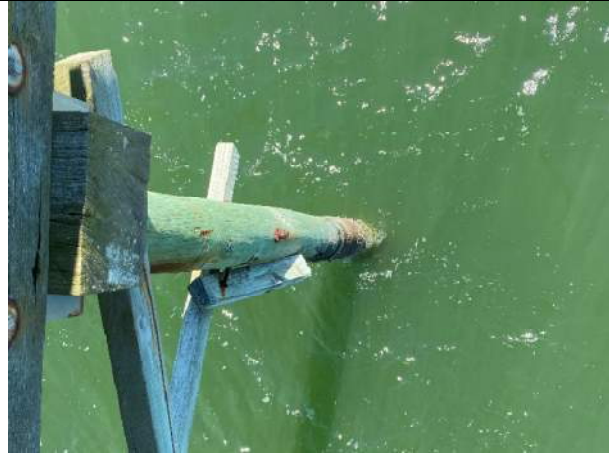
Photo 52: Typical Broken and Missing Bracing Member and Corroded Bolts near station 7+50

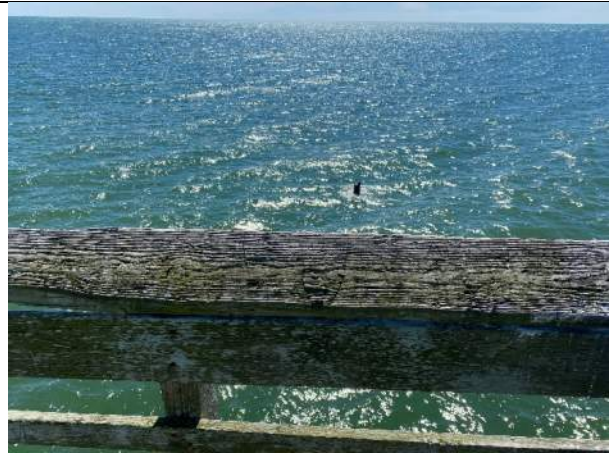
Photo 54: Broken Pile Beyond station 7+50

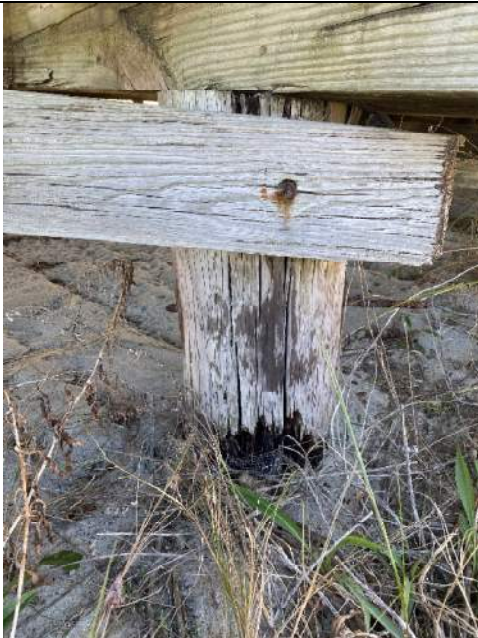
Photo 57: Typical Pile Exterior Rot Deterioration near station 0+00

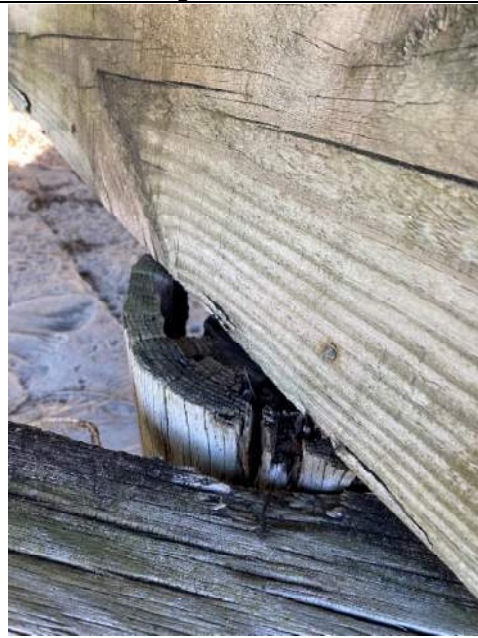
Photo 58: Typical Hollow Pile Deterioration near station 0+00

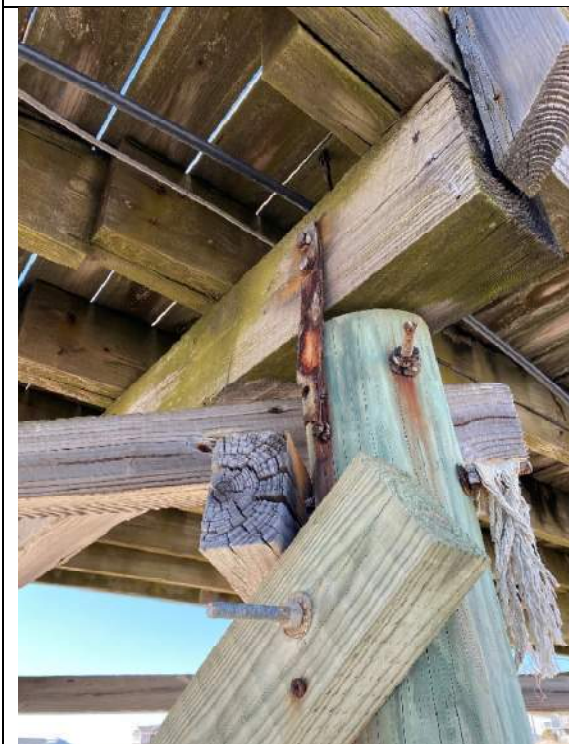
Photo 75: Corroded and Failed Pile / Pile Cap Connection near station 2+50

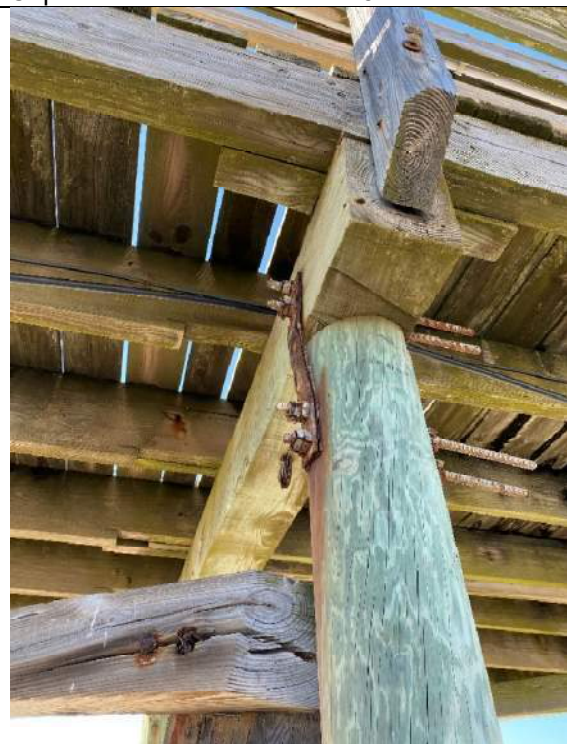
Photo 76: Corroded Pile / Pile Cap Connection and Cross Bracing Connection near station 2+50

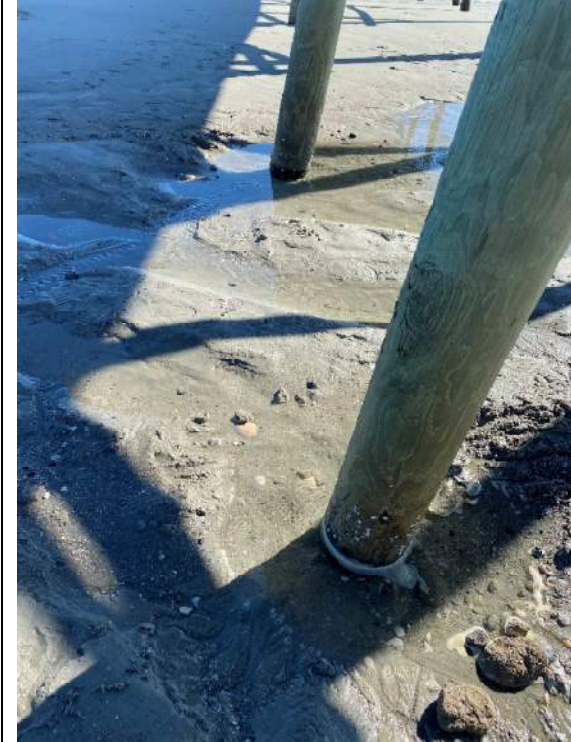
Photo 77: Typical Pile Marine Growth and Localized Scour in the Tidal Zone near station 2+75

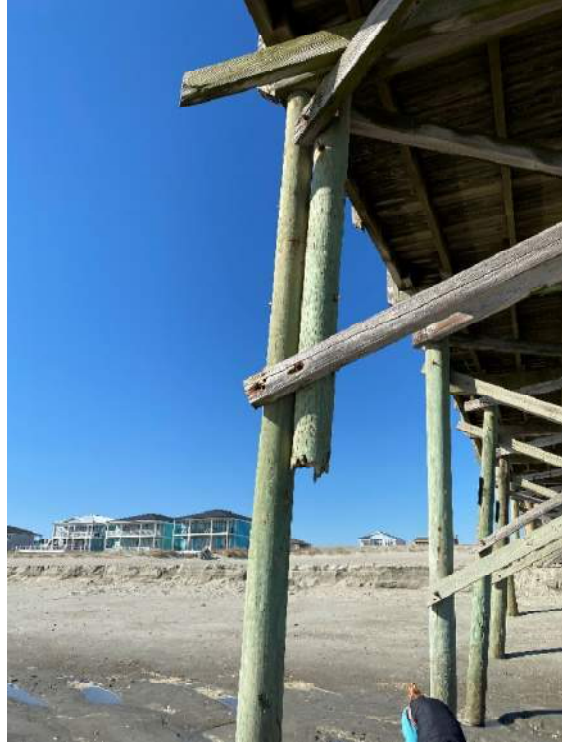
Photo 78: Typical Pile Sistering Repair near station 2+75

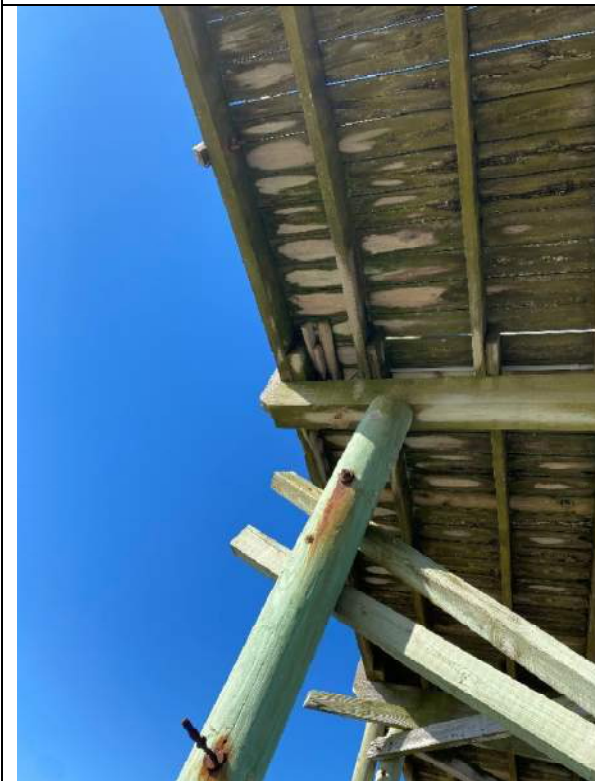
Photo 79: Typical Pile with Missing Cross Bracing and Missing Pile / Pile Cap Connection near station 3+00

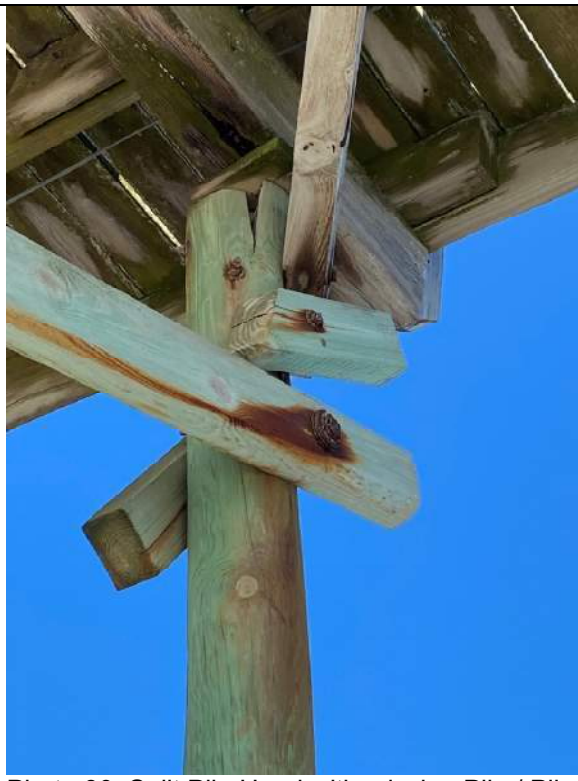
Photo 80: Split Pile Head with missing Pile / Pile Cap Connection Tie near station 3+50

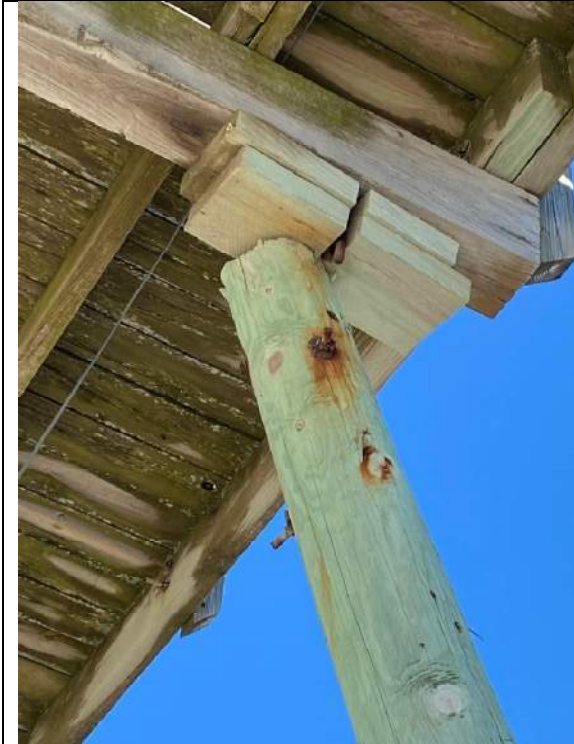
Photo 81: Misaligned Pile Missing Pile / Pile Cap Connection and Missing Bracing near station 3+75

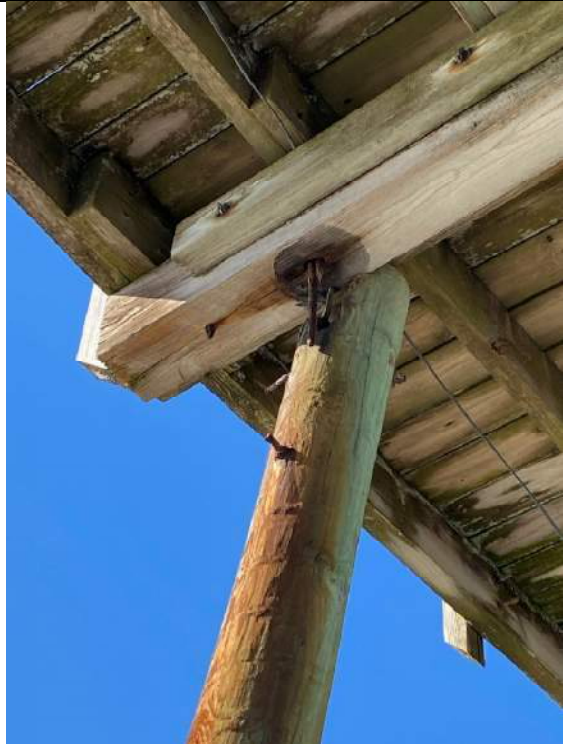
Photo 82: Misaligned Pile Missing Pile / Pile Cap Connection and Missing Bracing near station 3+75

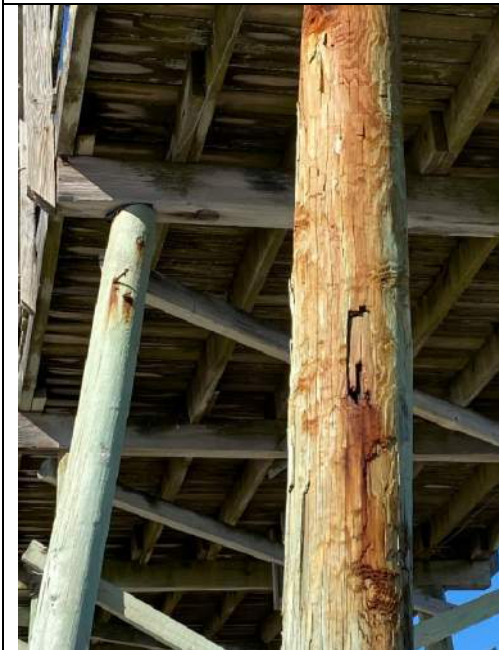
Photo 83: Pile Gouging and Flaking near station 3+75

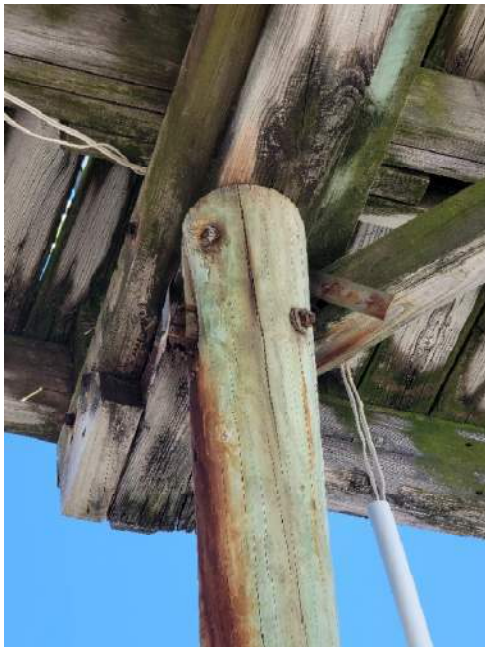
Photo 89: Pile / Pile Cap Connection Failure and Gouging at Pile Top near station 4+00

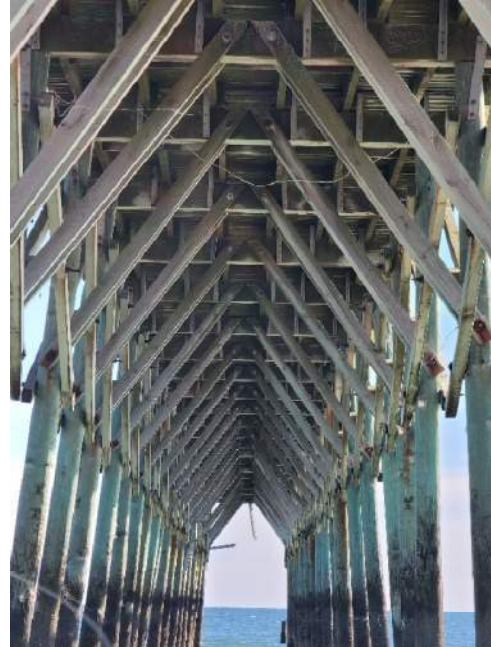
Photo 90: Broken Bracing and Corroded Connection Bolts Beyond station 4+00
