Project #: HLD-2601

Reference: Holden Beach Fishing Pier – 2026 Underwater Inspection Report  
Holden Beach, North Carolina

## **INTRODUCTION**

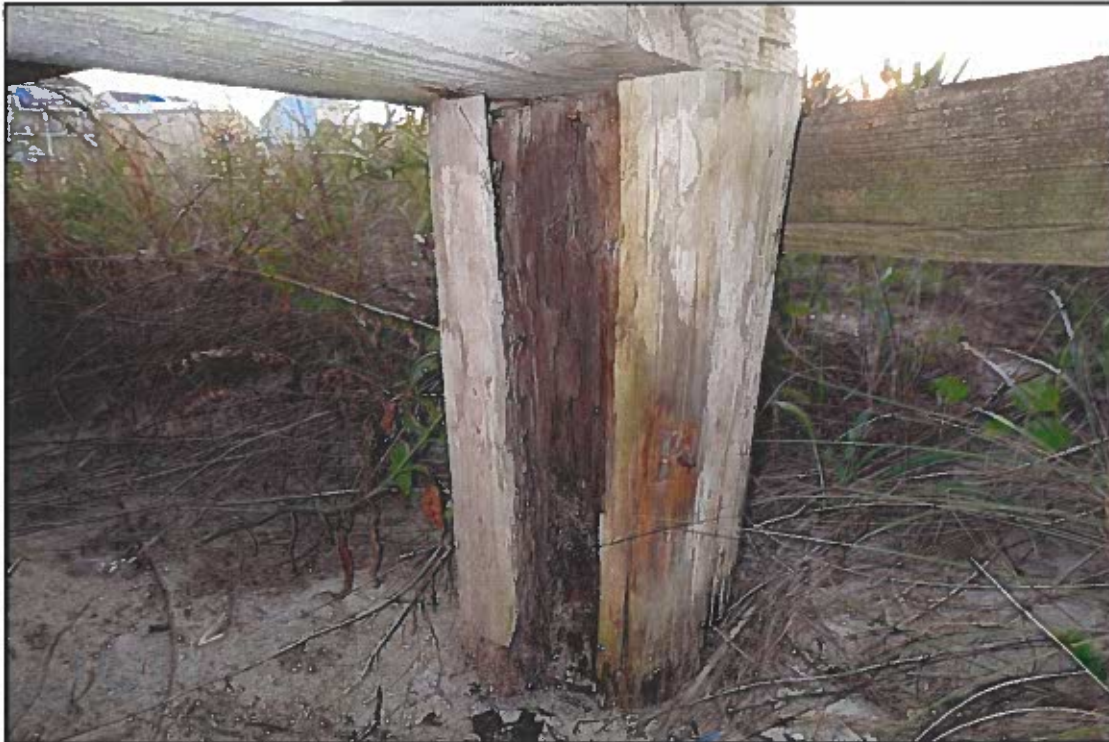
| PILE LOCATION | DAMAGE RATING | REASON FOR RATING |
|---|---|---|
| -5A | Severe | Heavy rot throughout; >75% section loss (Photograph 6). |

**Photograph 6: Pile -5A – Heavy rot throughout pile.**

| Structure | Bent | Row | Element | Shape | Material | Rating | Deterioration | Severity | Section Loss % | Diameter (in) | Dimensions (L x W x D) | Comments | Level I/II/III | Photo? | Depth (ft) | Time (HH:MM) | Photo # | Photo Comments |
|---|---|---|---|---|---|---|---|---|---|---|---|---|---|---|---|---|---|---|
| FISHING PIER | -5 | A | Pile | Round | Timber | SV | Rot | HVY | >75 | - | - | - | No | Yes | - | - | 183-191 | Heavy rot. |

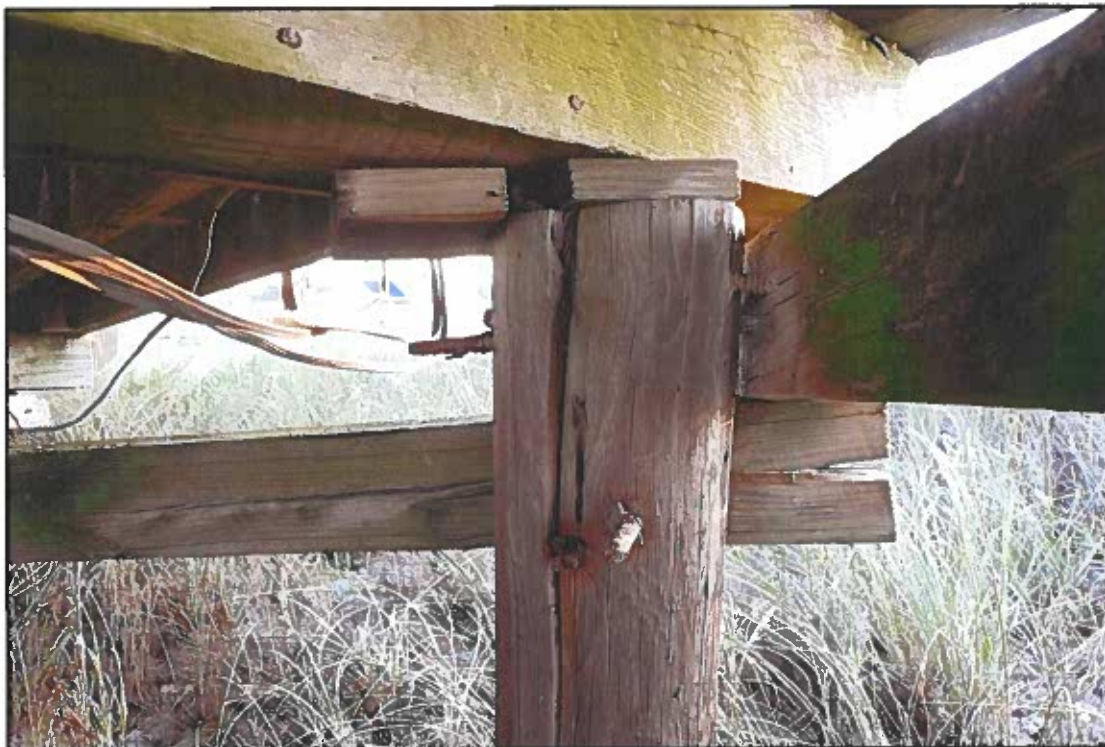
**Photograph 7: Pile -4A – Typical split in top of pile.**

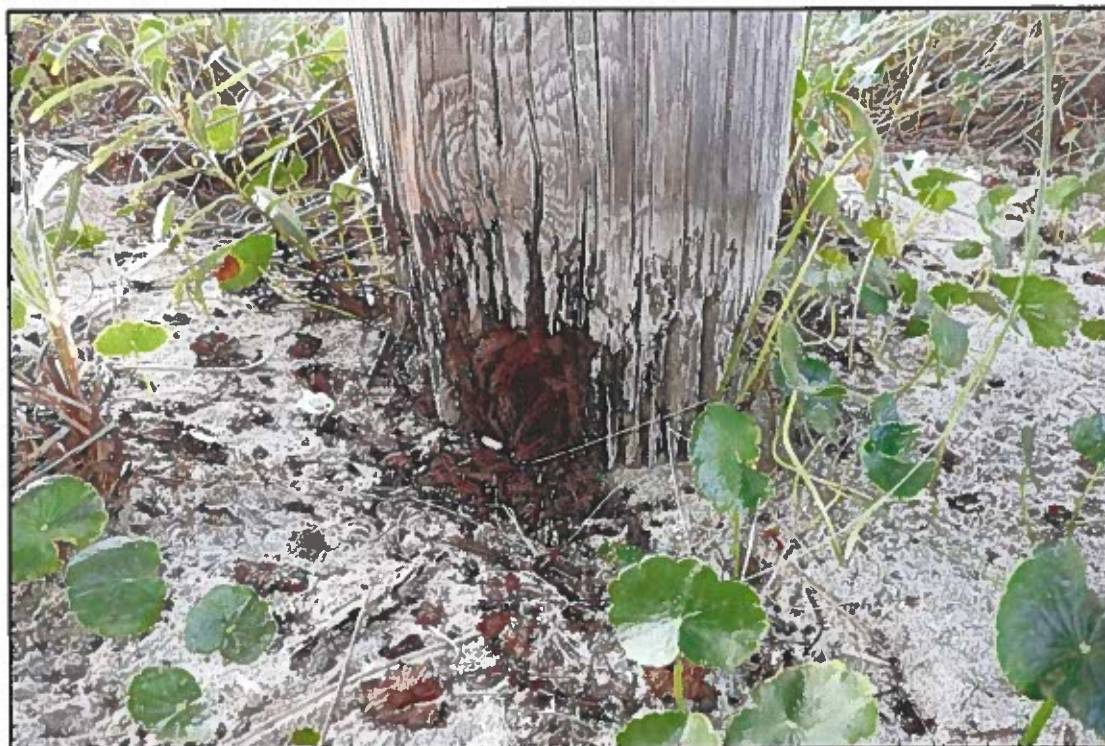
| PILE LOCATION | DAMAGE RATING | REASON FOR RATING |
|---|---|---|
| -2A | Major | Insect damage; 25-35% section loss (Photograph 8). |

**Photograph 8: Pile -2A – Insect damage at base of pile.**

| Structure | Bent | Row | Element | Shape | Material | Rating | Deterioration | Severity | Section Loss % | Diameter (in) | Dimensions (L x W x D) | Comments | Level I/II/III | Photo? | Depth (ft) | Time (HH:MM) | Photo # | Photo Comments |
|---|---|---|---|---|---|---|---|---|---|---|---|---|---|---|---|---|---|---|
| FISHING PIER | -2 | A | Pile | Round | Timber | MJ | Borer | MD | 25-35 | - | - | Insect damage at the base of pile. | No | Yes | - | - | 175-178 | Insect damage. |

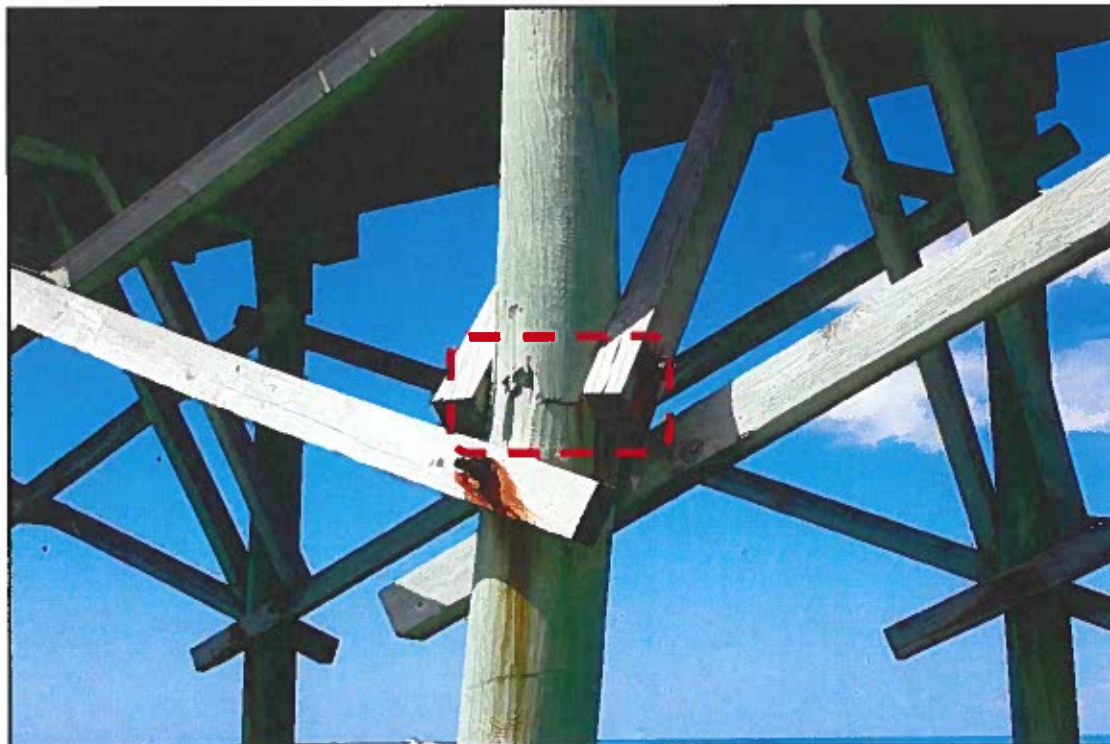
| PILE LOCATION | DAMAGE RATING | REASON FOR RATING |
|---|---|---|
| 49A | Severe | Broken 7 feet from top of pile (Photograph 12). |

**Photograph 12: Pile 49A - Broken pile 7' below top of pile.**

| Structure | Bent | Row | Element | Shape | Material | Rating | Deterioration | Severity | Section Loss % | Diameter (in) | Dimensions (L x W x D) | Comments | Level II/III | Photo? | Depth (ft) | Time (HH:MM) | Photo # | Photo Comments |
|---|---|---|---|---|---|---|---|---|---|---|---|---|---|---|---|---|---|---|
| FISHING PIER | 49 | A | Pile | Round | Timber | SV | Broken | HVY | - | - | - | Pile broke approx. 7' from T.O.P | No | Yes | - | - | 56-65 | Pile broke approx. 7' from T.O.P |

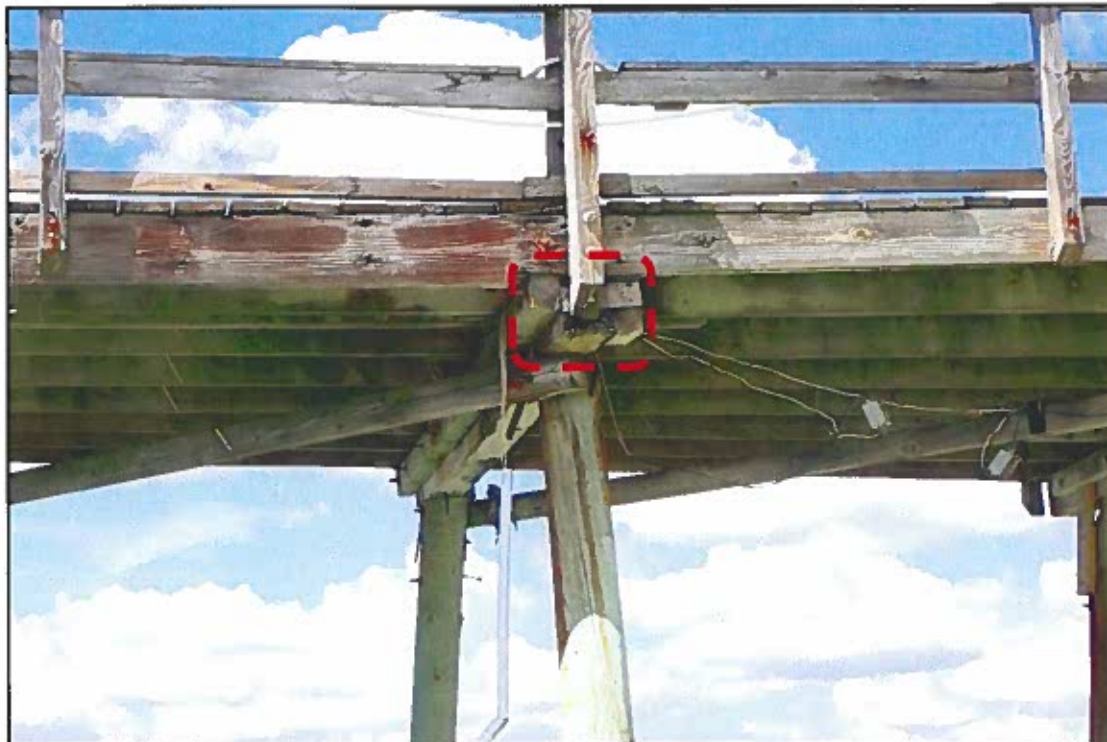
Fifty-six (56) of the 58 pile caps were rated Minor. The pile caps at Bents 26 and 27 were rated Major due to heavy end-grain rot with 35–50 percent section loss at the east ends of both caps (Photograph 16).

**Photograph 16: Bent 26 – End grain rot on east end of cap, looking west.**

| Structure | Boat | Row | Element | Shape | Material | Rating | Deterioration | Severity | Section Loss % | Diameter (in) | Dimensions (L x W x D) | Comments | Level I/II | Photo? | Depth (ft) | Time (HHMM) | Photo # | Photo Comments |
|---|---|---|---|---|---|---|---|---|---|---|---|---|---|---|---|---|---|---|
| FISHING PIER 26 | - | - | Cap | Square | Timber | MJ | Rot | HVY | 35-50 | - | 3' | EGR on East side of cap. | No | Yes | - | - | 110-122 | EGR on East side of cap. |
| FISHING PIER 27 | - | - | Cap | Square | Timber | MJ | Rot | HVY | 35-50 | - | 3' | EGR on East side of cap. | No | Yes | - | - | 110-122 | EGR on East side of cap. |

| Item | Quantity | Estimated Cost |
|---|---|---|
| Timber Pile Cap Replacement | 2 | \$52,000 |

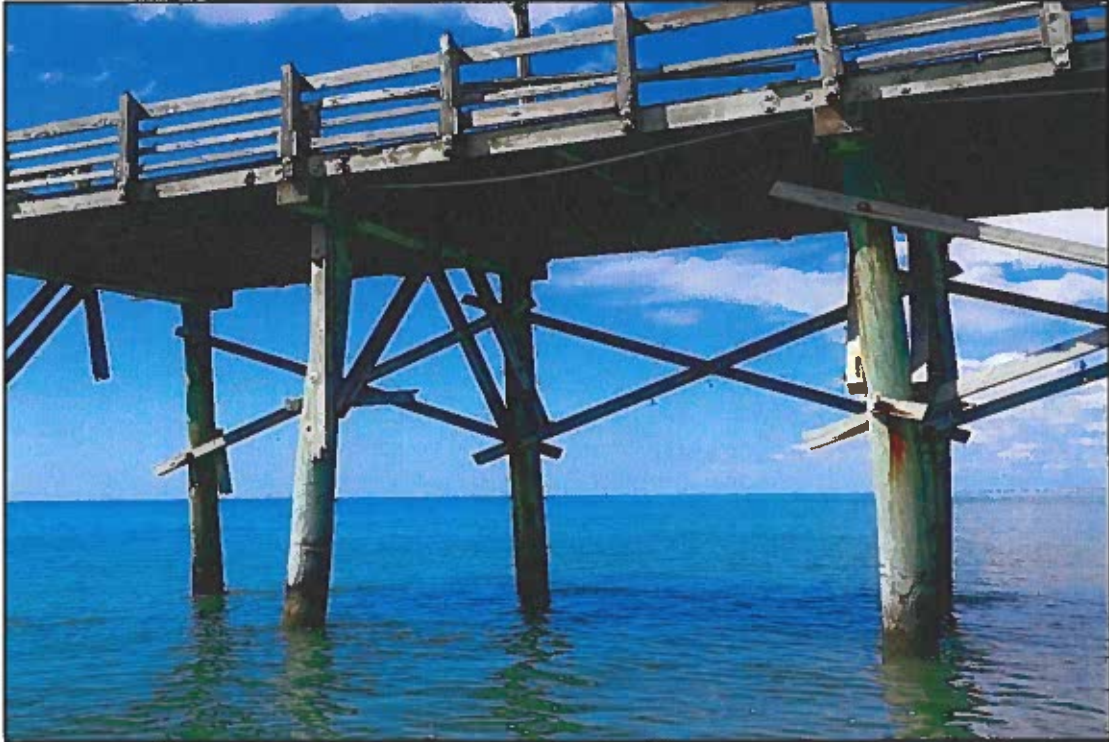
Typically, the timber bracing was rated Minor, with no defects noted. Sixteen (16) diagonal braces were rated Severe due to being broken and/or missing (Photograph 17). The locations of these braces are listed below:

**Photograph 17: Bent 51-52 – Typical bent-to-bent bracing broken and missing, looking west.**

| Structure | Boat | Row | Element | Shape | Material | Rating | Deterioration | Severity | Section Loss % | Diameter (in) | Dimensions (L x W x D) | Comments | Level I/II | Photo? | Depth (ft) | Time (HH:MM) | Photo # | Photo Comments |
|---|---|---|---|---|---|---|---|---|---|---|---|---|---|---|---|---|---|---|
| FISHING PIER | 51-52 | A-A, W | Diag. Brace | Square | Timber | SV | Broken | - | - | - | - | - | No | No | - | - | - | - |
| FISHING PIER | 51-52 | A-A, E | Diag. Brace | Square | Timber | SV | Broken | - | - | - | - | - | No | No | - | - | - | - |

| Item | Quantity | Estimated Cost |
|---|---|---|
| Bent Bracing Replacement | 8 | \$61,600 |
| Row Bracing Replacement | 8 | \$44,000 |

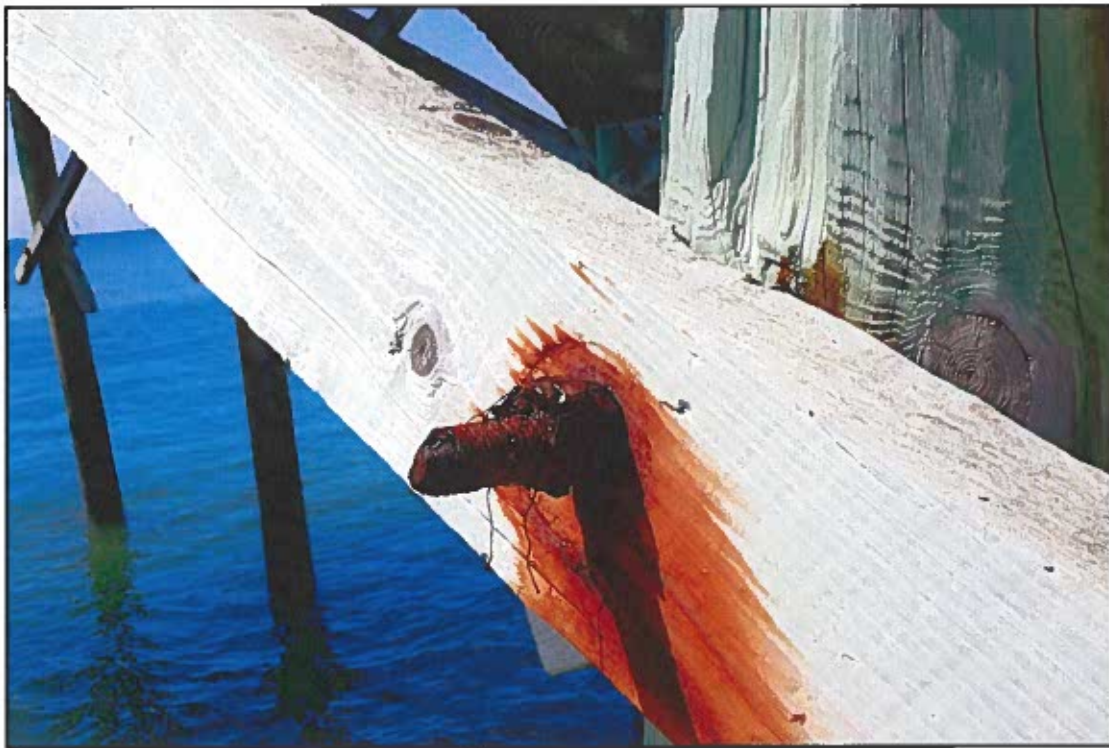
Lower-elevation hardware exhibited heavy corrosion with 50–75 percent section loss (Photograph 18) throughout the entire structure.

**Photograph 18: Typical corrosion to lower bracing connection hardware.**

| Item | Quantity | Estimated Cost |
|---|---|---|
| Lower Connection Hardware Replacement | 268 | \$77,720 |

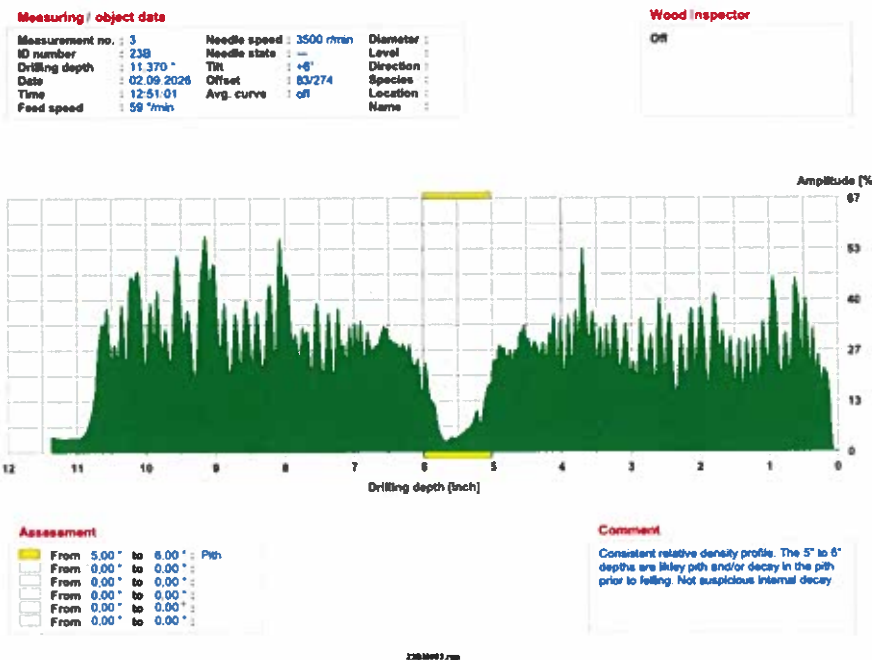
Figure 2 – Pile 23B. Profile is consistent. Internal low relative density is exactly at the location of pith (see similar trend is all other drillings). The particularly low level may represent heart rot in the pith at the time of felling and prior to manufacture.

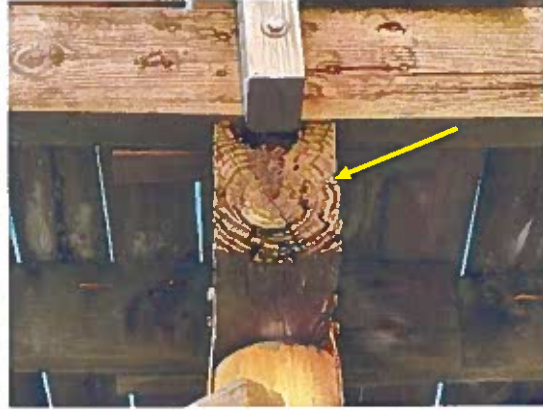
Wood decay was occasionally observed in the cross bracing and timber pile caps but was typically limited to end grain conditions (Photo 2). The remaining dimension lumber and timbers in the pier were generally in good condition except some cross braces that were fractured midspan (likely due to ocean debris during storms). The decking on the pier was not inspected since the pier was closed at the time of this inspection.

Photo 2 - Typical wood decay, when present, limited to exposed end grain.

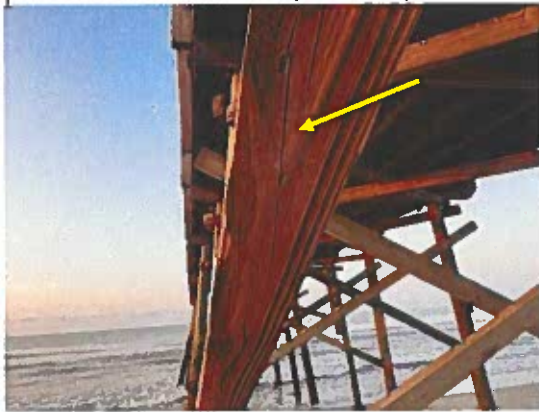
Photo 3 - Spole of grain consistent with No. 2 visual grade observed on one cross brace.

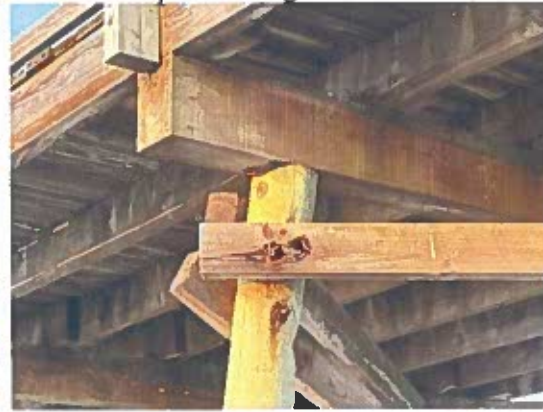
Photo 4 - General visual grade quality of timbers is at least consistent with No. 1. Fastener corrosion also visible.

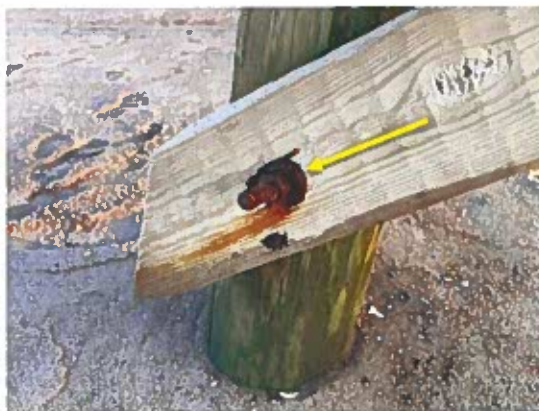
Fastener corrosion was frequently observed throughout the connections between elements. Photo 5 illustrates the typical fastener conditions observed.

Photo 5 - Typical fastener corrosion.
