***** Residential Inspection Report *****

105 Via Santo Tomas
Rancho Mirage, Ca. 92270

Date Of Inspection: February 3, 2011

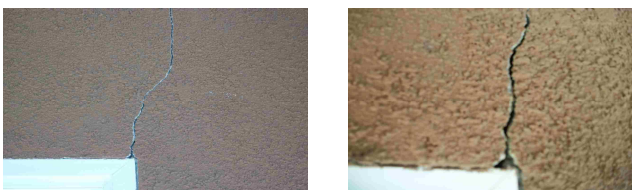
Further Comments: Cracks in stucco were observed on the north side wall, above middle window and on rear patio area, on top right corner of master bedroom slider. These types of cracks appear to be "Stud cracks" which are straight-line vertical fractures, which appear over or near framing studs of new construction. These can be caused by warping or twisting of studs, shrinking studs, vibrations from heavy traffic, vibrations from machinery, and severe blows from swinging doors. Cracking can also result from using green or wet lumber for framing. Lumber can twist and bow as it dries, cracking the stucco in the process. Cracks can also be caused by inadequate spaces between plywood sheets to allow for expansion. Recommend repairing cracks using approved stucco caulking sealant that will help prevent moisture intrusion. If cracks continue to re-appear recommend further investigation to determine cause.

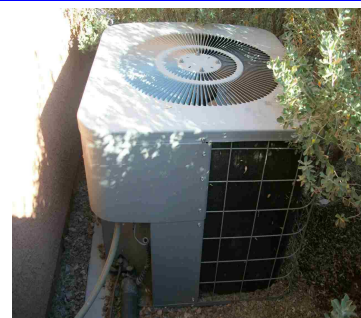
Cooling System (Bedroom areas)

Recommend clearing away shrubbery from cooling compressor unit. This will help unit to be more efficient in cooling and save in cost.

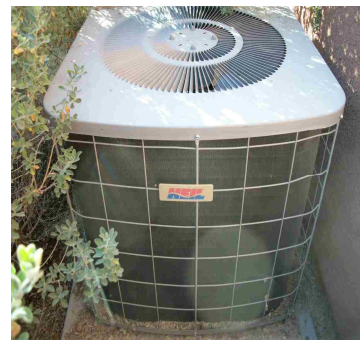
Recommend clearing away shrubbery from cooling compressor unit. This will help unit to be more efficient in cooling and save in cost.

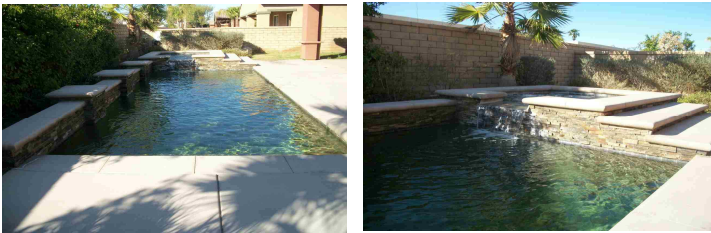
Further Comments: Pool light was inoperable at time of inspection; recommend speaking with pool maintenance technician to learn history about pool and functions of pool.
