DOT US Department of Transportation
PHMSA Pipeline and Hazardous Materials Safety Administration
OPS Office of Pipeline Safety – Accident Investigation Division

Principal Investigator Wesley Mathews
Acting Accident Investigation Director Chris Ruhl
Date of Report May 26, 2022
Subject Failure Investigation Report - Denbury Gulf Coast Pipelines, LLC – Pipeline Rupture/ Natural Force Damage

Failure Investigation Report – Denbury Gulf Coast Pipelines LLC
Pipeline Rupture/Natural Force Damage
February 22, 2020

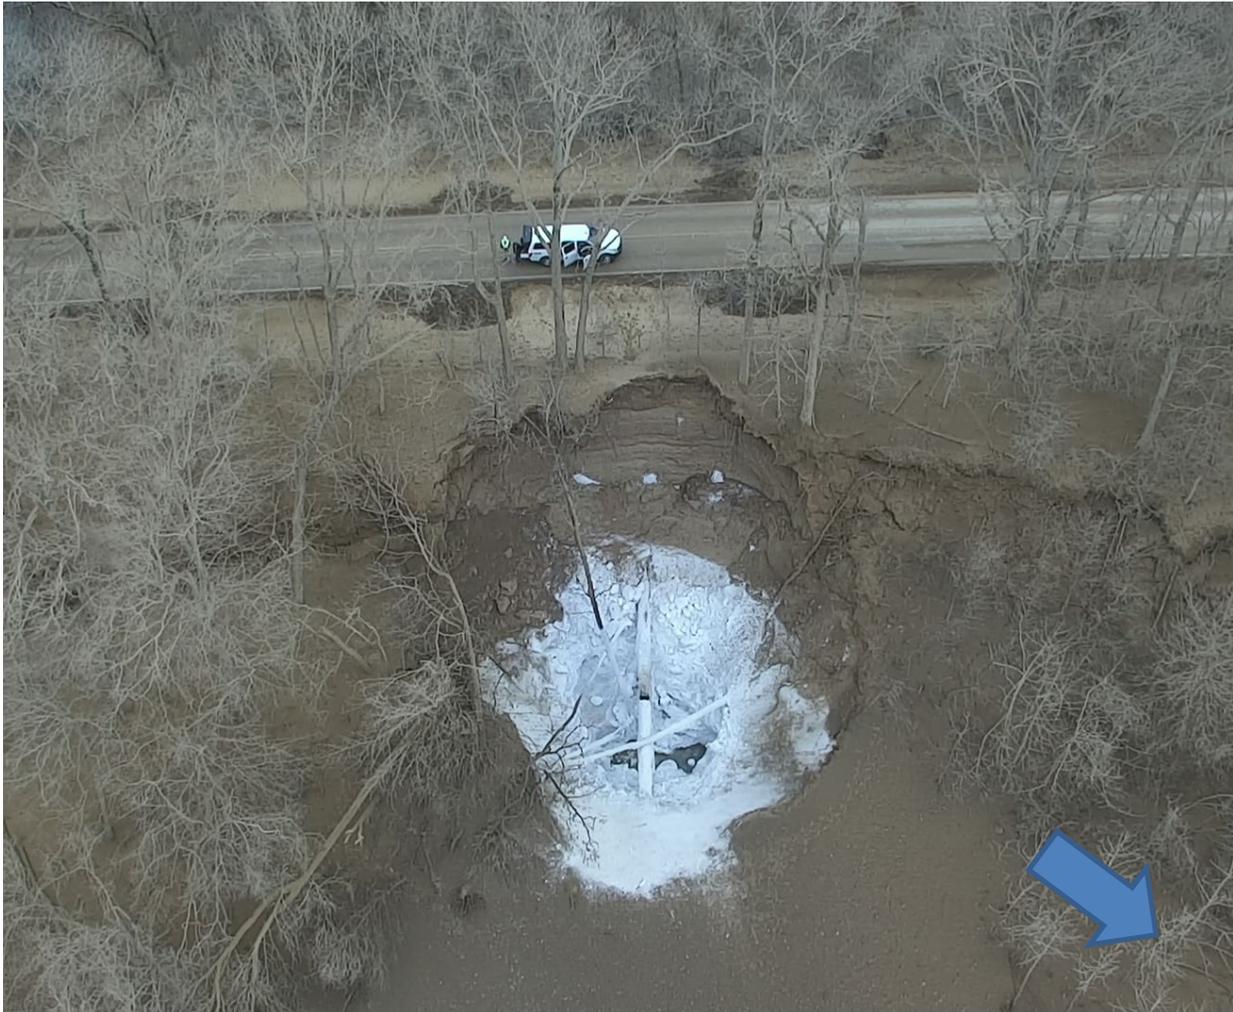
Figure 2: Vehicle is Parked on HWY 433 - The White is Ice Generated by the Release of CO₂ - The Blue Arrow Points North (Aerial Drone Photograph Courtesy of the Mississippi Emergency Management Agency)

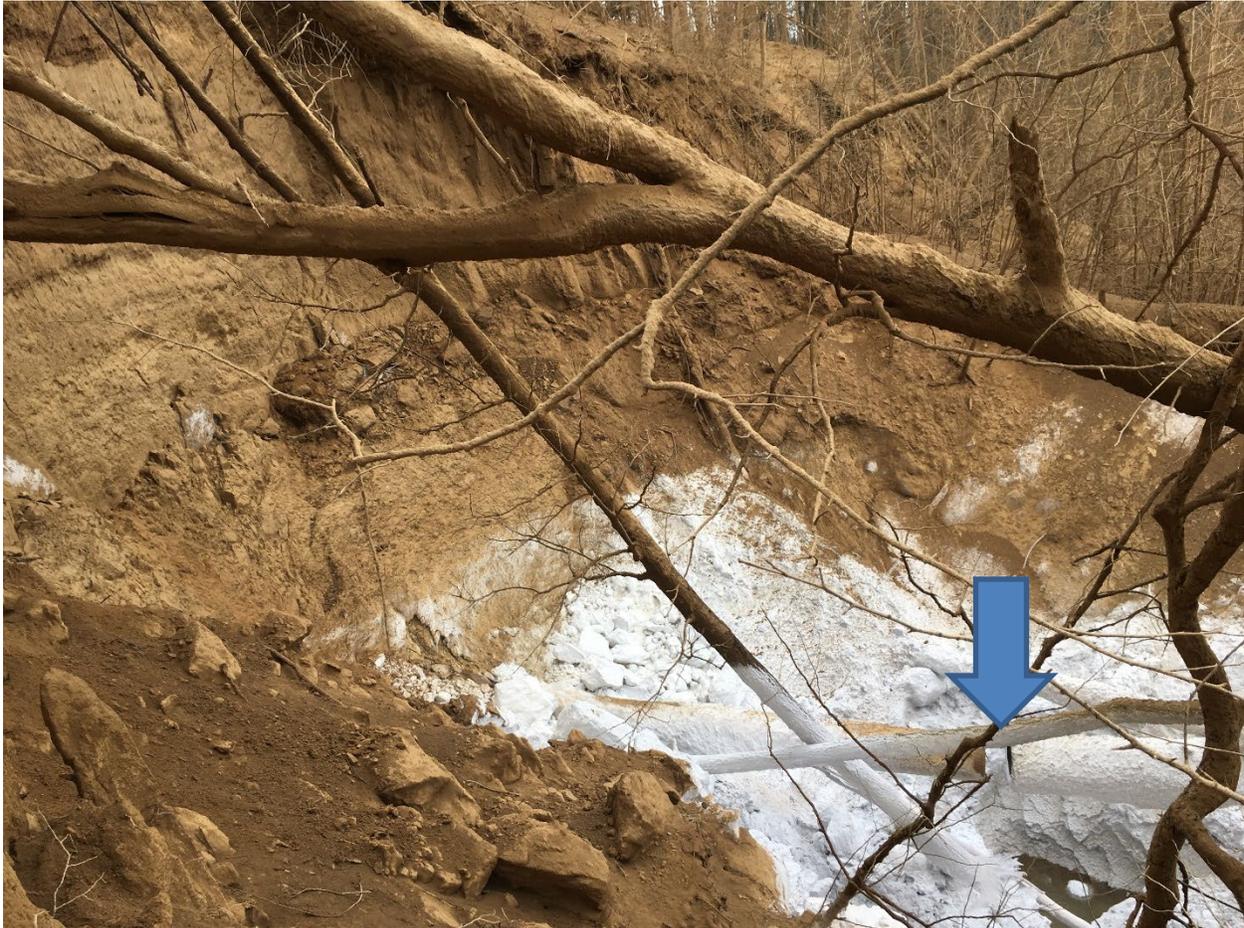
*Figure 3: Crater Created by the Rupture Containing Fallen Debris (dry ice, and the failed pipe sections)
(Blue Arrow is Pointing at the Pipeline Separation)*

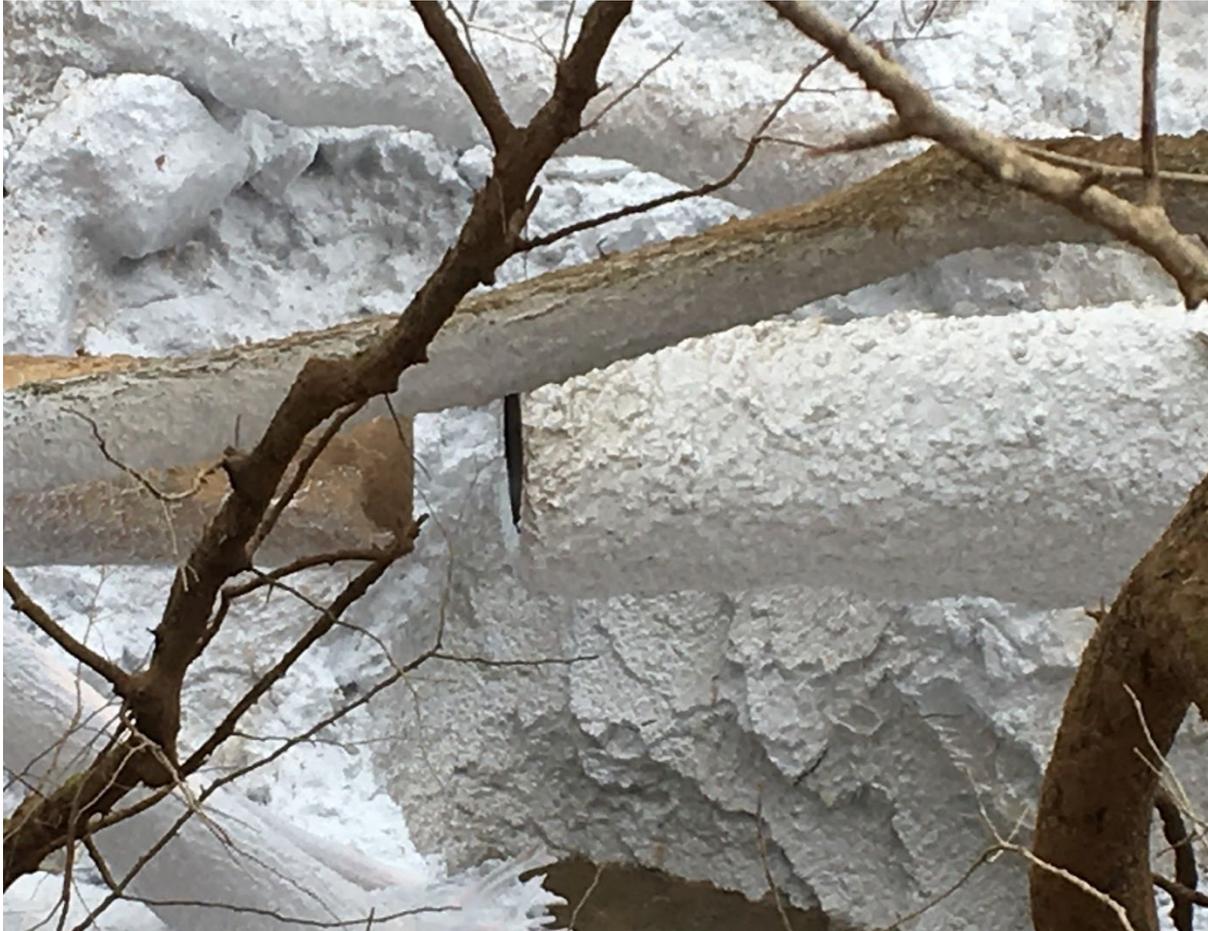
Figure 4: The failed pipe sections shown separated by a few inches.

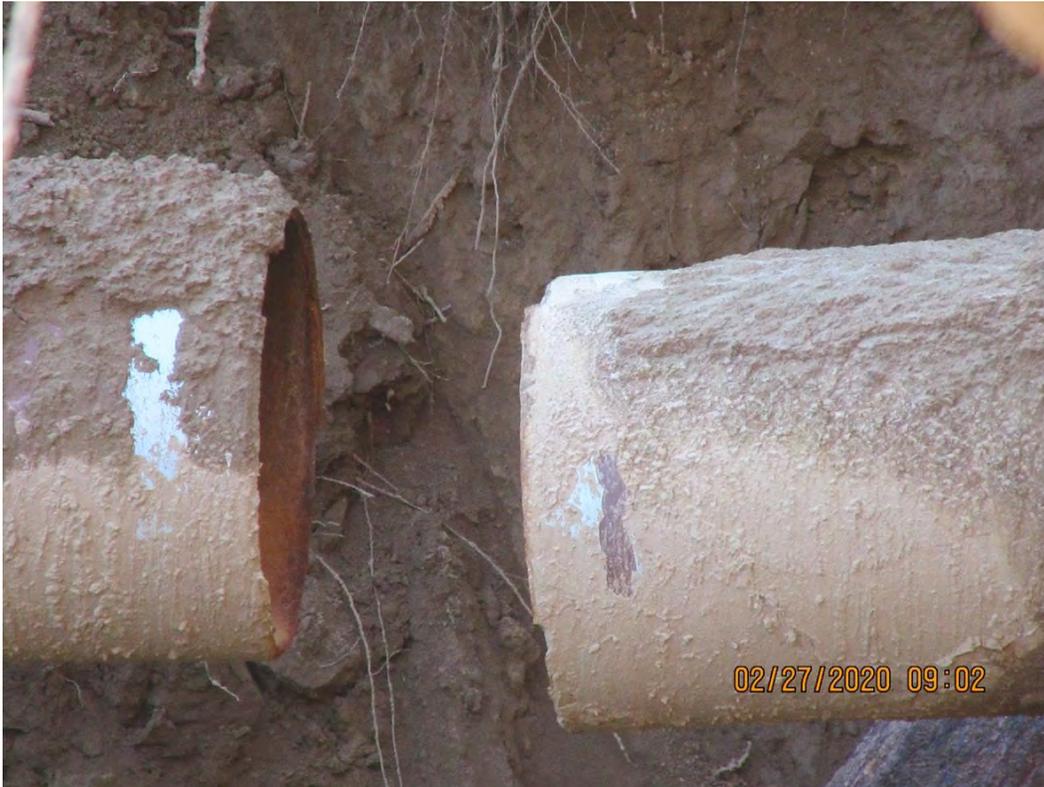
In-situ visual inspection of the exterior surface of the pipe identified a separation of the piping at a girth weld of approximately 8 inches, with slight misalignment between the upstream and downstream joints. Figure 8 provides a close-up of the as-found pipe and coating condition at the separation.

Figure 8. Delhi 24-inch Transmission Line Failure - As-Found Condition at Girth Weld

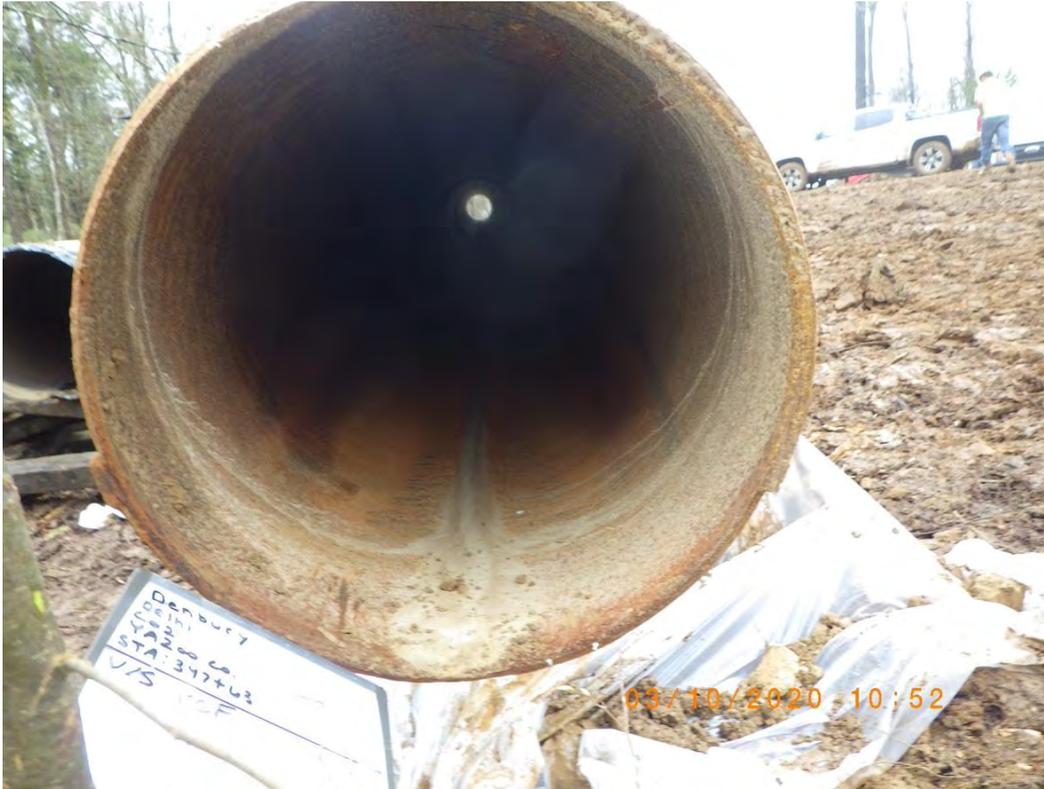
Initial visual inspection of the internal surface of the piping showed no accumulated solids or liquids in the pipe sample and no indications of pitting or corrosion. A view of the internal condition of the pipe section containing samples B & C after removal is provided in Figure 11.

Figure 11. Internal Condition of Pipe Sample During Removal

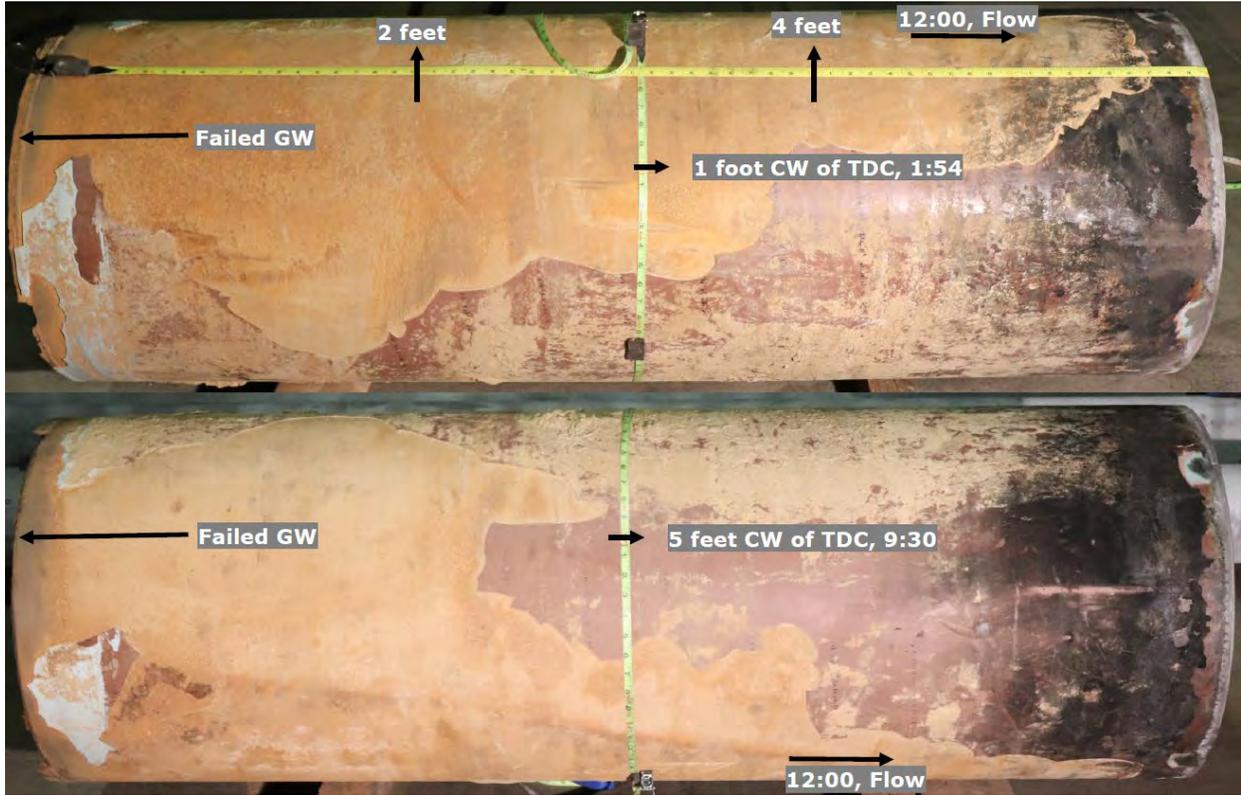
Figure 12. Pipe Sample A (PS A)

The pipe adjacent to the fracture surfaces and failed girth weld were visually inspected. The fractured surface was flat and generally at a 180-degree angle with no thinning and/or reduction of the affected area. The fracture path traversed or crossed over the weld at various locations.

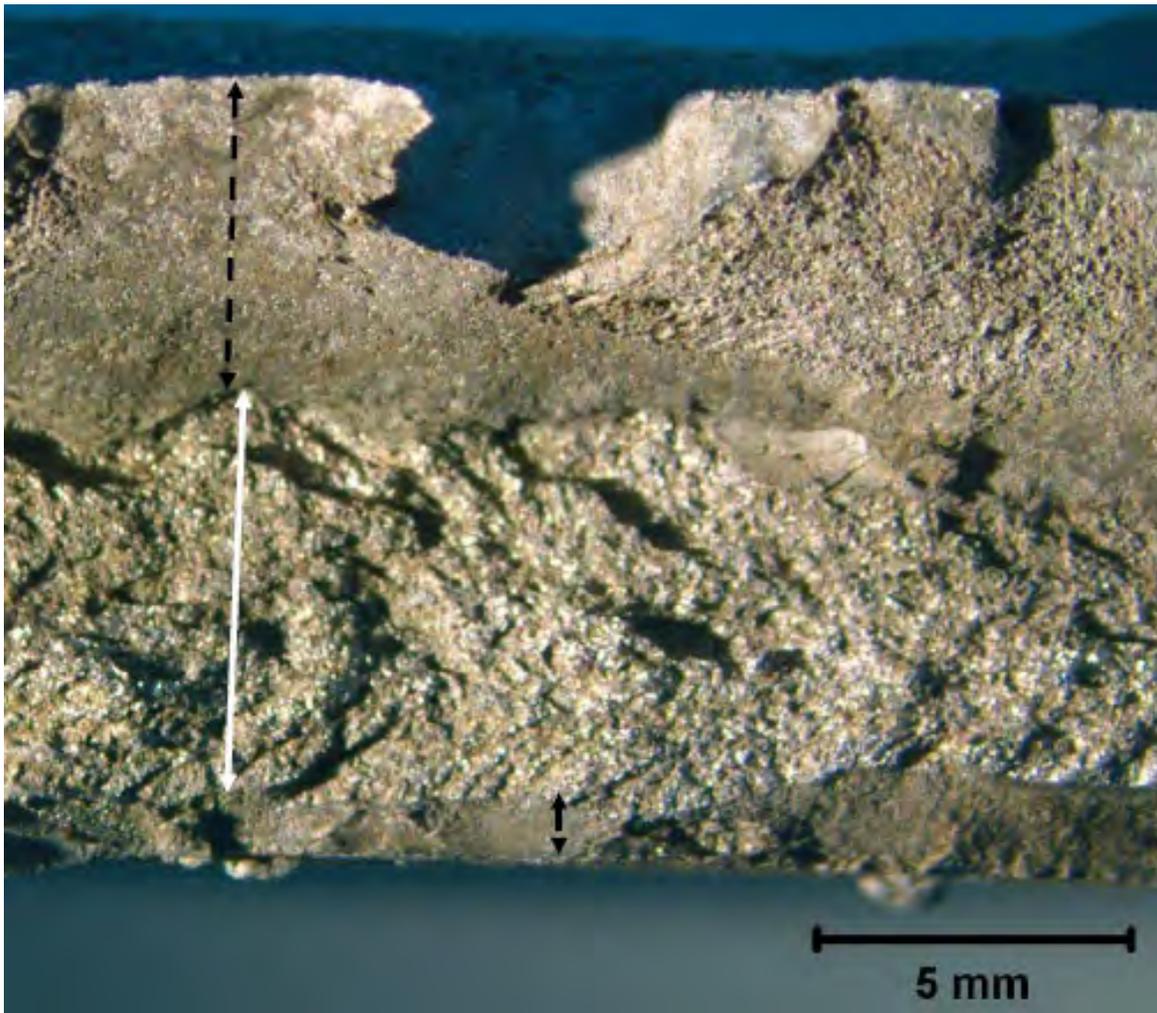
The internal and external surfaces of the failed girth weld were cleaned with a soft bristle brush to for more detailed examination. Five areas were selected for metallurgical analyses of the failed girth weld (PS A, PS B) and one area from the intact girth weld in PS C. The fracture surface consisted of smooth regions and rougher surfaces that varied in thickness throughout the rupture face. An example of these regions is provided in Figure 17. There was no evidence of pre-existing manufacturing flaws. It was not possible to determine the exact location of the failure initiation process due to the lack of chevrons on the fracture surface.

Figure 17. Image of Sample S2 - Smooth (Black Arrow) and Rough (White Arrow) Regions

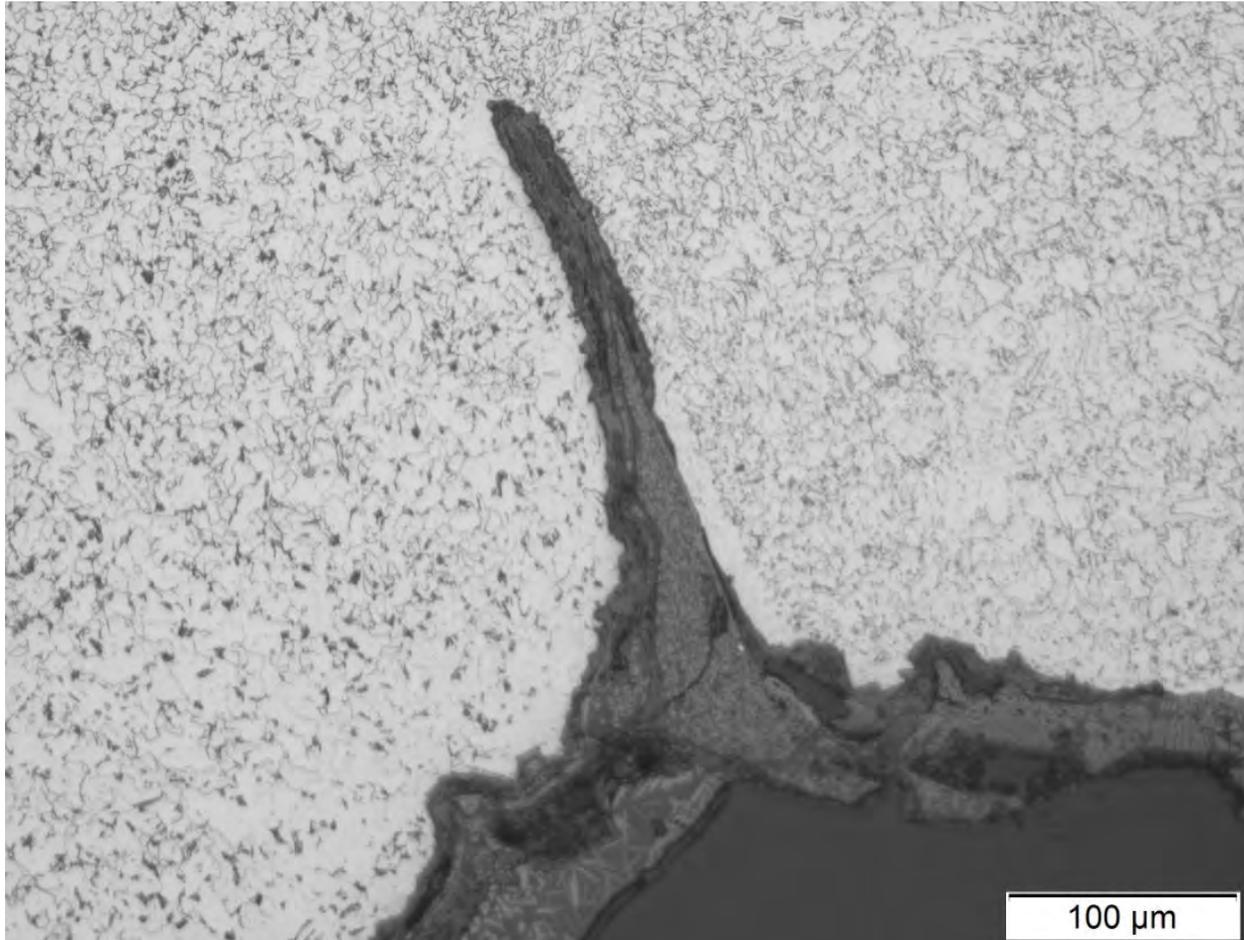
Figure 35. Close Up View of Sample MU1 Flaw

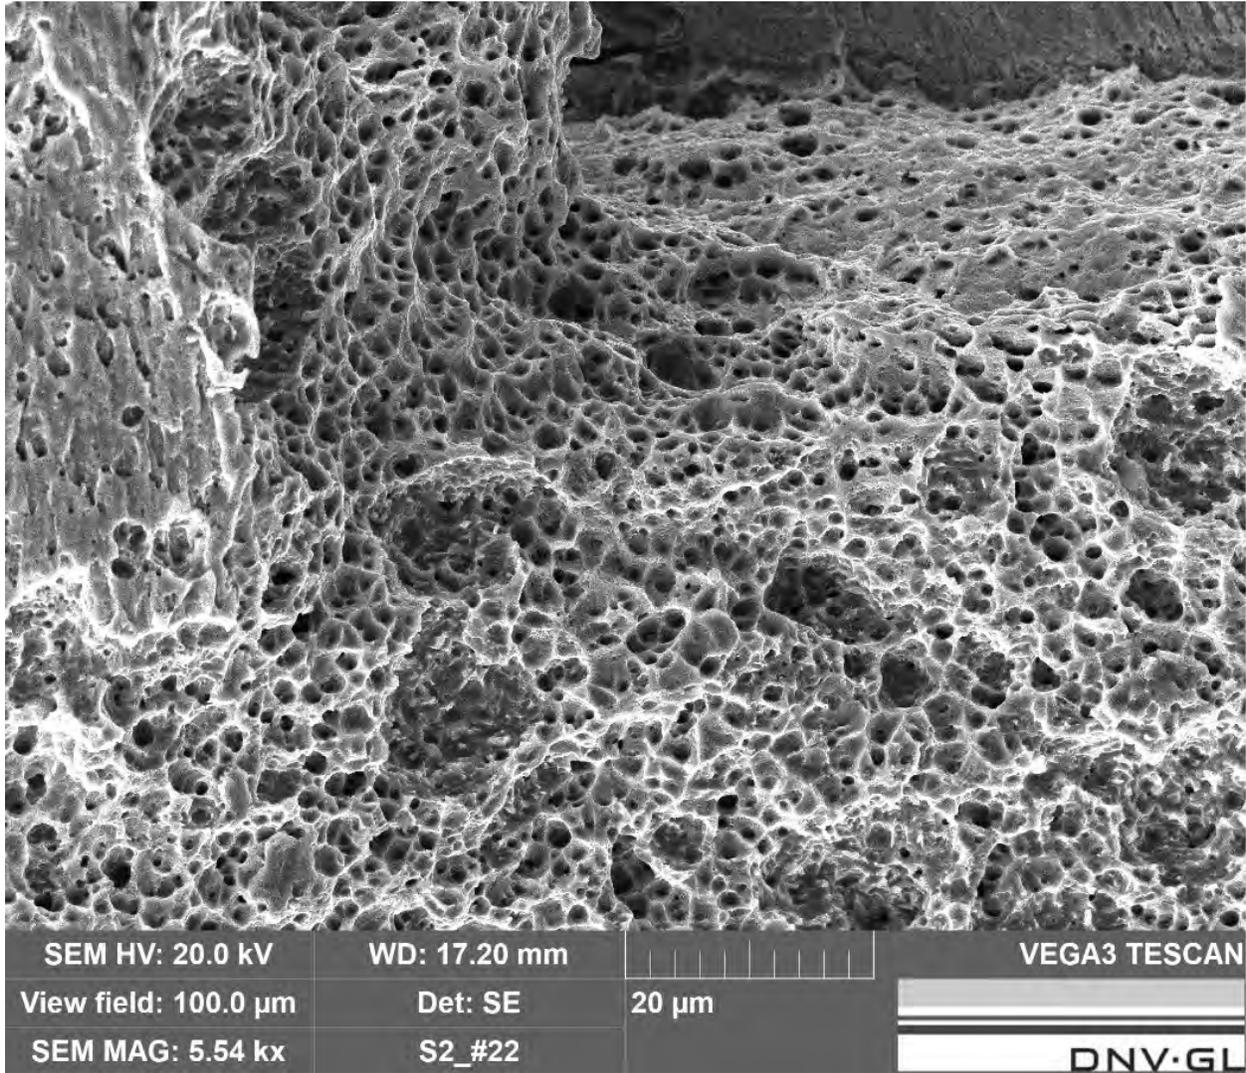
Figure 36. Sample S2 – Dimples Associated with Ductile Fracture

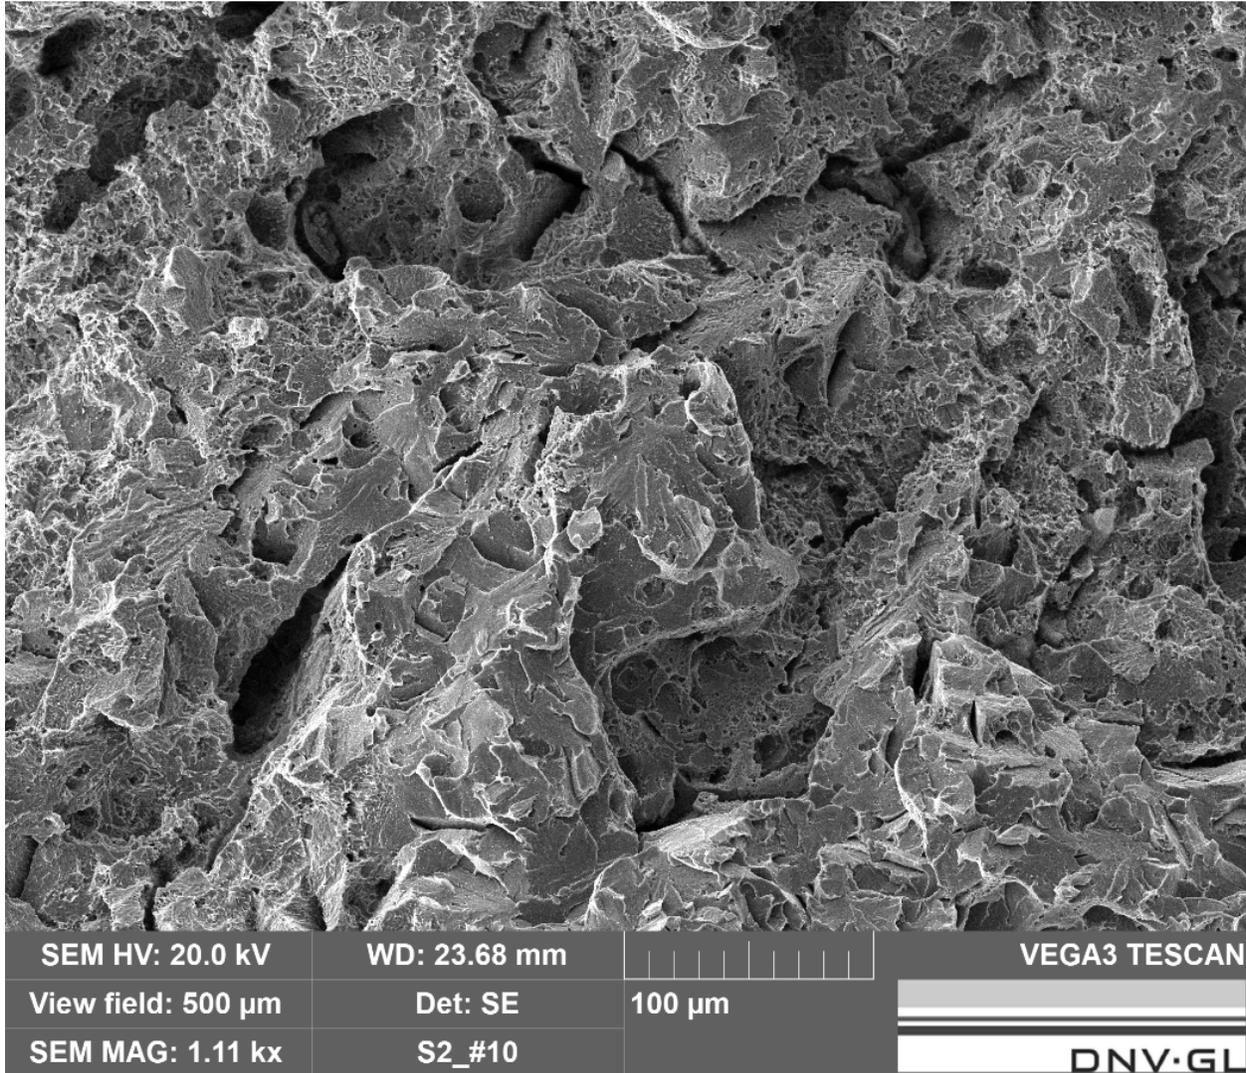
Figure 37. Sample S2 – Facets Associated with Brittle Fracture

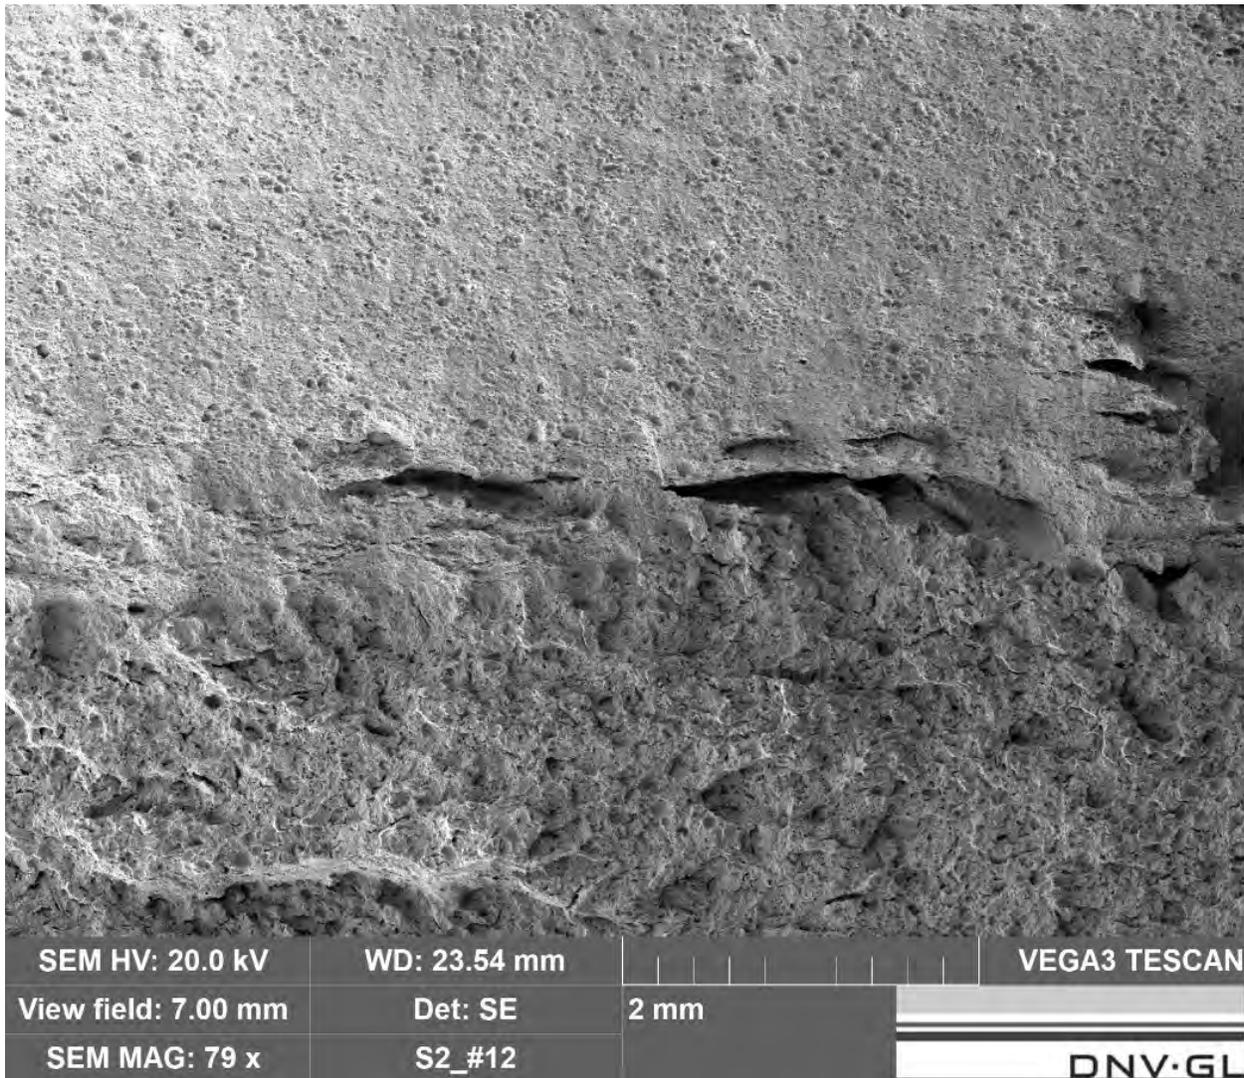
Figure 38. Sample S2 – Tears Mid-Wall (Smooth Region)

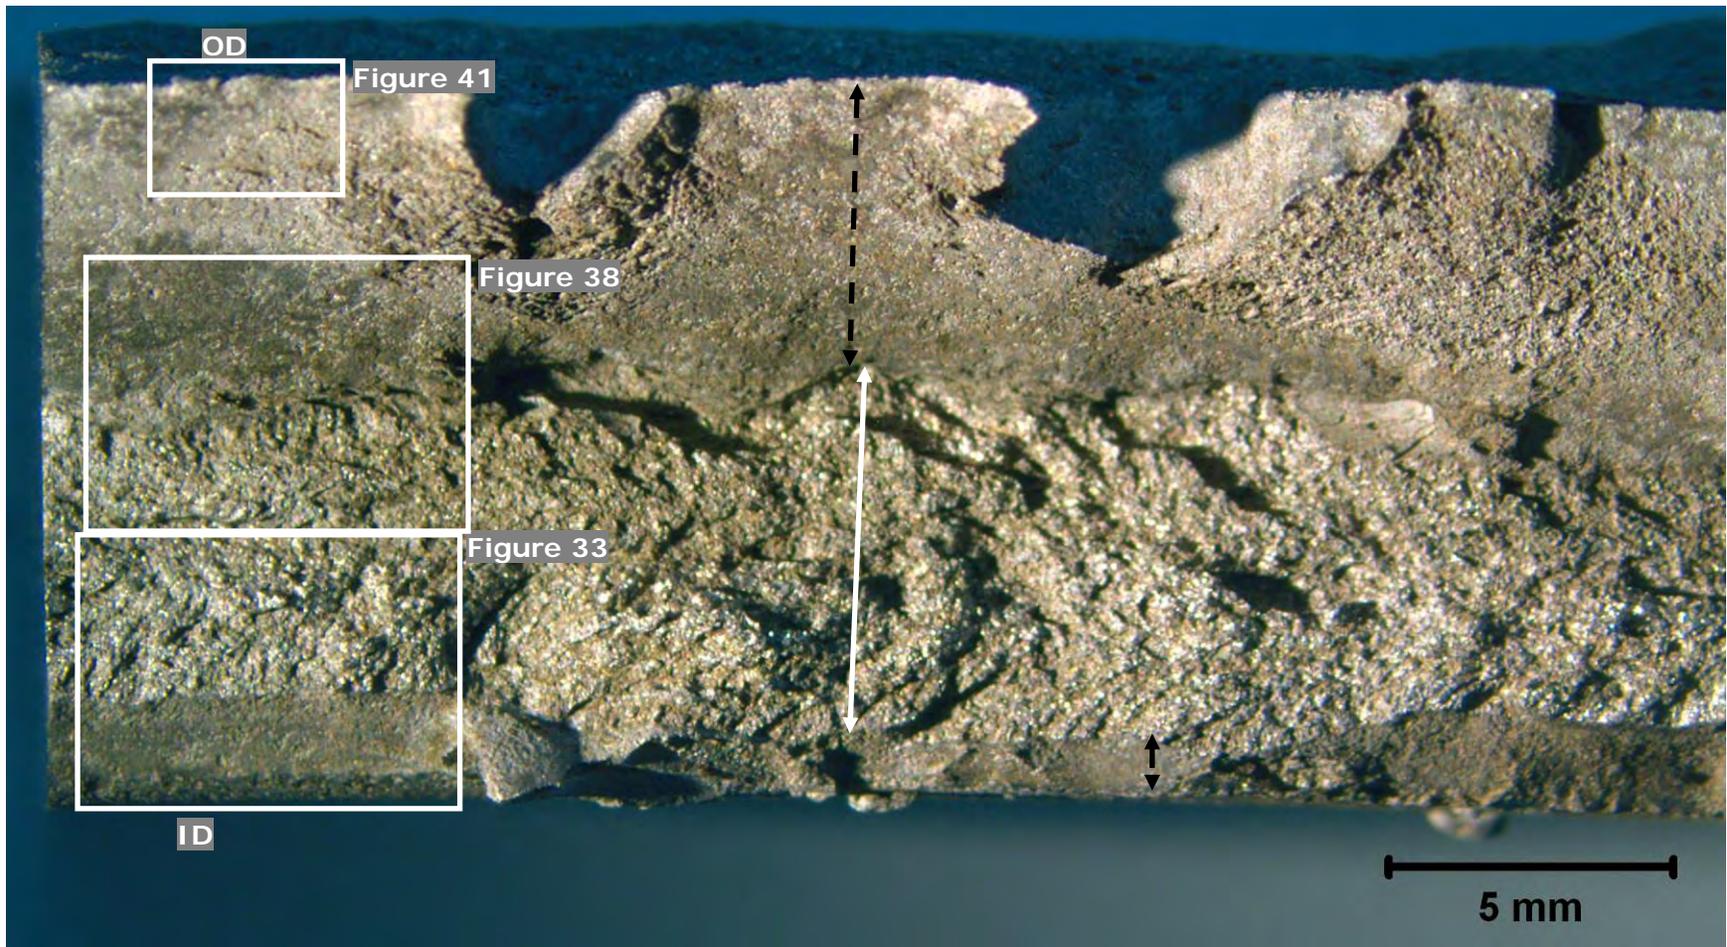
Figure 32. Light photomicrograph of the fracture surface of Sample S2, following cleaning in ENPREP® 214. The sample was removed near the 4:00 orientation from PSA; area indicated in Figure 23. The black, dashed double arrows indicate smooth regions and the white double arrow indicates a rough region.

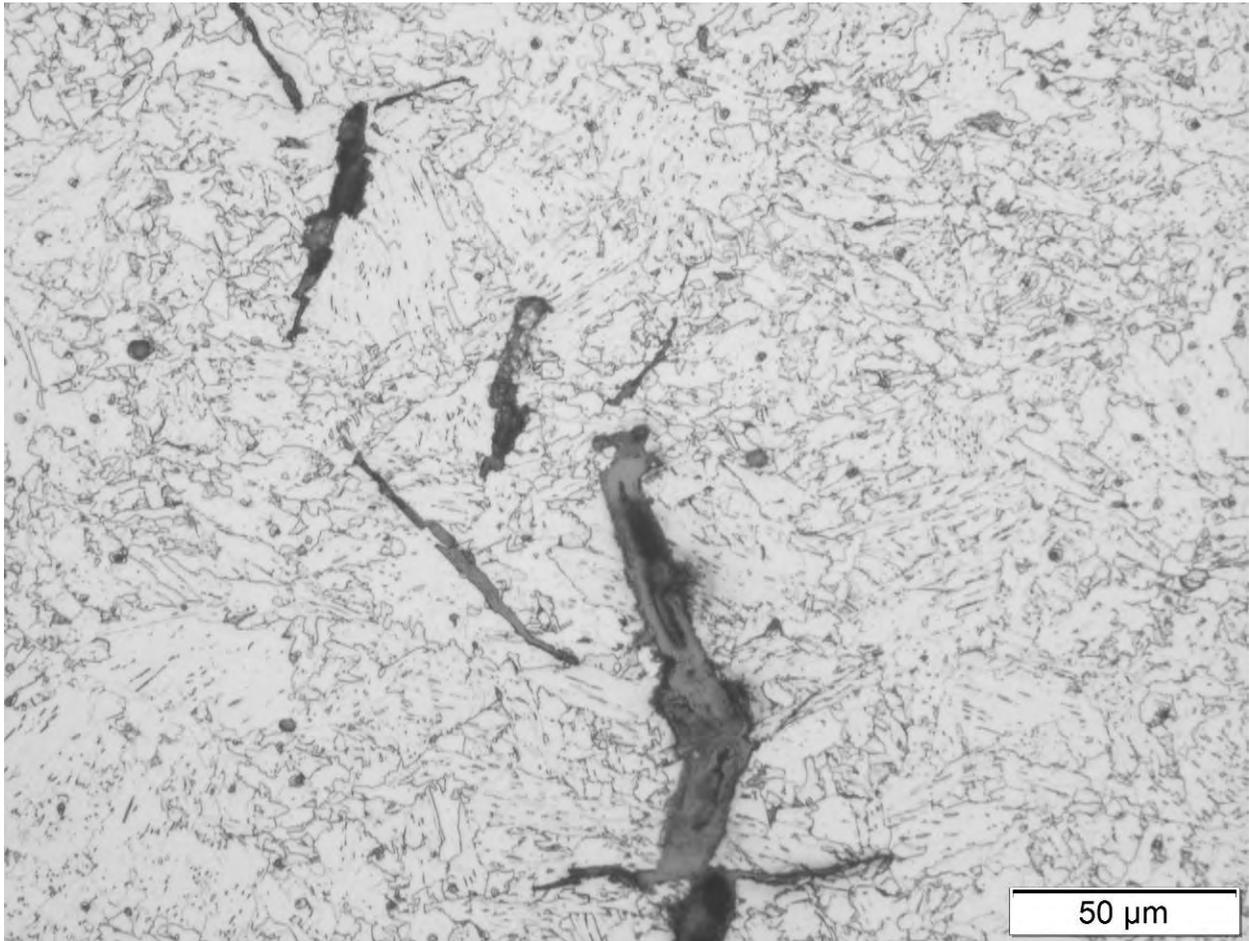
Figure 60. High magnification light photomicrograph of Mount M2 at fissures (2% Nital Etchant); area indicated in Figure 59.
