Veritas Property Inspection

Inspection Report

**1234 Safe Harbor Dr
Pleasantville, California 95555**

Inspection Date January 27, 2018
Client John Doe
Inspector Nicholas Peres, CPI
P.O. Box 1004
Lake Elsinore, CA 92530
(951) 230-5831
veritasproinspect@gmail.com
interNACHI, Infrared, IAC2 Mold Certified

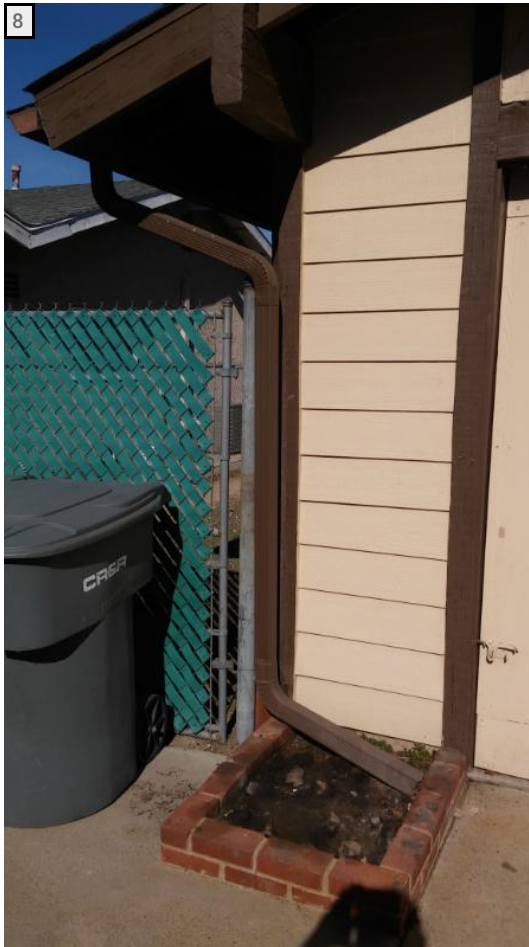
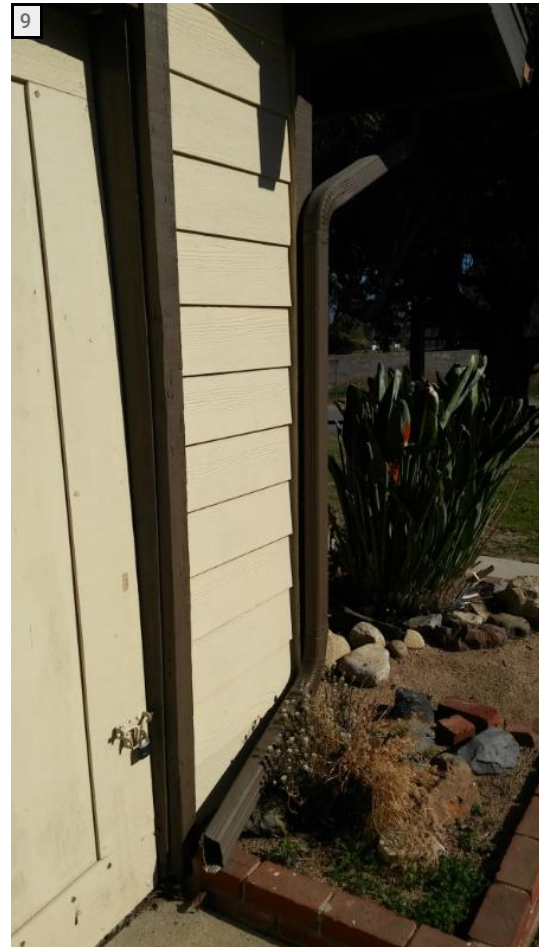
Extensions are missing

Location	Exterior: Ground View
Impact	Water flow is not contained and may drain near foundation increasing the risk of flooding
Suggested Action	Install downspout extensions reaching 5-6 feet from the building

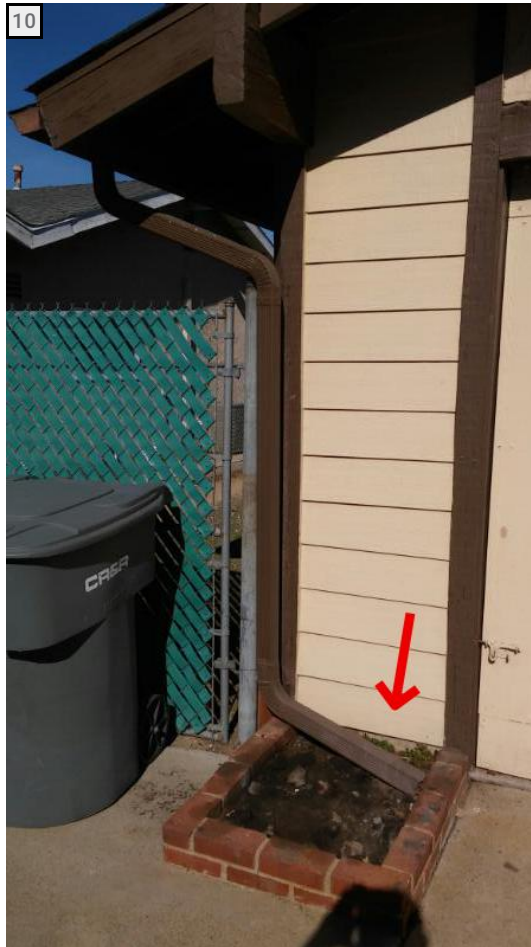
Moderate Concern**Fasteners are not held tight to the building**

Location	Exterior: Ground View
Impact	Without proper fasteners, the downspout could further pull away
Suggested Action	Resecure or replace the fasteners
Other Information	Fasteners hold the downspout secure to the building to avoid disconnection from the gutter

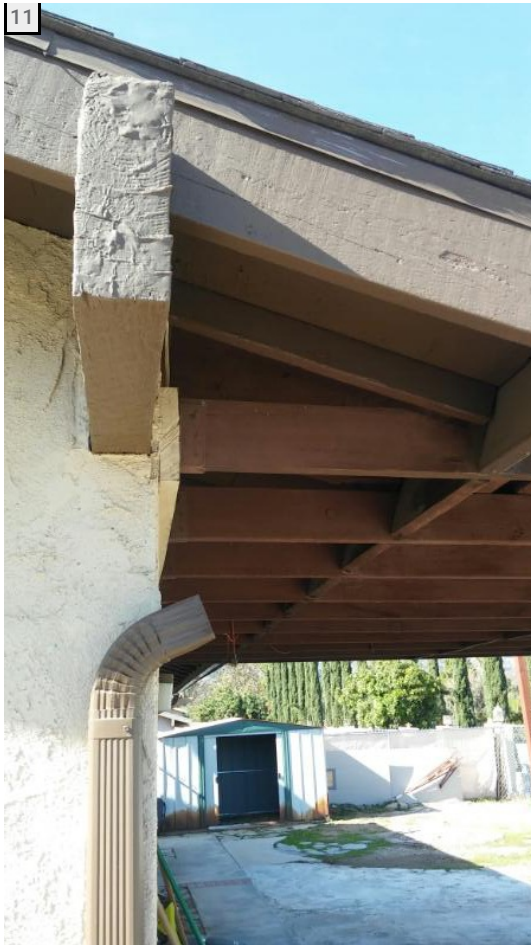
**Minor Concern****Elbow(s) are not properly connected**

Location	Exterior: Ground View (Rear home near kitchen.)
Impact	Improper connections prevent water drainage
Suggested Action	Secure or replace the elbow connector
Other Information	The elbow connector should be securely fastened to prevent the elbow from coming loose and assure a leak-free elbow

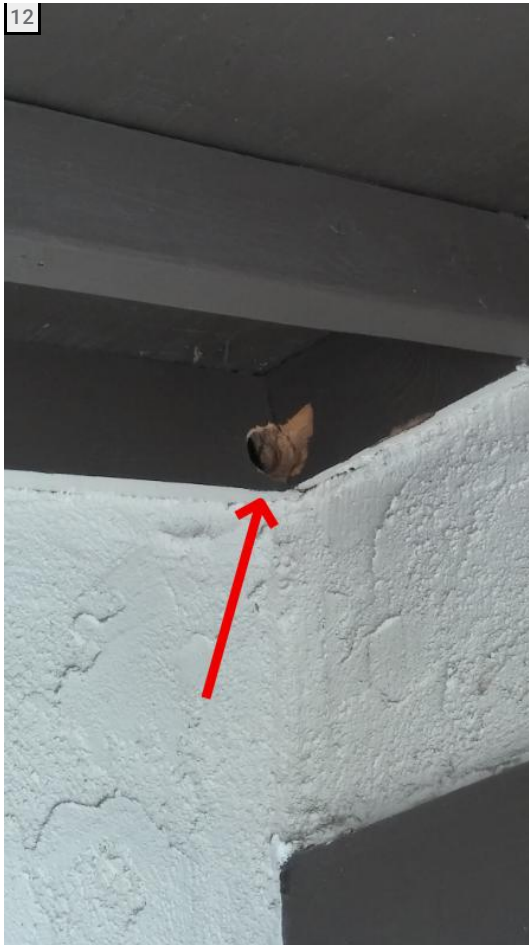
Wood soffit is damaged

Location	Exterior: Ground View (Above garage man door)
Impact	With damaged fascia, the home lacks protection from pests entering
Suggested Action	Replace the damaged area

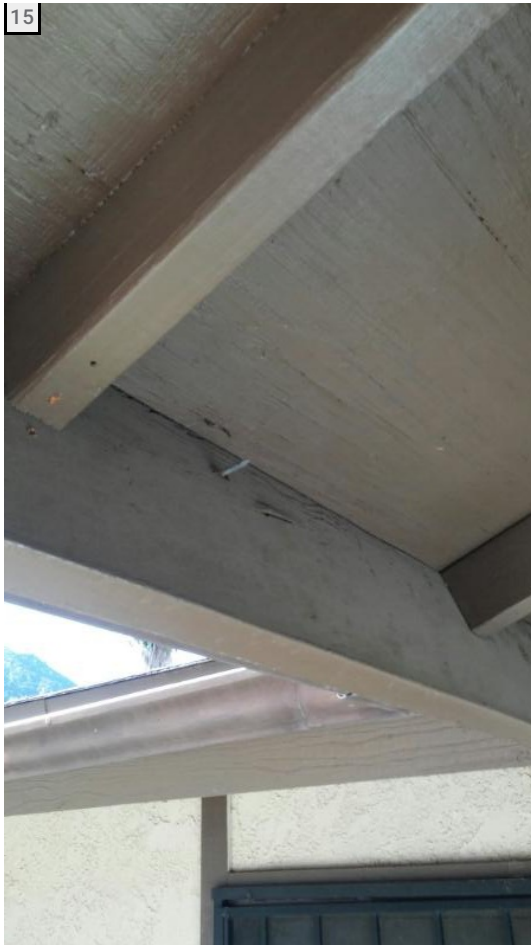
Location	Exterior: Ground View
Impact	The gutter could further pull away and / or fall down and over time cause damage to the fascia material
Suggested Action	Remount the gutters

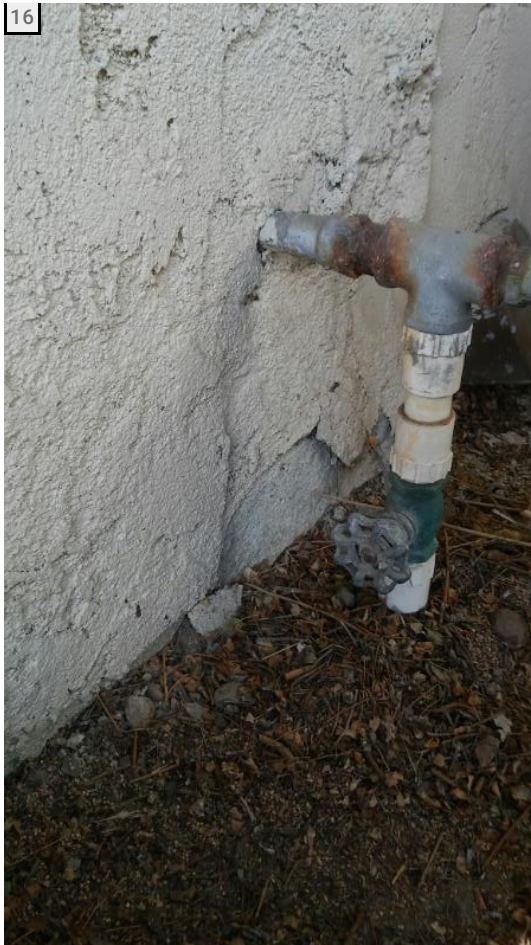
Showing signs of moisture intrusion

Location	Exterior: Ground View
Impact	With moisture intrusion present, mold could grow
Suggested Action	Have a stucco contractor assess for the source of moisture intrusion and recommend repairs

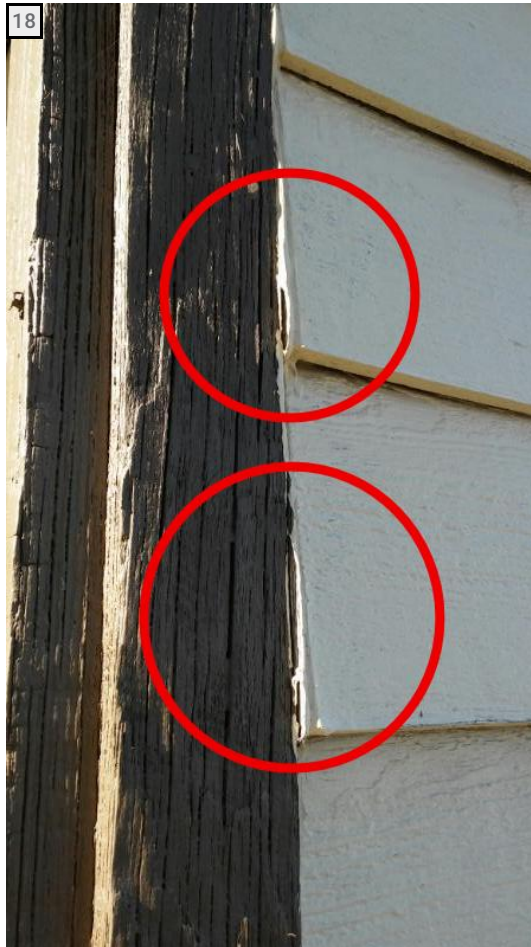
Location	Exterior: Ground View
Impact	The gaps provide no protection against insect intrusion and adversely affect the thermal barrier of the home, potentially increasing utility costs
Suggested Action	Have repaired by a licensed siding contractor
Other Information	Observed several affected areas.

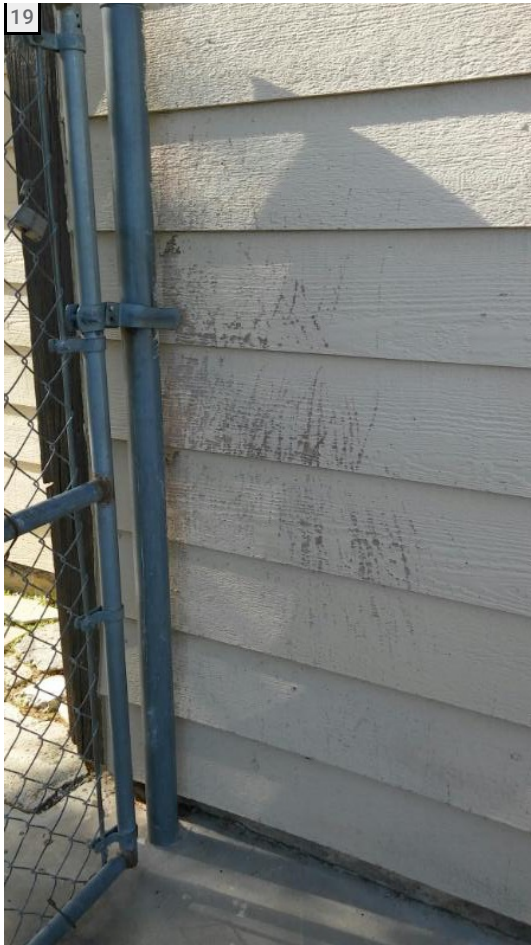
Mechanically damaged

Location	Exterior: Ground View
Suggested Action	Have a professional siding contractor repair the siding
Other Information	Mechanical damage can be caused by balls, stones, ladders, children, and/or pets

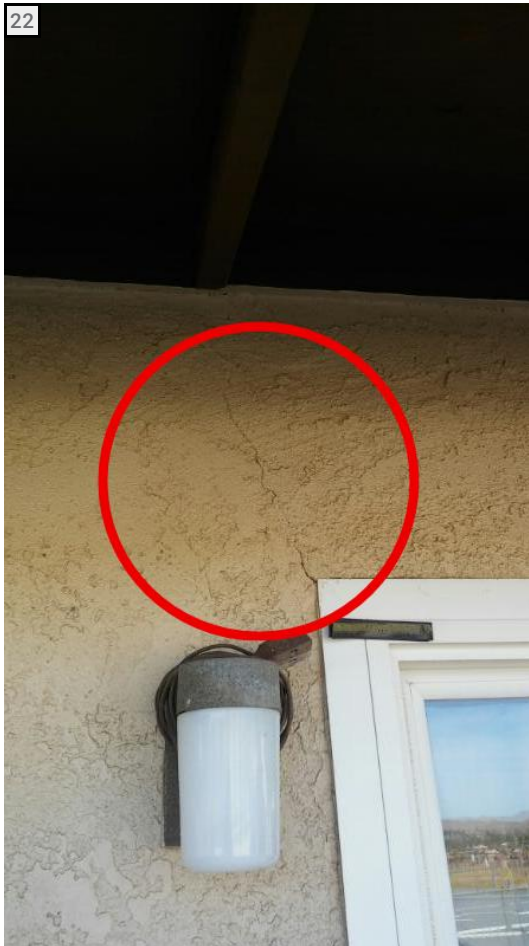
Stucco is cracked

Location	Exterior: Ground View (Master bedroom sliding door top)
Impact	Cracked stucco may allow for moisture and insect intrusion
Suggested Action	Have a licensed stucco contractor repair the affected areas
Other Information	Observed several affected areas

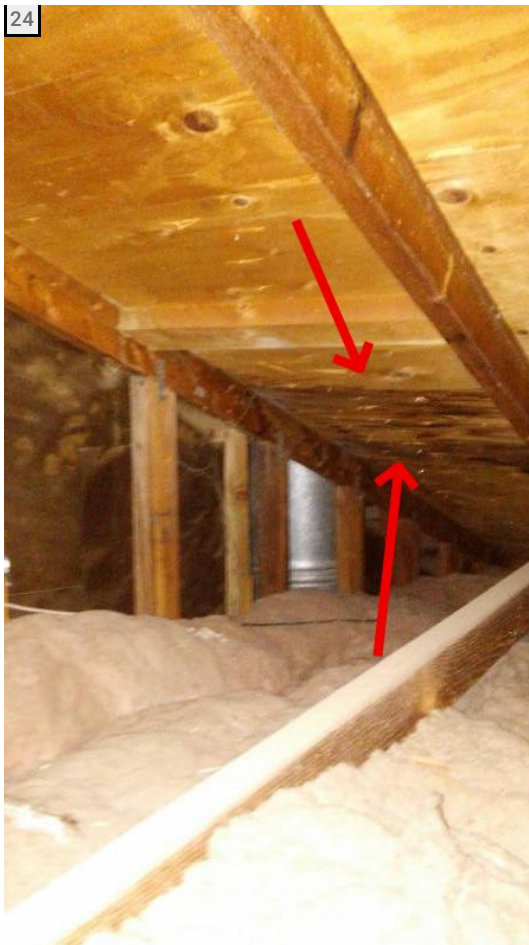
**Roof Sheathing****Possible Concern****Shows signs of past leakage**

Location	Attic
Impact	If leaking is current, the sheathing may become damaged to continued moisture intrusion
Suggested Action	Monitor for further leaking. Should any occur, consult with a roofing professional for suggested repairs

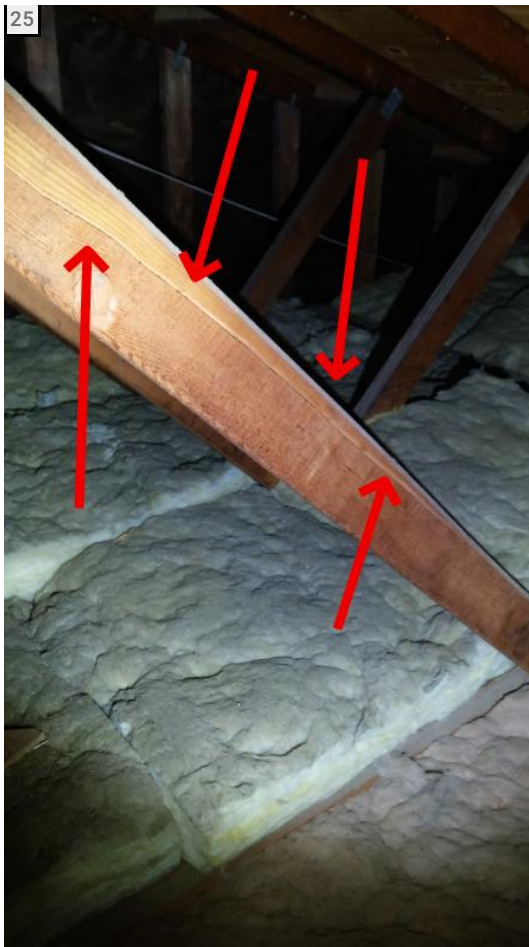
Cracked

Location	Attic
Impact	Any damage in the truss reduces the structural integrity of the truss system
Suggested Action	Repair or replace by a professional building contractor
Other Information	The truss is manufactured with load tolerances specific to each roof design

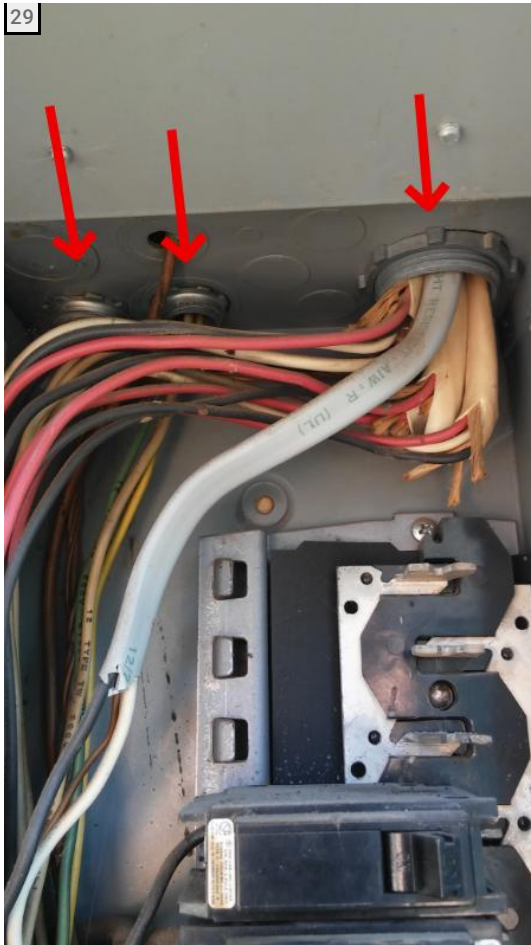
Location	Exterior: Ground View
Impact	wiring, cable, conductors, are subject to physical damage as a result of abrasion
Suggested Action	Have evaluated by a licensed electrician

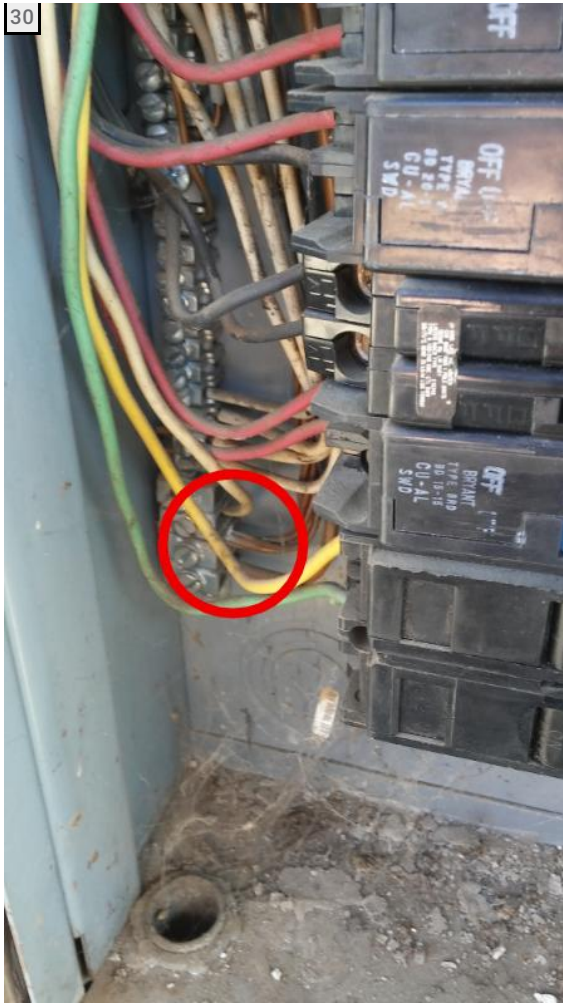
One or more ground wires are incorrectly connected under a single screw on the grounding or neutral bus bar at the panel.

Suggested Action Have evaluated by a qualified electrician

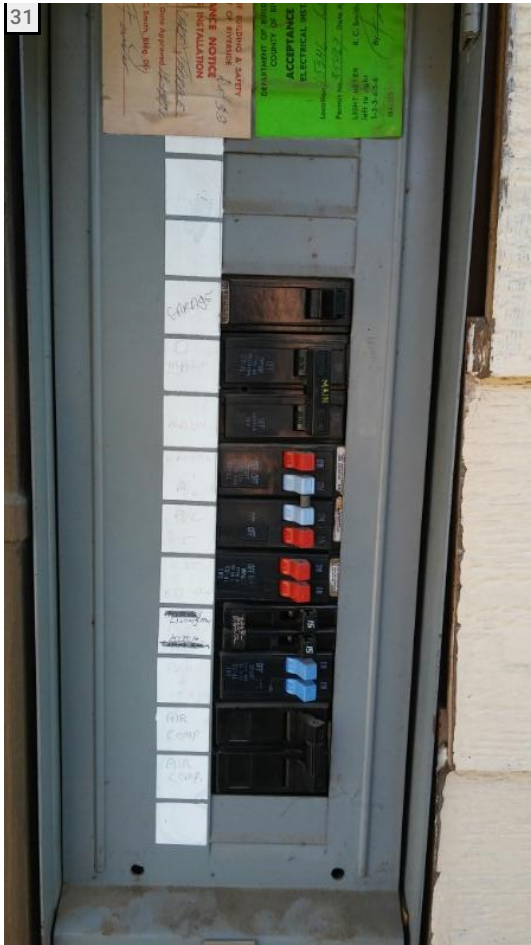
Observed panel circuit labeling is missing or illegible

Location	Exterior: Ground View
Impact	With missing or illegible panel circuit labeling, it is difficult to determine the assignment of the circuit breakers
Suggested Action	Have a qualified person Label the circuit breakers

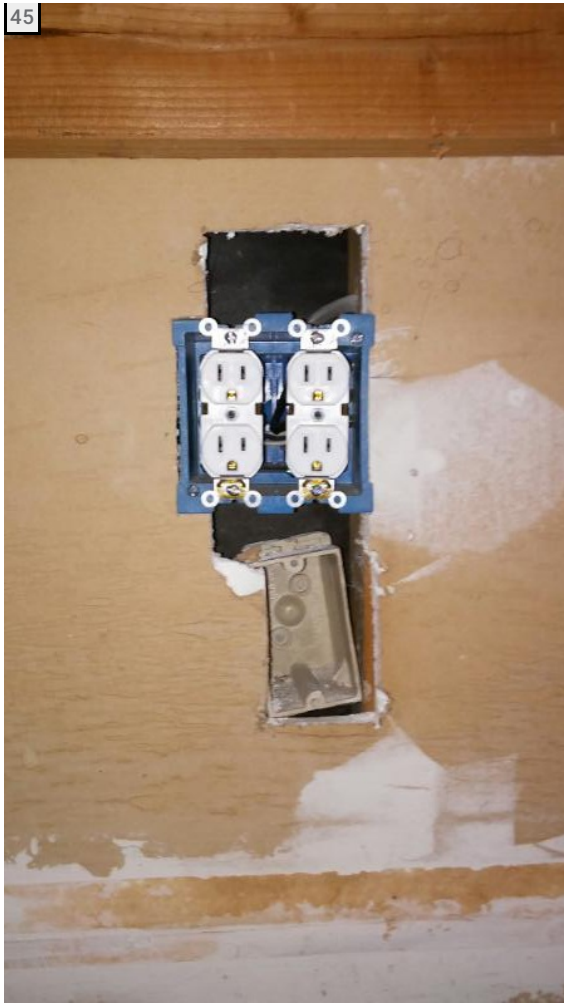
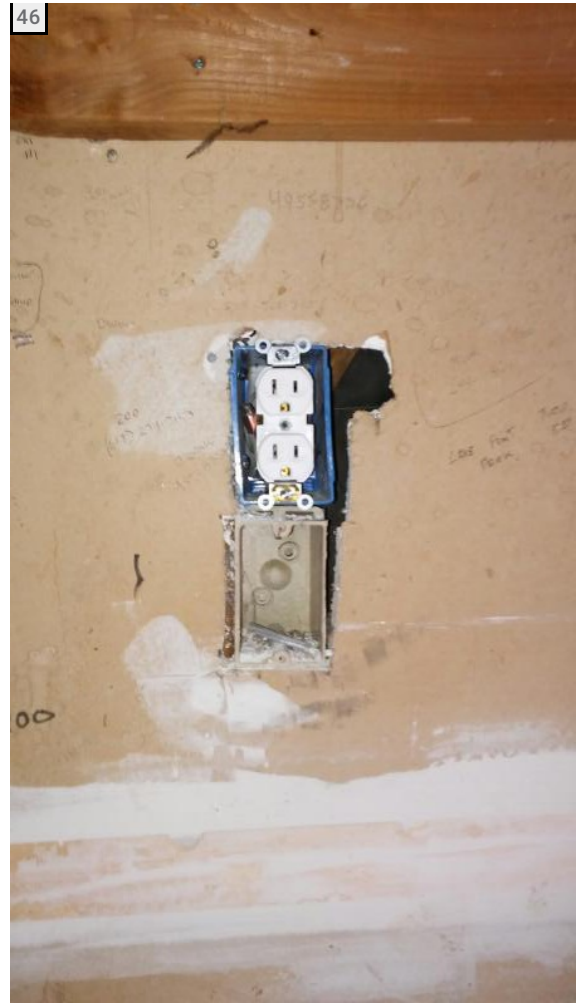
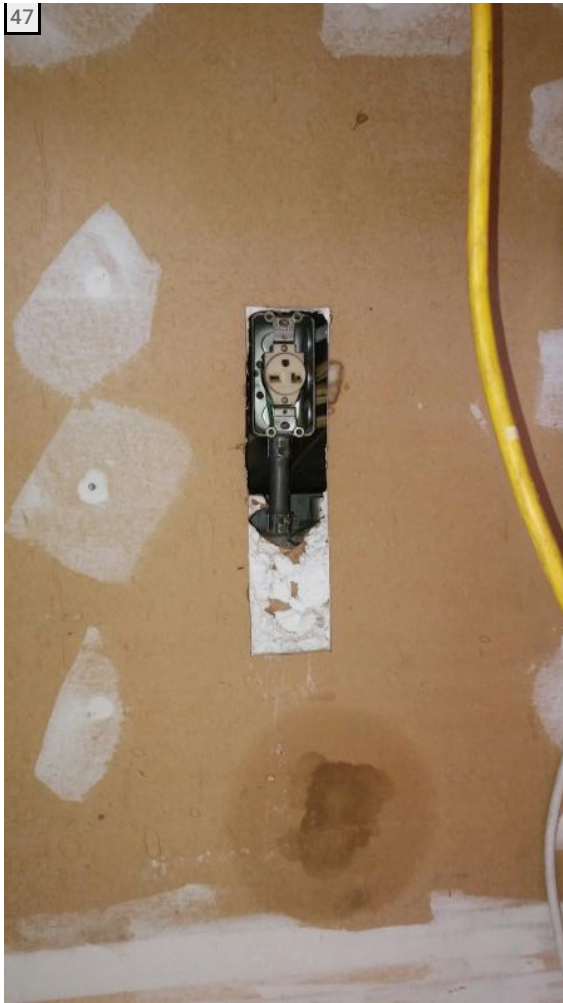
Safety Concern

Location	Attached Garage
Impact	Without a cover plate, can cause electrical shock if touched
Suggested Action	Install a cover

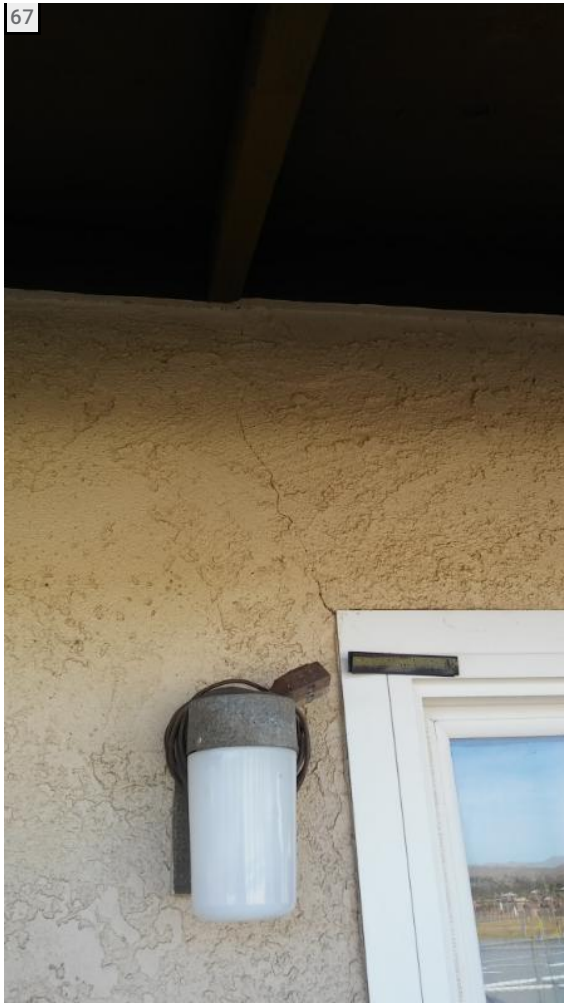
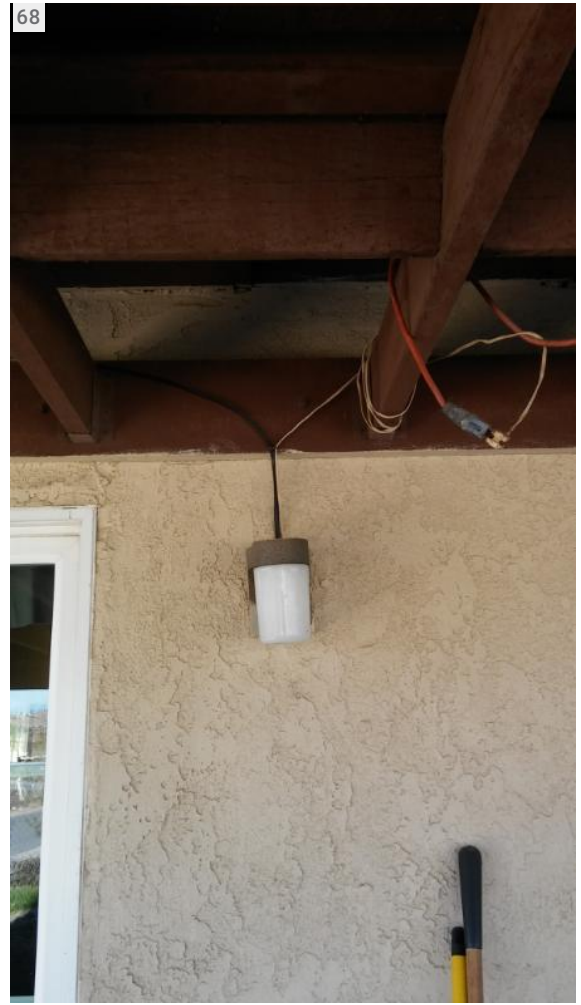
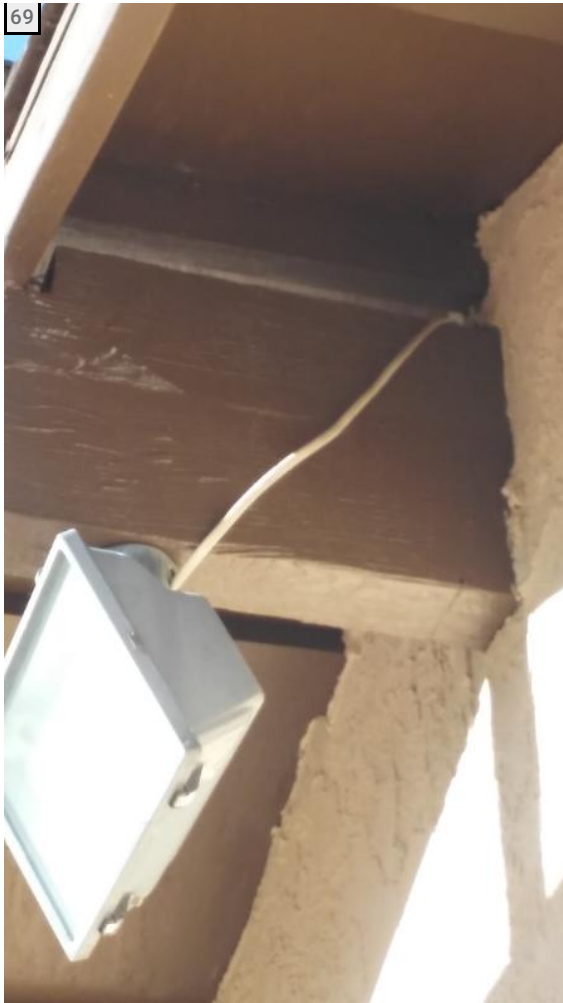
Location	Exterior: Ground View
Impact	Exposed wiring can cause electrical shock
Suggested Action	Have evaluated by a licensed electrician

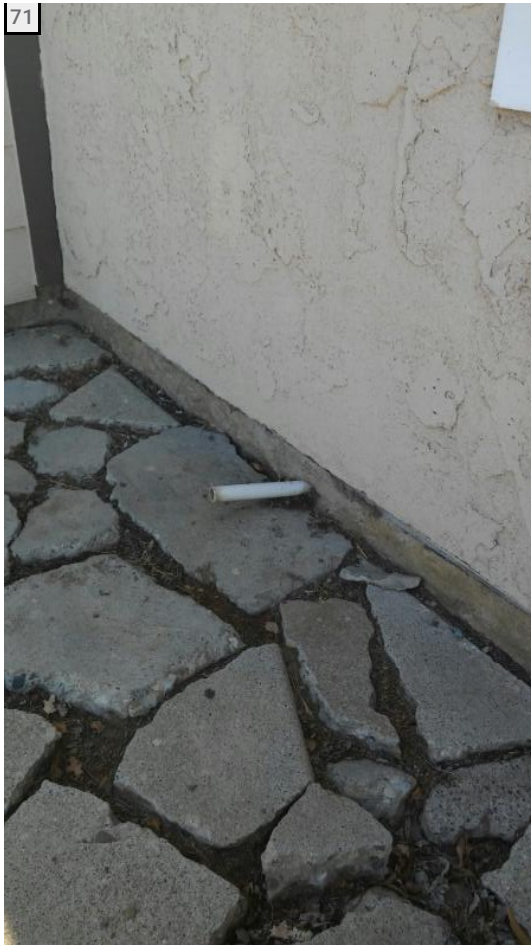
Location	Exterior: Ground View
Impact	This angle may prevent the discharge tube from draining, causing mold build-up
Suggested Action	Reposition on a downward slope to ensure proper drainage

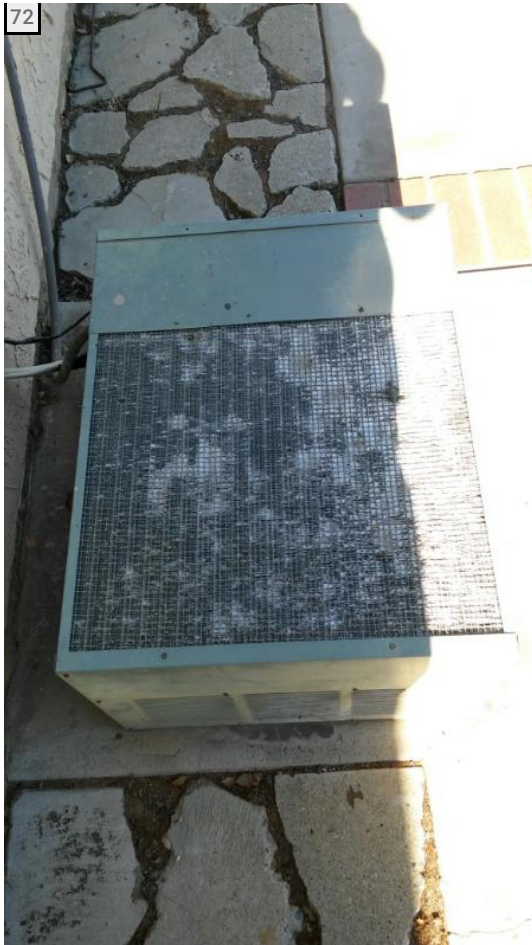
Condenser fins are damaged

Location	Exterior: Ground View
Impact	Damaged fins restrict the amount of air flow over the condensing coil. If less air flows over the coil, less heat is removed. That means the whole cycle warms up a bit, and your AC works harder to keep your home cool
Suggested Action	Have serviced by an HVAC service professional
Other Information	The fins on a condenser allow air to flow smoothly through and out of an air conditioner

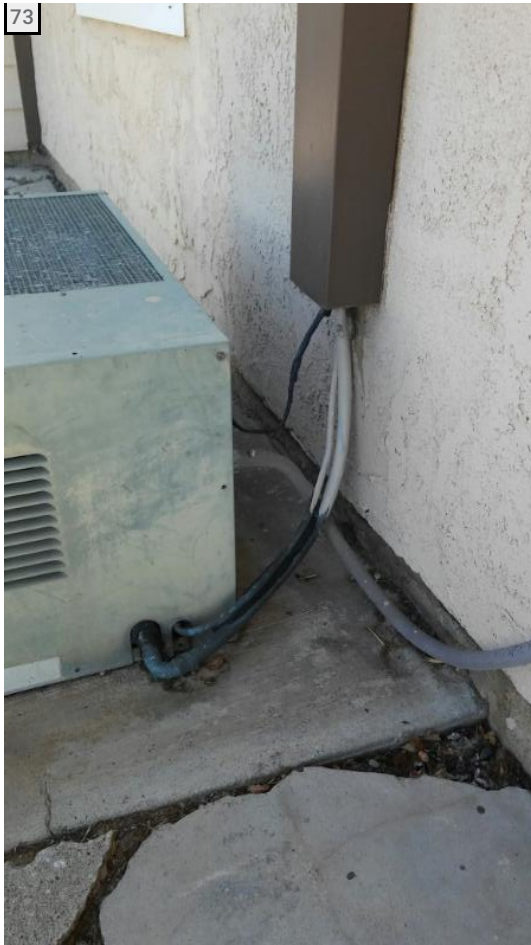
Insulation is missing

Location	Exterior: Ground View
Impact	Without insulation the warmer air may create condensation on the suction line which could damage the surrounding area and/or create a slipping hazard. In addition, by warming the refrigerant, operating efficiency is reduced
Suggested Action	Insulate the suction line with 3/4 to 1 inch vapor-proof insulation

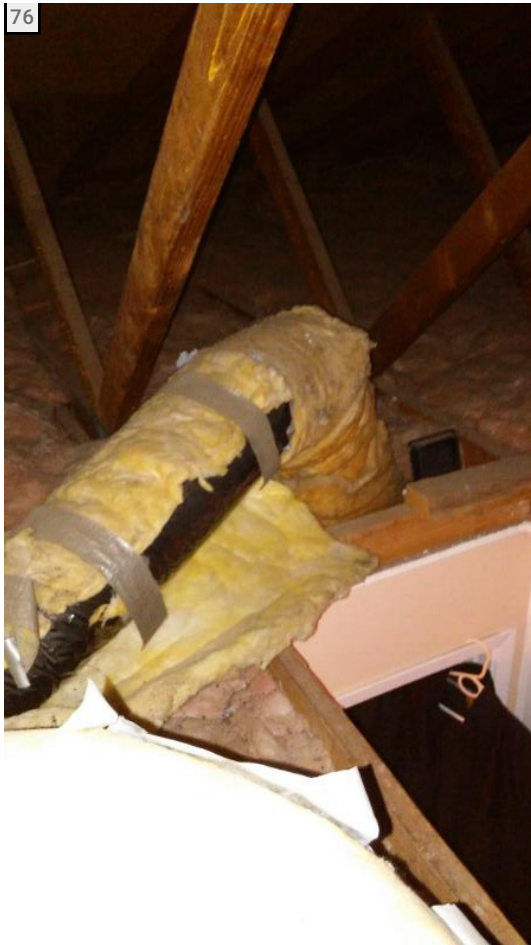
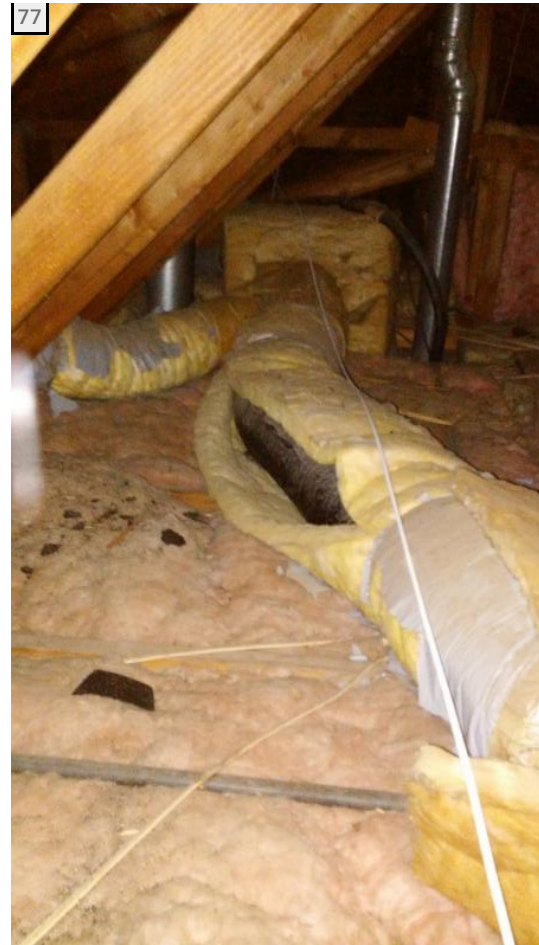
Location	Attic
Impact	Uninsulated ducts traveling through unconditioned spaces create condensation both inside and outside of the ducts
Suggested Action	Add insulation or replace with insulated ductwork

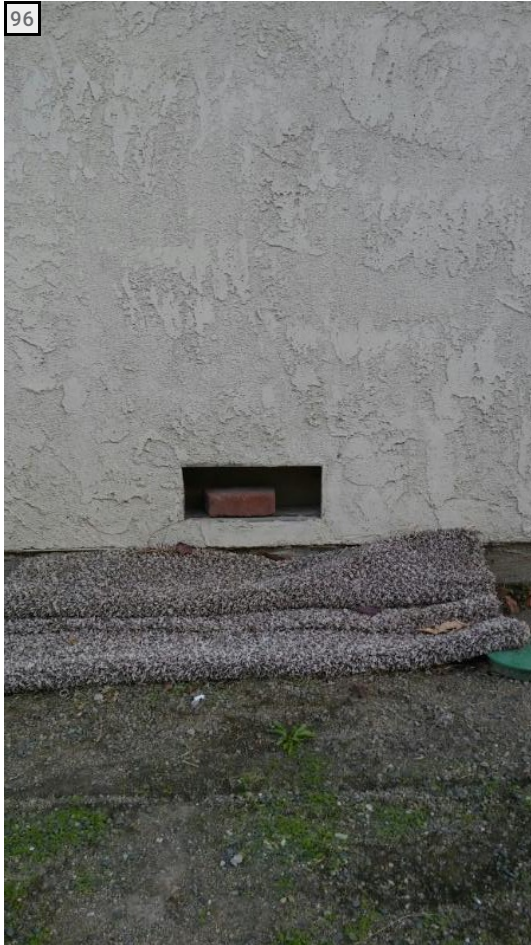
Vent screen missing

Location	Attached Garage
Impact	Rodent intrusion
Suggested Action	Install vent screen

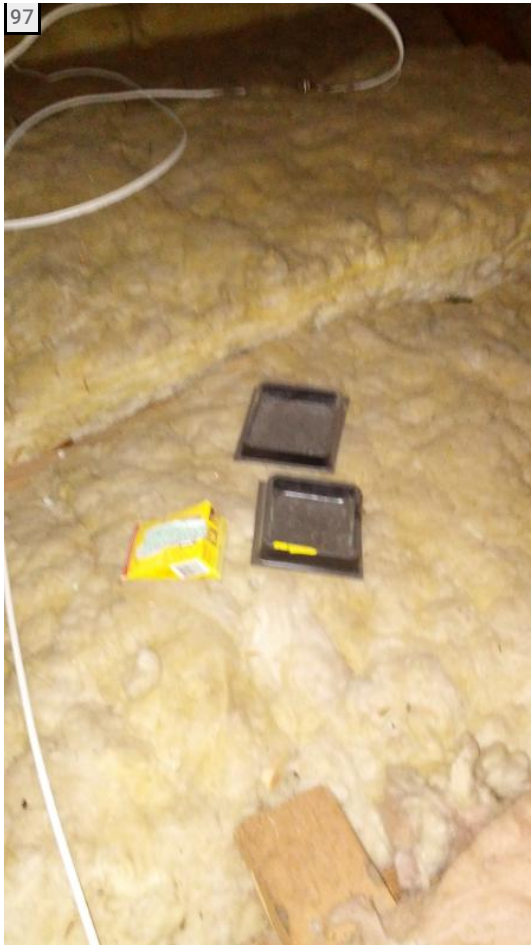
Observed suggestions of pest infestation

Location	Attic
Impact	Rodents and other pests can damage building materials and/or promote unhealthful conditions
Suggested Action	Have a pest control company evaluate for treatment

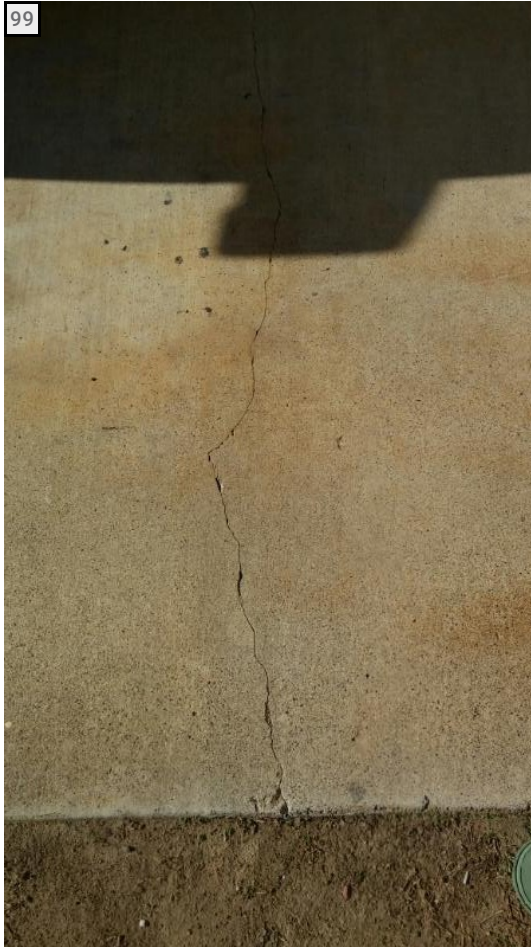
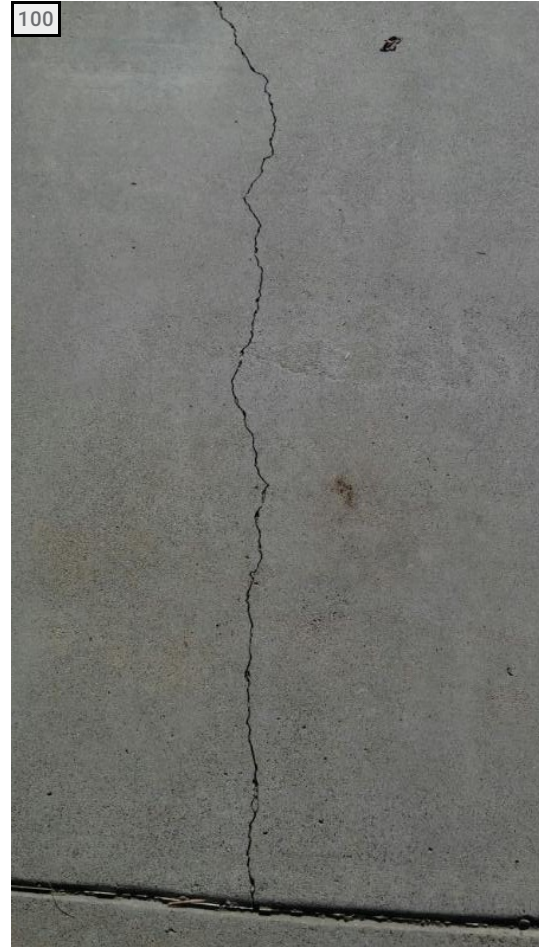
Location	Exterior: Ground View
Impact	The cracks allow for water intrusion, which may cause the surrounding surfaces to also deteriorate possibly requiring a complete driveway replacement
Suggested Action	Seal the crack(s) with weather-resistant pliable concrete sealer

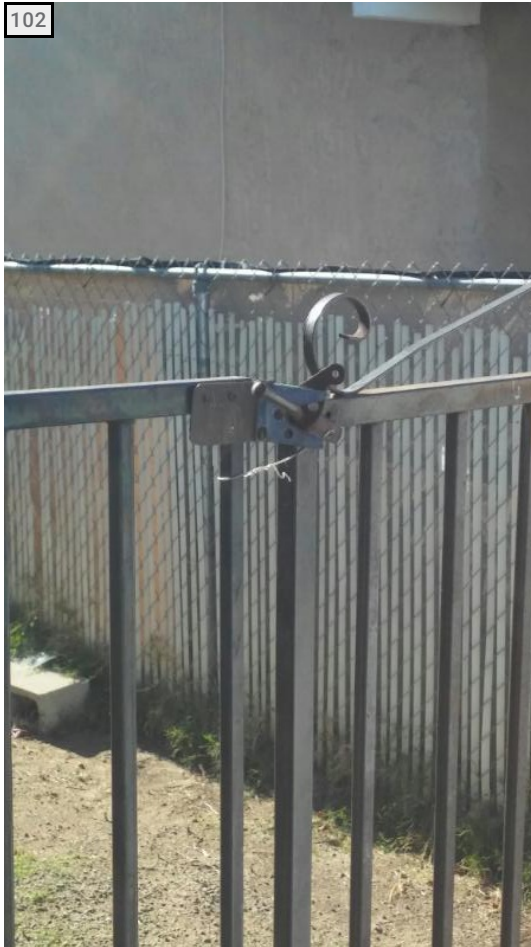
Location	Exterior: Ground View
Suggested Action	Repair the gate

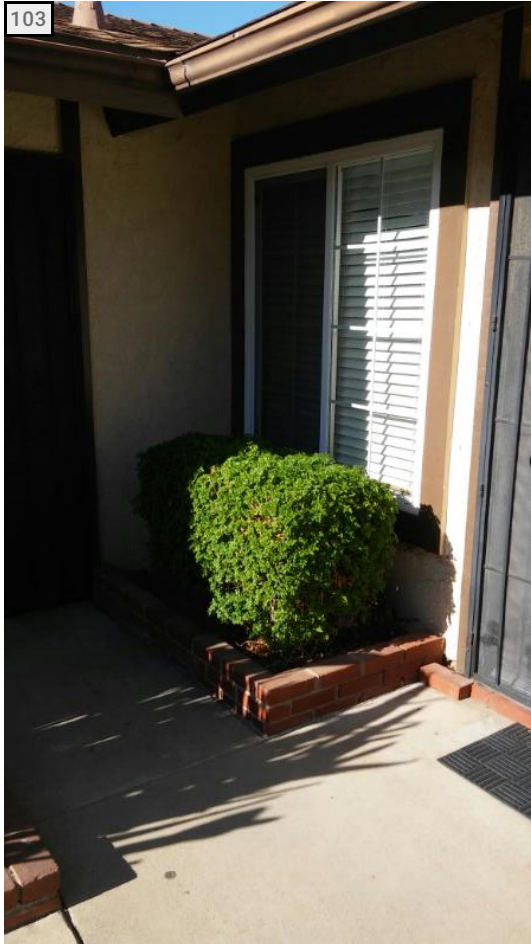
Location	Exterior: Ground View
Impact	The shrubbery provides an environment where moisture and/or insects could intrude
Suggested Action	Regularly trimm the shrubbery to achieve a clearance of at least 6 - 8 feet

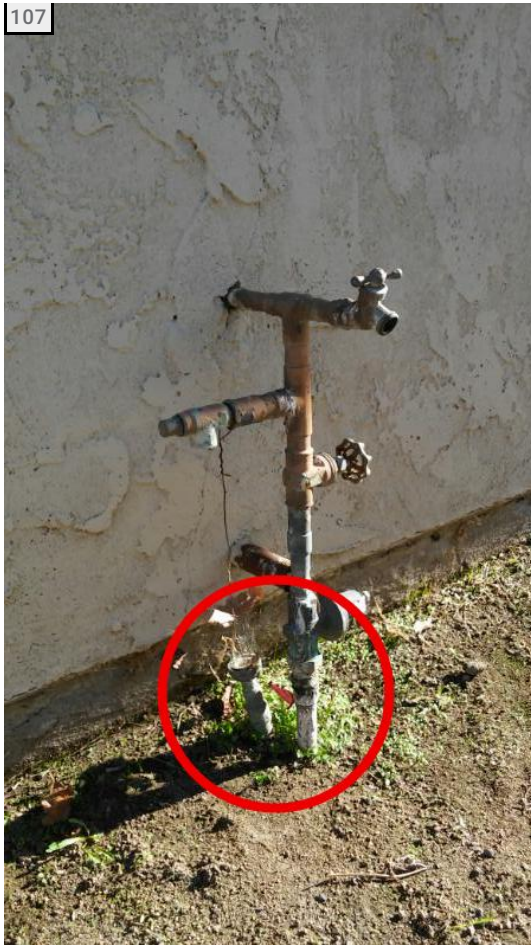
Location	Exterior: Ground View
Impact	Improper repairs may contribute to poor functioning or failure
Suggested Action	Suggest evaluation by licensed plumber.

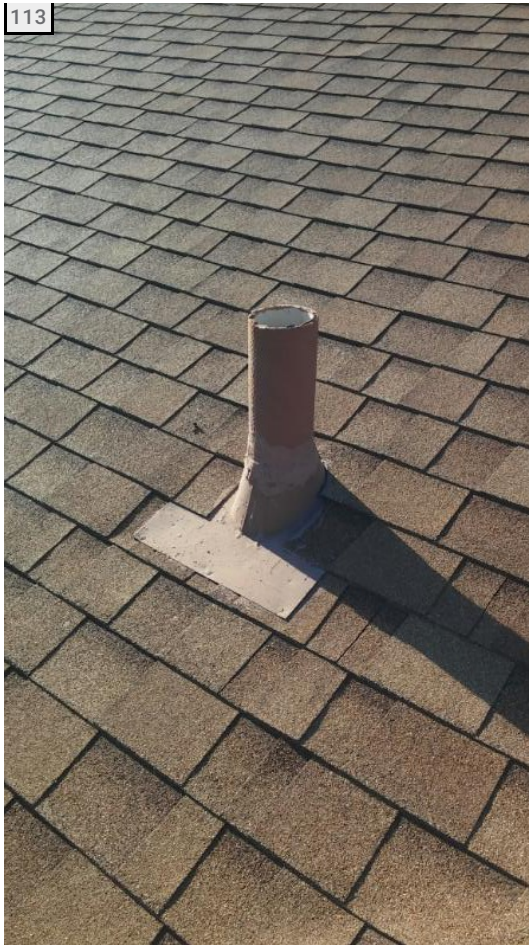
Missing "B" vent Cap

Location	Exterior: Roof View
Impact	Vent cap helps prevent rain and debris from entering the vent
Suggested Action	Install "B" vent cap

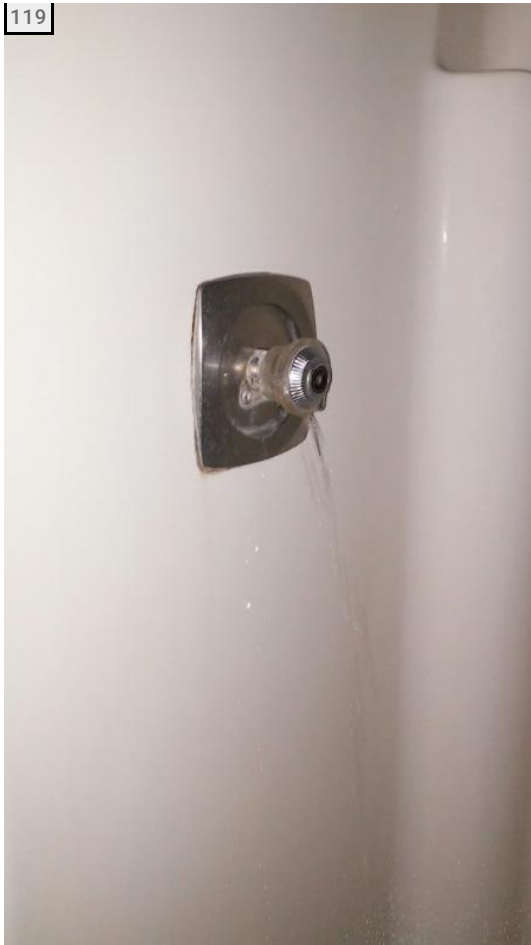
Location	Master Bathroom
Impact	The leak may cause excessive water usage
Suggested Action	Repair the handle valve or replace the entire faucet assembly

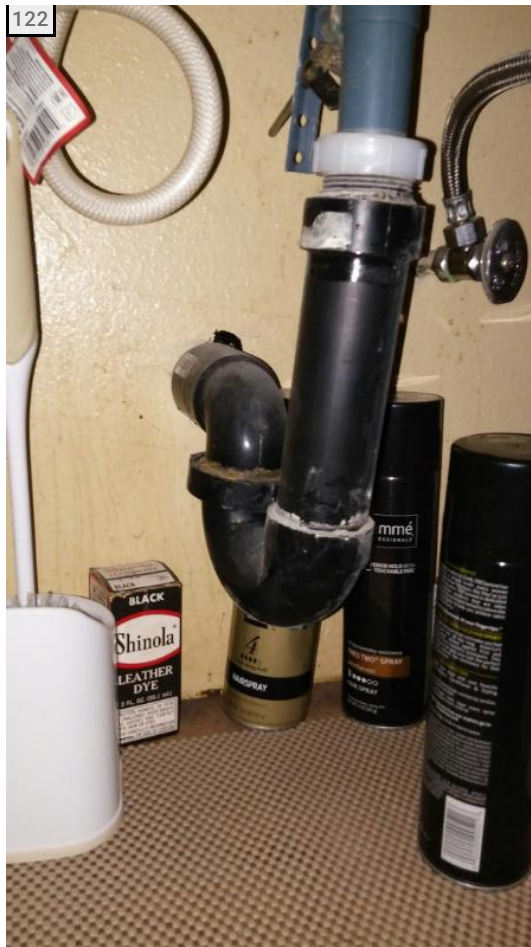
Location	2nd Bathroom
Impact	The corrosion may worsen and leak
Suggested Action	Have repaired by a plumber

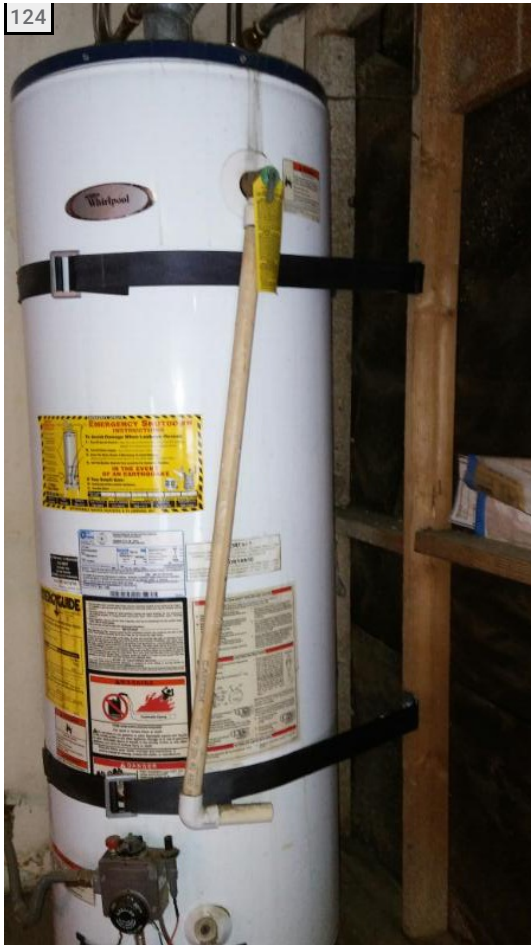
Location	Attached Garage
Impact	If the valve extension is higher than 6" from the floor and the valve trips, scalding hot water discharging could splash causing potential severe injury to those nearby
Suggested Action	Install a proper extension that terminates between 4 and 6" from the floor
Other Information	The relief valve should be piped to between 4 and 6" from the floor

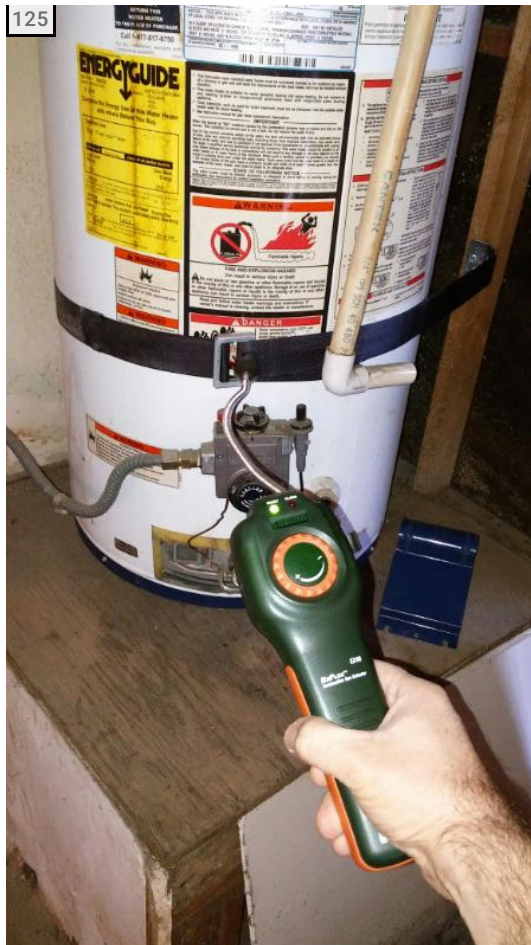
Observed minor gas leak at hot water heater.

Location	Attached Garage
Suggested Action	Recommend evaluation by licensed plumber.

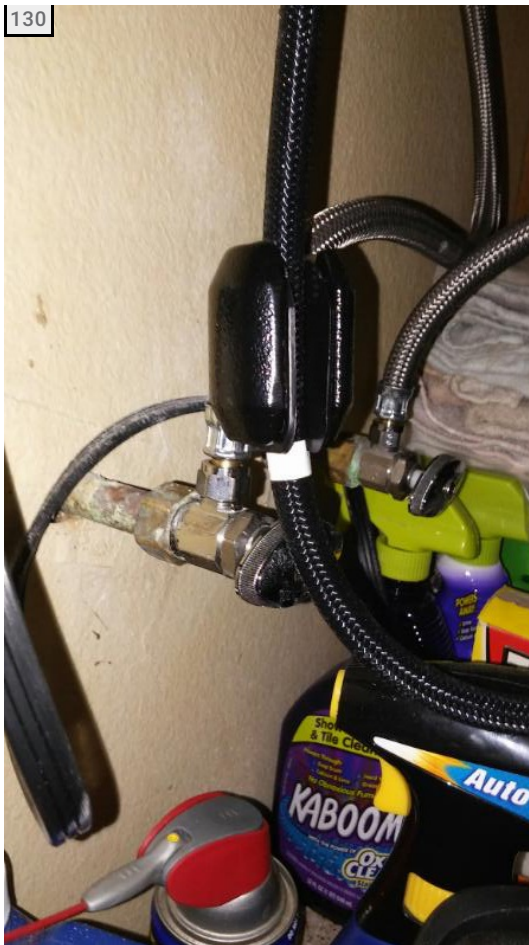
Location	Kitchen
Impact	Corrosion can indicate prior leaks and may indicate the possibility of future leaks
Suggested Action	Have evaluated by a licensed plumber

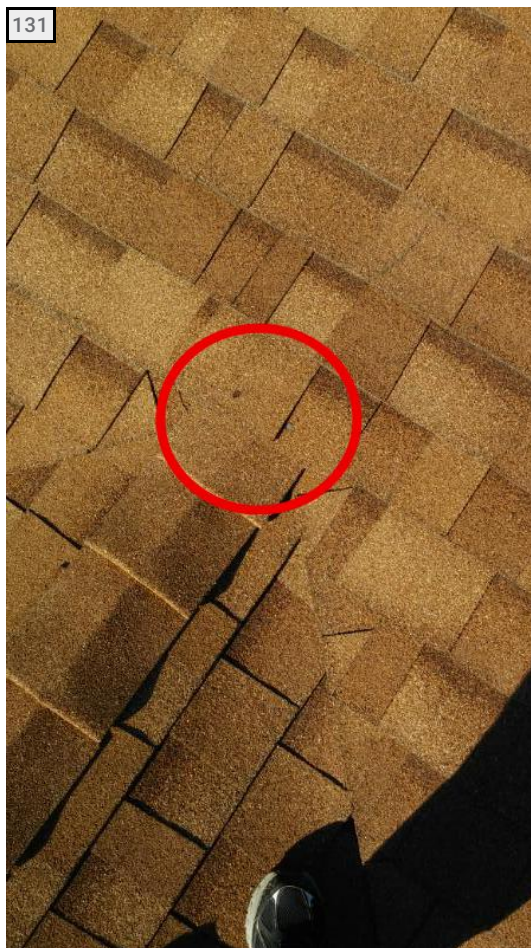
Other Information Nail pops can be caused by a variety of reasons. When the temperature changes, expansion and contraction can cause the nails to pop up and lift the shingles. It may also be caused by inadequate ventilation. Other causes of nail pops can be that the shingles were not nailed tightly when the roof was installed
