Veritas Property Inspection

Inspection Report

**1234 Safe Harbor Dr
Pleasantville, California 95555**

Inspection Date January 27, 2018
Client John Doe
Inspector Nicholas Peres, CPI
P.O. Box 1004
Lake Elsinore, CA 92530
(951) 230-5831
veritasproinspect@gmail.com
interNACHI, Infrared, IAC2 Mold Certified

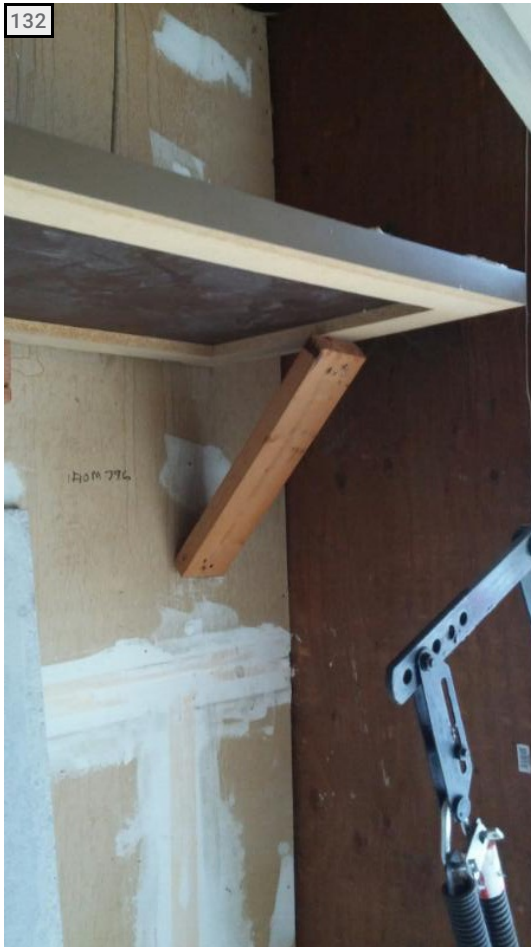
Location	Attached Garage
Suggested Action	Recommend evaluation by licensed Carpenter.

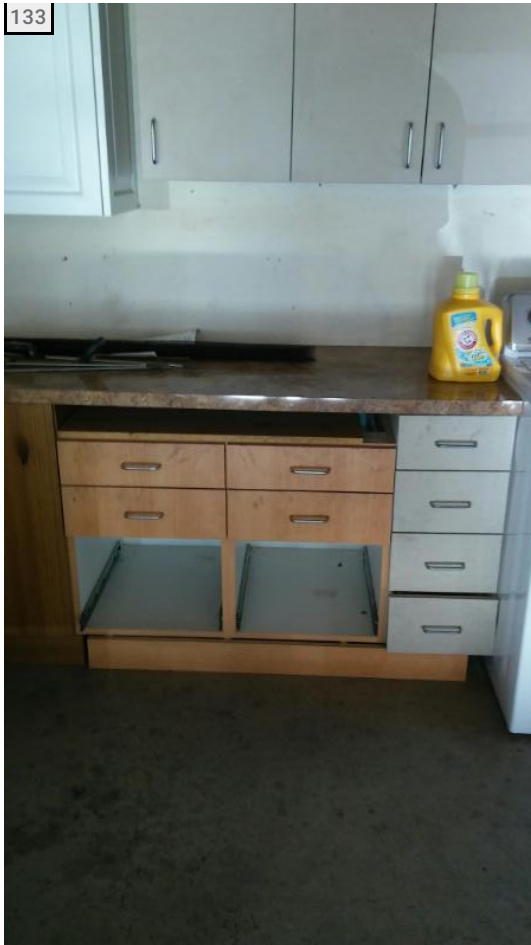
Drawer front is missing

Location	Attached Garage
Impact	The missing front renders the cabinet drawer unusable
Suggested Action	Install a drawer front

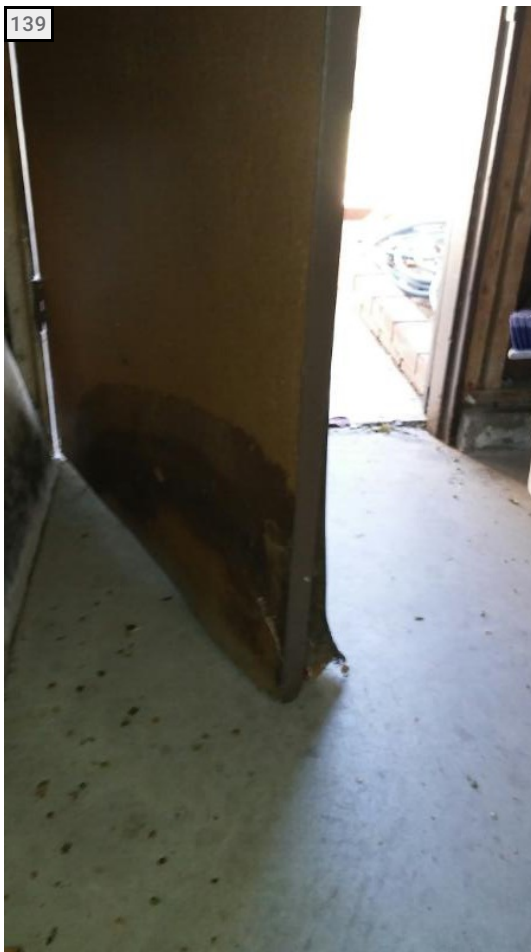
Location	Exterior: Ground View (Garage man door)
Suggested Action	Repair the damage or replace the door depending on your preference

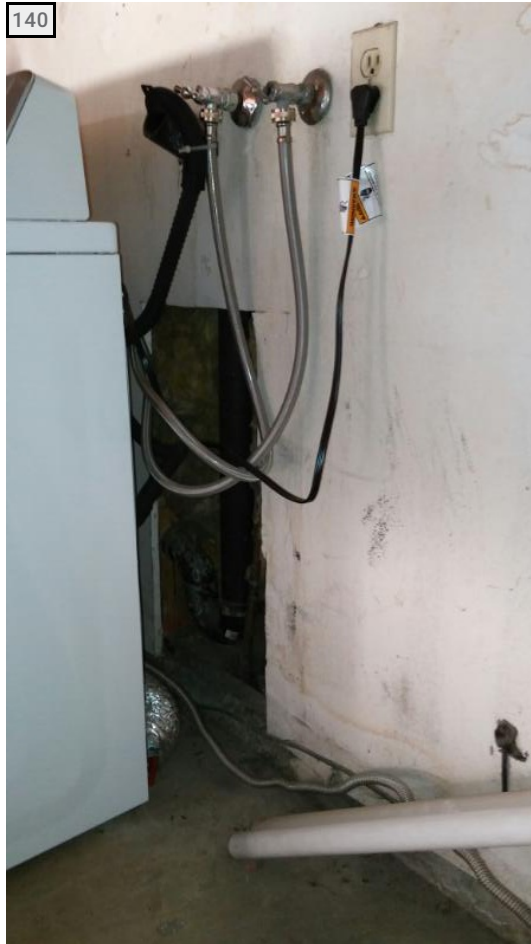
Location	Attached Garage
Impact	Should a fire ignite in the garage, the fire will spread more quickly to the living areas of the home
Suggested Action	Repair the damaged areas with fire-resistant material, such as drywall
Other Information	The firewall is intended to slow the spread of fire from the garage to the living space

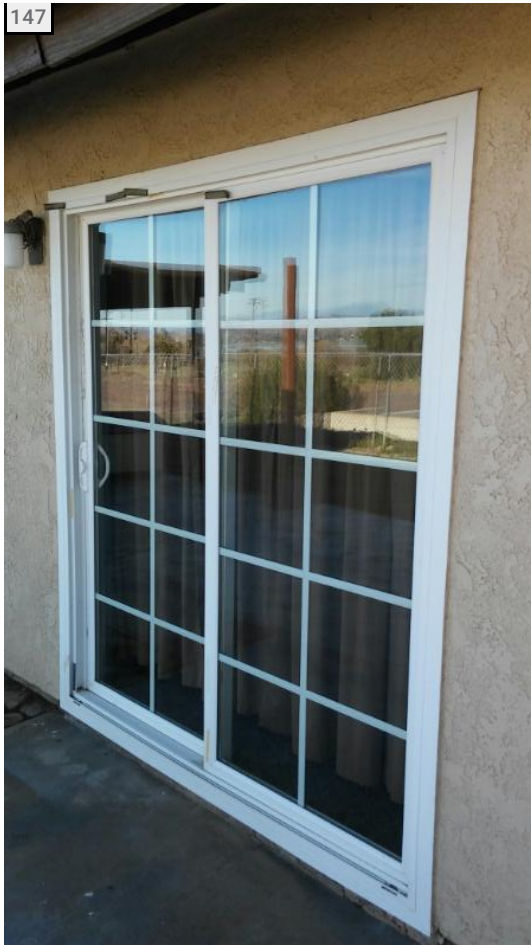
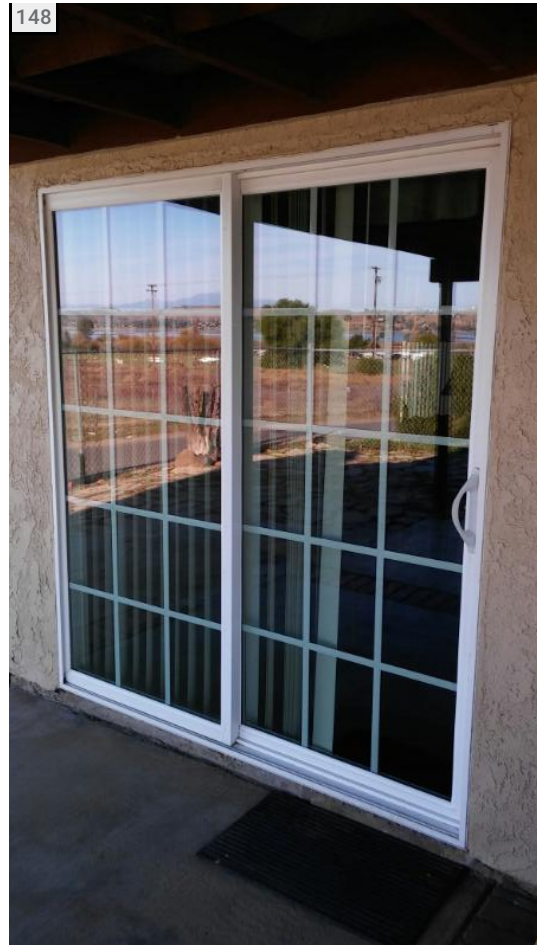
Location	Exterior: Ground View
Impact	Should the window be open, lacks protection from insects
Suggested Action	Consult with seller to identify if screens exist. If they do not, install screens as needed

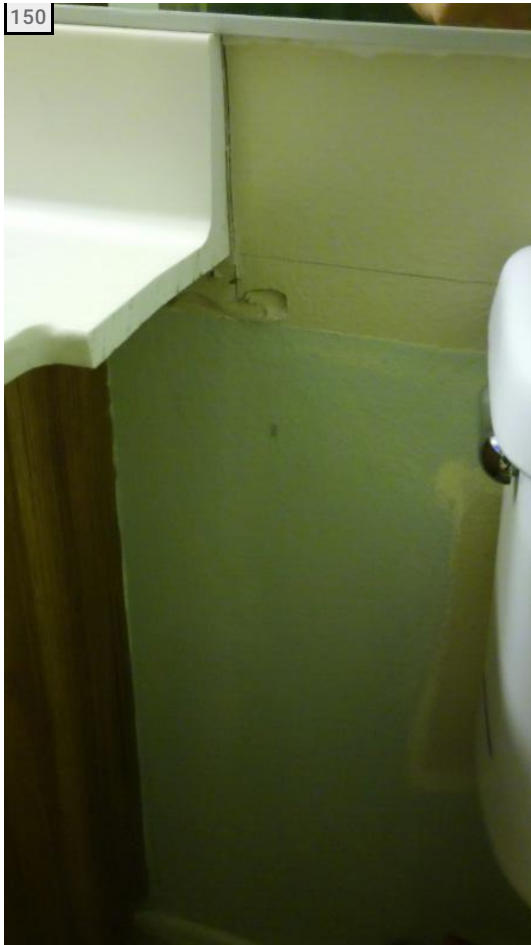
Location	Master Bathroom
Impact	Beyond being an aesthetic issue, the lack of the gaps in the wall affect the thermal boundary of the home
Suggested Action	Replace the damaged areas of the wall
Other Information	The finished aspect of the wall is a component in creating a thermal boundary of a home which controls the transfer of energy (heat) between the interior and the exterior

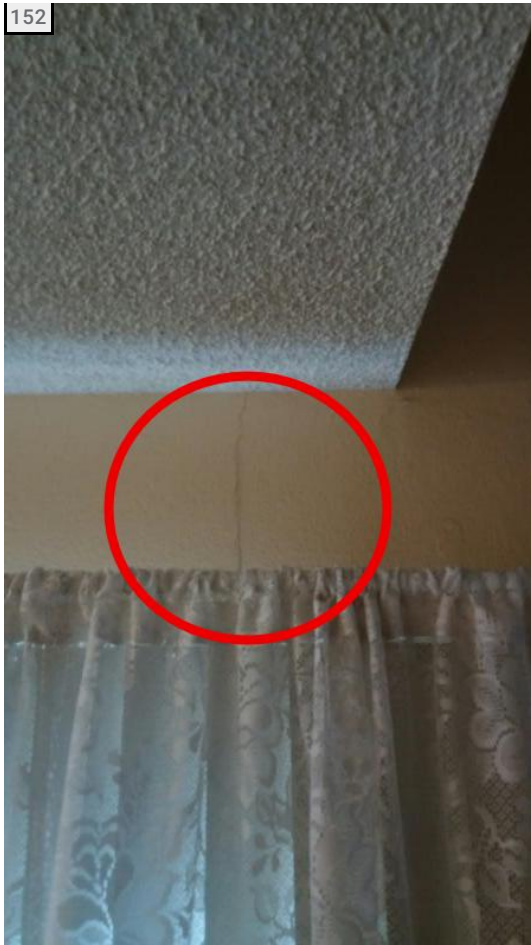
Location	Living Room
Suggested Action	Repair with drywall tape and drywall compound and repaint
Other Information	Observed throughout home
