An assessment of fungal growth and moisture distribution at

## DEVIZES ASSIZE COURT

### INTRODUCTION

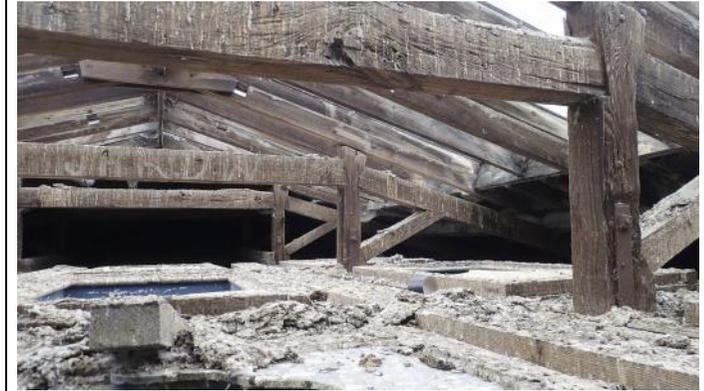
1

The significant degree of decay initiated in the ceiling structure is the result of water ingress through damaged rooflights. The principal roof structure-composed of four trusses-has not suffered to the same extent as it bears on the masonry wall heads which are approximately 500 mm above the line of the ceiling.

However, some of the truss connections, mainly the purlin- principal rafter connections, have been affected by decay, where water has run over the top of them (from the defective rooflights). On the E elevation there is compression in the rafter plate below the second truss from the N which has caused it to drop slightly at this point.

All bar two small areas, most of the water ingress appears to have been stopped for the time being.

There is still a possibility that the tie beams of the four principal trusses may have been compromised by decay mid span above the coffered ceiling, but this will only become apparent when the exposure of the damaged areas of the coffered ceiling is completed.

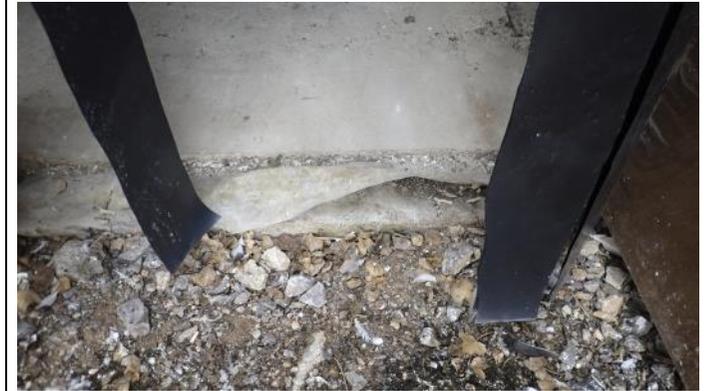
3

Photo 873 showing the relatively recent floor screed poured over the slab in the Entrance Hall.

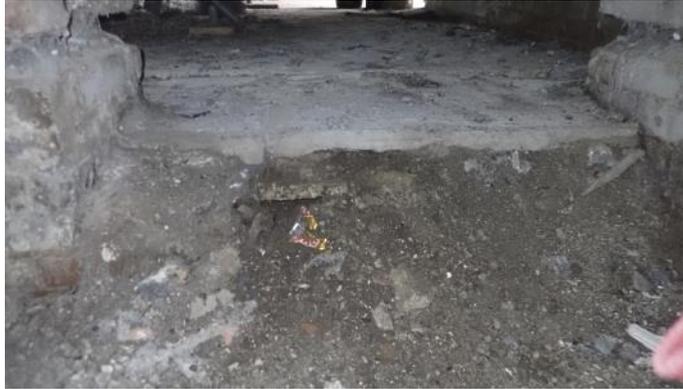
4  
 Photo 887 showing what appears to be relatively recent fill below the Entrance Hall slab. It may be that this is just a filler for the threshold – or that the entire Entrance Hall slab is a relatively recent addition.

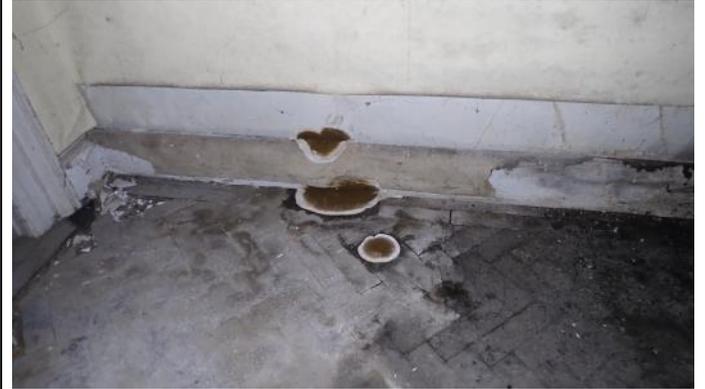
5  
 Photo 874 showing active growth of Dry rot below a point of water ingress through the roof. The fungus is decaying the skirting – and possibly other embedded timber – not the hardwood block floor. However, wetting and expansion of the wood block is causing it to lift.

There is some active dry rot fungal growth in the W Office. There is not much soft wood left at floor level for the fungus to attack-although if current conditions continue it will not be long before there are further outbreaks and decay to the small amount of softwood remaining in the rooms of the S elevation.

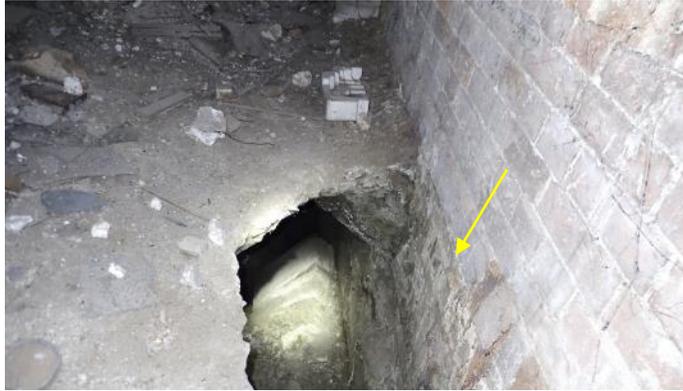
6  
 Photo 889 showing the footing of the S wall, where a hole has formed (or been made) in the sub base layer of the sub floor. The probable line of a physical damp proof course is arrowed.

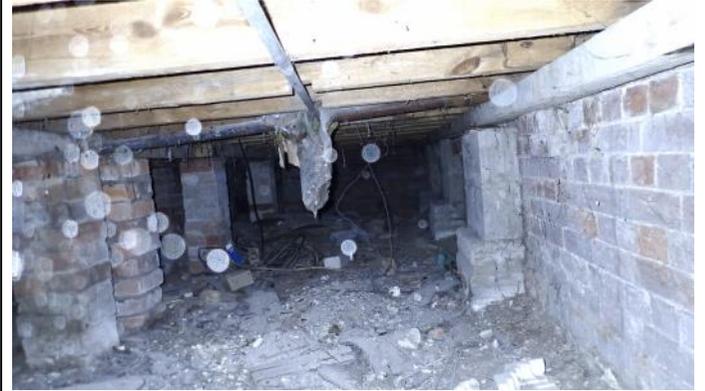
7  
 Photo 894 showing the arrangement of what is a relatively recent (and not well executed) floor construction. The general over site however seems dry.

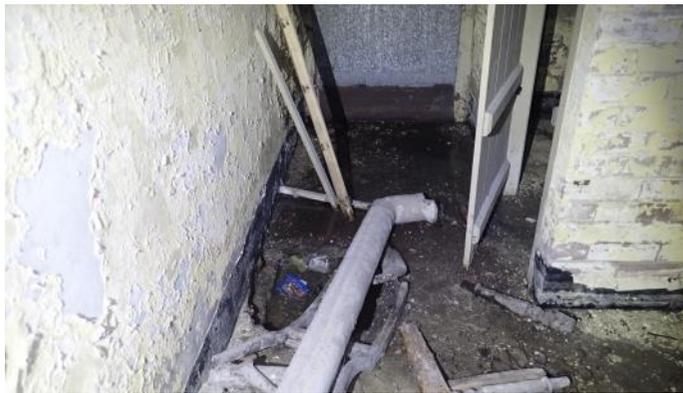
8  
 Photo 908 showing water coming into the cellar under the door. Damp shadows on the floor indicate the extent of standing water is occasionally much greater.

The environment of this building is further humidified by blocked drains in the light well and stairwell in the NW corner and the pre-existing cellar entry on the E elevation-observations 8 and 9 respectively.

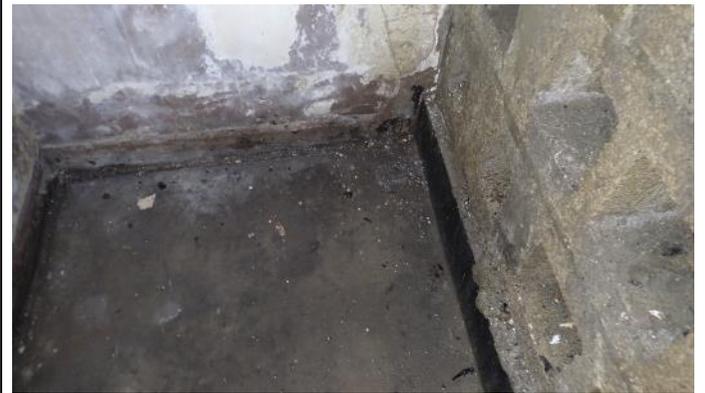
9  
 Photo 871 showing the loosely bricked up opening for what is assumed to be previous external stairs. Water is entering freely at this point – see ob 10 below.

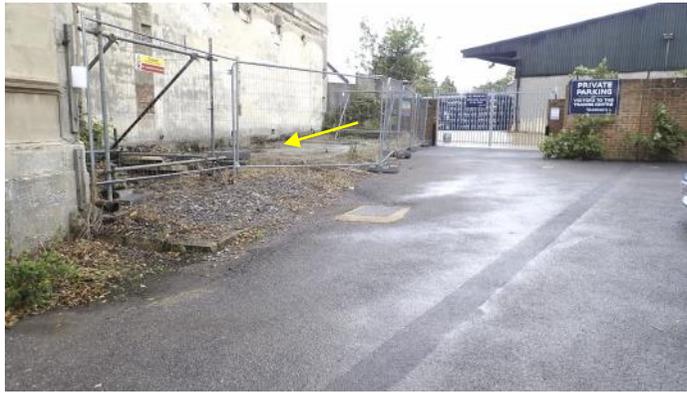
<p>10 Photo 902 showing where the external ground levels have risen over the years – with the arrow marking the point where water is finding its way – via the surface of the concrete slab – into the building envelope ob 9.</p>

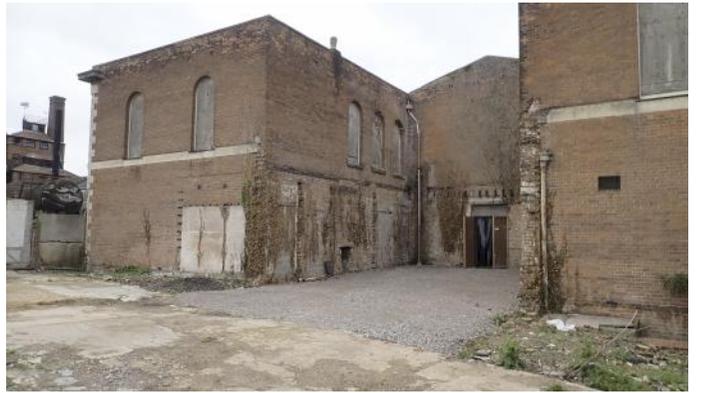
<p>11 Photo 863 showing the area left after removal of the flat roof. The sub base material will be acting as a sump, collecting water and channelling it into the wall bases.</p>

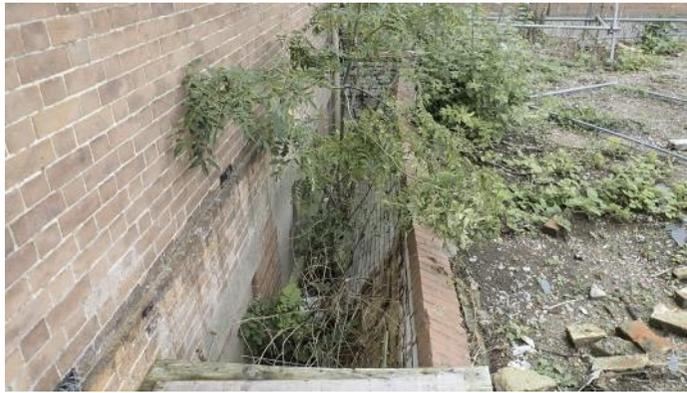
<p>12 Photo 862 showing the light well area to be over grown – the drains of which are almost certainly blocked.</p>

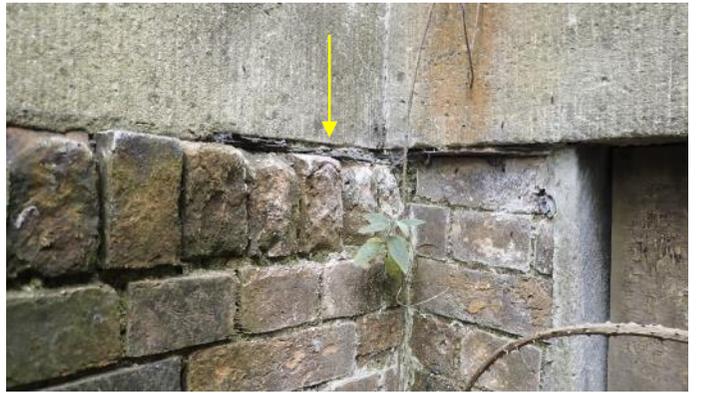
<p>13 Photo 861 showing a physical slate damp proof course between brick and facing stone – arrowed.</p>

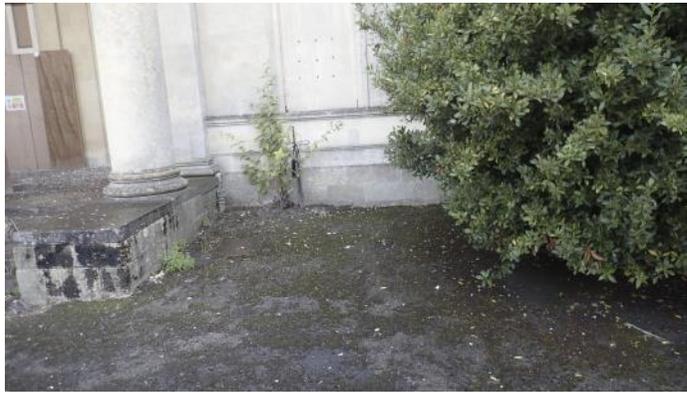
<p>14 Photo 899 showing the external ground levels adjacent to the portico. The arrow shown in ob 6 above is approximately 500mm below the top of tarmac which indicates external ground levels have risen along this elevation also.</p>

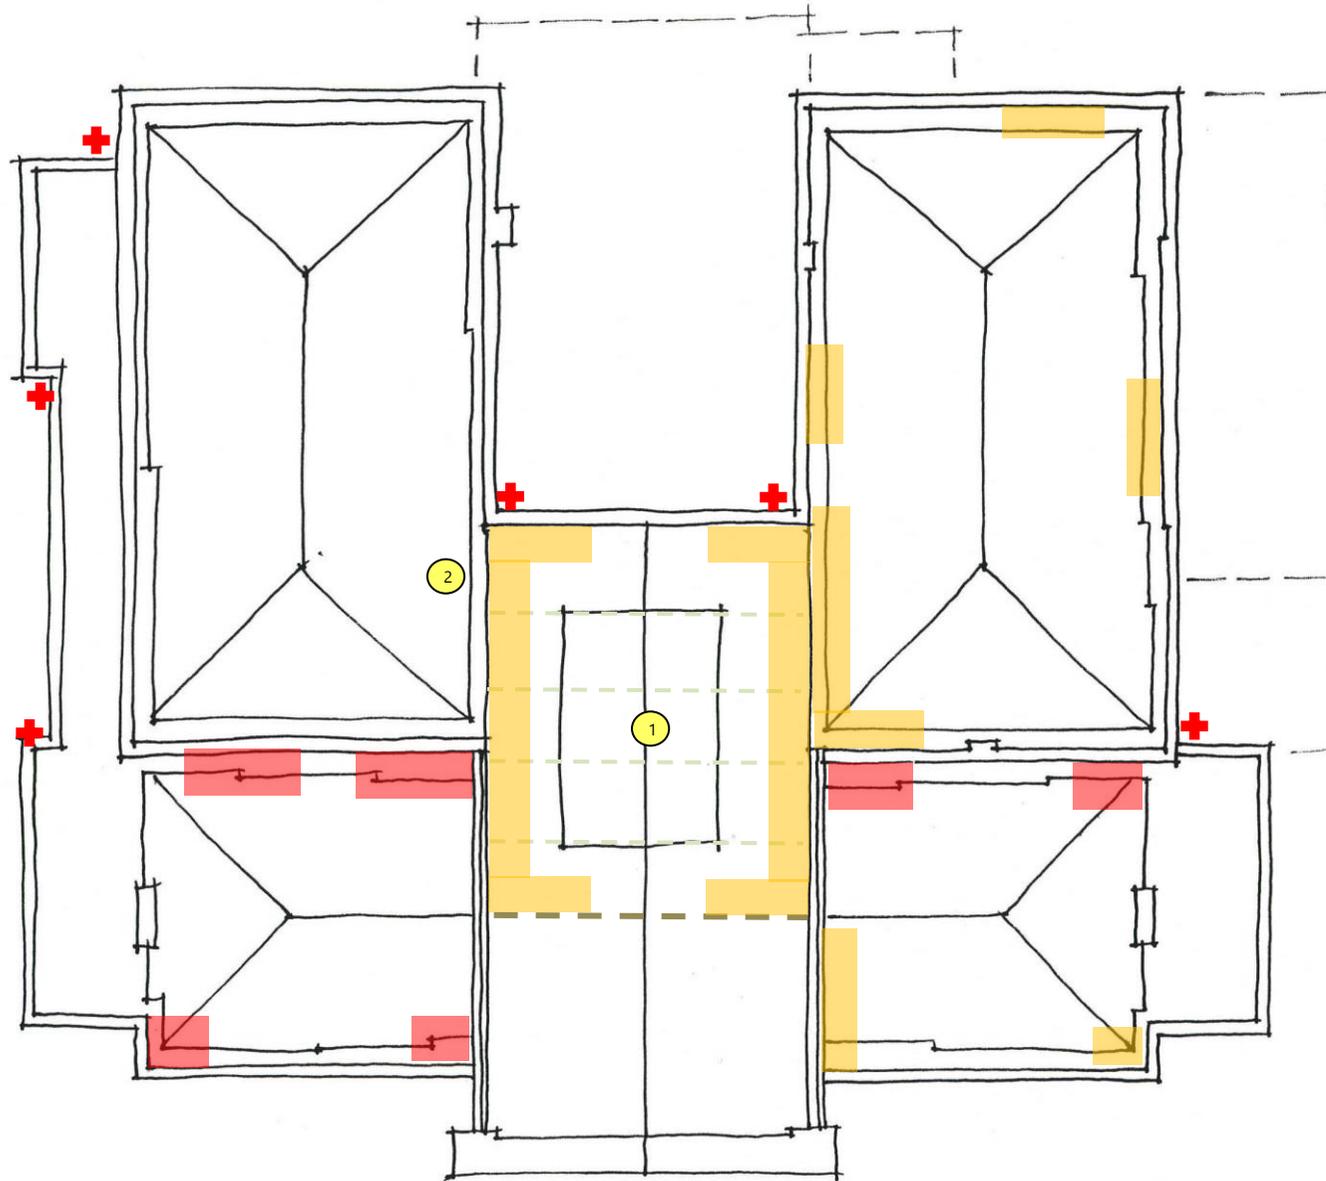
**Figure 1 – Roof**

Yellow shading indicates historic or inactive decay

Red shading indicates active wetting and decay.

Red crosses indicate downpipe positions.

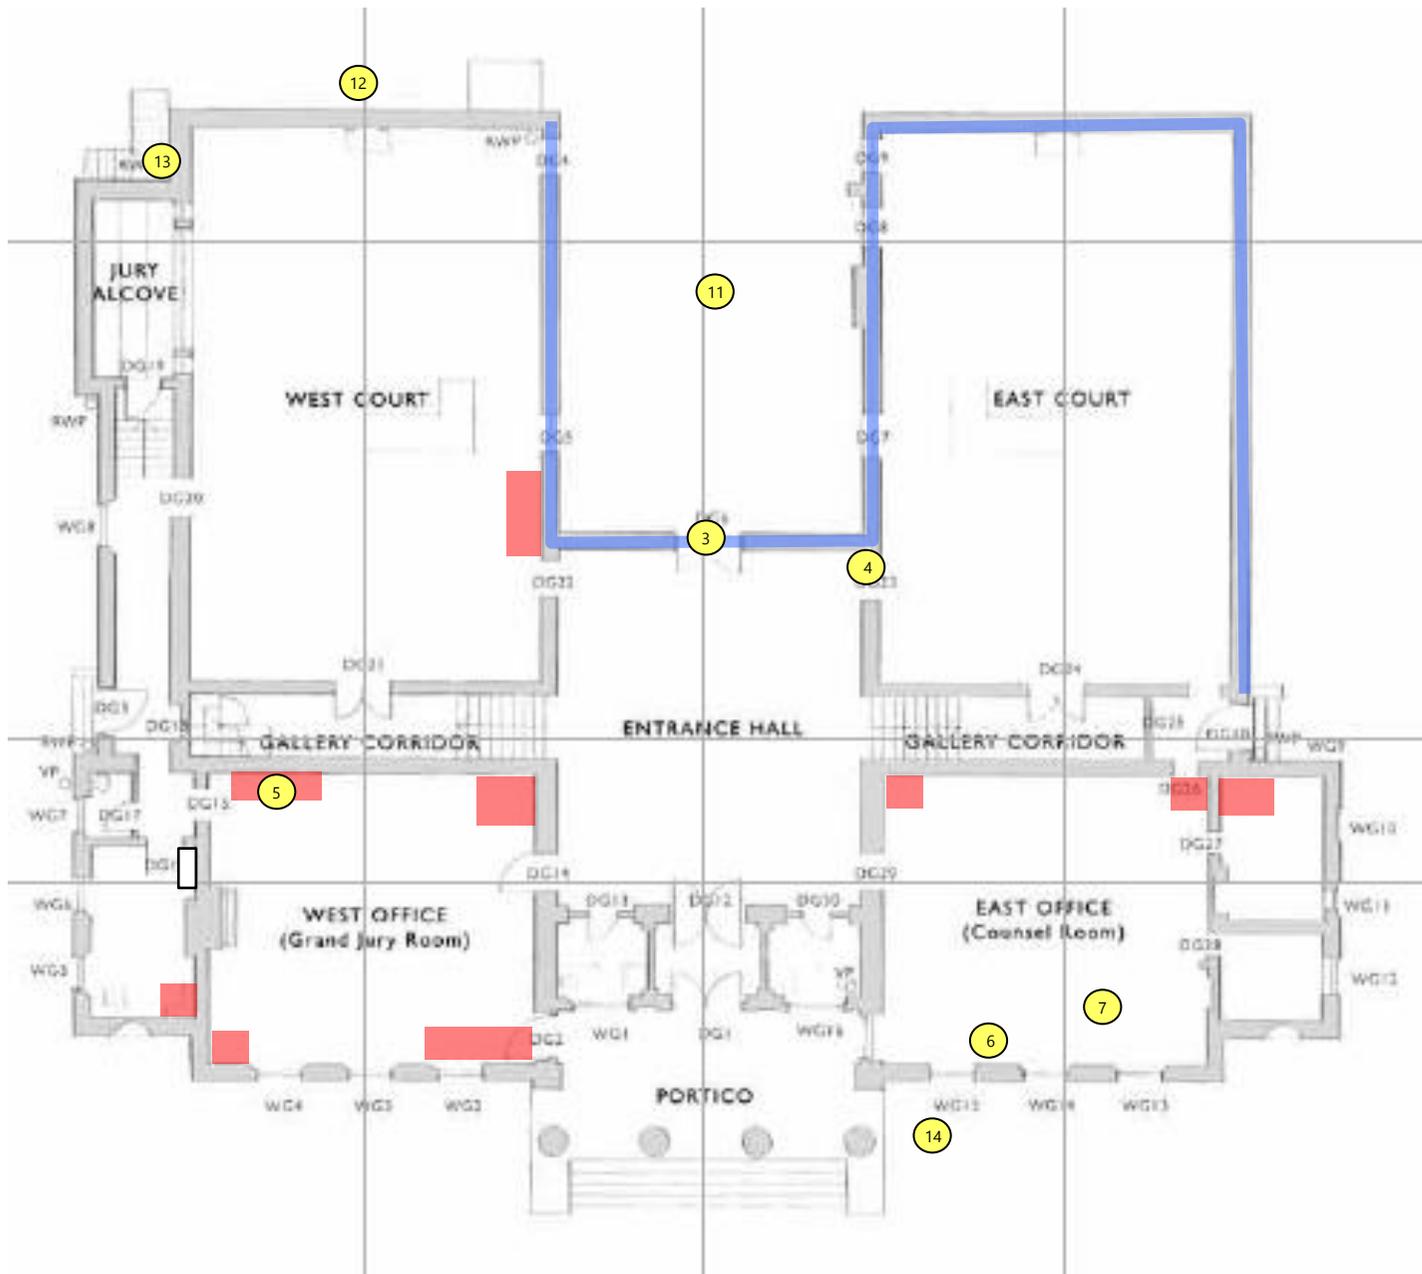
**Figure 2 – Ground floor**

Red shading indicates active wetting and decay.

Blue line indicates wet wall bases.

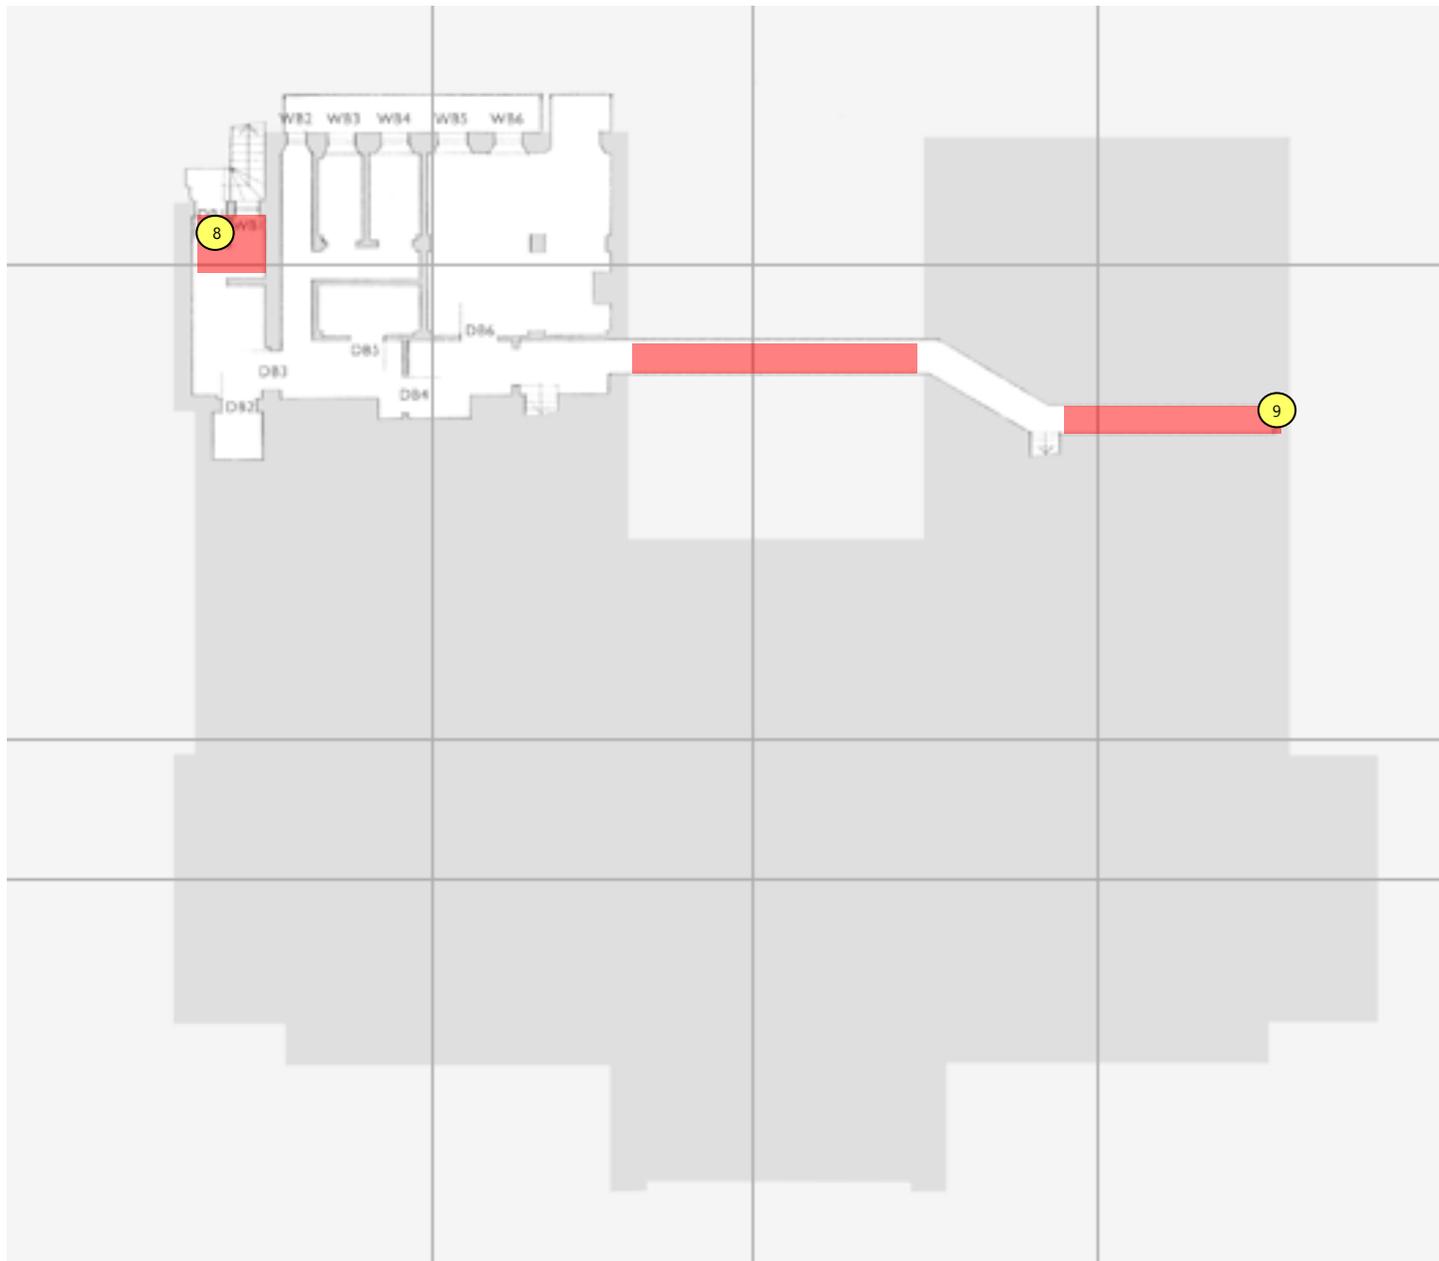
### Figure 3 - Cellar

Red shading indicates active wetting and standing water.
