APPENDIX A

Village Store / Union Hall
S. Acworth, New Hampshire
November 2023 – April 2024

EXTERIOR CONDITIONS

ACWORTH VILLAGE STORE
Historical Building Assessment
Mixed Use Building Preliminary Code Review

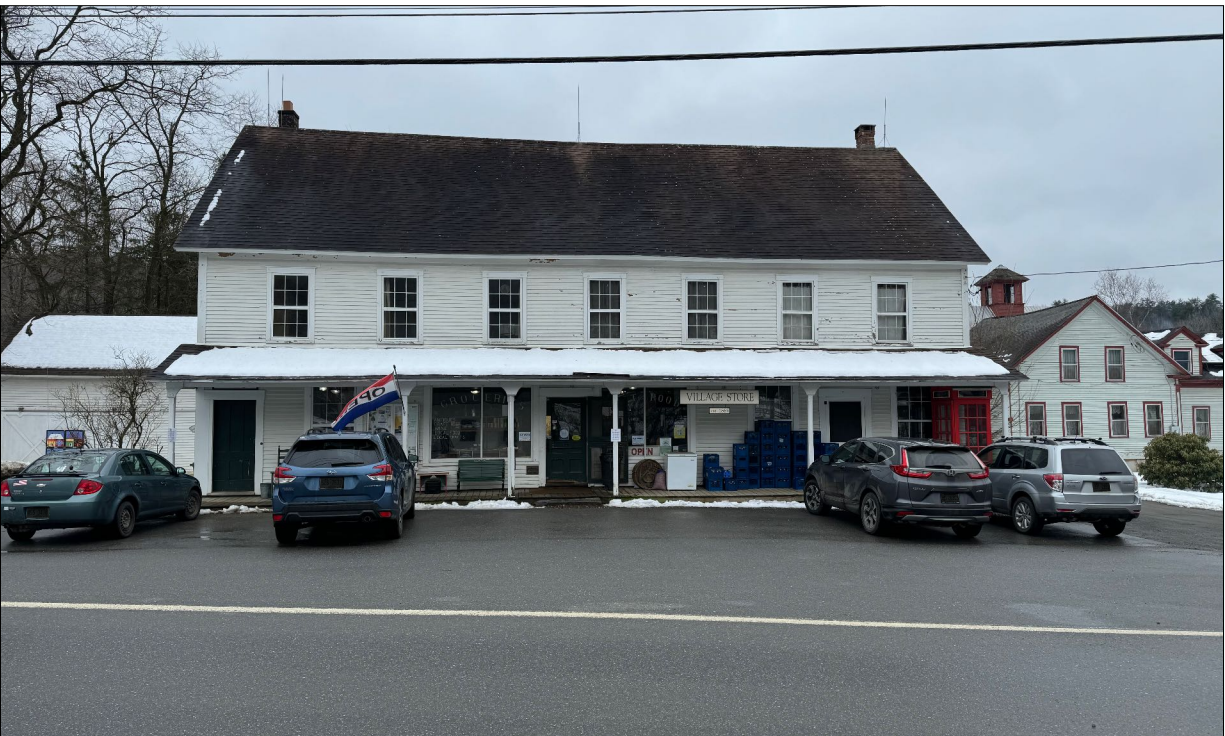
A-5: Porch and store entrance. Deflection along eaves and roof ridge.

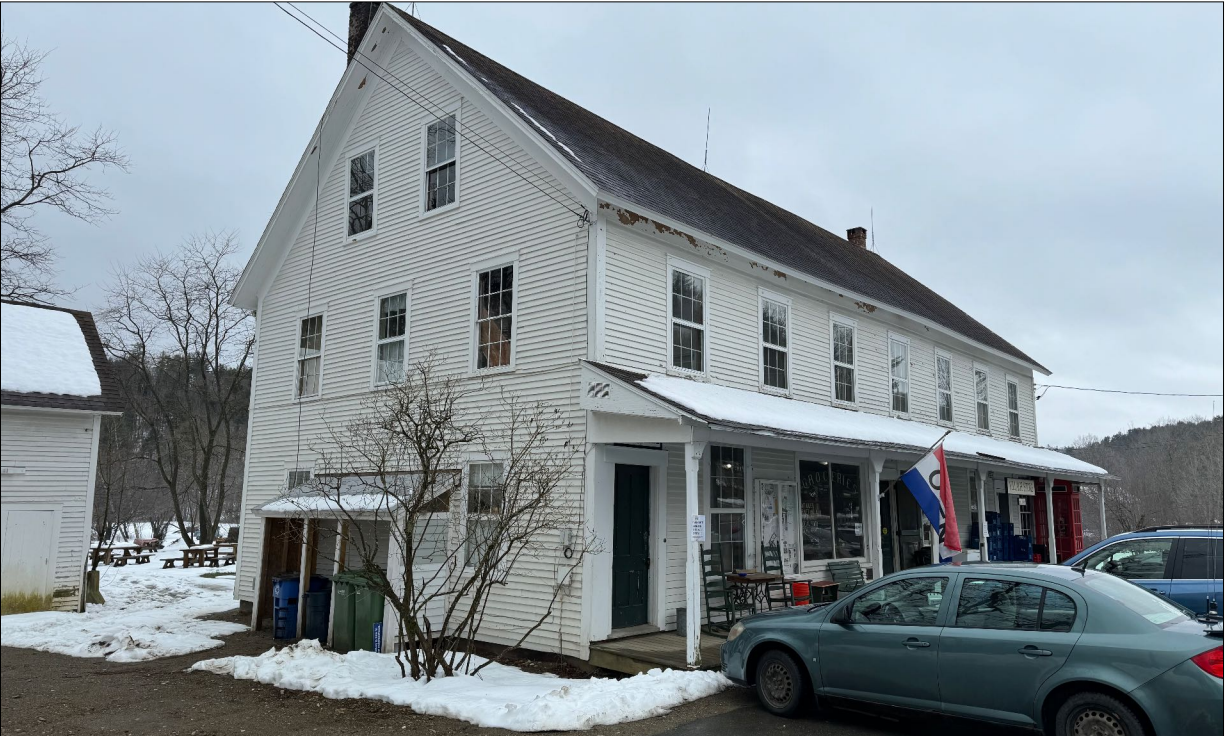
A-6: View of Union Hall stair entrance. Paint loss under eaves.

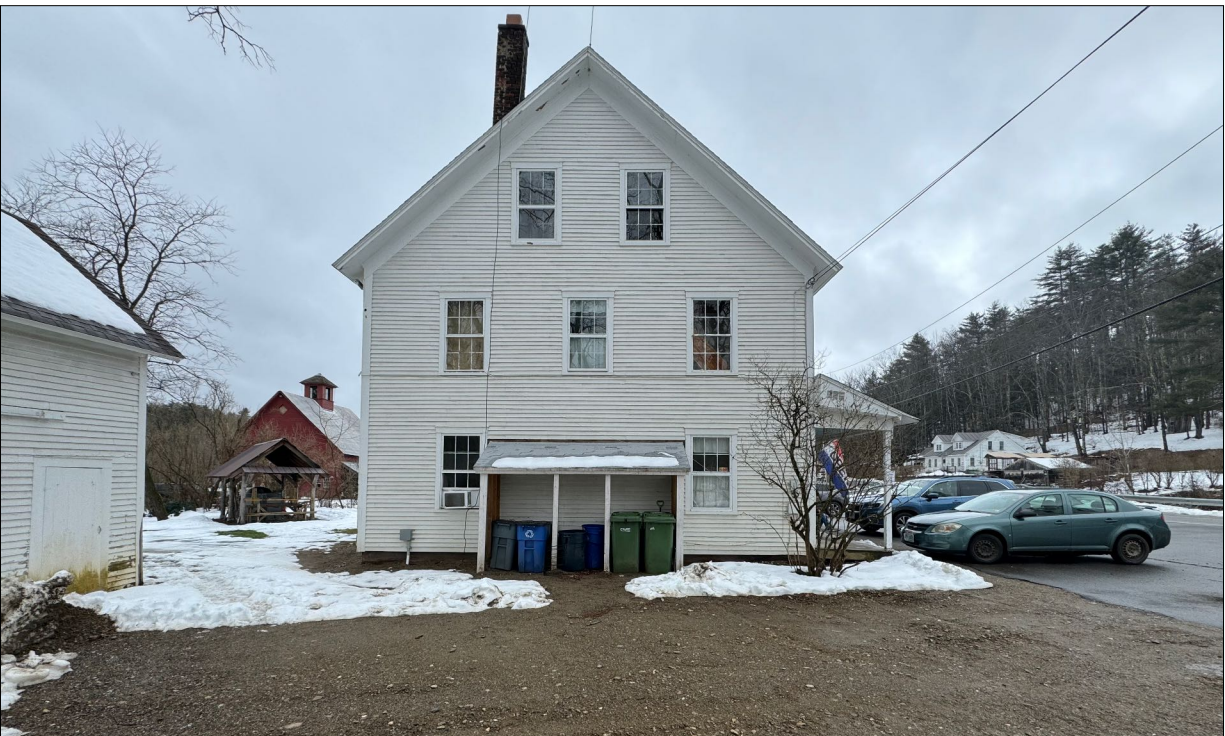
A-7: New garbage bin shed addition at east end. Crawlspce access through the shed.

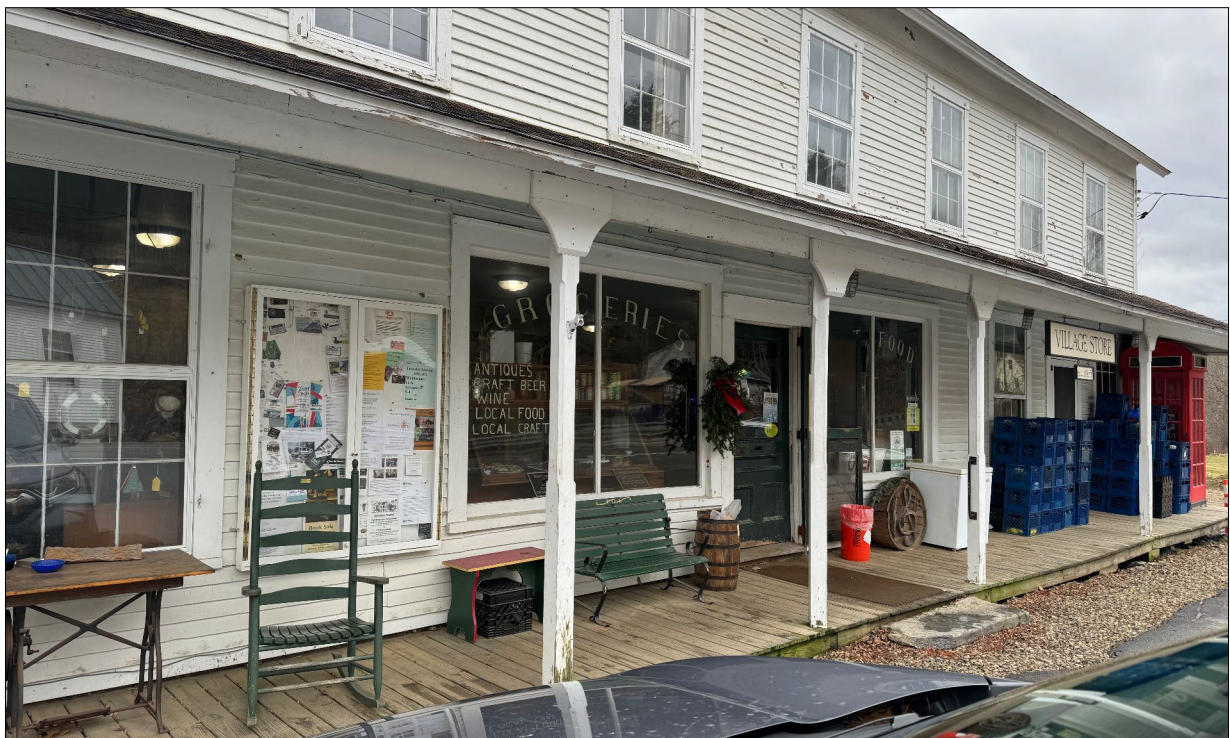
A-9: Partially chamfered porch posts with added “capitals” — details carried forward through time. Community notice board and display windows. Paint loss on upper clapboards and window sills.

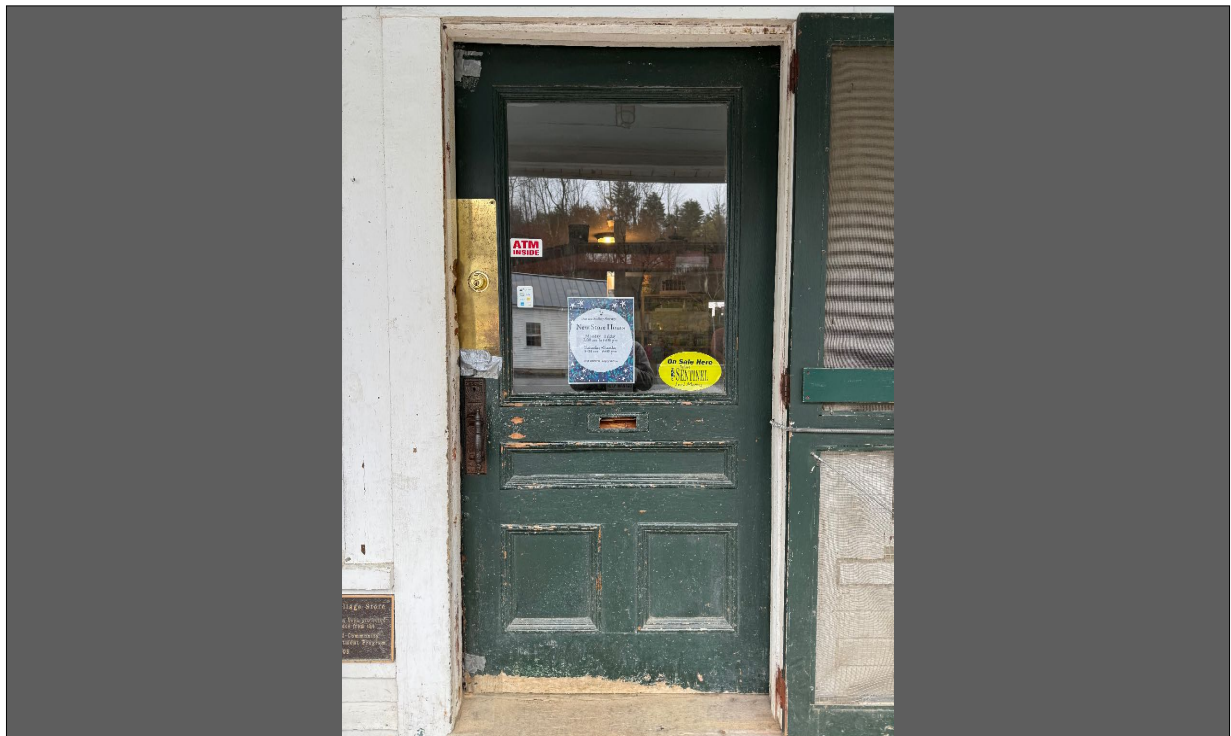
A-10: Main entrance to the store. Door shows wear patterns and is patched with duct tape. Screen door propped fully open.

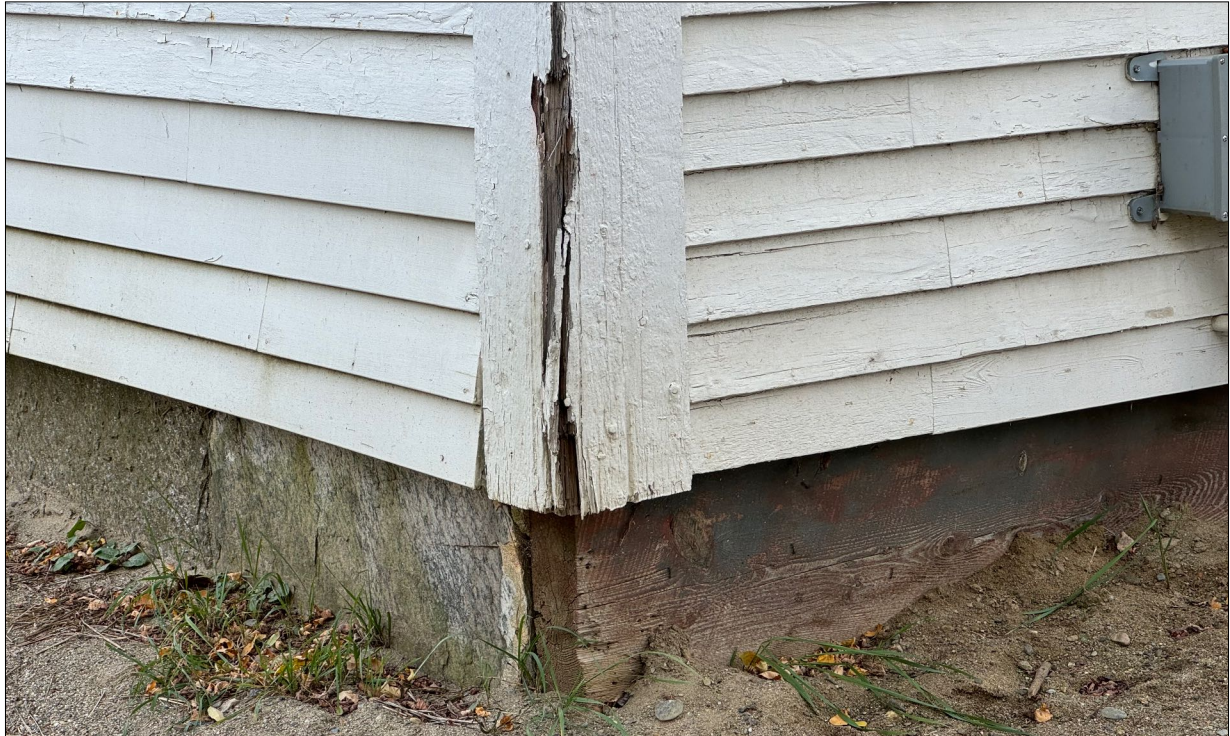
A-12: Cornerboard damage. Note granite and plank underpinning below. New lower clapboards along the south side may indicate a location of previous foundation or sill repairs.

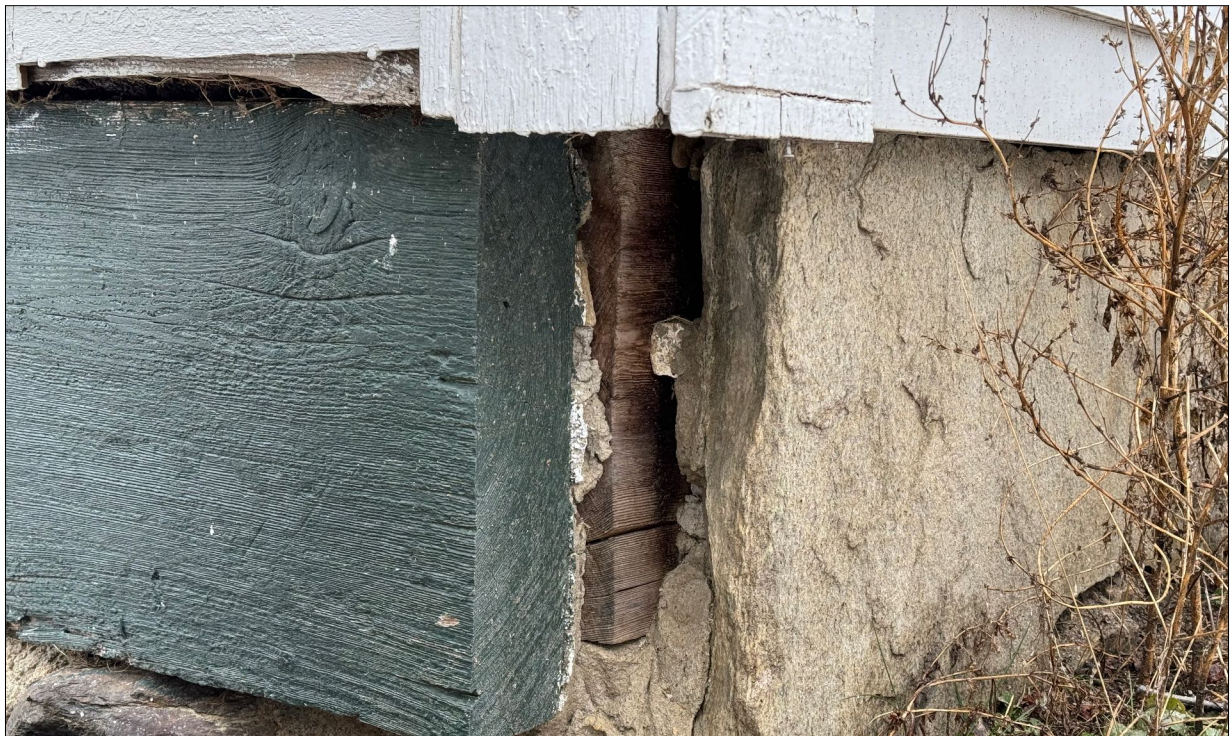
A-13: More plank underpinning at the southwest corner.

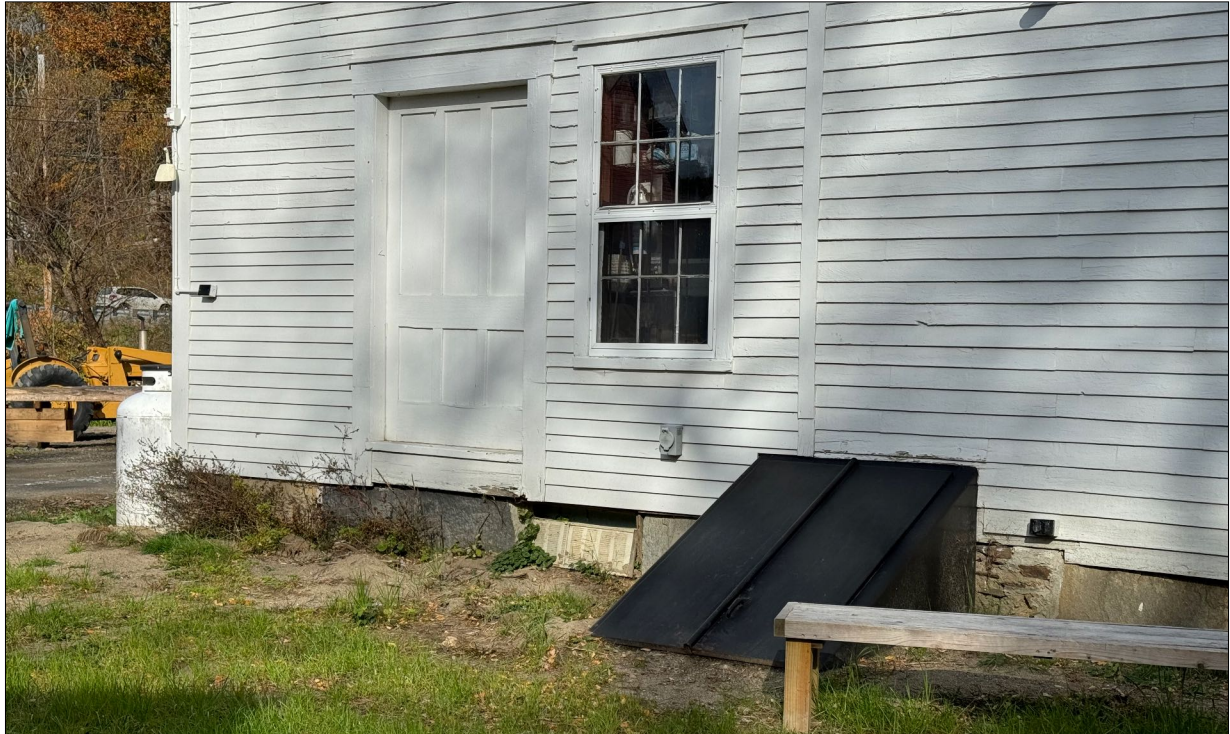
A-14: Metal bulkhead covers a drop (i.e. no stairs) to the excavated portion of the basement. Note infill to the right of the bulkhead. Wide, six panel door (without stairs) is not in use; formerly led into a storage addition.

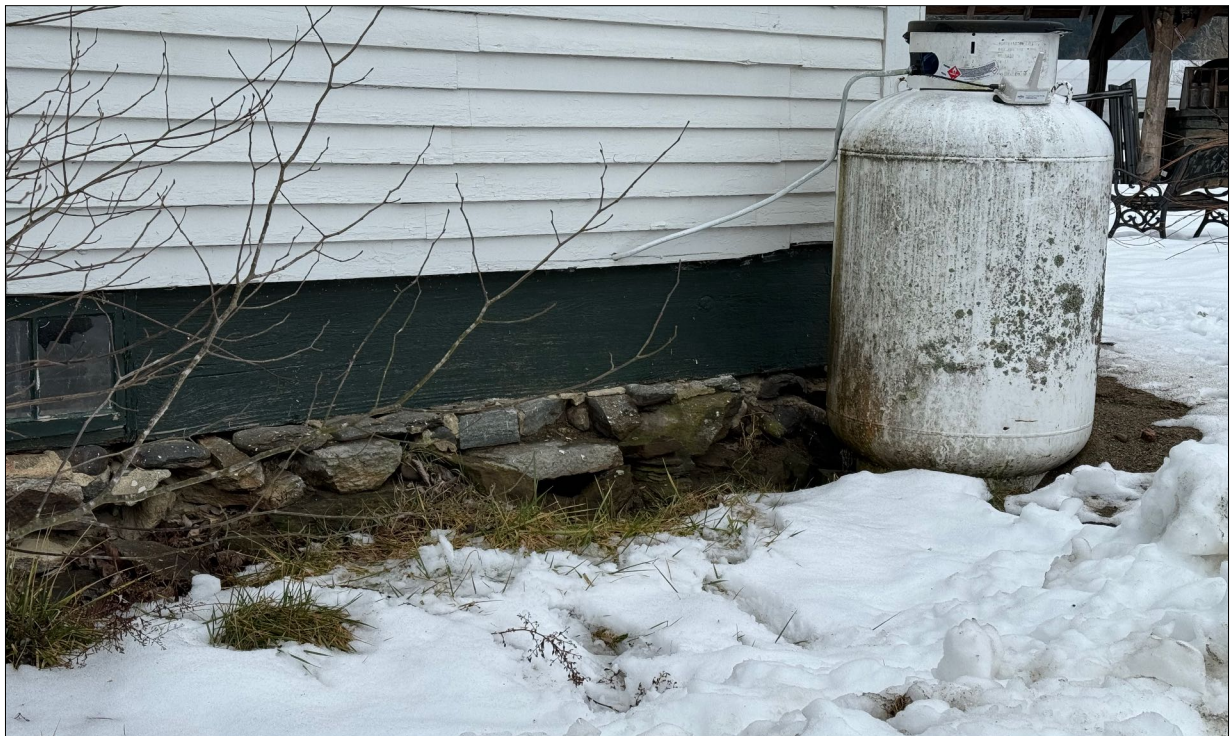
A-15: Exposed stone foundation and wood plank underpinning along the west end of the building. Propane tank serves the commercial stove.

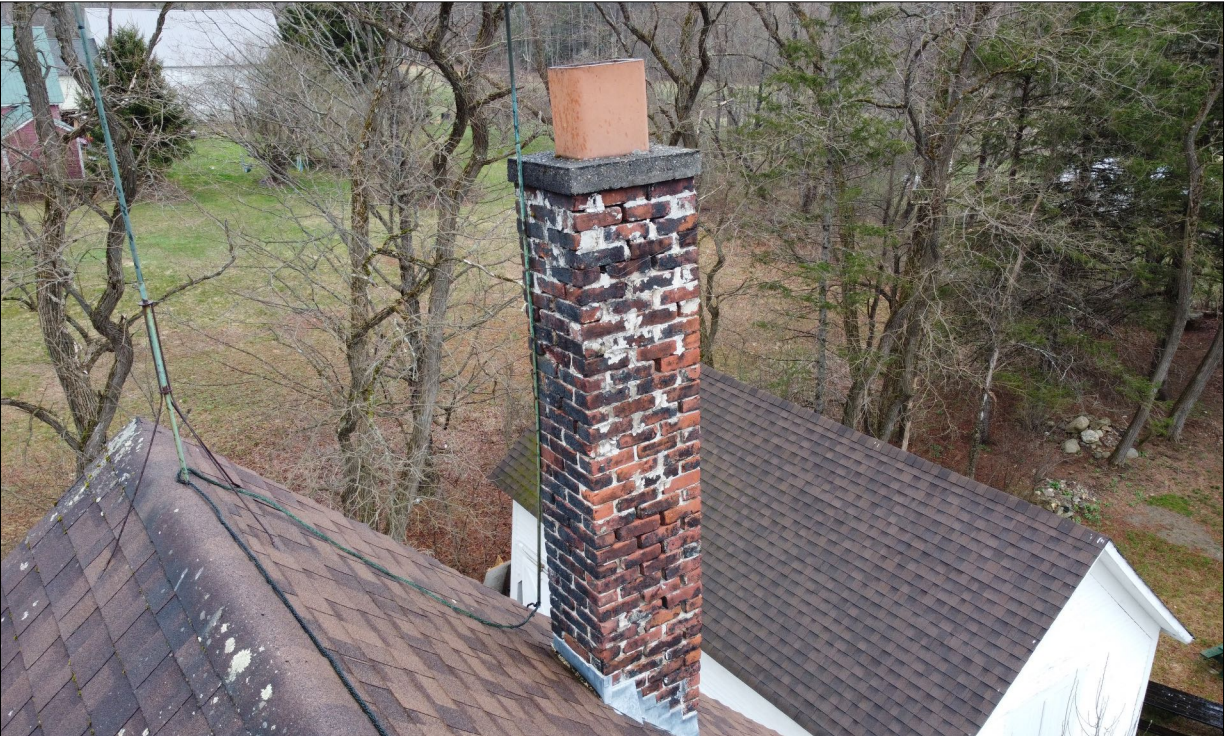
A-16: East chimney in poor condition and may require reconstruction from the roof plane or below.

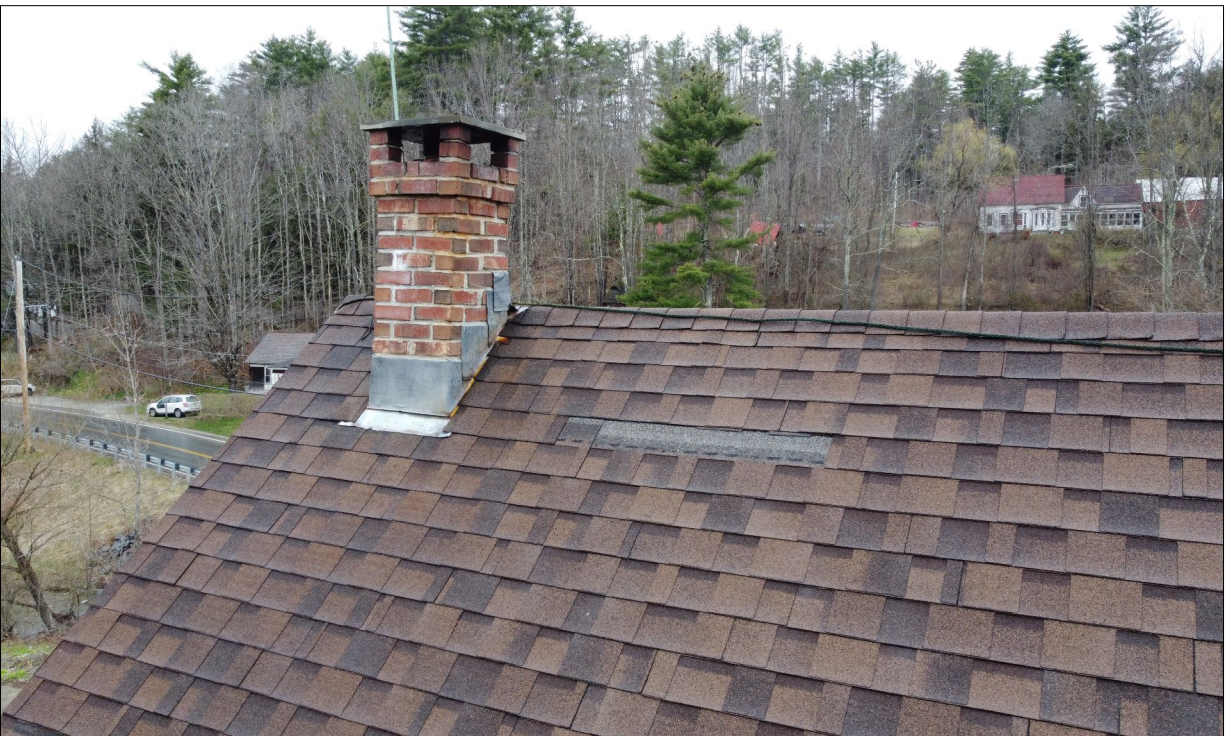
A-17: West chimney has been a source of past roof leaks. Mortar and flashing should be inspected more closely. Note discoloration of step flashing and a missing strip of shingles.

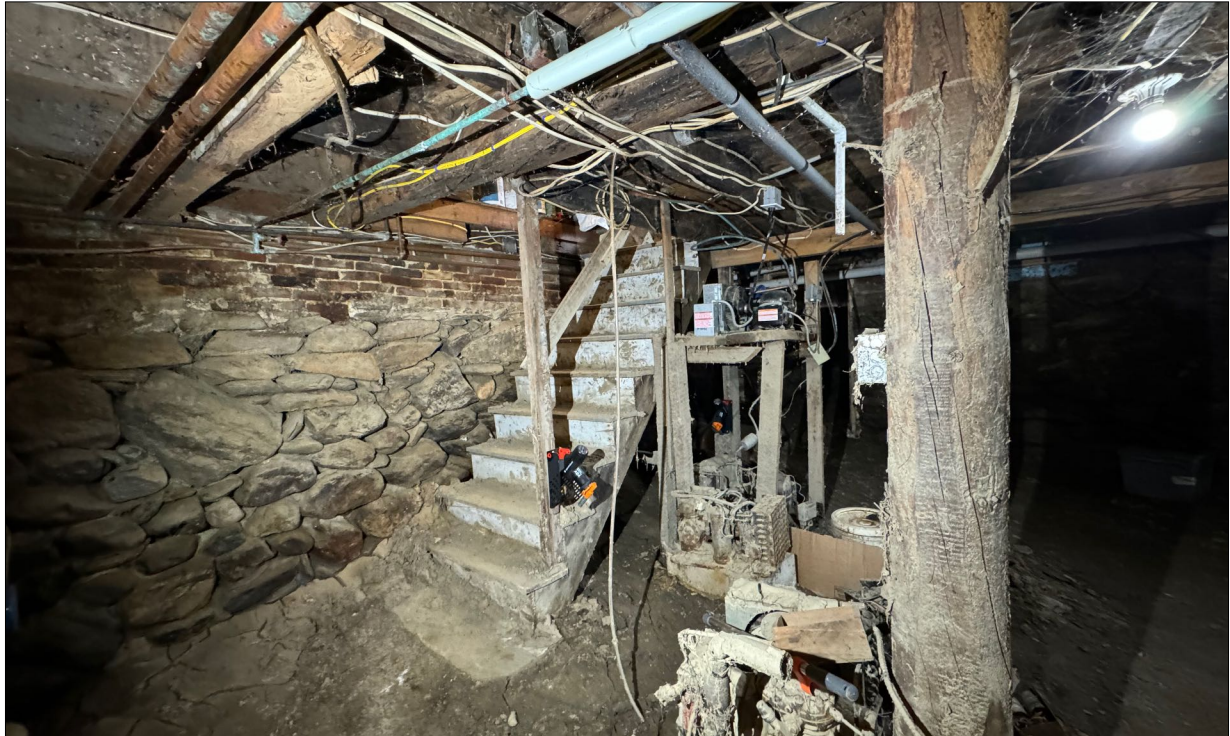
B-0.1: Basement stairs, still partially covered in silt from summer flooding. Note electrical wiring (multiple types) overhead.

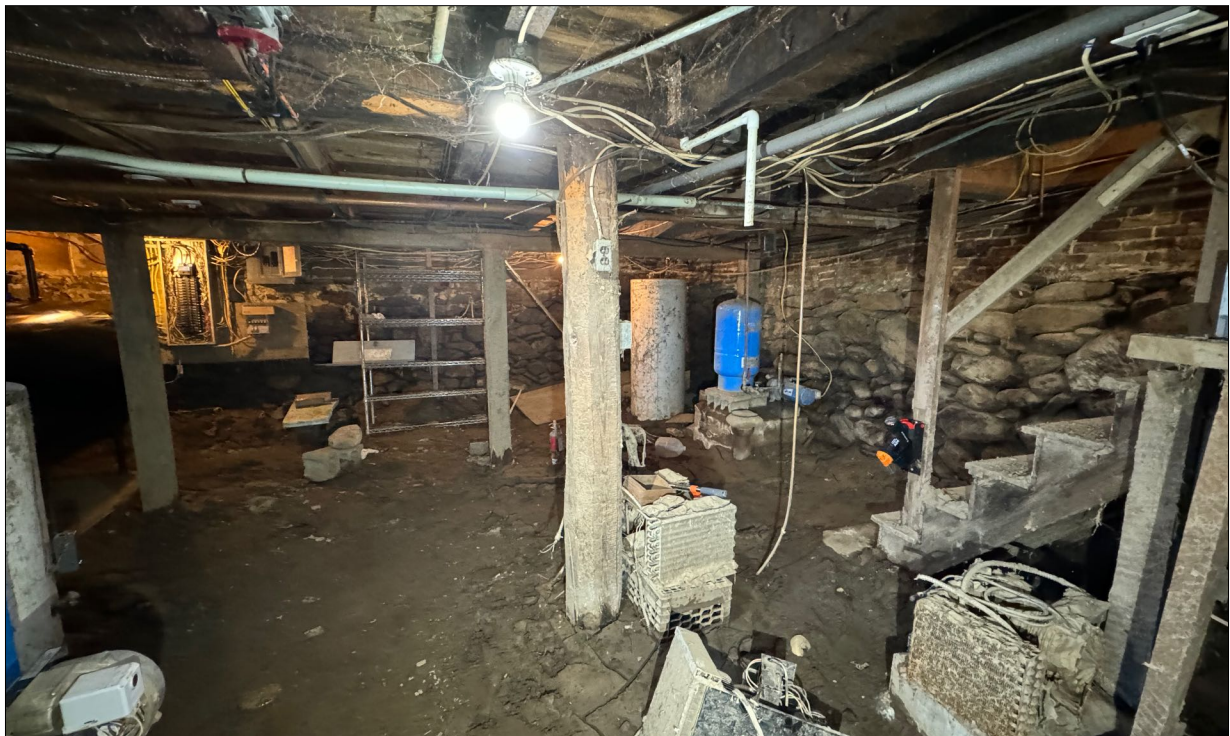
B-0.2: Basement still damp and littered with abandoned equipment months after the latest flood.

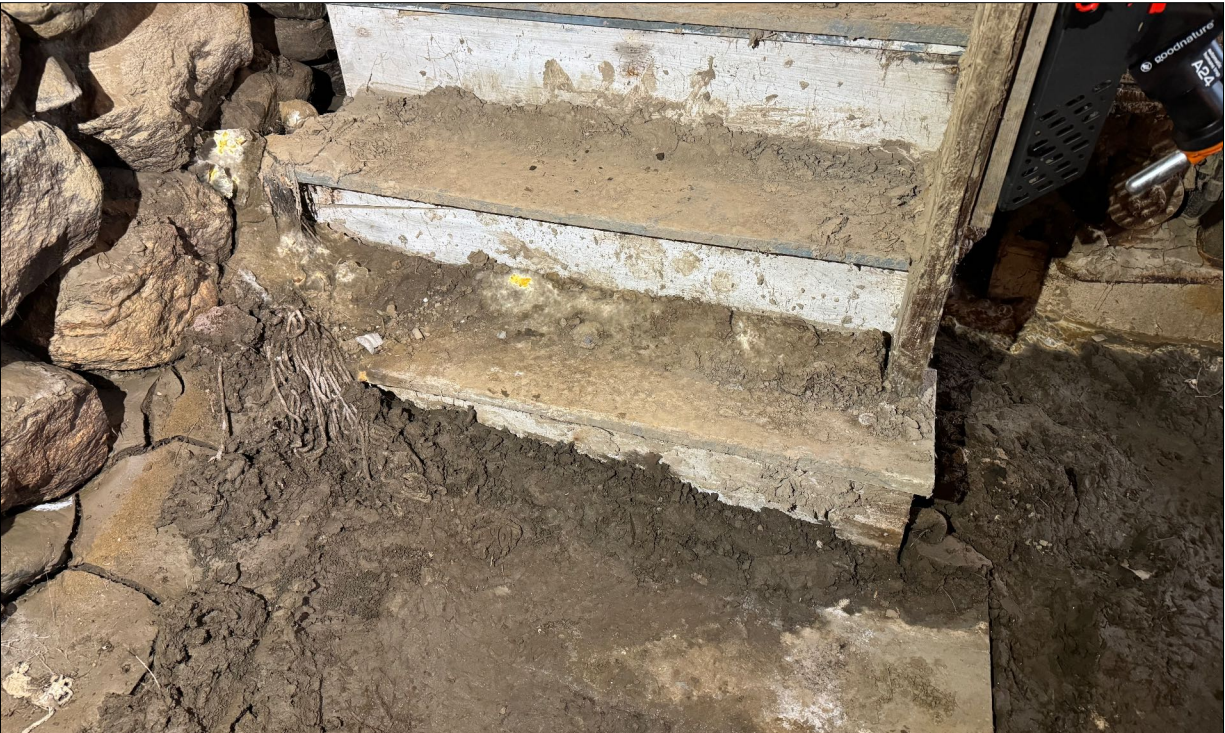
B-0.4: Basement stairs with silt residue from 2023 flooding.

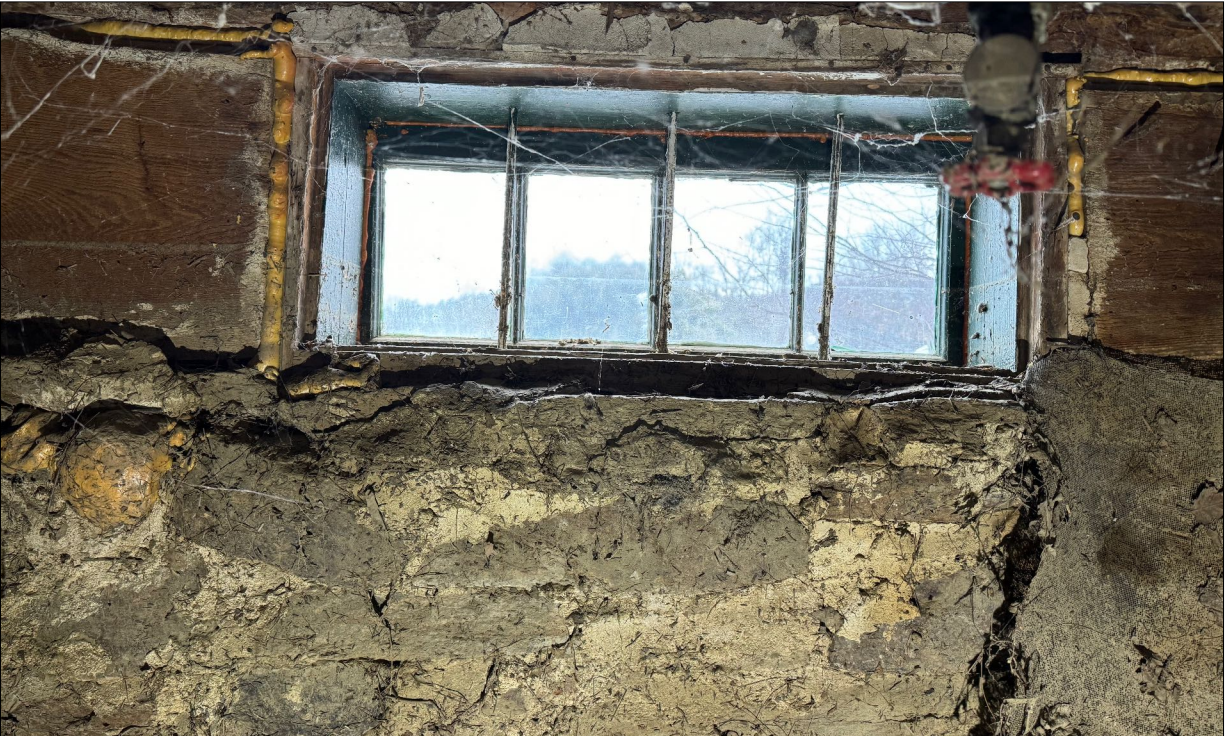
B-0.5: Basement window, note horizontal floodwater line about 3" above the window sill.

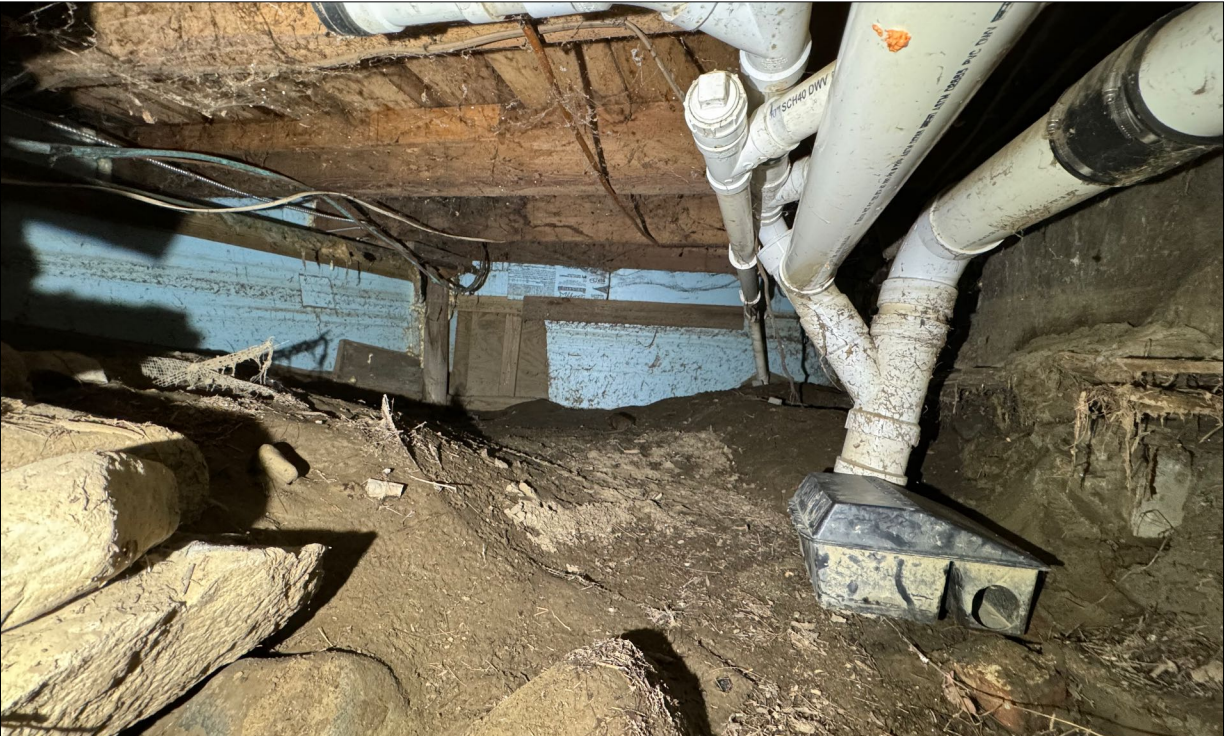
B-0.7: View into crawlspace under kitchen area; rigid foam panels block access under eastern half of the building.

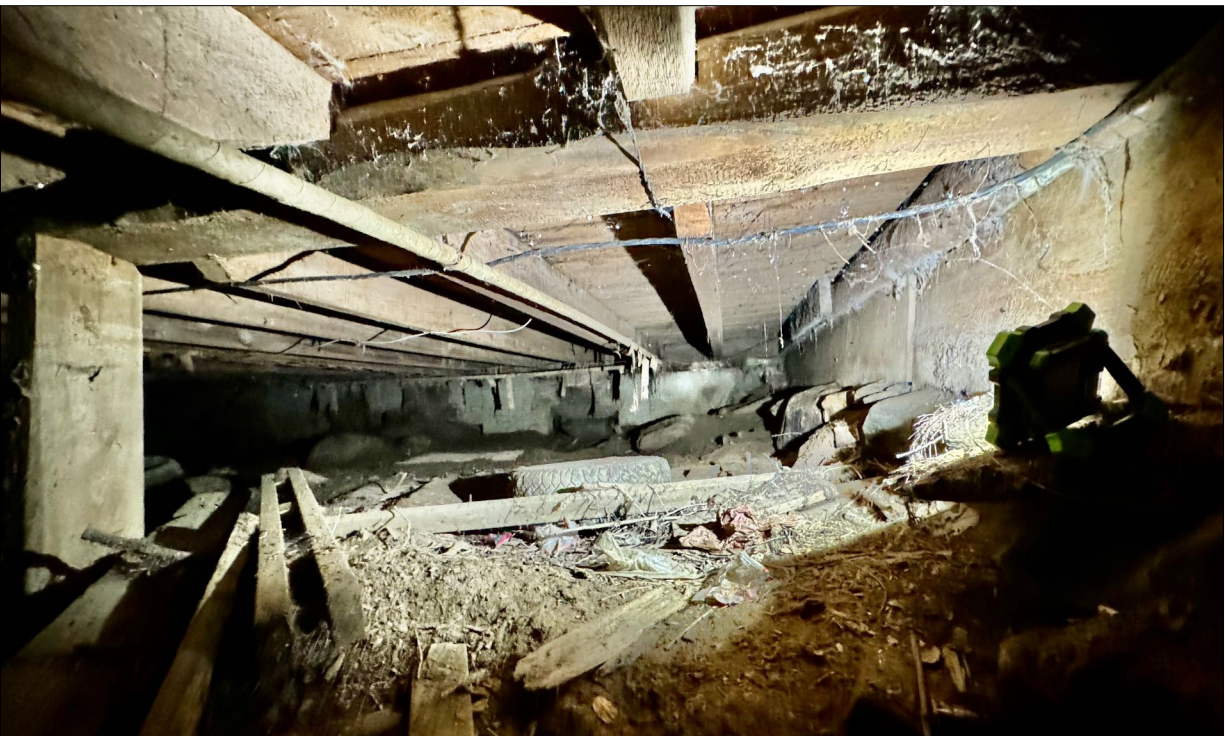
B-0.8: View into crawlspace under the main store area, accessible through the trash shed (east), looking north. New concrete reinforcement visible along the east wall where the porch joins the building.

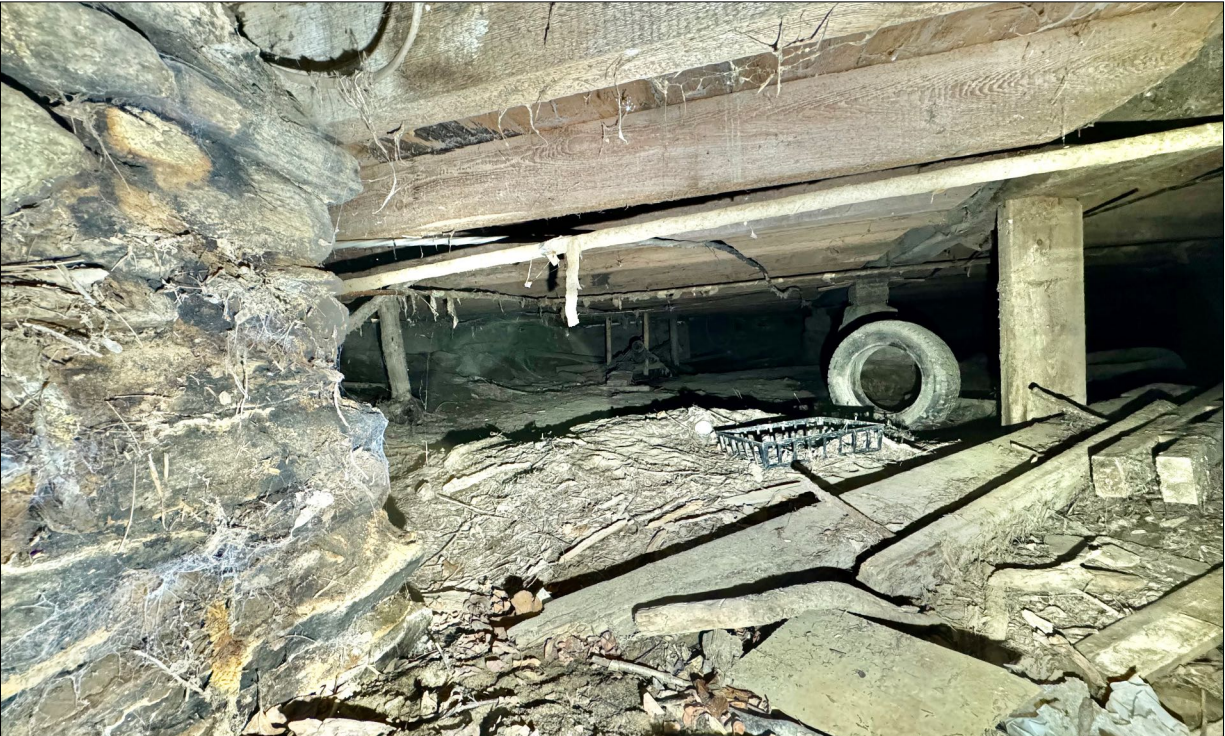
B-0.9: View into crawlspace under the main store area, looking southwest; conditions appear relatively dry and the flooring sound.

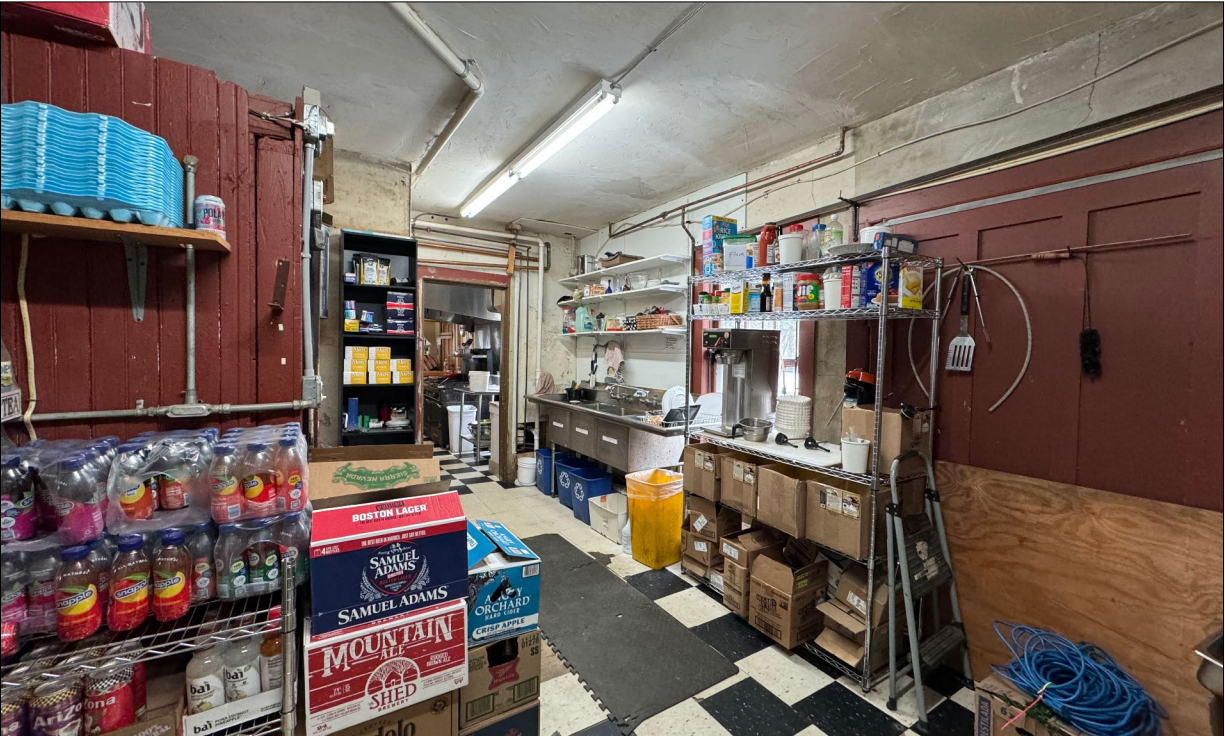
B-1.7: Food storage shelves, walk-in freezer, and washing area. Floor tiles missing. Note variety of plumbing materials. Surface mounted electrical wiring for lighting.

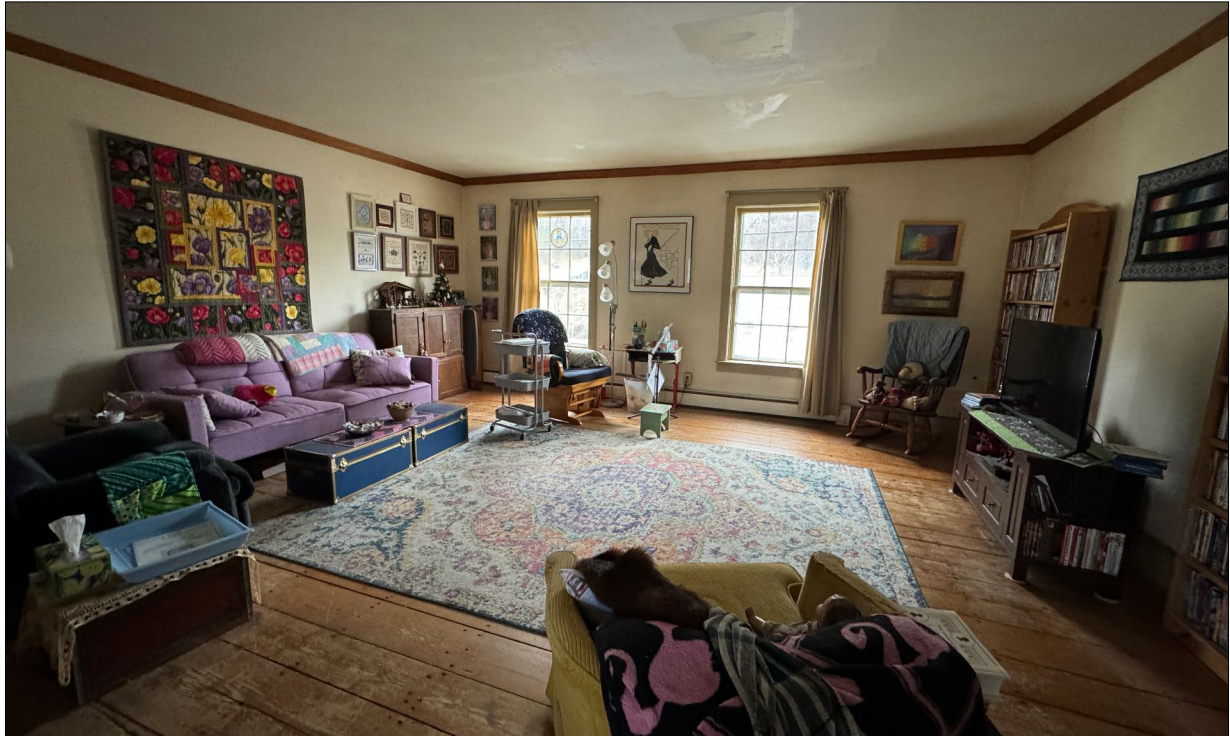
B-2.3: Main living room area. Note ceiling repair.

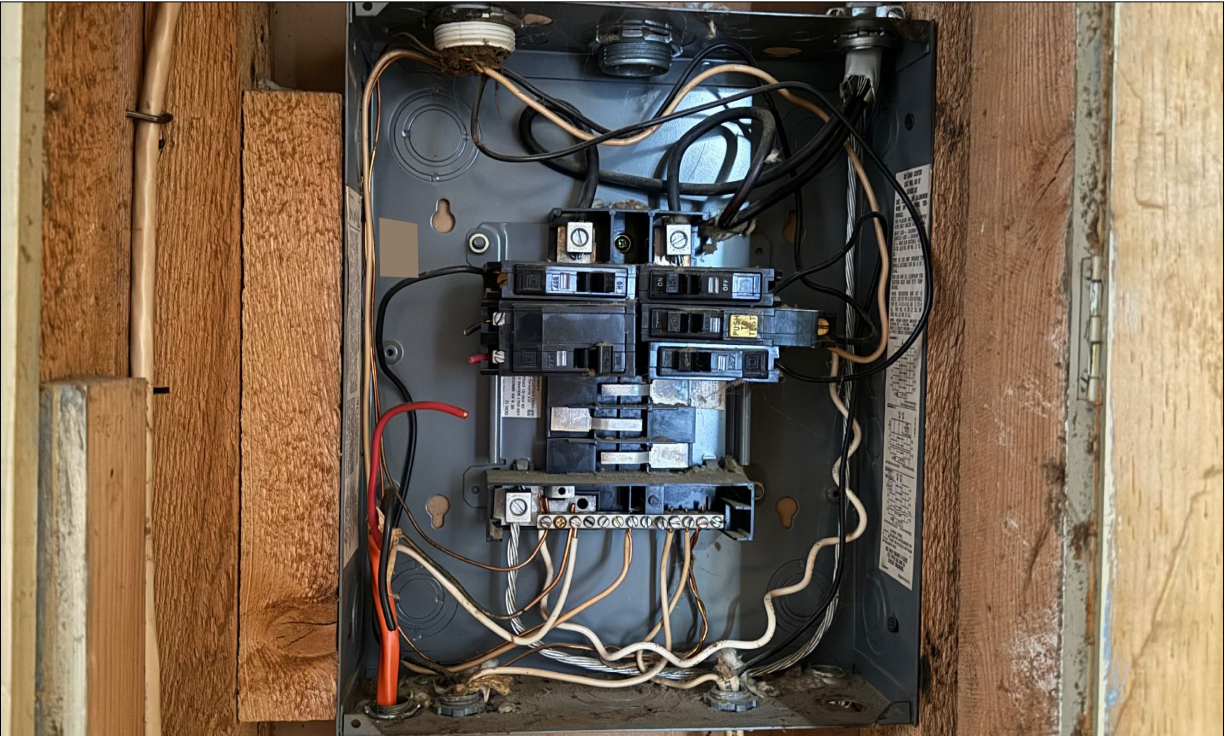
B-2.5: Sub-panel with exposed clipped wiring on large breaker; no box door.

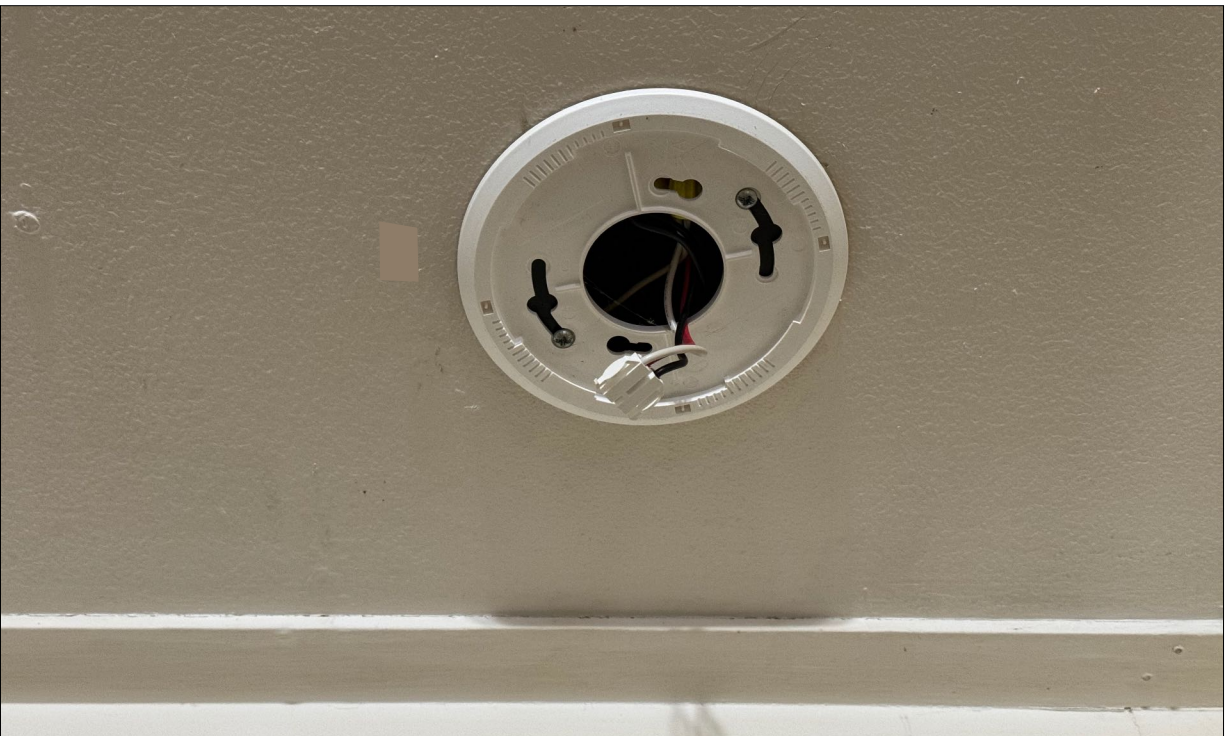
B-2.6: One of several missing or disconnected smoke detectors in the residential area.

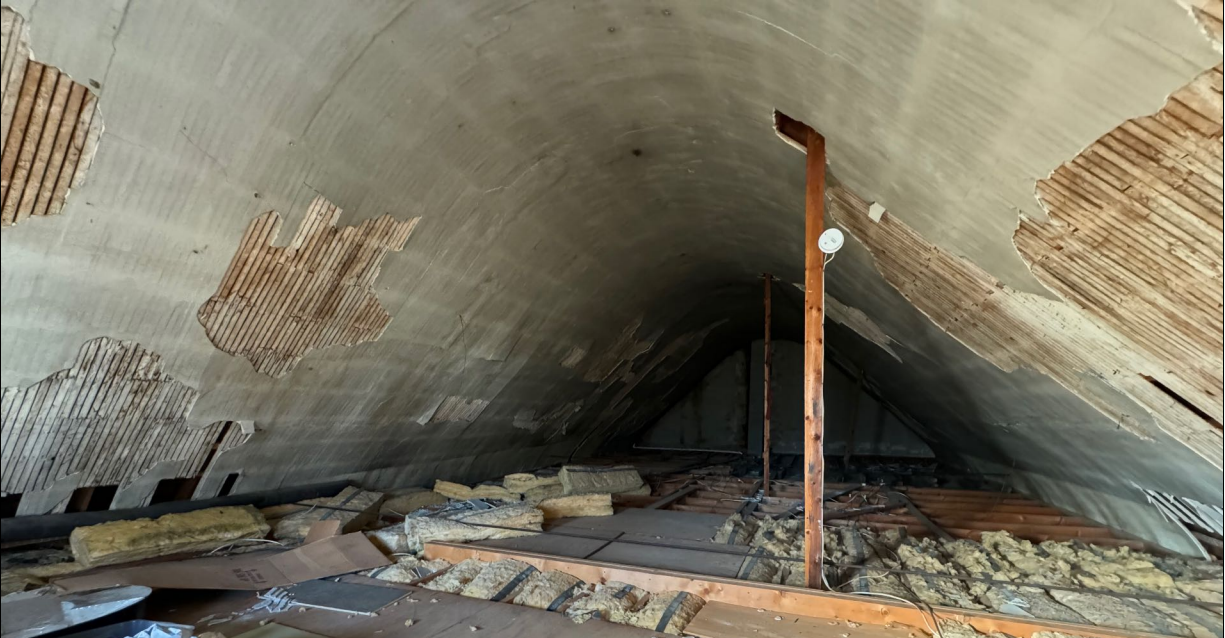
B-3.2: View towards west gable; sawn lath and one-coat plaster ceiling; vaulted apex. Note intermittent bracing/support for the new ceiling joists; this area was formerly an open void. A steel rod ties the north and south walls together near the mid-point of the structure.

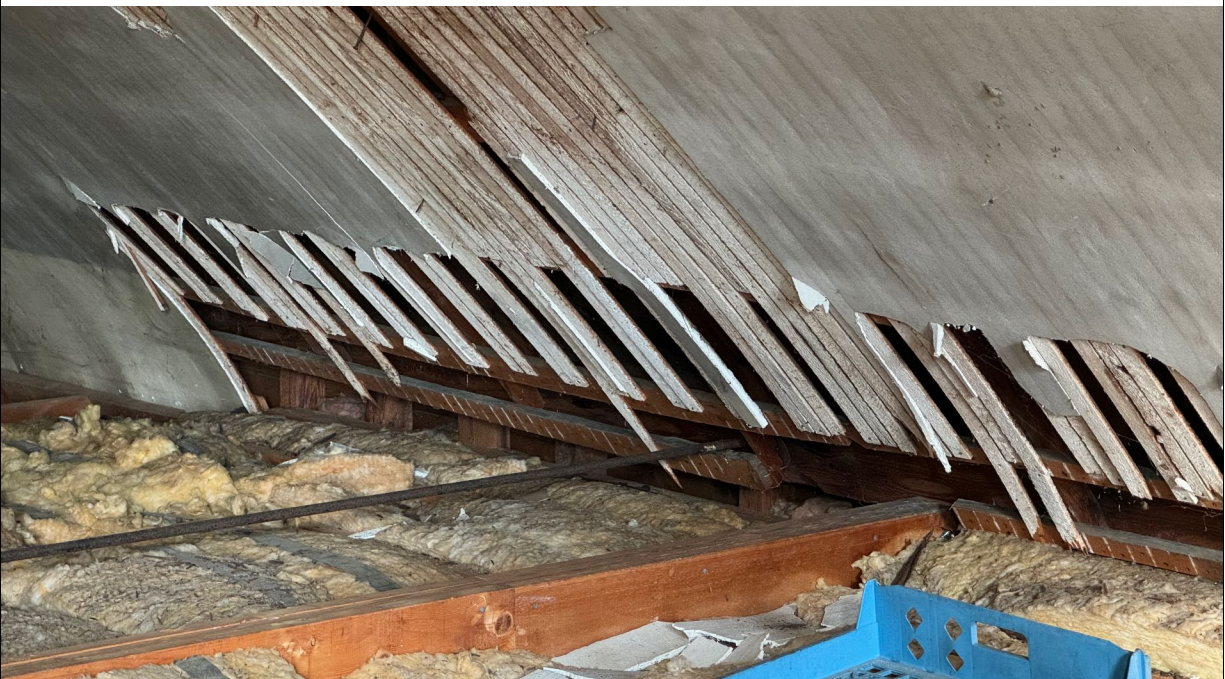
B-3.3: Plaster and lath partially removed along this north section.

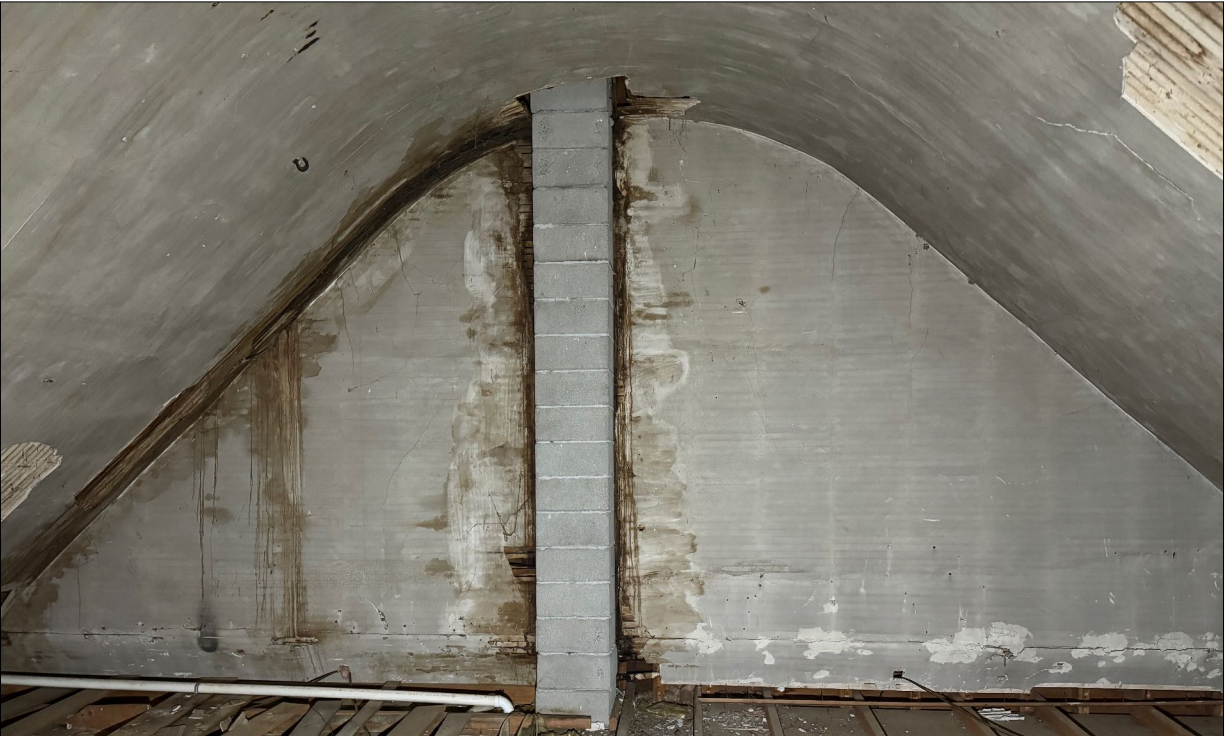
B-3.4: View of west gable with interior CMU chimney stack and evident water damage.
