South Acworth Village Store / Union Hall

1068 NH Route 123A
Acworth, New Hampshire

1. Introduction

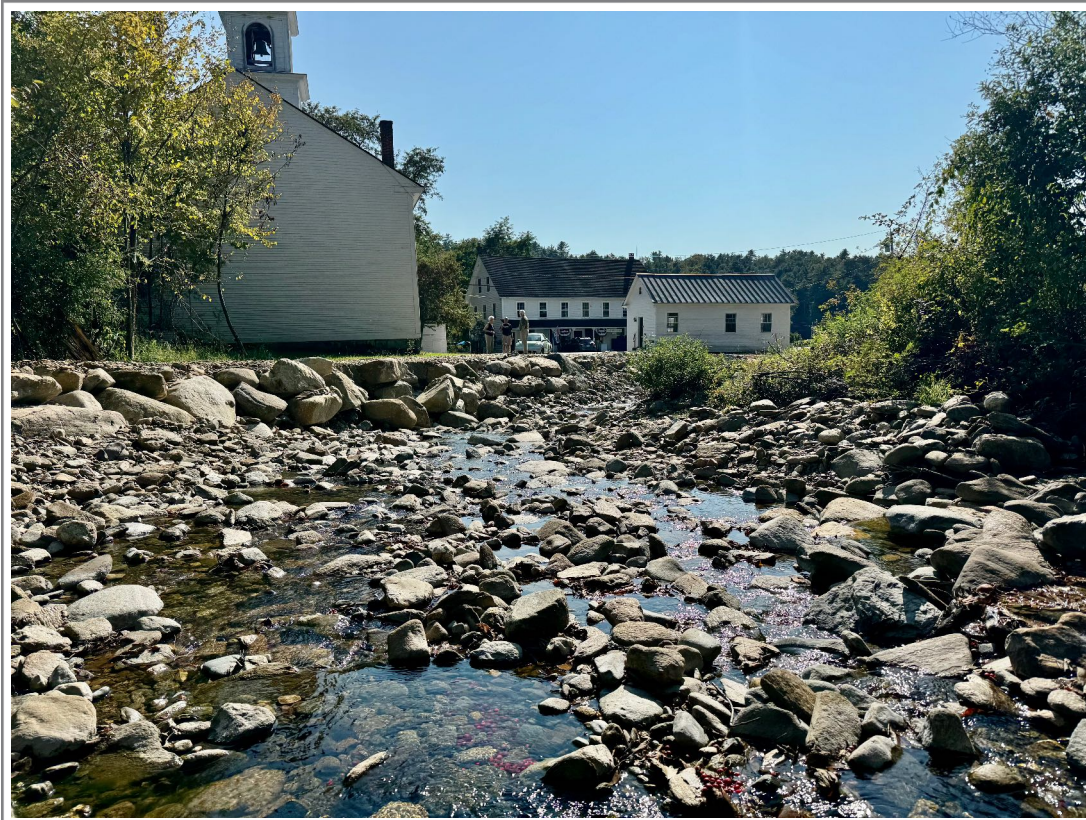
Bowers Brook, looking downstream at the former church and community aid buildings, with the store beyond. August 2024

Today a small church and Community Aid Building still stand opposite the Village Store, separated by Bowers Brook; in 2021 and 2023 its floodwaters severely undermined and damaged these buildings as well as the store.

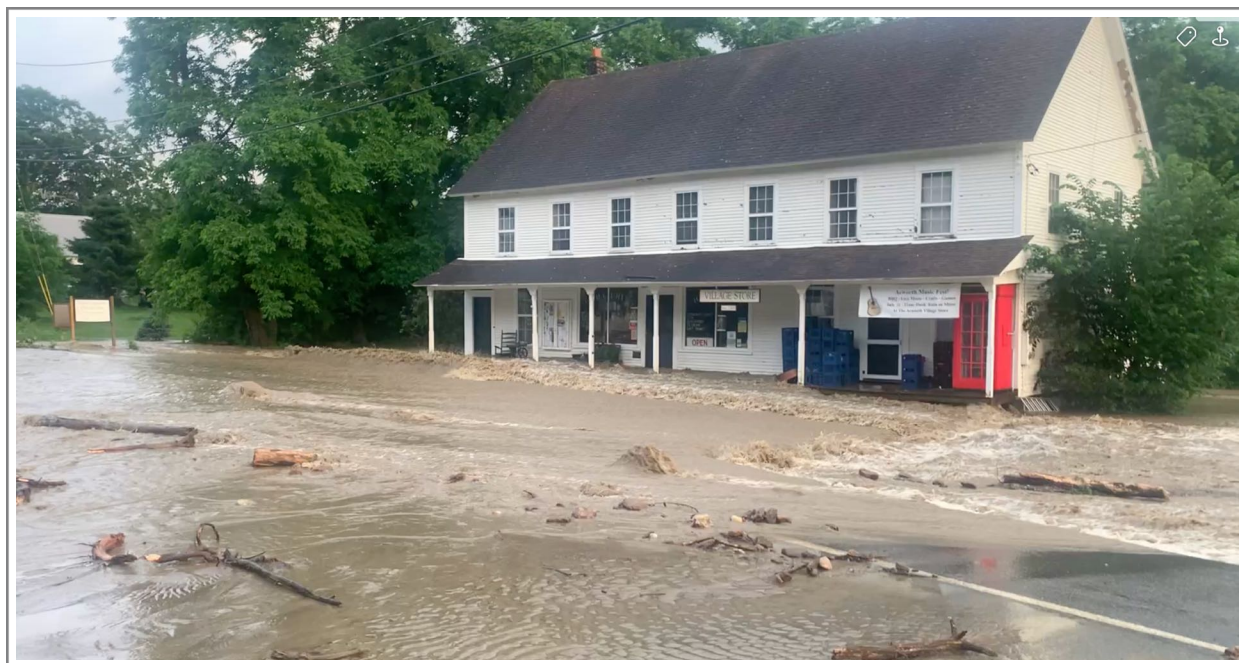
*Bowers Brook floodwaters crossing the state highway
July 10, 2023*

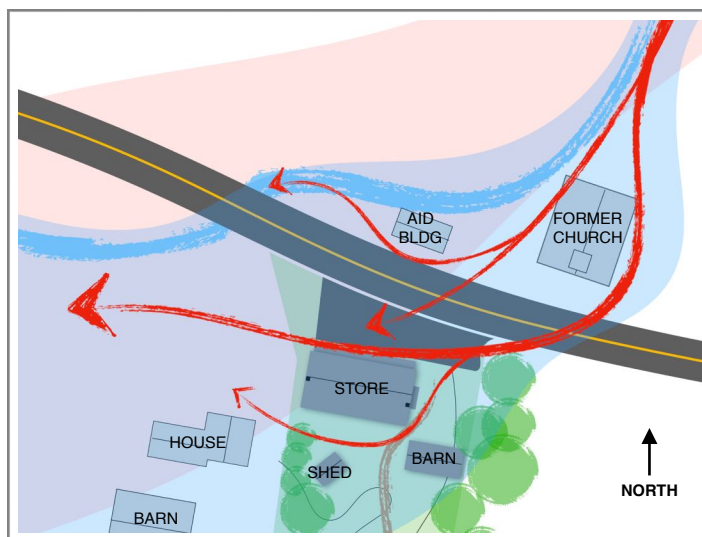
Still images and video of the 2023 flooding show the direction and relative flow rates of water moving past the South Acworth Village Store. In the diagram below, the flooded area (shaded blue) extended south and east of the designated flood hazard zone (shaded pink). In addition to relocating utilities, resilience plans should include measures to deflect onrushing floodwaters originating from north and east of the building in order to minimize interior flooding and mitigate the hydrologic forces which may weaken the building's dry stone foundation.

*Relative magnitude/direction of floodwaters
July 10, 2023*
