Motor Vehicle Crash Police Report

Date of Crash 02/02/2026	Time of Crash 0441 24HR	City/Town Auburn	Number Vehicles 2	Number Injured 2	Speed Limit 40	State Police Local Police MBTA Police Campus Police Other: _____
-----------------------------	-------------------------------	---------------------	----------------------	---------------------	-------------------	--

Crash Report ID# 26-51-AC

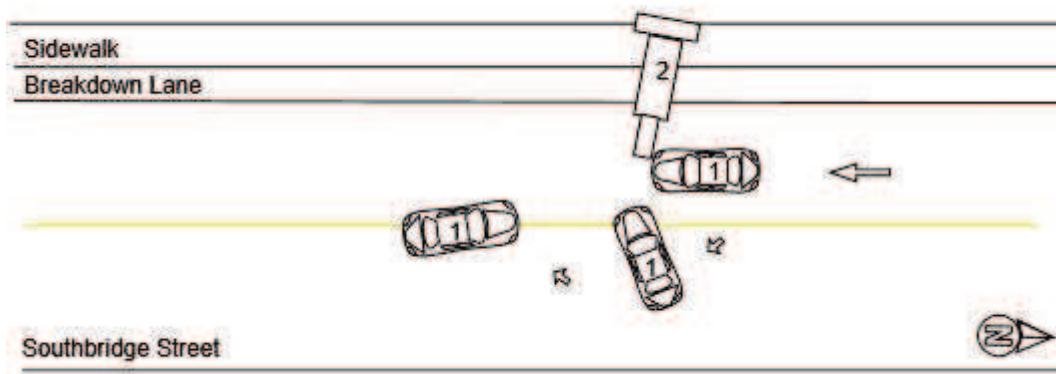
Crash Diagram:

The Town of Auburn Depar. of Public Works employees were clearing sidewalks and intersections due to a large amount of snow from a storm the previous week. Vehicle 2 (V2) is a backhoe equipped with a front loader and rear bucket. V2 was perpendicular in the roadway removing snow from the sidewalks with the front loader. Vehicle 1 (V1) was traveling southbound on Southbridge St. The rear bucket of V2 was in the middle of the southbound travel lane. The front right bumper/hood area of V1 collided with the rear bucket of V2. The collision caused the rear boom of V2 to bend. When I arrived on scene, the flashing amber lights of V2 were activated. There were no street lights in this area. Drivers of V1 & V2 suffered minor injuries and were transported to hospital. V1 sustained major front end damage and was towed. V2 suffered major rear damage but could be driven from scene.
