Police Use Only			Commonwealth of Massachusetts					RMV Document Number			
Date of Crash 09/09/2025	Time of Crash 0834 24HR	City/Town Auburn	Motor Vehicle Crash Police Report			Number Vehicles 2	Number Injured 1	Speed Limit 45	Latitude +042.1827	Longitude -071.853	State Police Local Police MBTA Police Campus Police Other:
AT INTERSECTION:			< LOCATION >		NOT AT INTERSECTION:						
<div>11</div> <div>Route# Direction Name of Roadway/Street</div> <div>At</div> <div>Route# Direction Name of Intersecting Roadway/Street</div> <div>Also at Intersection with</div> <div>Route# Direction Name of Intersecting Roadway/Street</div>					<div>210</div> <div>20 E WASHINGTON ST</div> <div>Route# Direction Address # Name of Roadway/Street</div> <div>Feet N S E W of or Mile Marker Exit Number</div> <div>311</div> <div>200 S W HILLCREST AVE</div> <div>Feet N S E W of Route# Intersecting Roadway/Street</div> <div>Landmark</div>

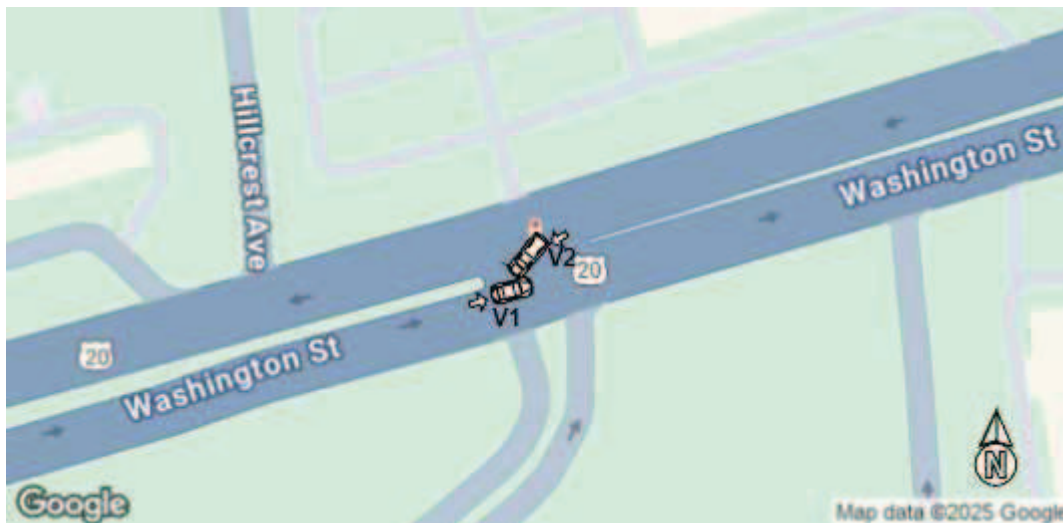
### Crash Diagram:

V1 was travelling east approaching the traffic light/intersection with the driveway for 779 Washington St. V2 was travelling west in the dedicated left turn lane. Operator of V1 stated that she had a green light and V2 collided with her left side when she proceeded through the intersection. V2 was equiped with a dash camera; the operator accessed the video for my review. I observed that V2 only proceeded to turn left after the green turn arrow activated. Only the eastbound dedicated left turn lane would display a green arrow at that time. The video showed V1 proceed east when other eastbound traffic came to a stop. Operator of V1 was given a verbal warning for failure to yield.
