Case Study — Cracking Platform on Large Feeder

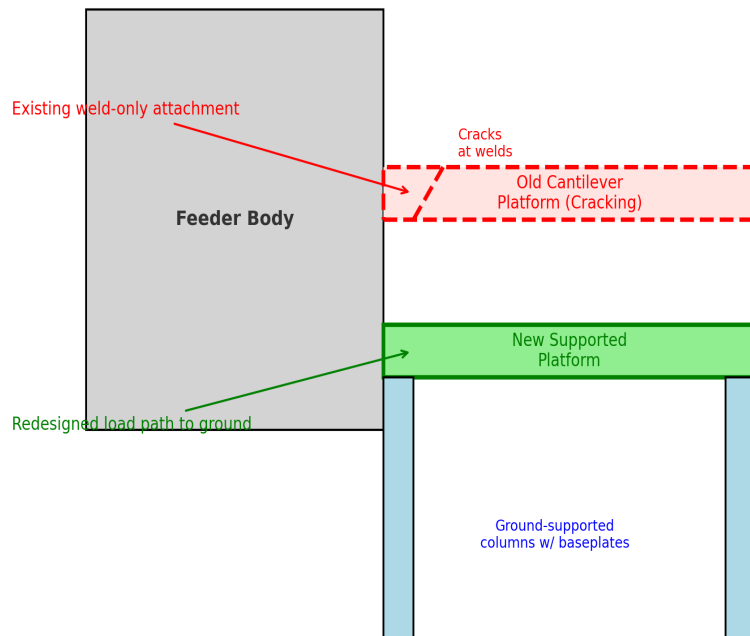
Platform Retrofit Concept — Old vs New

- Cracks concentrated at fillet welds and heat-affected zones.
- Welds undersized with poor toe blending.
- Feeder vibration and ore impact transmit into the platform.
- Platform acts as a cantilever; guardrails add leverage.

1. Structural resonance amplifying feeder vibrations.
2. Poor load transfer — welds alone carried vertical and dynamic loads.
3. Improper detailing with undersized fillet welds.
4. Repaired welds added brittle HAZ and failed quickly.

- **Immediate Safety:** Restrict access and install temporary shoring.
- **Redesign:** Ground-supported platform columns tied into foundation, gusseted brackets, and bolted clip plates with vibration isolation.
- **Guardrails:** Shorter posts with mid-height bracing, avoid direct weld leverage.
- **Fabrication:** Remove cracks fully, use E7018/FCAW-G welds with preheat, perform NDT after repairs.
