Home Inspections

Inspector: **Greg Karkowsky**

Property Inspection Report

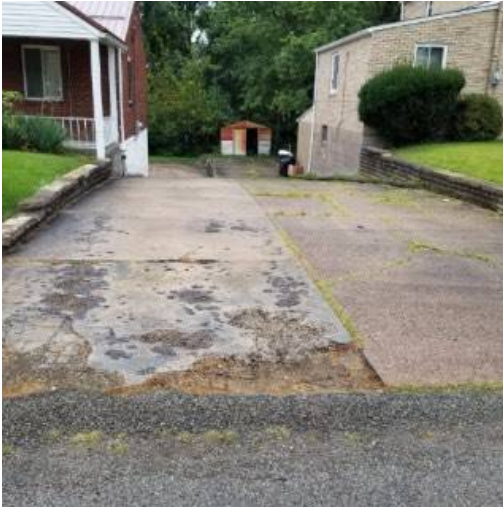
Photo 6-1

Cracks, holes, settlement, heaving and/or deterioration resulting in trip hazards were found in the sidewalks or patios. For safety reasons, recommend that a qualified contractor repair as necessary to eliminate trip hazards.

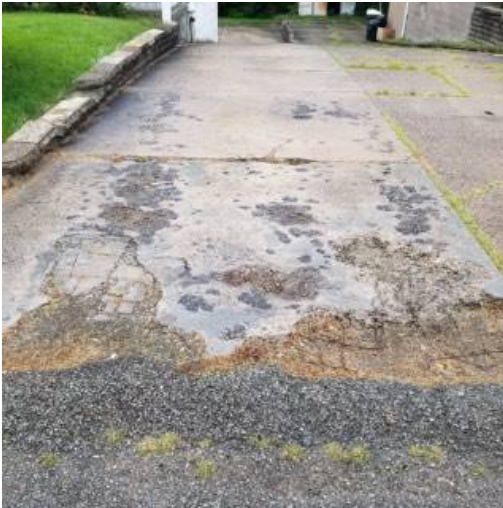
Photo 7-1

Minor deterioration (e.g. cracks, holes, settlement, heaving) was found in the driveway, but no trip hazards were found. The client may wish to have repairs made for cosmetic reasons.

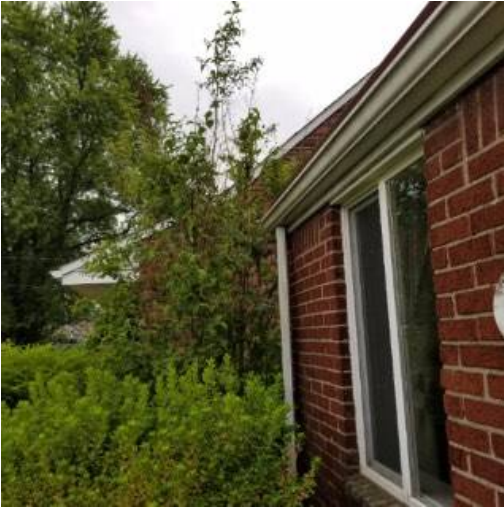
Photo 8-1

Vegetation such as trees, shrubs and/or vines was in contact with or close to the building exterior. Vegetation can serve as a pathway for wood-destroying insects and can retain moisture against the exterior after it rains. This is a conducive condition for wood-destroying organisms. Recommend pruning, moving or removing vegetation as necessary to maintain at least 6 inches of space between it and the building exterior. A 1-foot clearance is better.

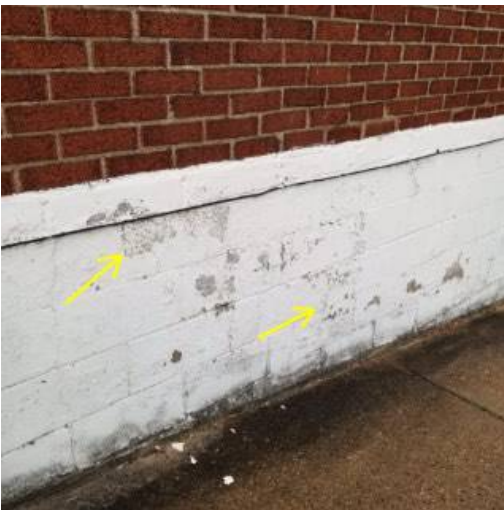
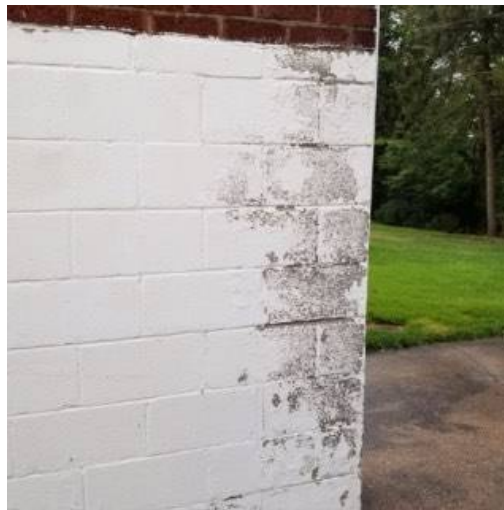
9) 🛠️💧 The paint or stain finish in some areas was failing (e.g. peeling, faded, worn, thinning). Siding and trim with a failing finish can be damaged by moisture. Recommend that a qualified contractor prep (e.g. clean, scrape, sand, prime, caulk) and repaint or restain the building exterior where necessary and per standard building practices. Any repairs needed to the siding or trim should be made prior to this.

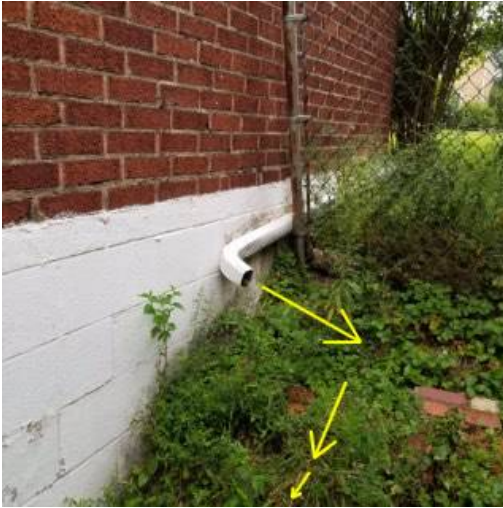
Photo 10-1

10) 🛠️ Extensions such as splash blocks or drain pipes for one or more downspouts were missing. Water can accumulate around the building foundation or inside crawl spaces or basements as a result. Recommend that a qualified person install, replace or repair extensions as necessary so rainwater drains away from the structure.

should be extended as far away from the foundation as possible

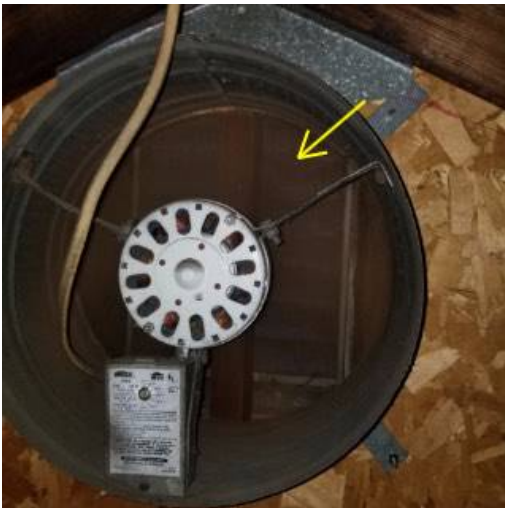
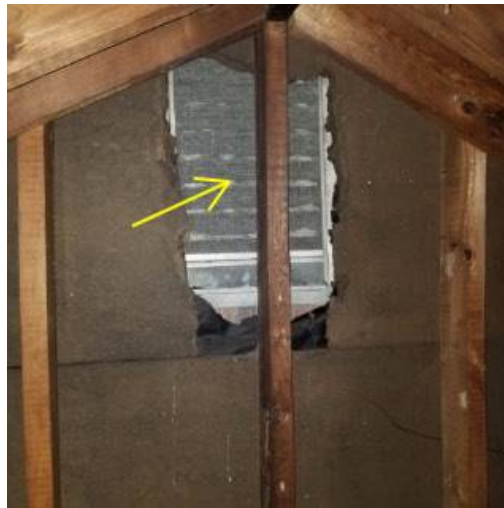
One or more attic or roof vent screens were missing, deteriorated or substandard. Recommend that a qualified person replace or repair screens as necessary to prevent birds or vermin from entering the attic.

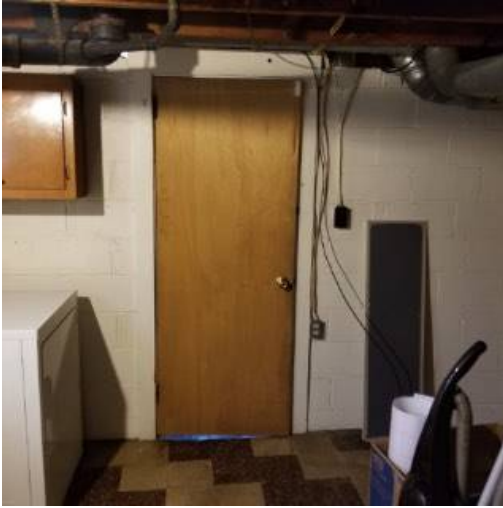
Photo 14-1

The door between the garage and the house did not appear to be fire resistant, or the inspector was unable to verify that it was via a label. This is a potential safety hazard. House to garage doors, to prevent fire and fumes from spreading from the garage into interior living space, should be constructed of fire-resistant materials. Doors, generally considered to be suitable for the purpose, are solid core wood, steel, honeycomb steel or a door that has been factory labeled as fire rated. Recommend that a qualified contractor replace or repair the door and, at that time, make any other corrections that might be required to provide suitable fire resistance between the garage and the dwelling per standard building practices. For more information, visit: <https://www.reporthost.com/?AGFR>

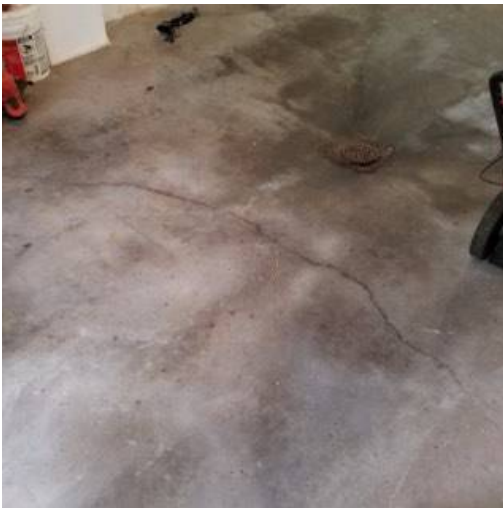
Photo 15-1

Minor cracks were found in the concrete slab floor. These are common and appeared to be only a cosmetic issue.

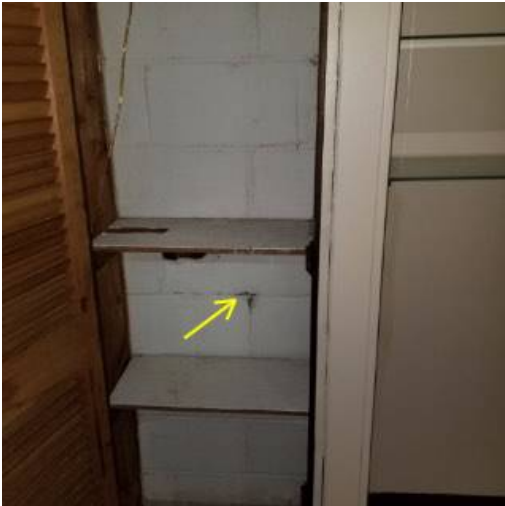
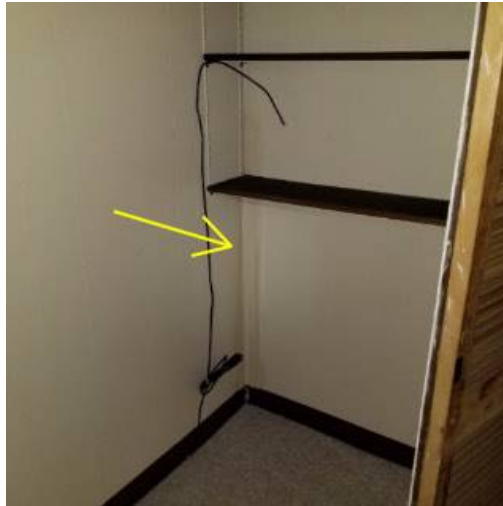
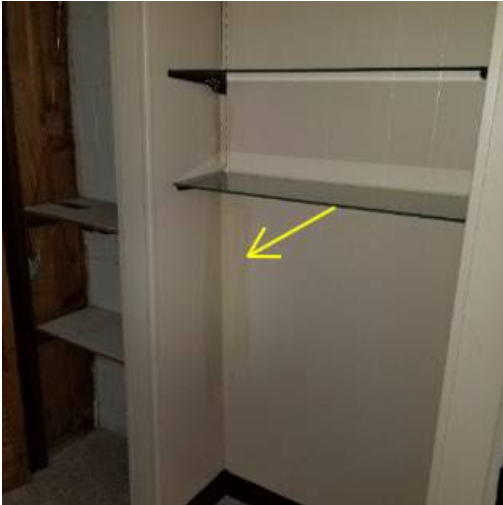
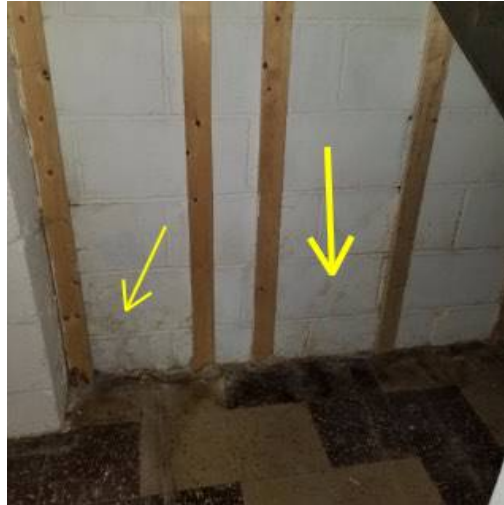
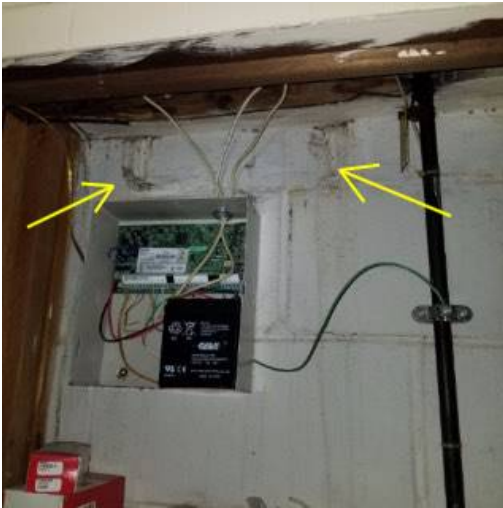
Evidence of prior water intrusion was found in one or more sections of the basement. For example, water stains or rust at support post bases, efflorescence on the foundation, etc. Accumulated water is a conducive condition for wood-destroying organisms and should not be present in the basement. Recommend reviewing any disclosure statements available and ask the property owner about past accumulation of water in the basement. The basement should be monitored in the future for accumulated water, especially after heavy and/or prolonged periods of rain. If water is found to accumulate, then recommend that a qualified contractor who specializes in drainage issues evaluate and repair as necessary. Typical repairs for preventing water from accumulating in basements include:

- Repairing, installing or improving rain run-off systems (gutters, downspouts and extensions or drain lines)
- Improving perimeter grading
- Repairing, installing or improving underground footing and/or curtain drains

Ideally, water should not enter basements, but if water must be controlled after it enters the basement, then typical repairs include installing a sump pump.

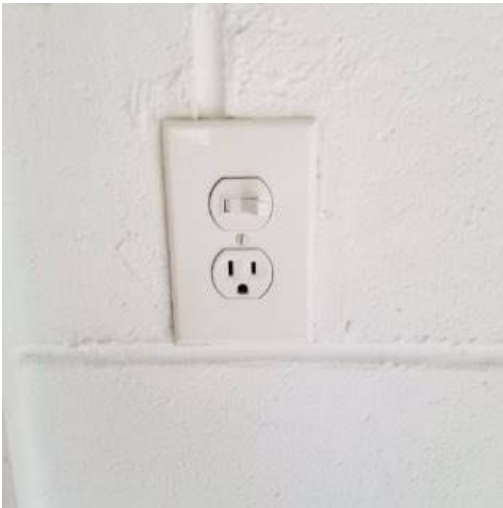
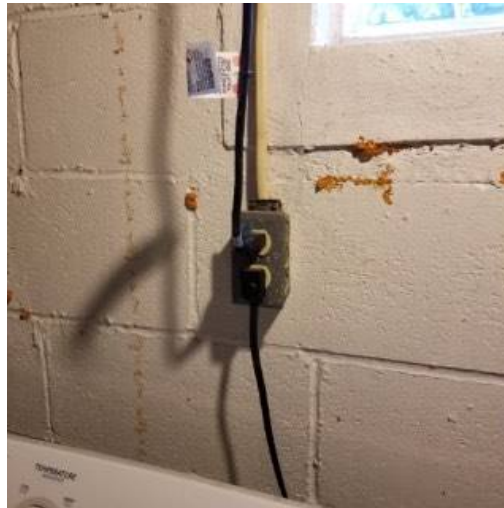
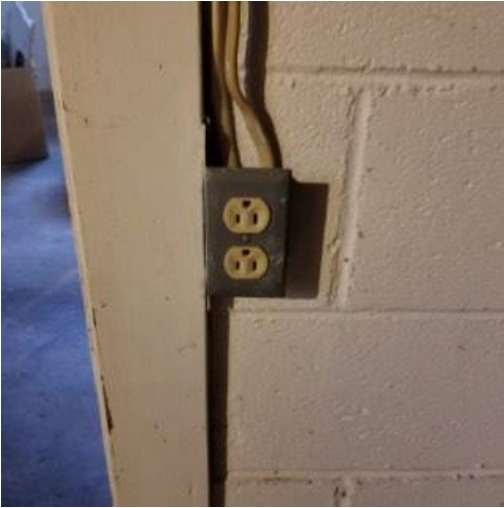
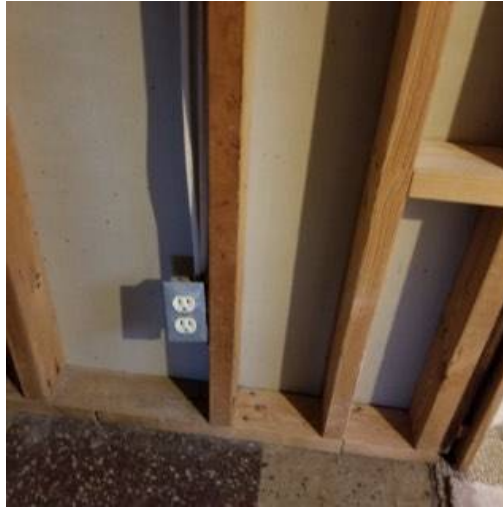
One or more electric receptacles (outlets) at the laundry sink and/or utility sink had no visible ground fault circuit interrupter (GFCI) protection, or the inspector was unable to determine if GFCI protection was present. If not GFCI-protected, receptacles in wet areas pose a shock hazard. Recommend that a qualified electrician evaluate and install GFCI protection if necessary and per standard building practices. General guidelines for GFCI-protected receptacles include the following locations:

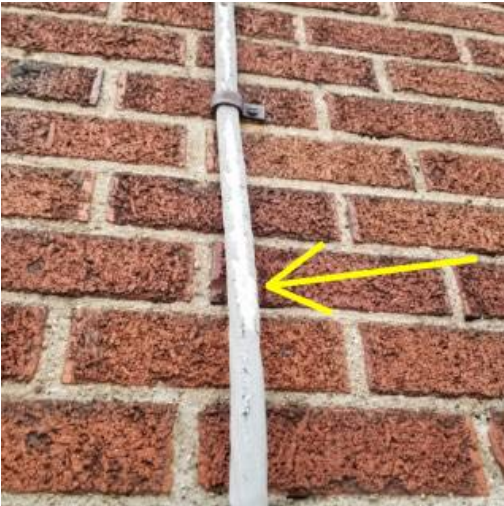
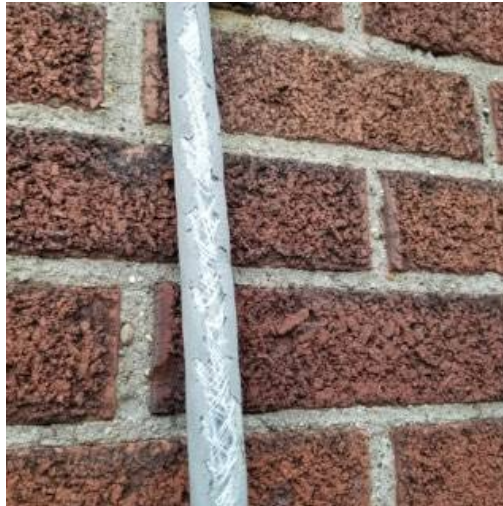
this is the main line that brings all of the power to the house. they are exposed to all types of weather conditions. sometime they can begin to deteriorate.

If conditions are right the inner HOT wires could begin to breakdown as well.

you should consult a qualified electrician to evaluate and make any repairs.

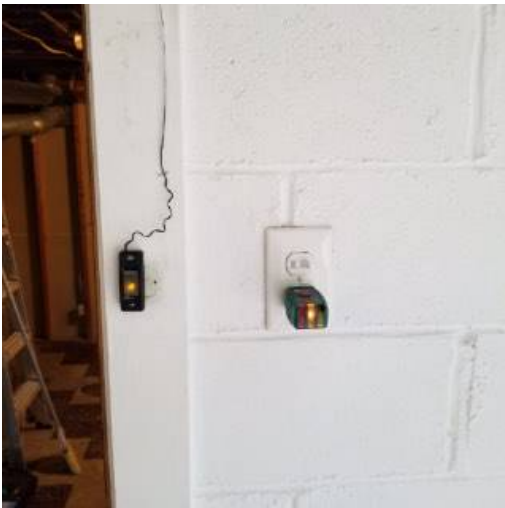
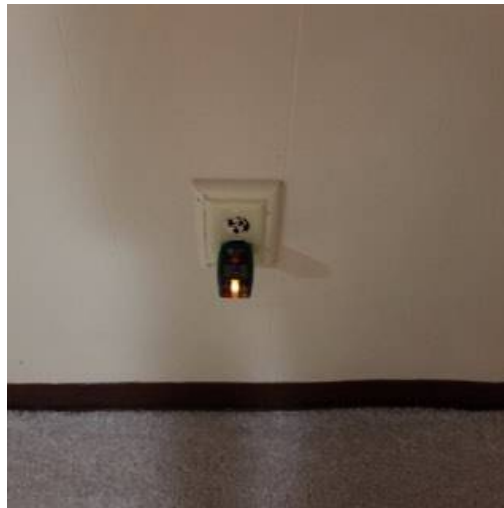
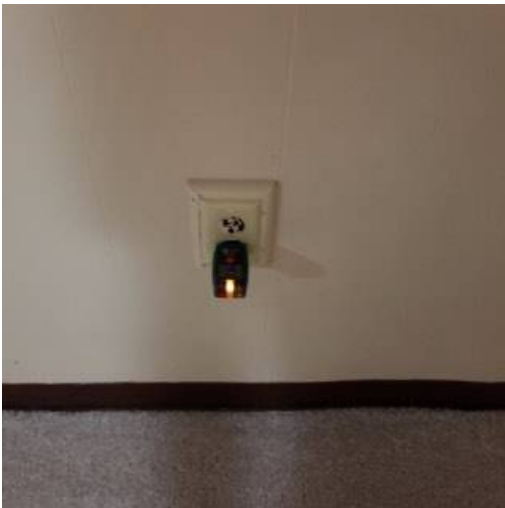
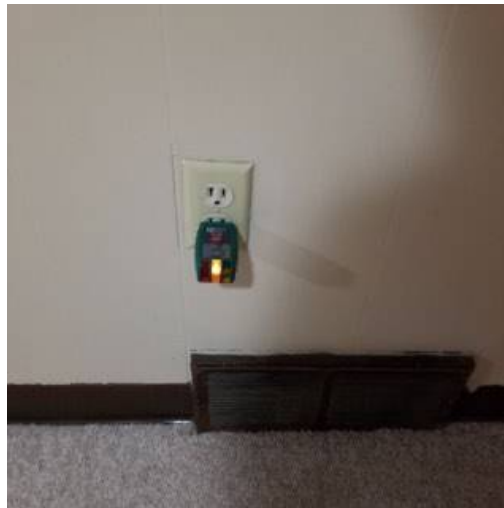
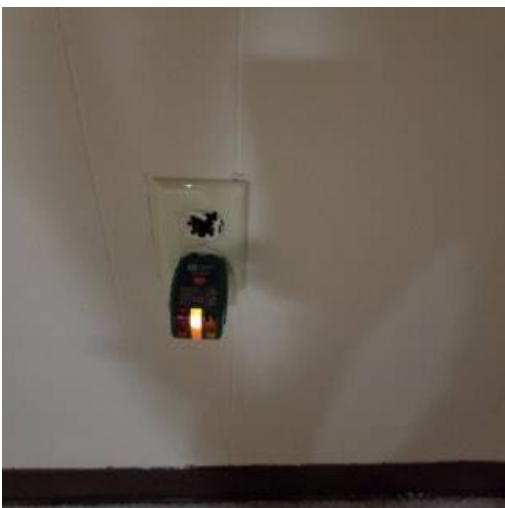
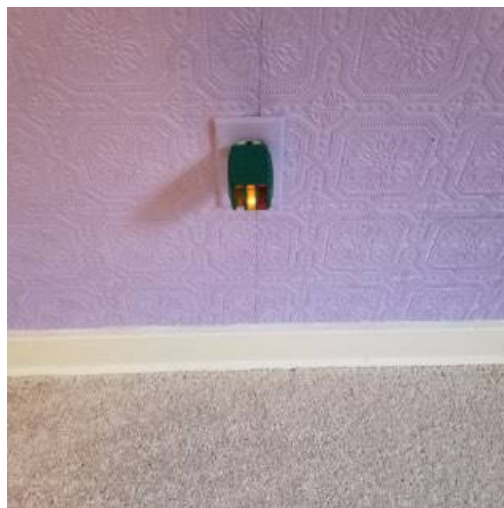
One or more electric receptacles (outlets) were incorrectly wired with "false grounds" where the receptacle's ground screw is connected to the neutral or white wire in the circuit. Such receptacles may appear to be grounded when they aren't. This is a shock hazard, and can damage equipment plugged into such receptacles. Recommend that a qualified electrician repair as necessary. For more information, visit:

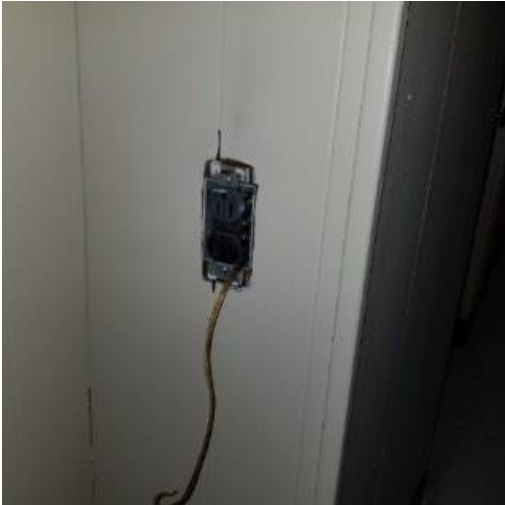
Photo 20-1

One or more cover plates for switches, receptacles (outlets) or junction boxes were missing or broken. These plates are intended to contain fire and prevent electric shock from occurring due to exposed wires. Recommend that a qualified person install cover plates where necessary.

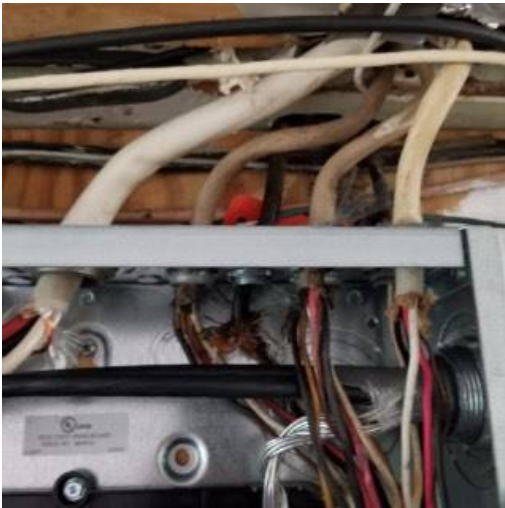
Photo 22-1

Branch circuit wiring installed in buildings built prior to the mid 1980s is typically rated for a maximum temperature of only 60 degrees Celsius. This includes non-metallic sheathed (Romex) wiring, and both BX and AC metal-clad flexible wiring. Knob and tube wiring, typically installed in homes built prior to 1950, may be rated for even lower maximum temperatures. Newer electric fixtures including lighting and fans typically require wiring rated for 90 degrees Celsius. Connecting newer fixtures to older, 60-degree-rated wiring is a potential fire hazard. Repairs for such conditions may involve replacing the last few feet of wiring to newer fixtures with new 90-degree-rated wire, and installing a junction box to join the old and new wiring.

It is beyond the scope of this inspection to determine if such incompatible components are installed, or to determine the extent to which they're installed. Based on the age of this building, the client should be aware of this safety hazard, both for existing fixtures and when planning to upgrade with newer fixtures. Consult with a qualified electrician for repairs as necessary.

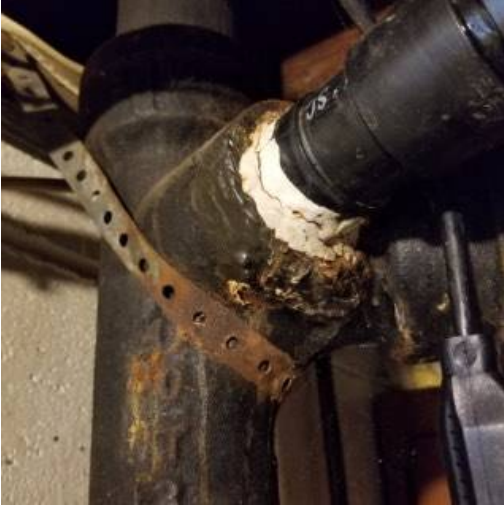
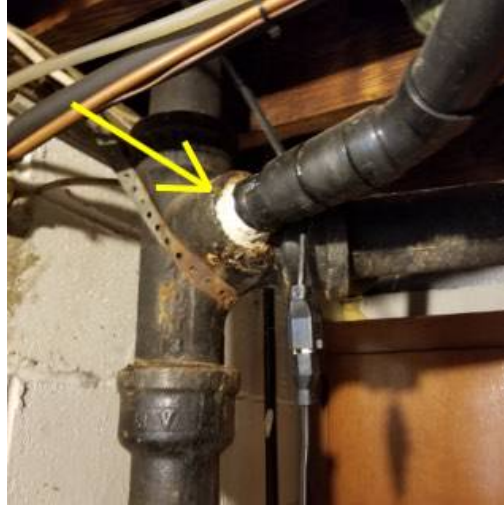
26) this is the where drain from the kitchen meets up with the main drain stack.
the connection looks like it is made of putty or caulking.
it is dry now but it is cracked and deteriorated.
it will most likely begin to leak.
the joint should be repaired properly

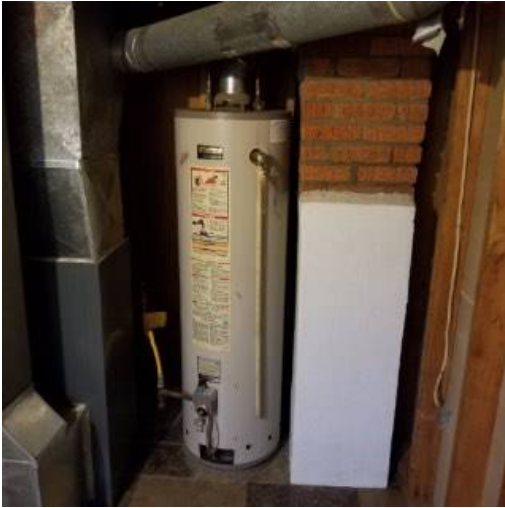
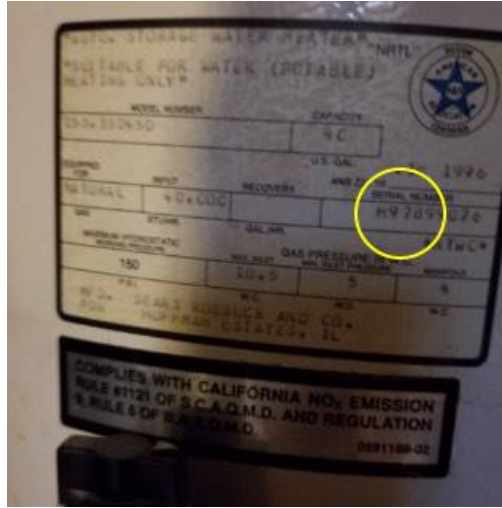
28) **i** The estimated useful life for most water heaters is 8-12 years. This water heater appeared to be beyond this age and/or its useful lifespan and may need replacing at any time. Recommend budgeting for a replacement in the near future, or considering replacement now before any leaks occur. The client should be aware that significant flooding can occur if the water heater fails. If not replaced now, consider having a qualified person install a catch pan and drain or a water alarm to help prevent damage if water does leak.

circa 1999

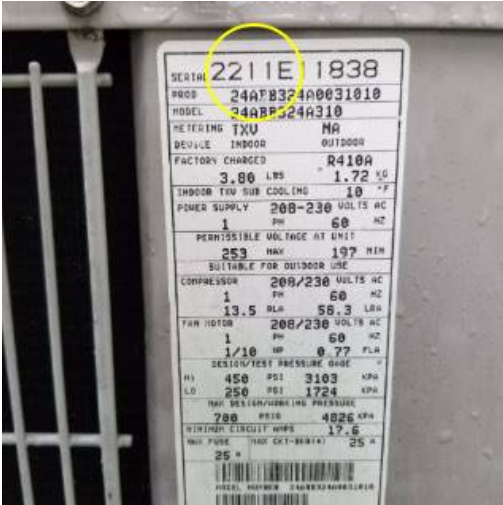
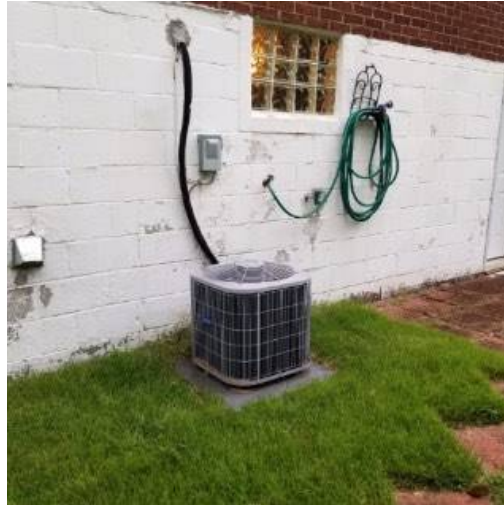
29) ⓘ ⓘ ⓘ The estimated useful life for most heat pumps and air conditioning condensing units is 10-15 years. This unit appeared to be near this age and/or its useful lifespan and may need replacing or significant repairs at any time. Recommend budgeting for a replacement in the near future.

circa 2011

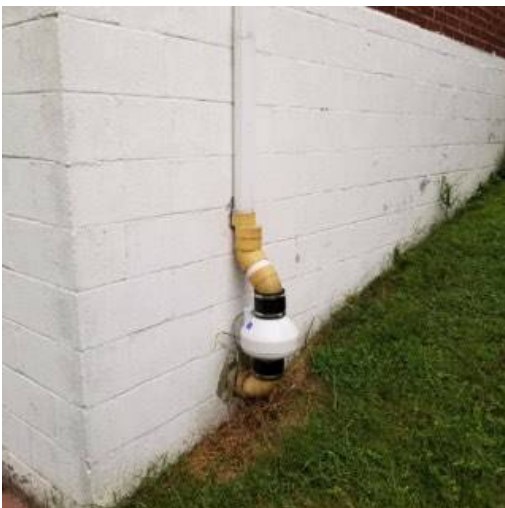
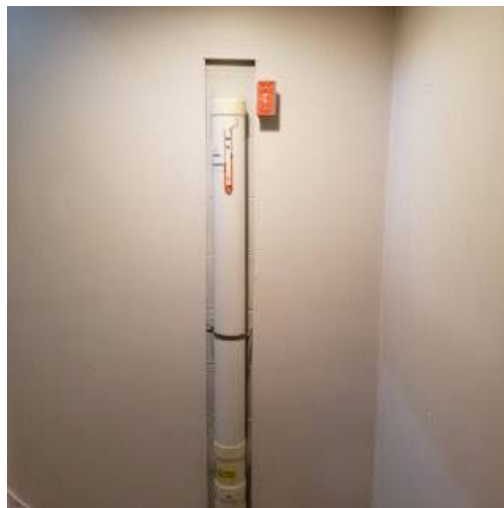
32) general view of radon mitigation system appears to be working well.
there is a strong vacuum on the system

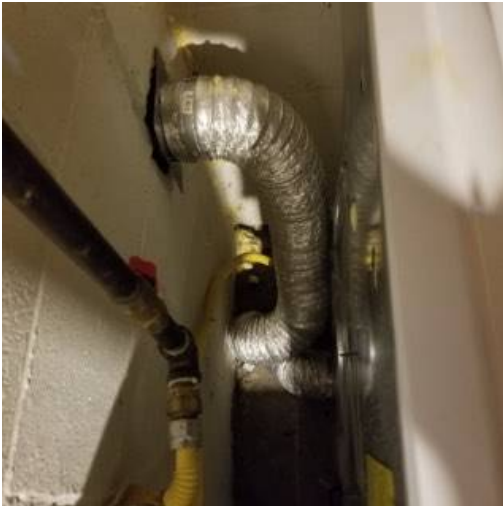
Photo 33-1

The clothes dryer was equipped with a vinyl or mylar, accordion-type, flexible exhaust duct. The U.S. Consumer Product Safety Commission considers these types of ducts to be unsafe, and a fire hazard. They can trap lint and are susceptible to kinks or crushing, which can greatly reduce the air flow and cause overheating. Recommend that such ducts be replaced with a rigid or corrugated semi-rigid metal duct, and by a qualified contractor if necessary. For more information, visit:

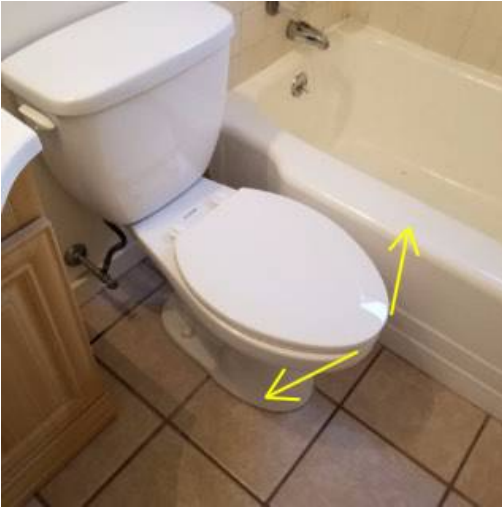
Photo 34-1

The toilet at location(s) # was loose where it attached to the floor. Leaks can occur. Flooring, the sub-floor or areas below may get damaged. Sewer gases can enter living spaces. Recommend that a qualified contractor remove the toilet(s) for further evaluation and repair if necessary. A new wax ring should be installed and toilet(s) should be securely anchored to the floor to prevent movement and leaking.

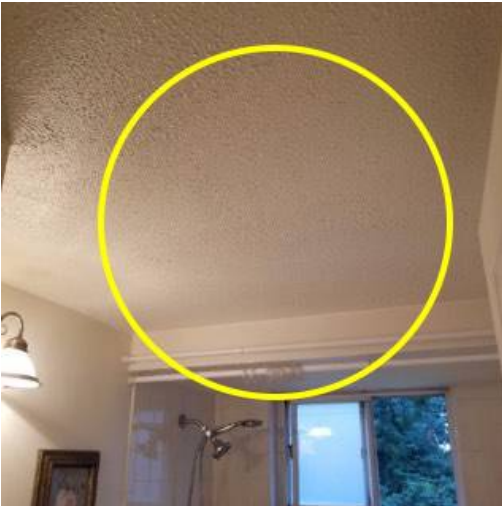
Photo 35-1

The bathroom with a shower or bathtub at location(s) # didn't have an exhaust fan installed. Moisture can accumulate and result in mold, bacteria or fungal growth. Even if the bathroom has a window that opens, it may not provide adequate ventilation, especially during cold weather when windows are closed or when wind blows air into the bathroom. Recommend that a qualified contractor install exhaust fans per standard building practices where missing in bathrooms with showers or bathtubs.

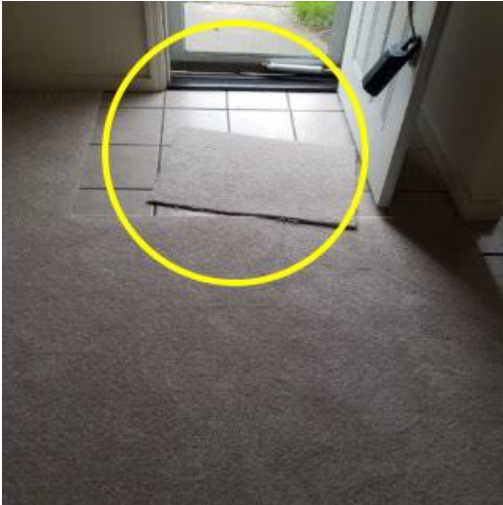
Photo 36-1

Squeaking or creaking noises occur when walking on one or more sections of flooring. This is usually caused by substandard construction practices where the sub-floor decking is not adequately fastened to the framing below. For example, not enough glue was used and/or nails were used rather than screws. In most cases, this is only an annoyance rather than a structural problem. Various solutions such as [Squeeeeeek No More and Counter Snap fasteners](#) exist to correct this. Repairs to eliminate the squeaks or creaks may be more or less difficult depending on the floor covering and the access to the underside of the sub-floor. Recommend that a qualified contractor evaluate and repair as necessary. For more information, visit: <https://www.reporthost.com/?SQUEAK>

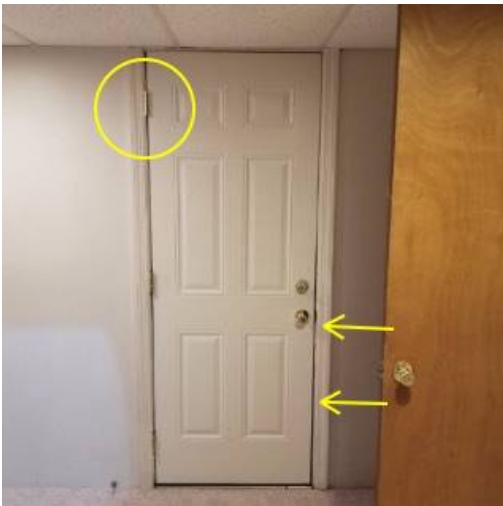
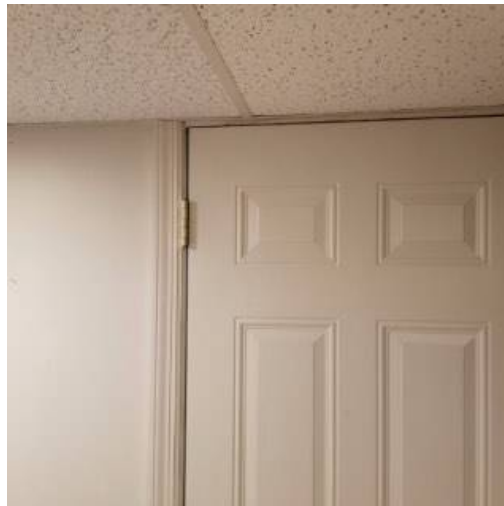
Some exterior door hardware, including hinges were loose. Recommend that a qualified person repair or replace as necessary.

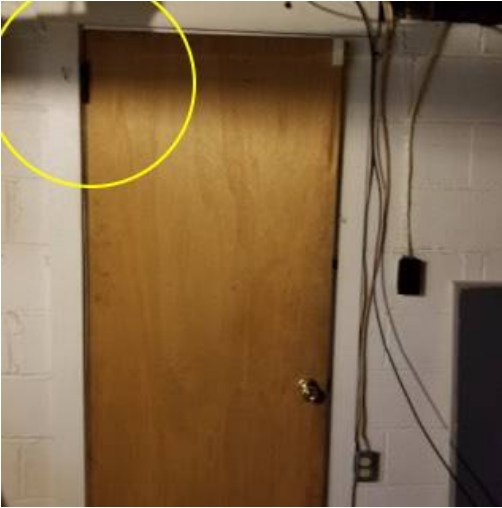
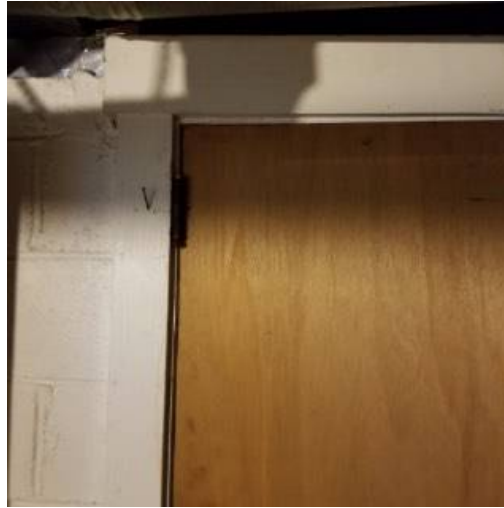
Some interior door hardware (hinges) were loose. Recommend that a qualified person repair or replace as necessary.

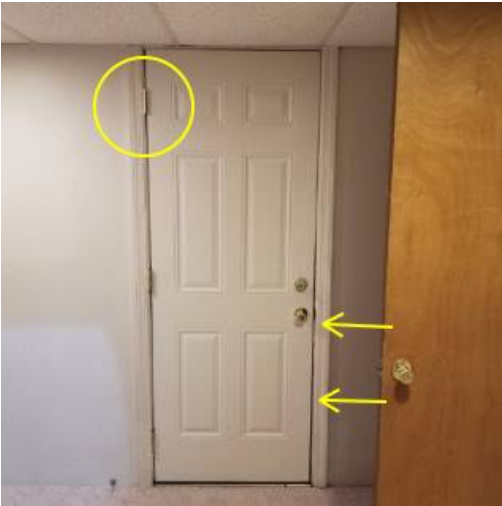
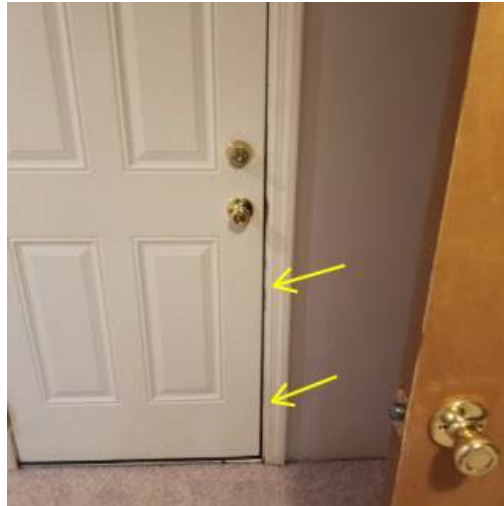
39) Missing or deteriorated weather stripping around an exterior door. Daylight can be seen between the door and it's frame. Air can pass through these gaps which can be an expensive energy lose.

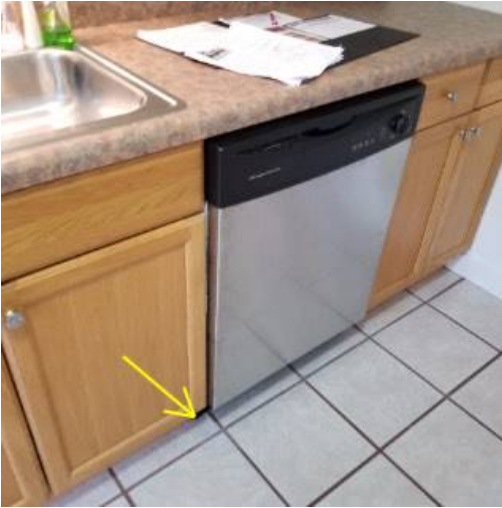
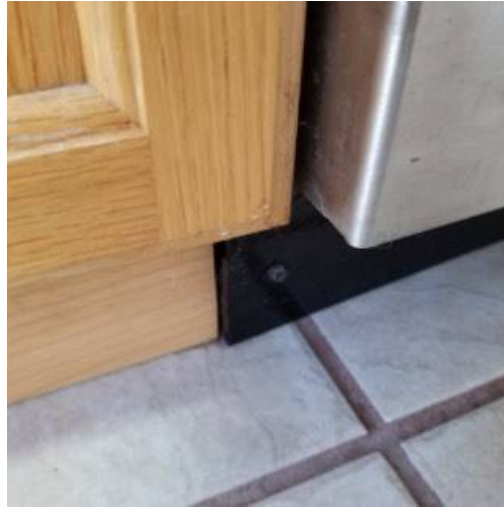
40) 🔧🔍 The dishwasher was leaking. Recommend that a qualified specialist evaluate and repair or replace as necessary.

there is a slight leak at the left corner of the dishwasher lid
