# INSPECTION REPORT

For the Property at:  
**282 ##### AVE**  
TORONTO, ON #####

Prepared for: Client  
Inspection Date: Thursday, August 5, 2021  
Prepared by: DAN LIU

Report No. 1021

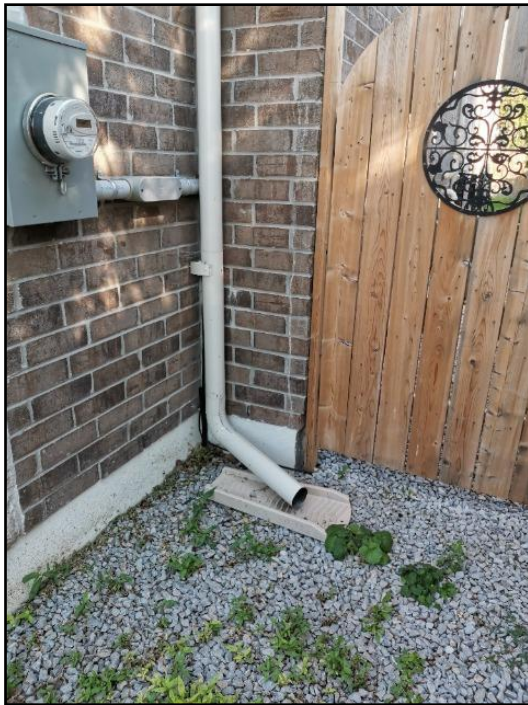
3. Condition: • [Should discharge 6 feet from building](#)

Implication(s): Chance of water damage to structure, finishes and contents

7. Should discharge 6 feet from building

Task: Improve

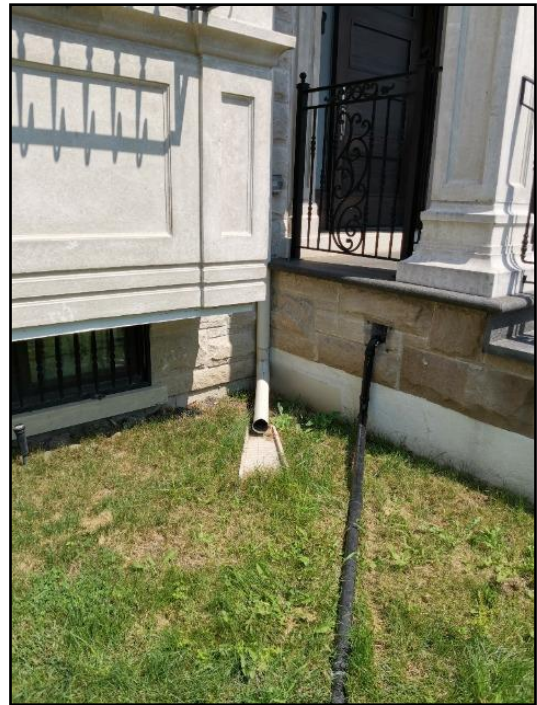
8. Should discharge 6 feet from building

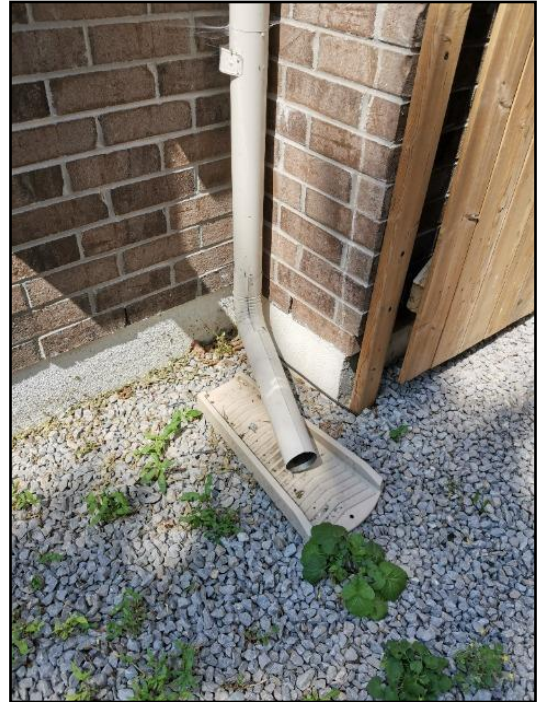
10. Should discharge 6 feet from building

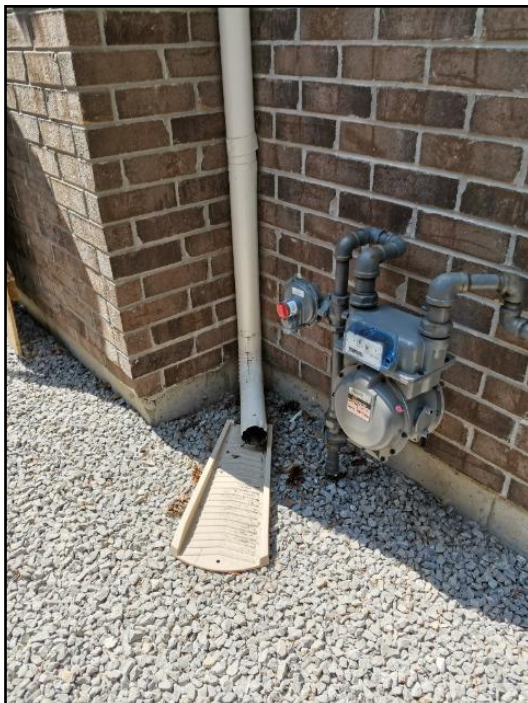
11. Should discharge 6 feet from building

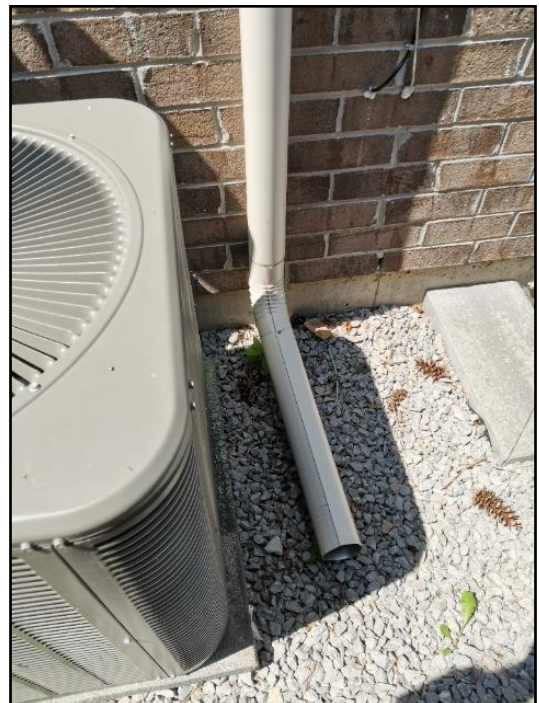
12. Should discharge 6 feet from building

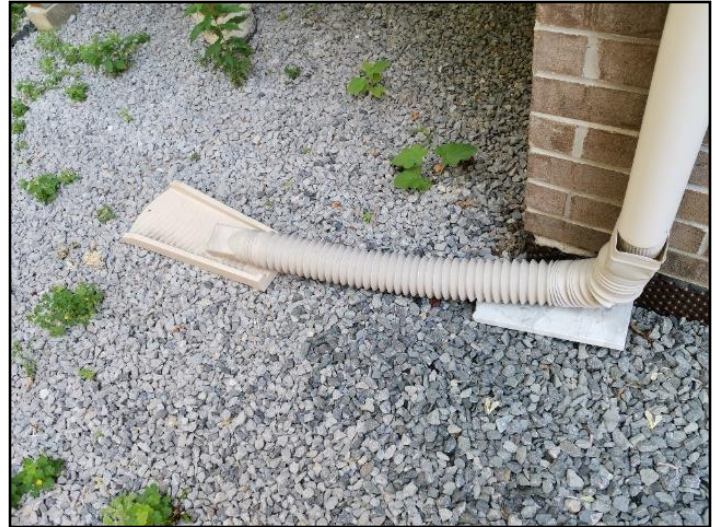
14. Should discharge 6 feet from building

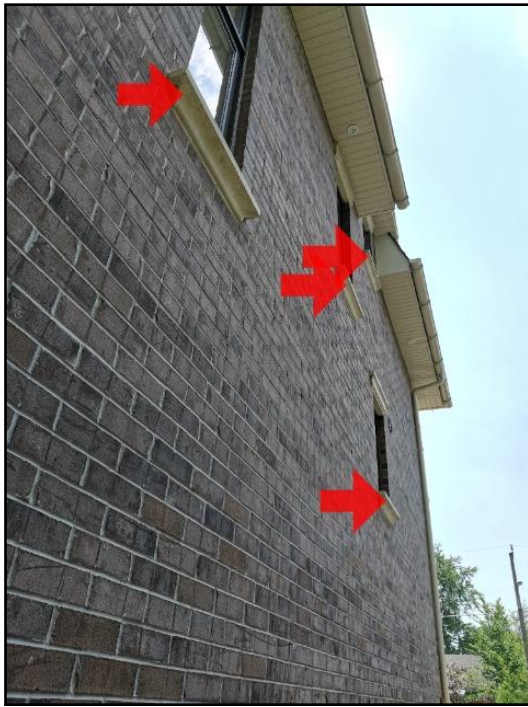
4. Condition: • [No capillary break \(drip edge\) on sill](#)

Implication(s): Chance of water damage to structure, finishes and contents

15. No capillary break (drip edge) on sill

Task: Improve

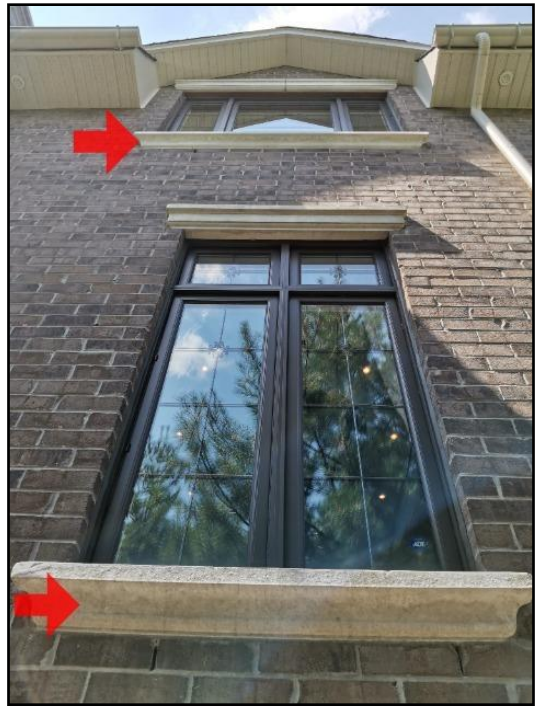
16. No capillary break (drip edge) on sill

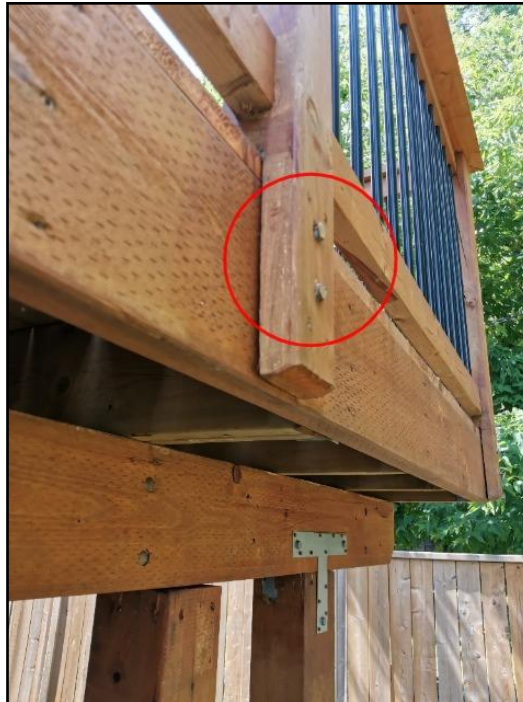
5. Condition: • [Loose](#)

**Implication(s):** Fall hazard  
**Location:** North Exterior Deck  
**Task:** Repair  
**Time:** Immediate

17. Loose

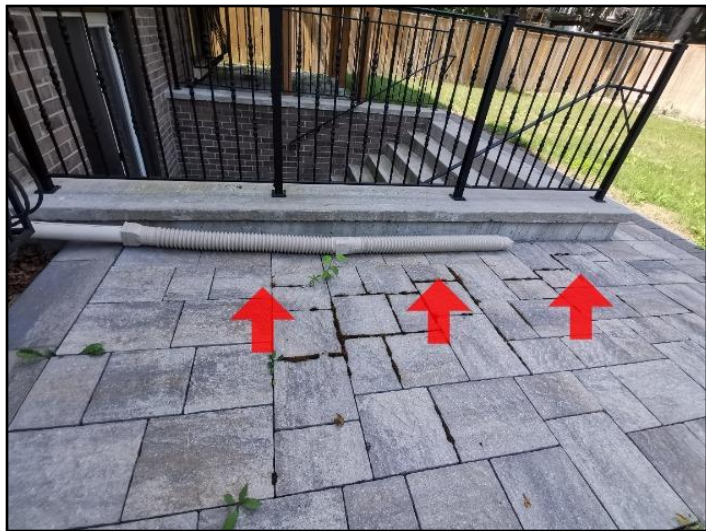
**6. Condition:** • [Slope toward building](#)

**Implication(s):** Chance of water damage to structure, finishes and contents

18. Slope toward building

**Task:** Repair

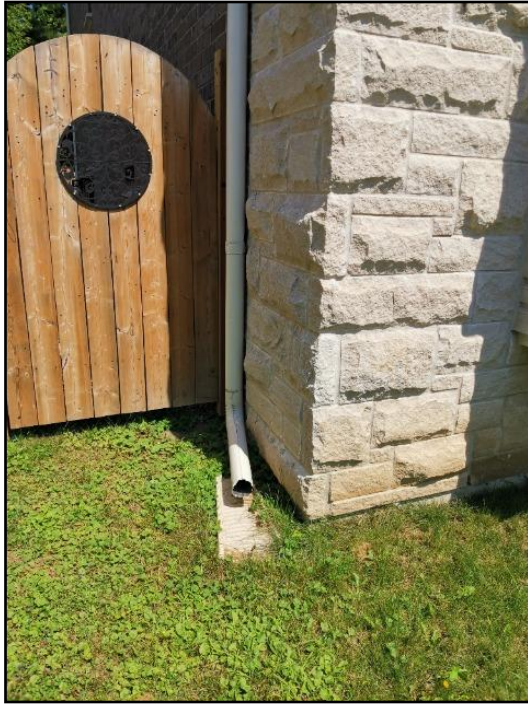
7. Condition: • [Planters and gardens against walls](#)

Implication(s): Chance of water entering building | Chance of damage to structure | Chance of structural movement

19. Planters and gardens against walls

Task: Correct

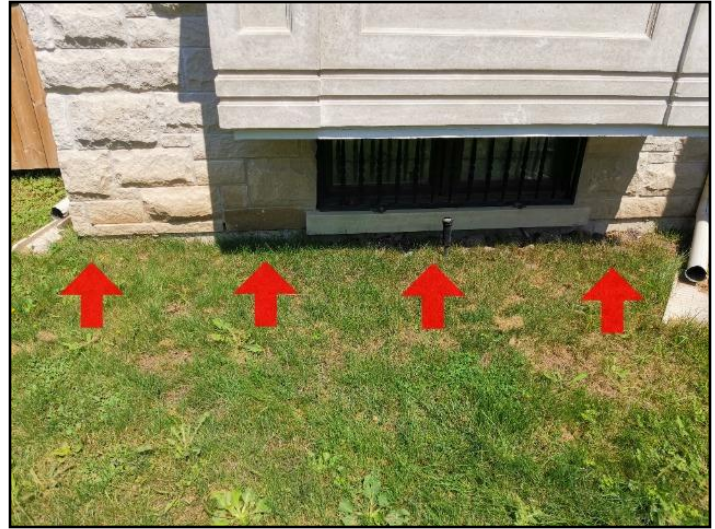
20. Planters and gardens against walls

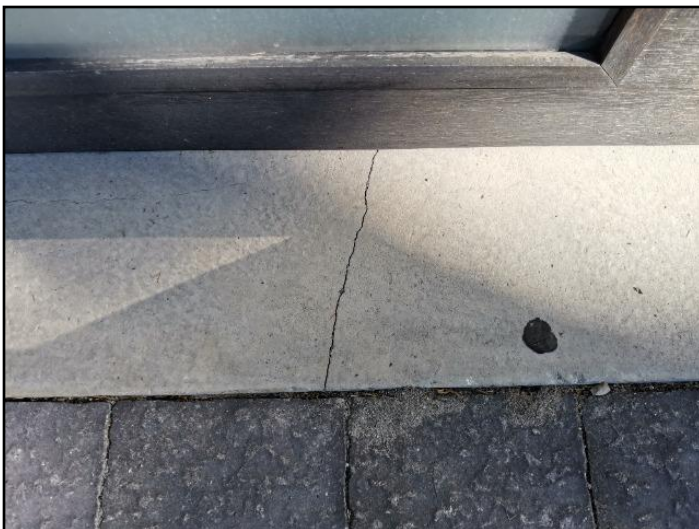
8. Condition: • [Cracked](#)

Implication(s): Uneven floors

21. Cracked

Task: Monitor

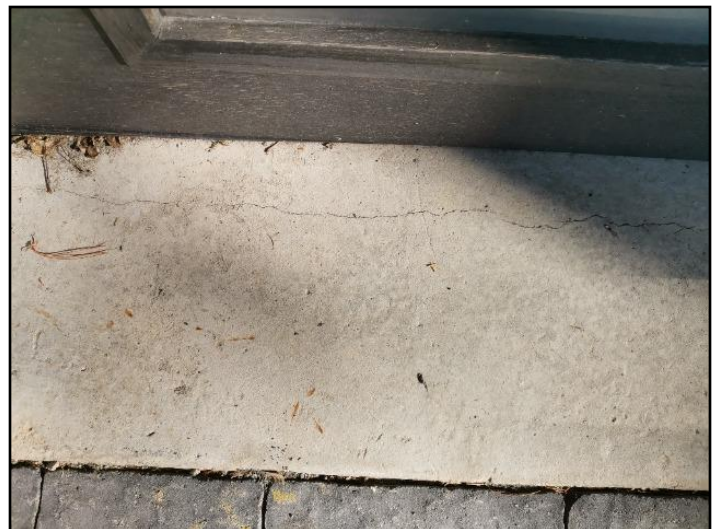
22. Cracked

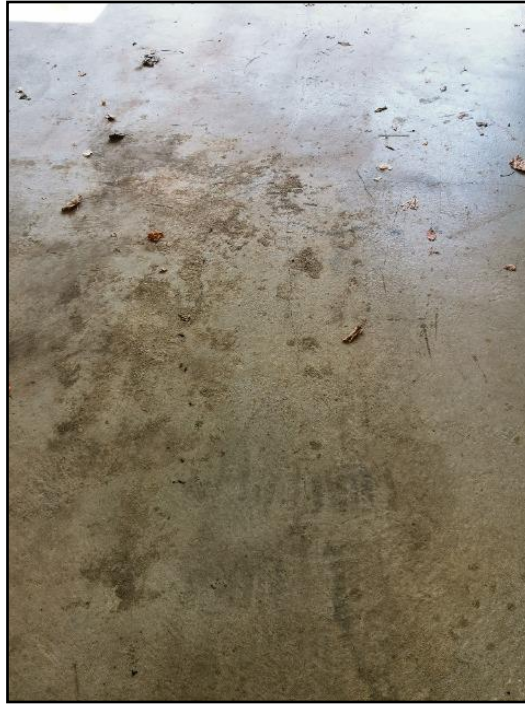
23. Cracked

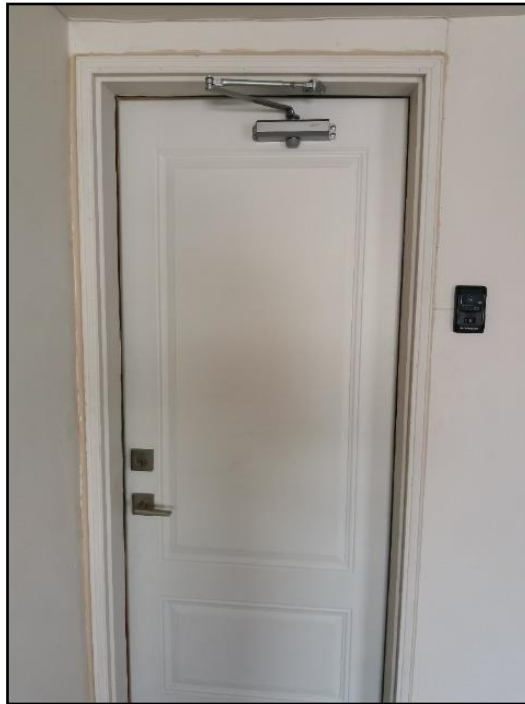
**9. Condition:** • [Opens into bedroom](#)

**Implication(s):** Hazardous combustion products entering home

24. Opens into bedroom

**Task:** Repair

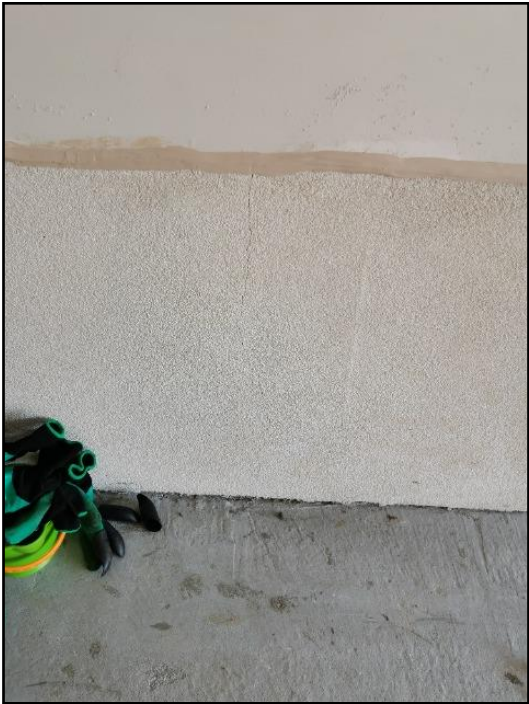
- 11. Condition:** • Typical minor cracks
- Implication(s):** Chance of water entering building
- Location:** First Floor Garage
- Task:** Repair
- Time:** If necessary

25. Typical minor cracks

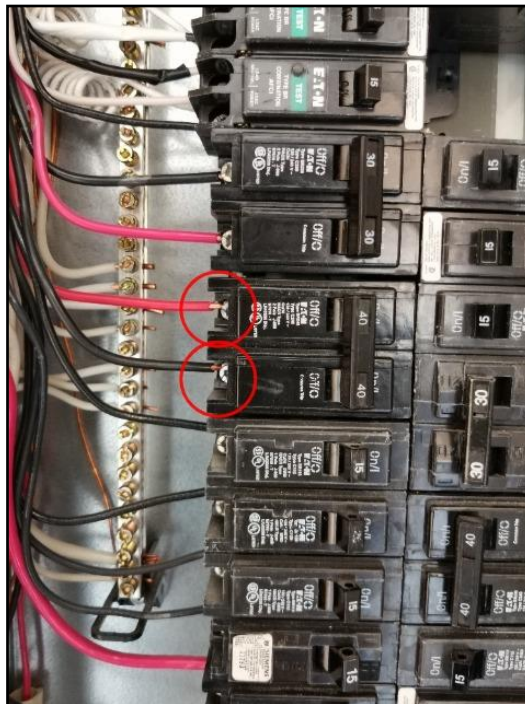
**12. Condition:** • [Undersized wire](#)

**Implication(s):** Electric shock | Fire hazard

26. Undersized wire

**Task:** Correct

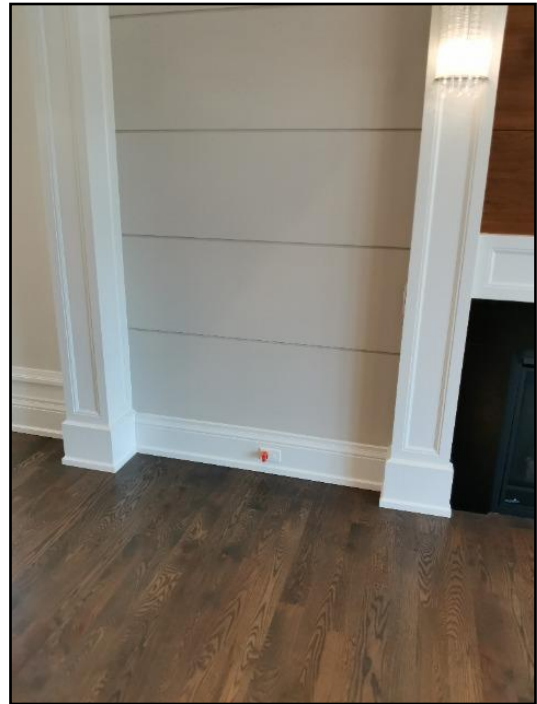
The reversed hot/neutral line recepticals are throughout the hallway and living room which are suspected in one distribution line.

**14. Condition:** • [Reversed polarity](#)

29. Reversed polarity

**Task:** Repair

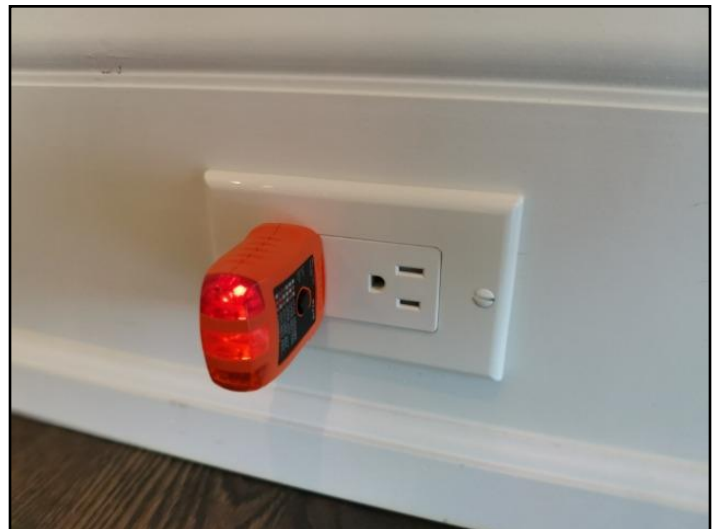
31. Reversed polarity

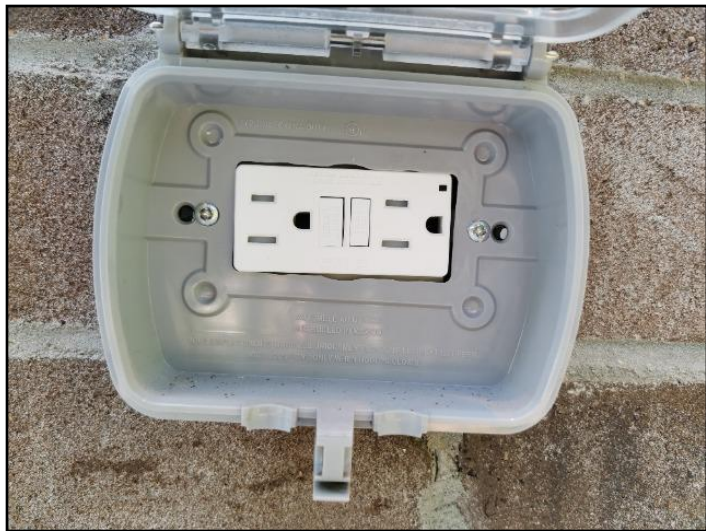
**15. Condition:** • Not suitable for outdoor (exterior) use  
**Implication(s):** Shock hazard or interruption of electrical service  
**Location:** Various Exterior  
**Task:** Replace  
**Time:** Immediate

32. Not suitable for outdoor (exterior) use

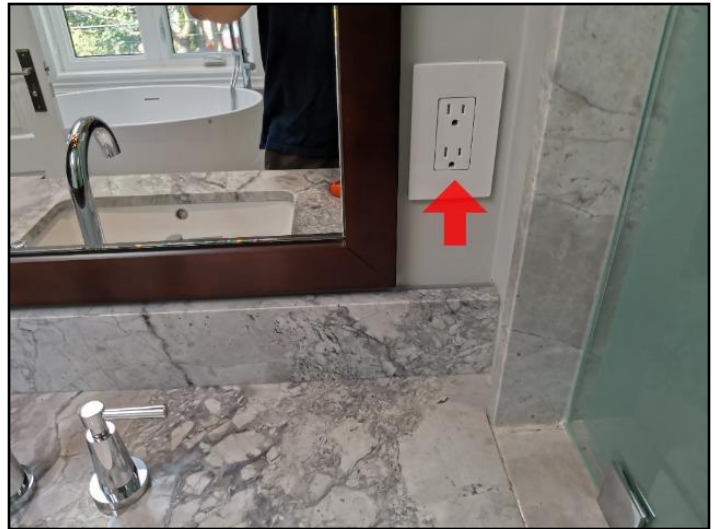
16. Condition: • [GFCI/GFI needed \(Ground Fault Circuit Interrupter\)](#)

34. GFCI/GFI needed (Ground Fault Circuit...

Task: Replace

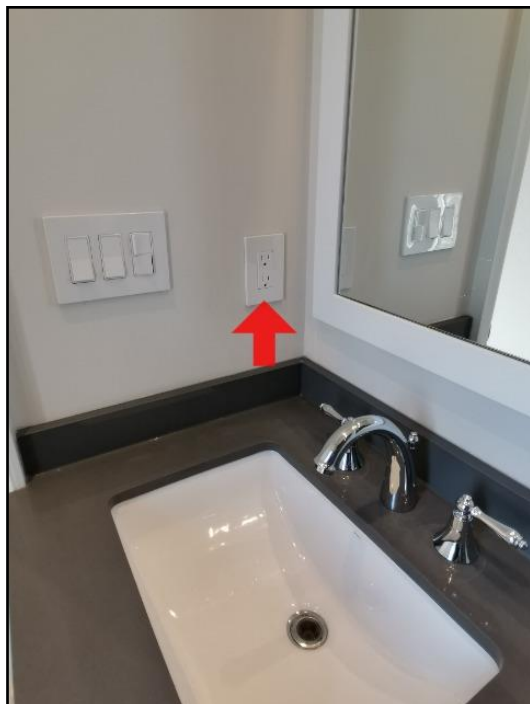
35. GFCI/GFI needed (Ground Fault Circuit...

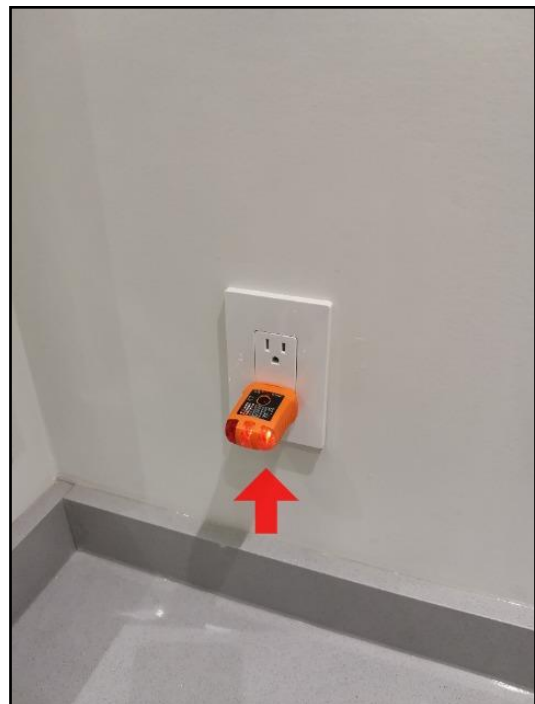
36. GFCI/GFI needed (Ground Fault Circuit...

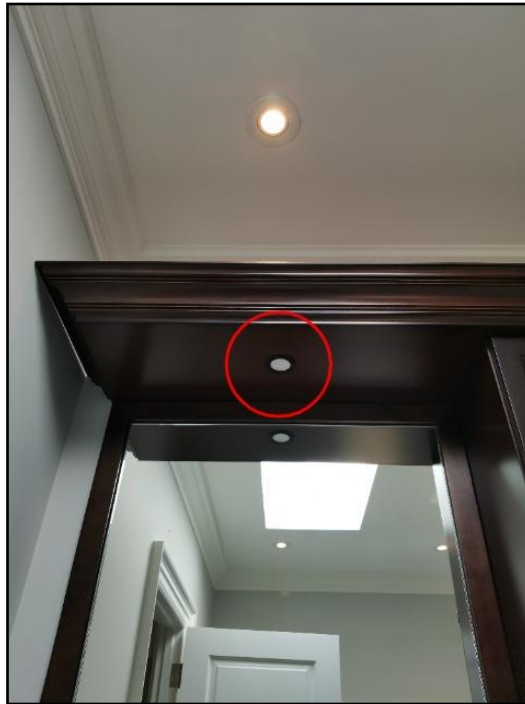
17. Condition: • [Inoperative](#)

Implication(s): Inadequate lighting

37. Inoperative

Task: Replace

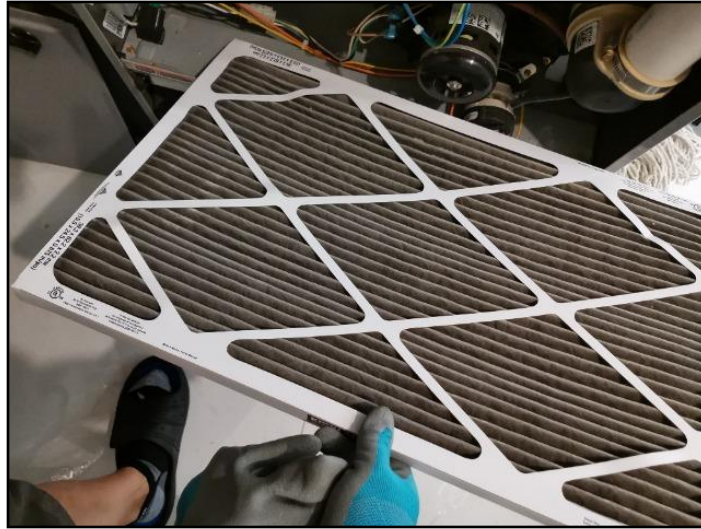
**18. Condition:** • [Dirty](#)

38. Dirty

**Task:** Replace

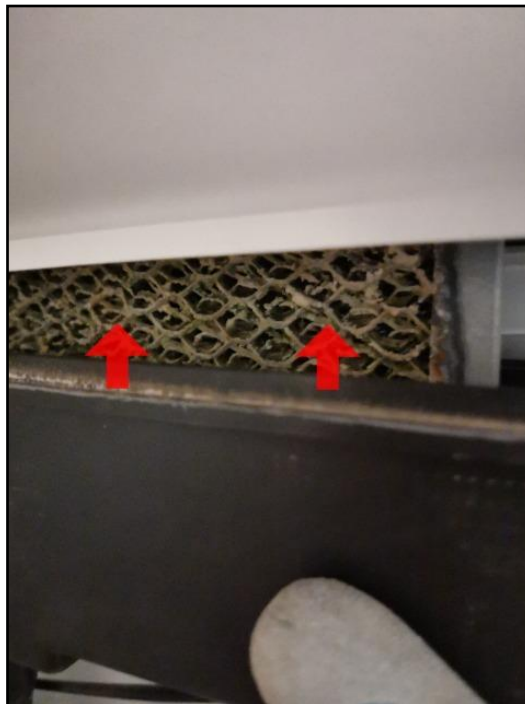
19. Condition: • [Clogged pad, mesh or nozzle](#)

39. Clogged pad, mesh or nozzle

Task: Replace

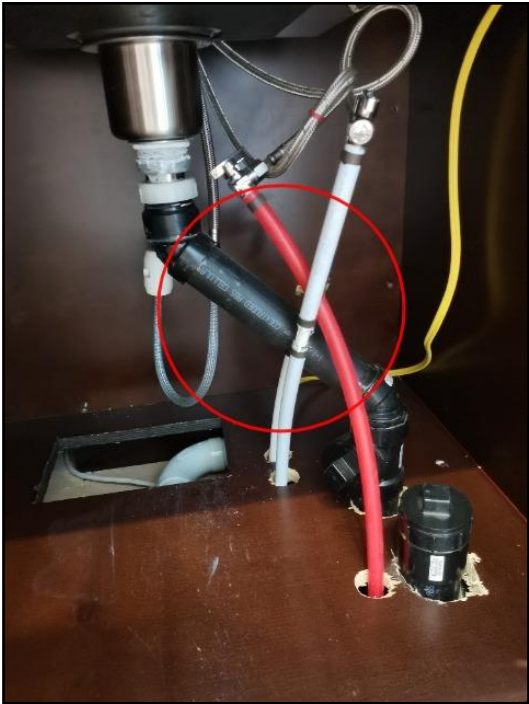
**21. Condition:** • [Wrong type](#)  
**Implication(s):** Sewer gases entering the building  
**Location:** First Floor Kitchen  
**Task:** Repair  
**Time:** Immediate

41. Wrong type

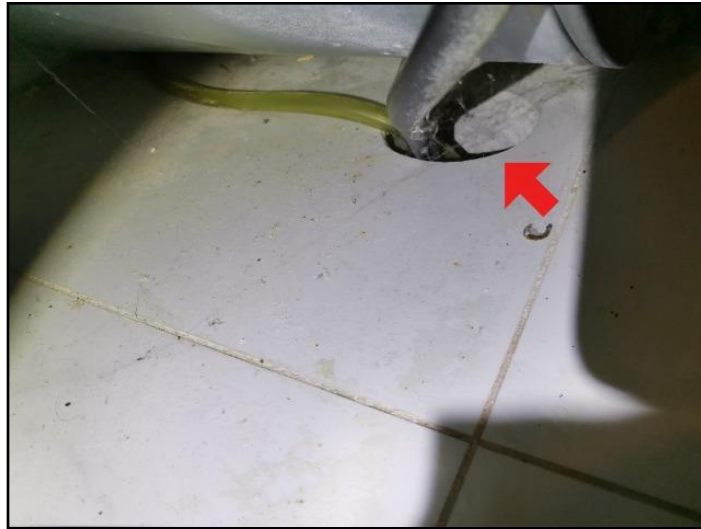
22. Condition: • [Grate missing, rusted or obstructed](#)

**Implication(s):** Chance of water damage to structure, finishes and contents | Trip or fall hazard

42. Grate missing, rusted or obstructed

**Task:** Provide

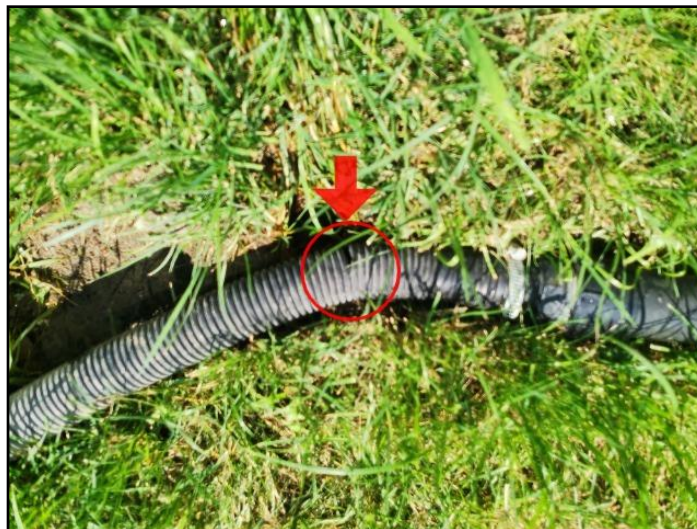
23. **Condition:** • [Discharge pipe problems](#)

**Implication(s):** Chance of water damage to structure, finishes and contents

43. Discharge pipe problems

**Task:** Repair or replace

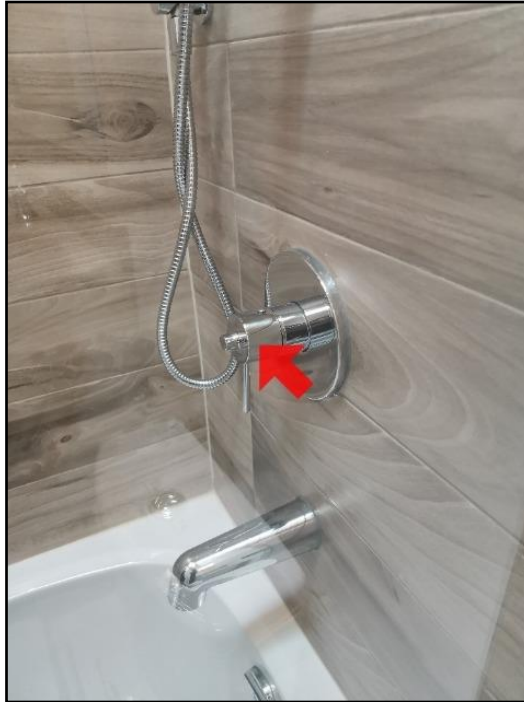
24. Condition: • [Loose](#)

Implication(s): Equipment failure

44. Loose

Task: Repair

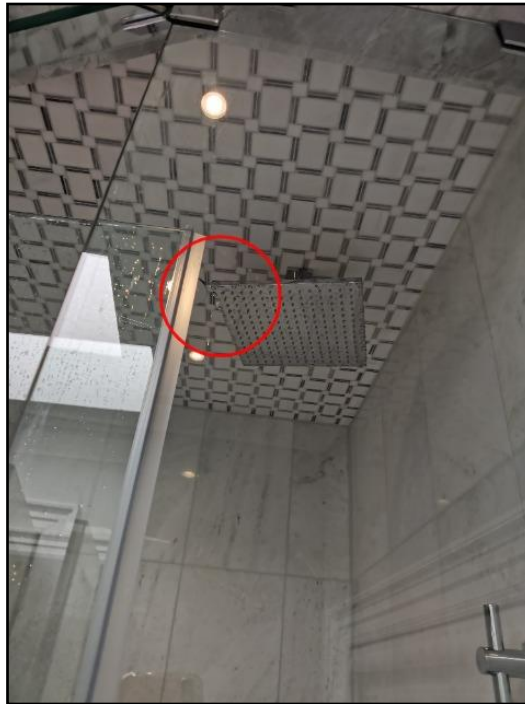
**25. Condition:** • Shower head damaged

45. Shower head damaged

**Task:** Repair or replace

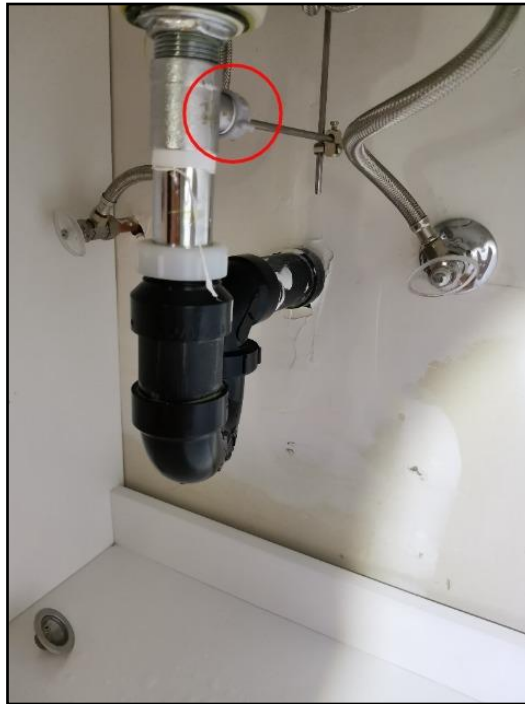
26. Condition: • [Leak](#)

**Implication(s):** Chance of water damage to structure, finishes and contents | Sewage entering the building

46. Leak

**Task:** Repair or replace

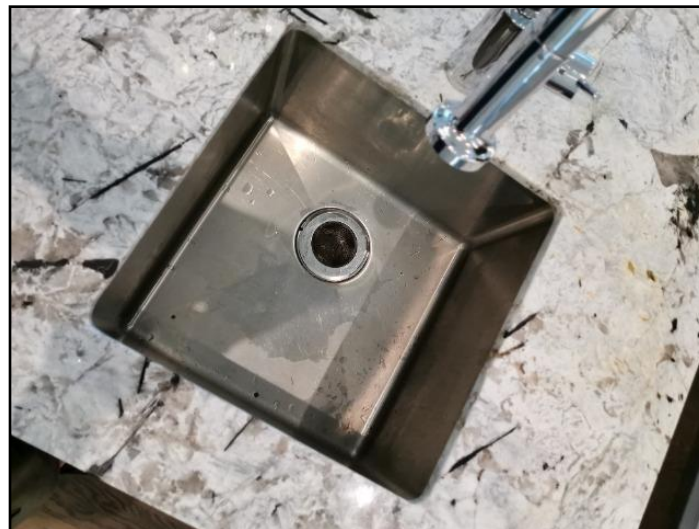
27. Condition: • [Overflows missing, leak, rust or inappropriate](#)

Implication(s): Chance of water damage to structure, finishes and contents

47. Overflows missing, leak, rust or...

Task: Repair or replace

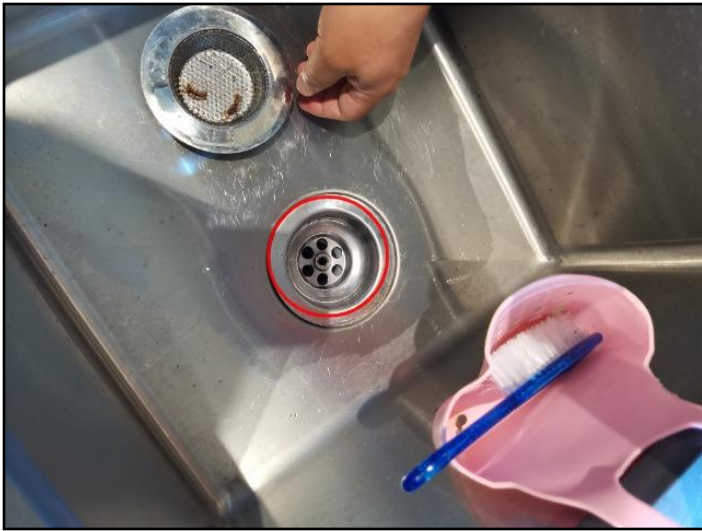
**28. Condition:** • Drain stop missing

48. Drain stop missing

**Task:** Provide

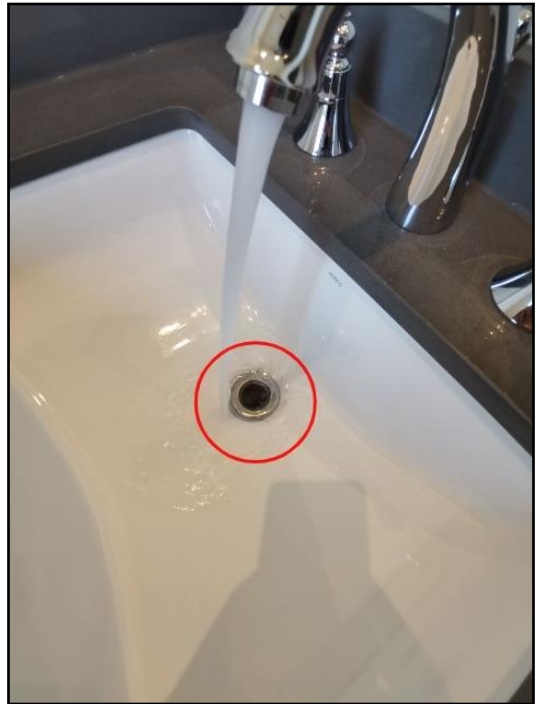
49. Drain stop missing

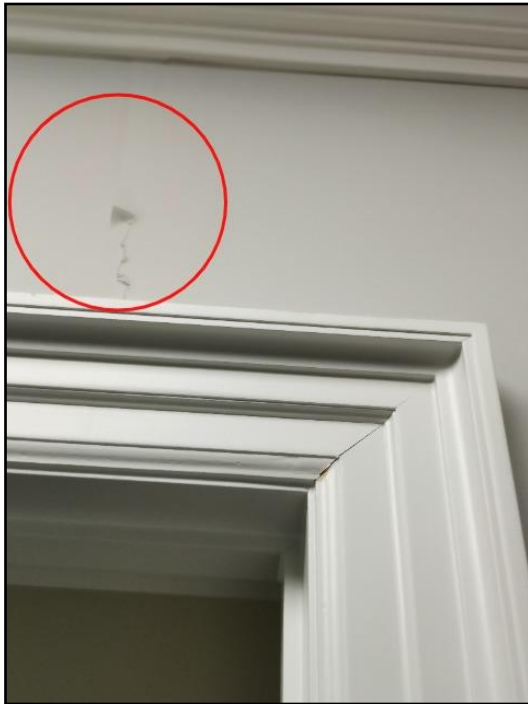
**30. Condition:** • [Cracked](#)

50. Cracked

**Task:** Repair

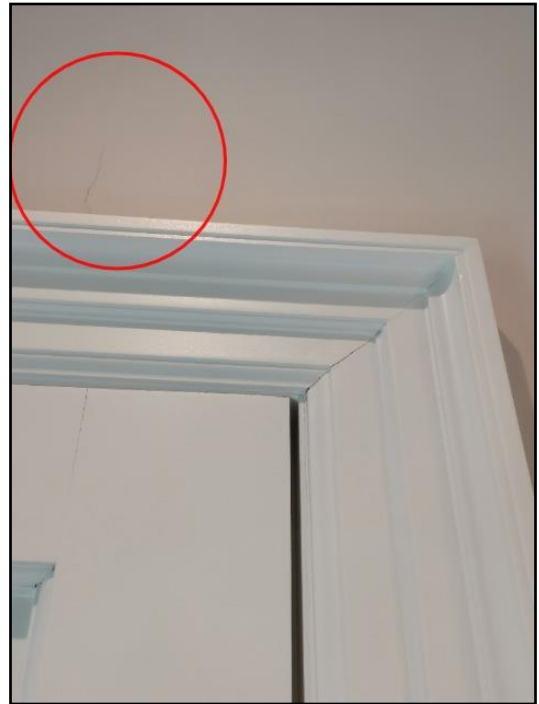
51. Cracked

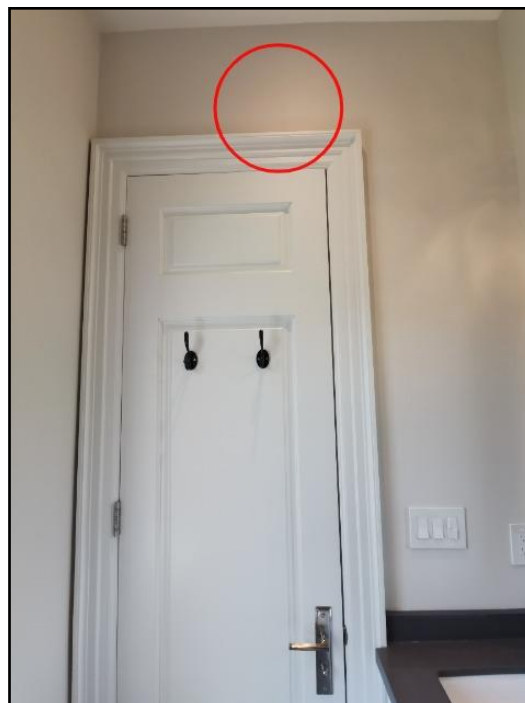
52. Cracked

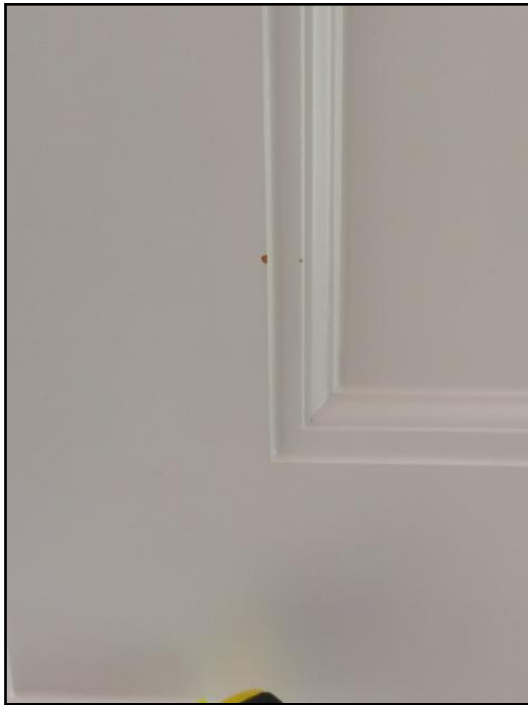
31. Condition: • [Typical flaws](#)

53. Typical flaws

Task: Repair

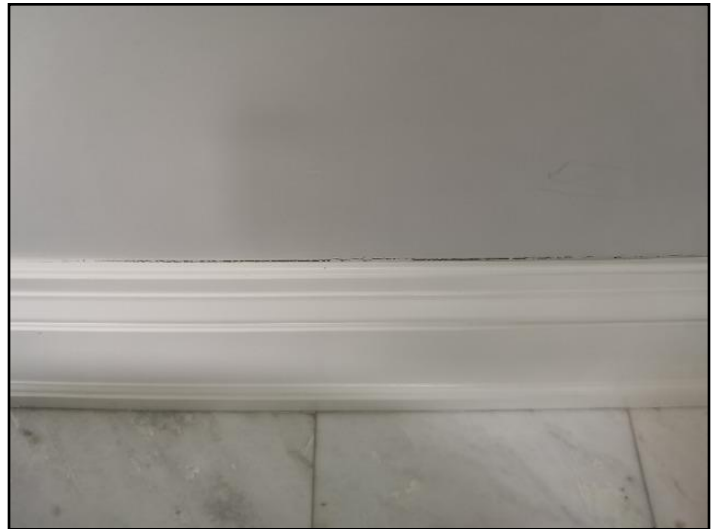
54. Cracked

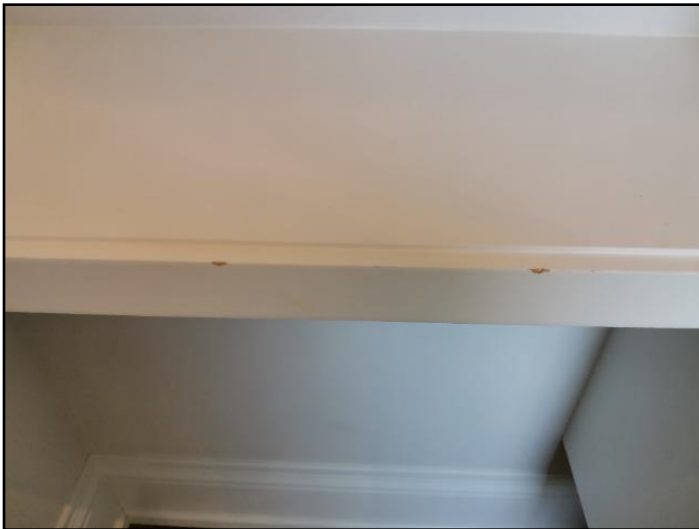
55. Typical flaws

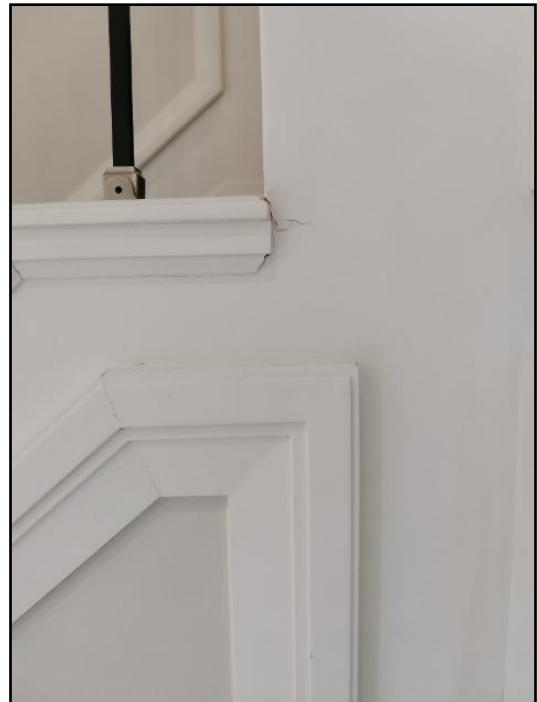
56. Typical flaws

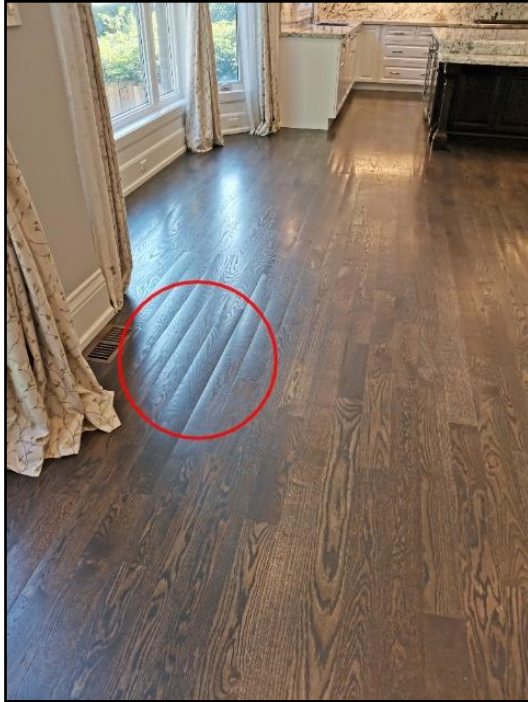
32. Condition: • [Warped](#)

**Implication(s):** Trip or fall hazard  
**Location:** Various First Floor Dining Room  
**Task:** Repair  
**Time:** Discretionary

57. Warped

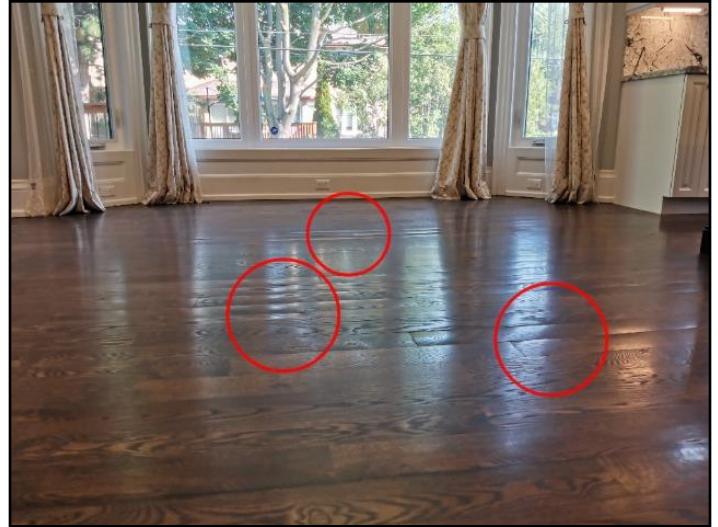
58. Warped

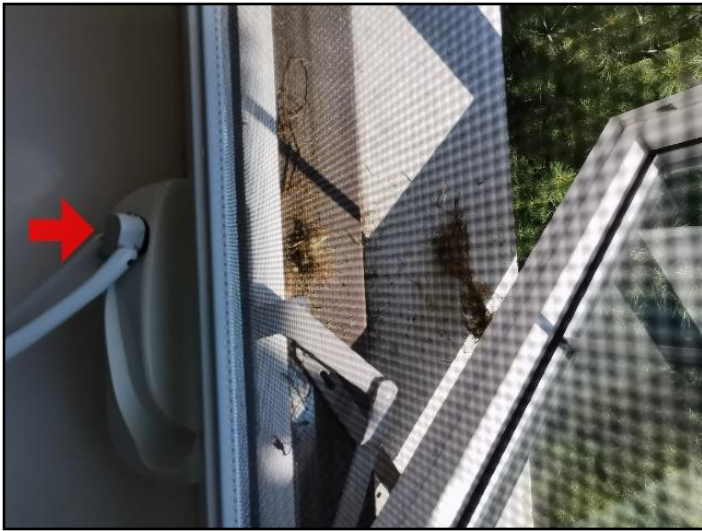
33. Condition: • [Inoperative](#)

59. Inoperative

**Task:** Repair

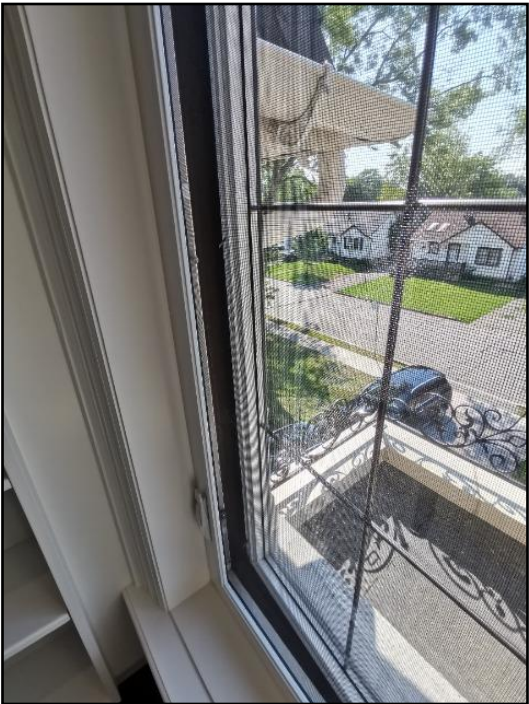
60. Inoperative

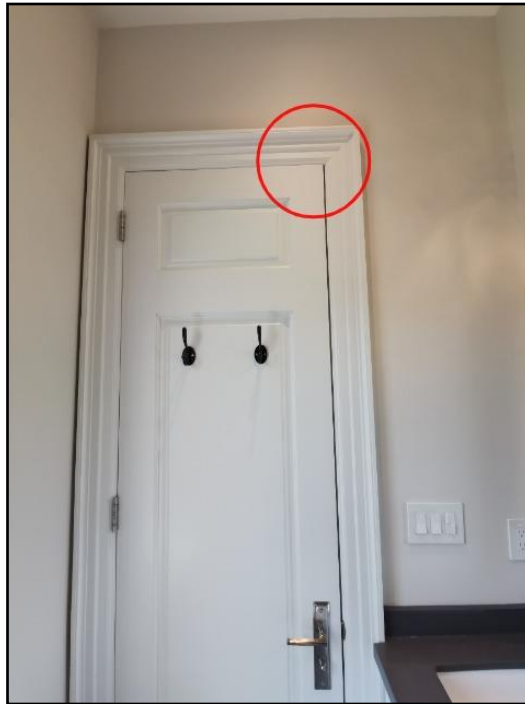
**34. Condition:** • [Stiff](#)

61. *Stiff*

**Task:** Repair

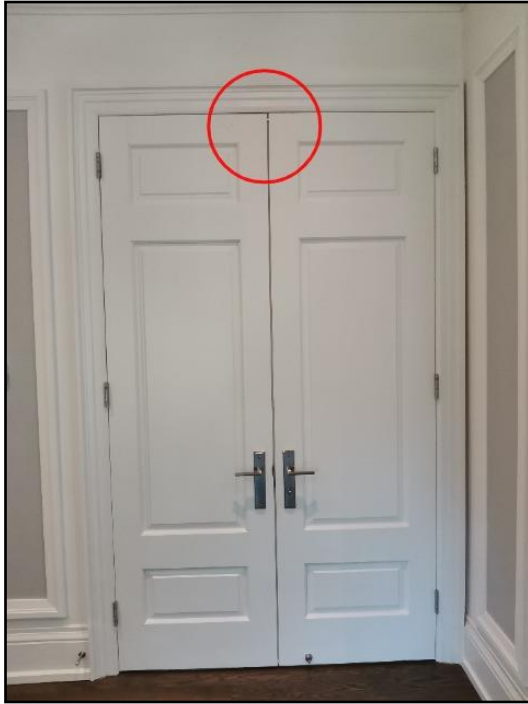
35. Condition: • [Cracked](#)

Implication(s): Material deterioration

62. Cracked

Task: Repair

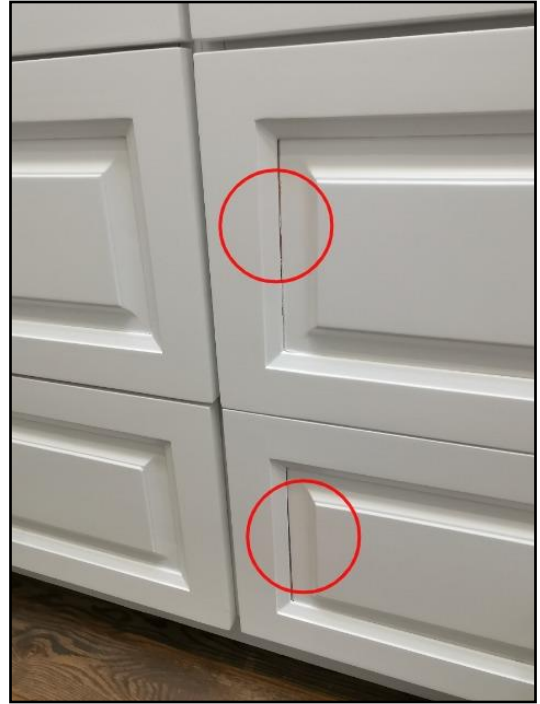
63. Cracked

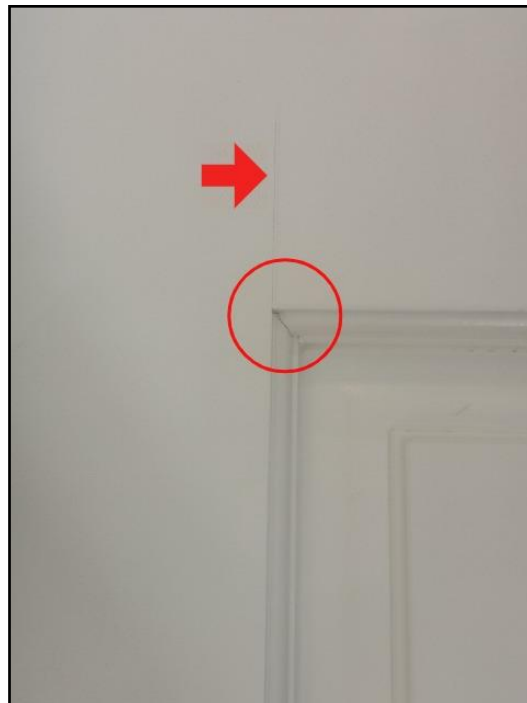
64. Cracked

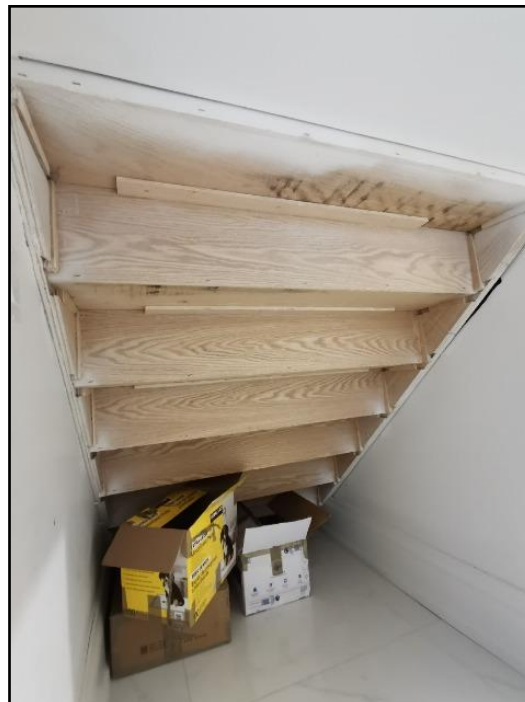
36. Condition: • [Drywall missing or incomplete on underside of stairs](#)

Implication(s): Increased fire hazard

65. Drywall missing or incomplete on underside...

**Location:** Basement  
**Task:** Improve  
**Time:** Immediate
