INSPECTION REPORT

SAMPLE REPORT

VAUGHAN, ON L0D 6J9

RE: Report No. 1041, v.3
Sample Report
Vaughan, ON
L0D 6J9

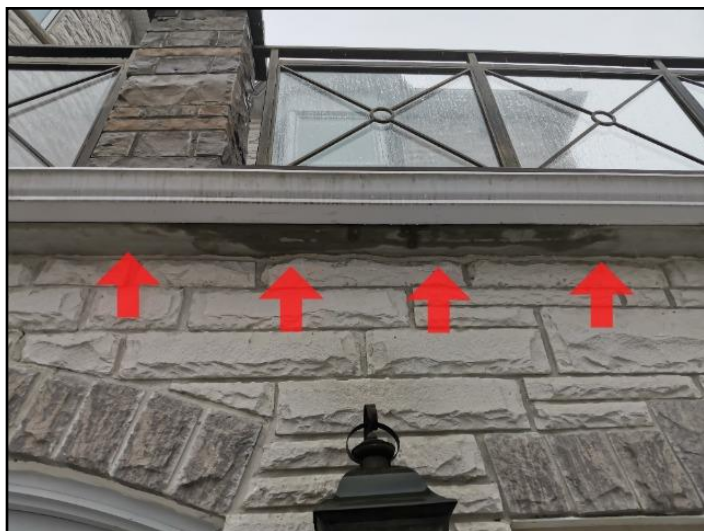
23. Leak

9. Condition: • Leak

Implication(s): Chance of water damage to structure, finishes and contents

Task: Repair

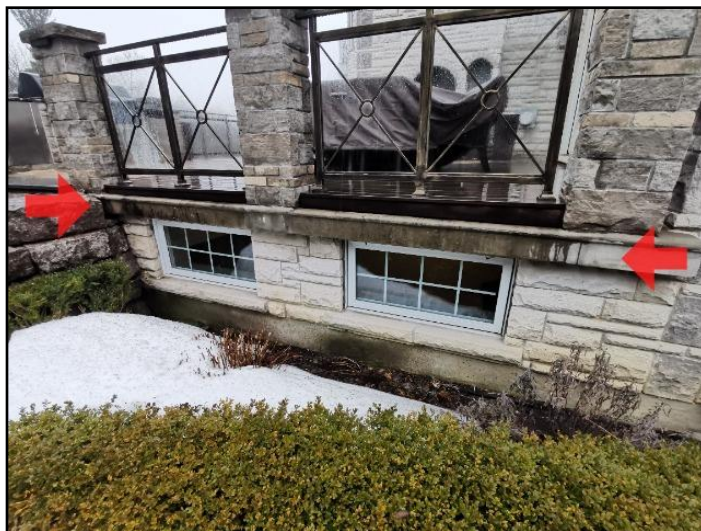
24. Missing

10. Condition: • Missing

Implication(s): Chance of water damage to structure, finishes and contents

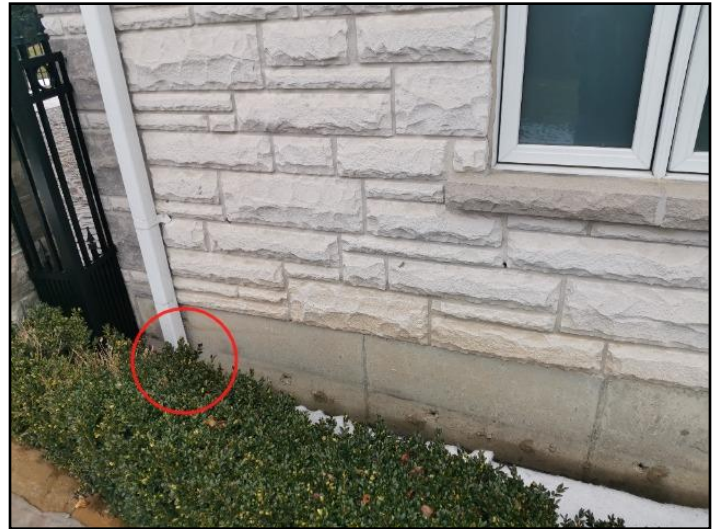
38. Discharge below grade

11. Condition: • Discharge below grade

Implication(s): Chance of water damage to structure, finishes and contents

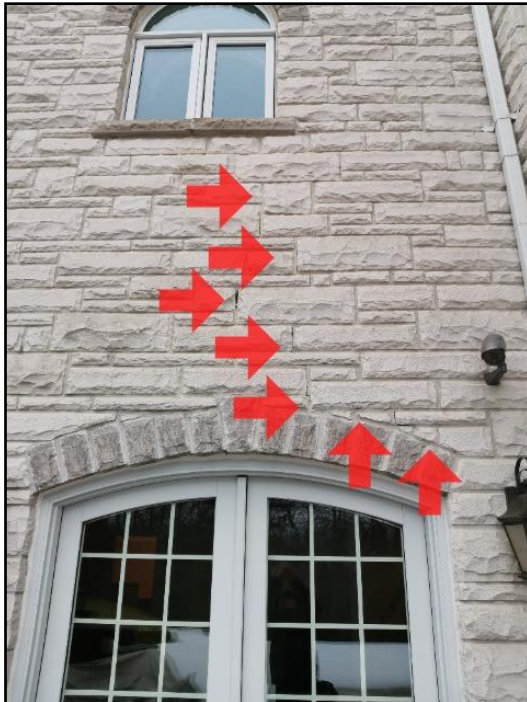
42. Cracked

14. Condition: • Cracked

Task: Repair Inspect annually

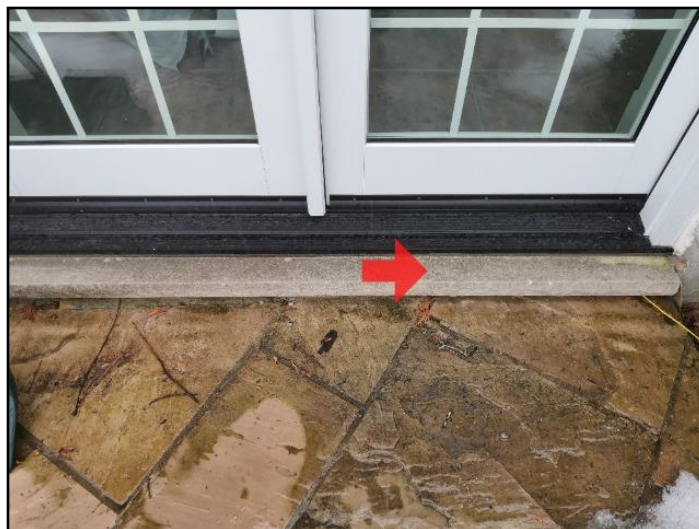
55. Damaged, cracked or loose

18. Condition: • Damaged, cracked or loose

Implication(s): Chance of damage to finishes and structure

Task: Repair

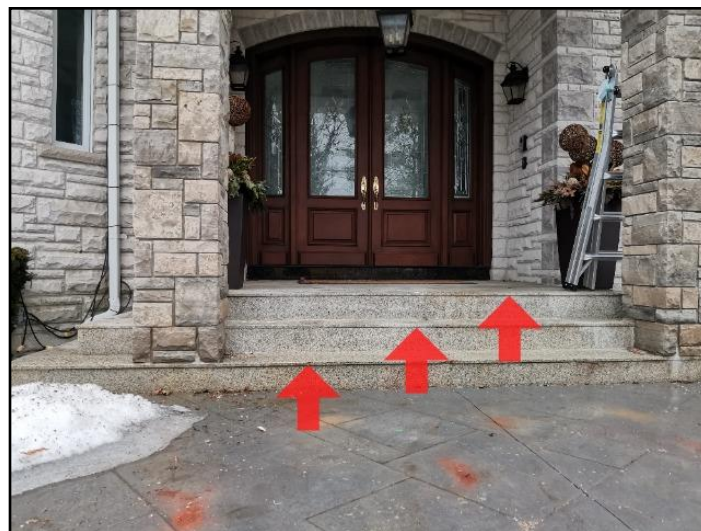
56. Steps slope

19. Condition: • Steps slope

Implication(s): Trip or fall hazard

Task: Repair

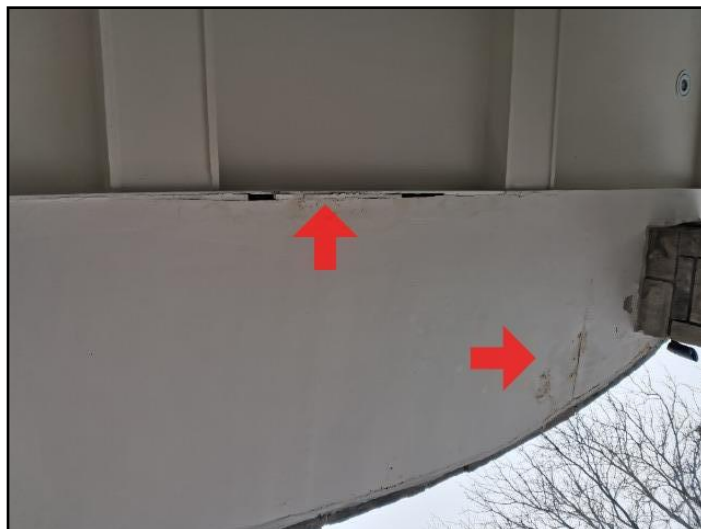
57. Paint or stain needed

20. Condition: • Paint or stain needed

Implication(s): Material deterioration

Task: Repair

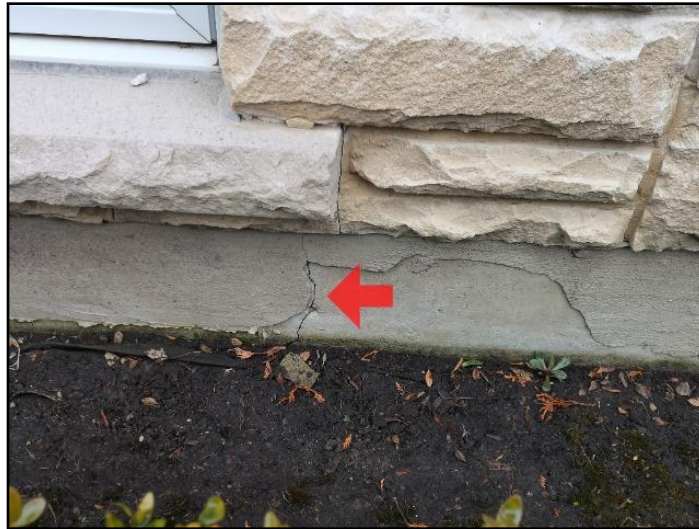
67. Cracked

24. Condition: • Cracked

Implication(s): Weakened structure | Chance of water damage to structure, finishes and contents

Task: Repair Inspect annually

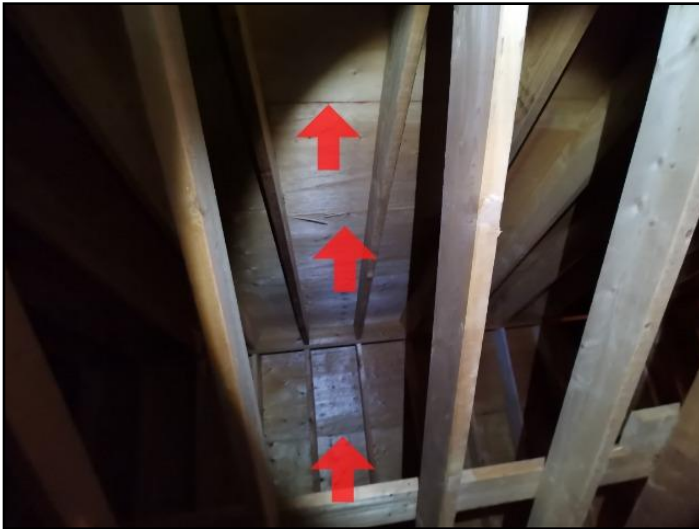
68. H-clips missing

25. Condition: • H-clips missing

Task: Monitor

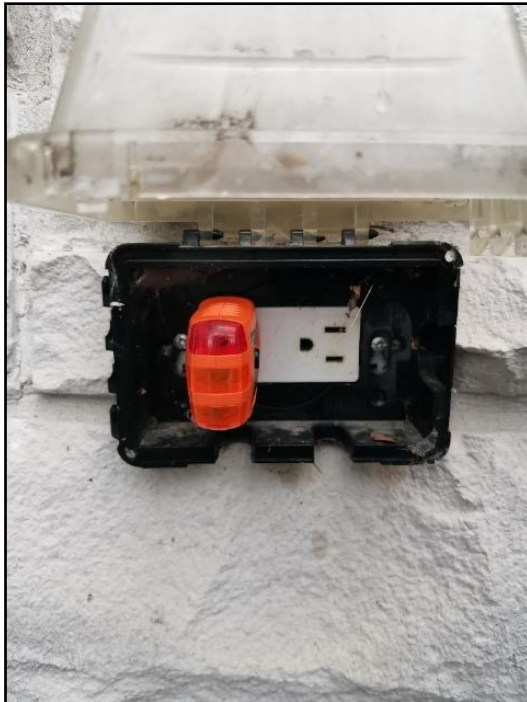
72. Not suitable for outdoor (exterior) use

27. Condition: • Not suitable for outdoor (exterior) use

Implication(s): Shock hazard or interruption of electrical service

Task: Replace

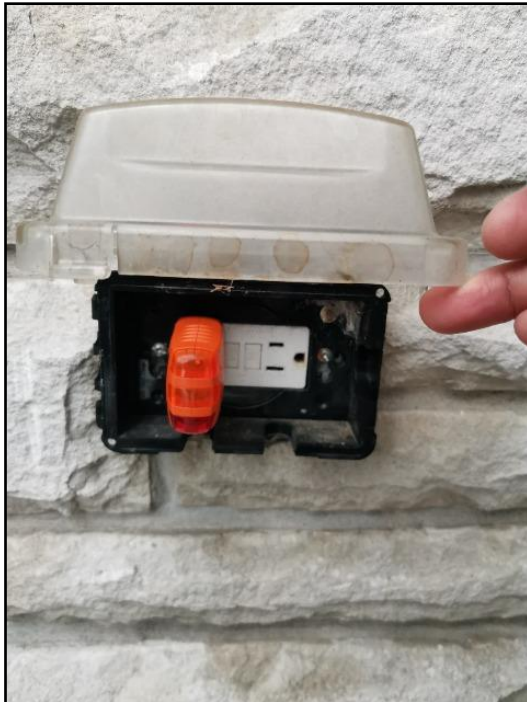
77. Test faulty on GFCI/GFI (Ground Fault...

28. Condition: • Test faulty on GFCI/GFI (Ground Fault Circuit Interrupter)

Task: Repair or replace

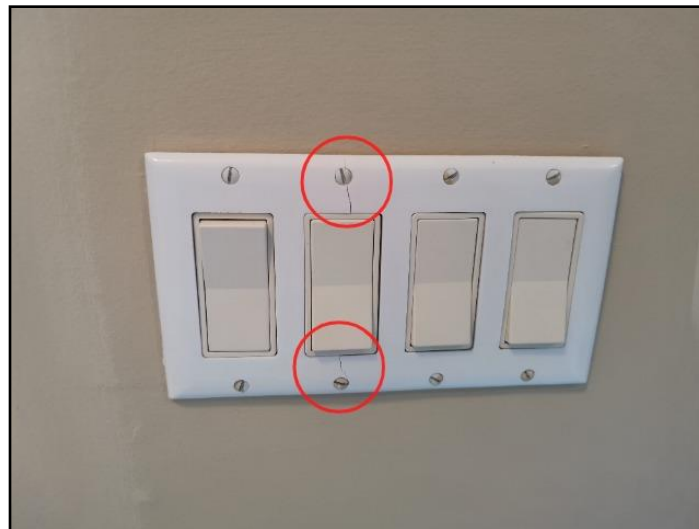
83. For switch is damaged

30. Condition: • For switch is damaged

Task: Replace

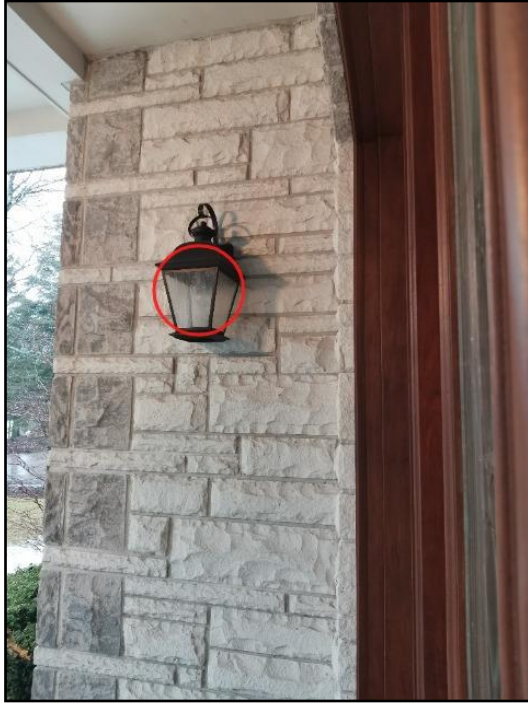
84. Inoperative

31. Condition: • Inoperative

Implication(s): Inadequate lighting

Task: Replace

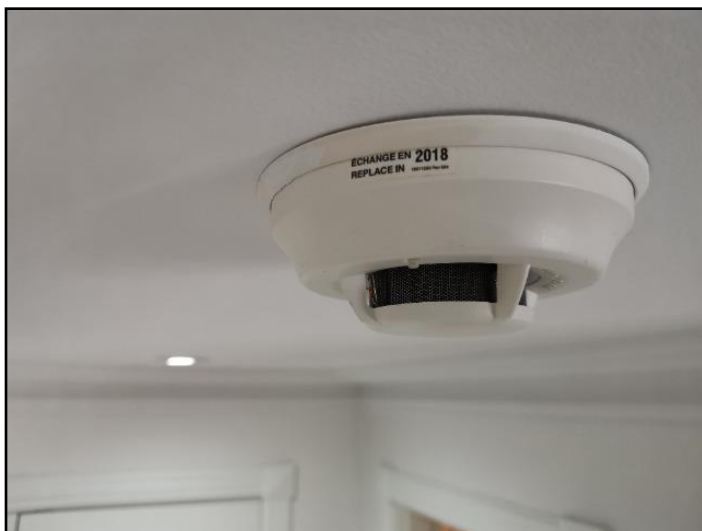
90. Past life expectancy

DISTRIBUTION SYSTEM \ Smoke alarms (detectors)**32. Condition:** • Past life expectancy**Implication(s):** Life safety hazard**Location:** Throughout**Task:** Replace**Time:** Immediate

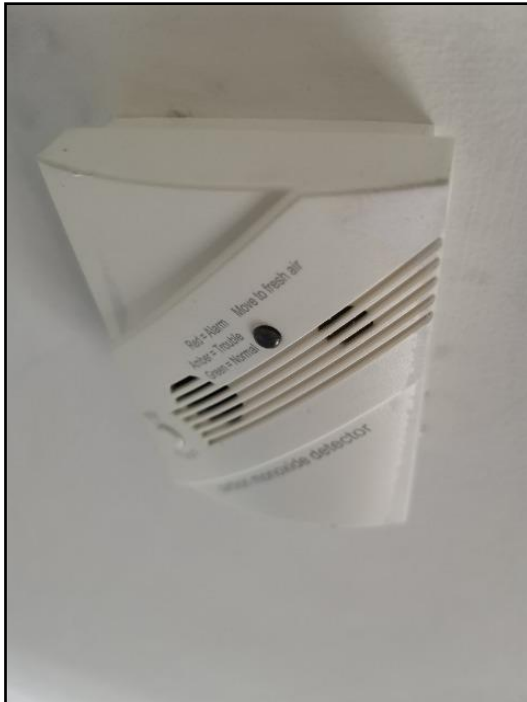
95. Past life expectancy

33. Condition: • Past life expectancy

Implication(s): Health hazard | Life safety hazard

Task: Replace

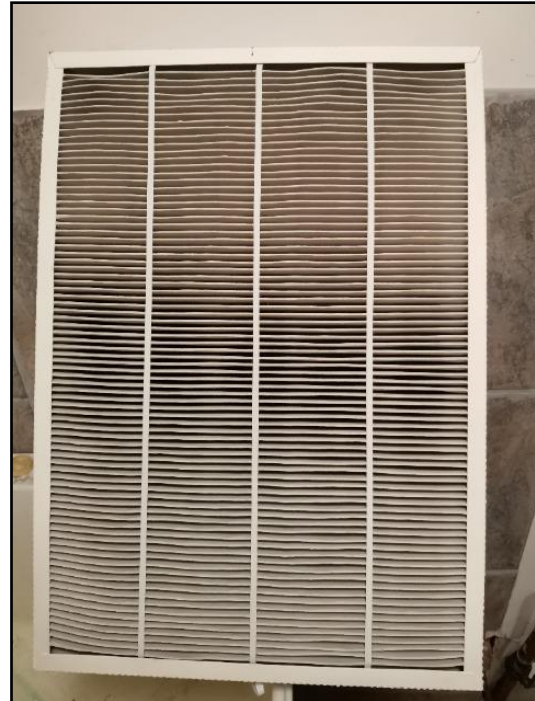
100. Dirty

35. Condition: • Dirty

Task: Replace

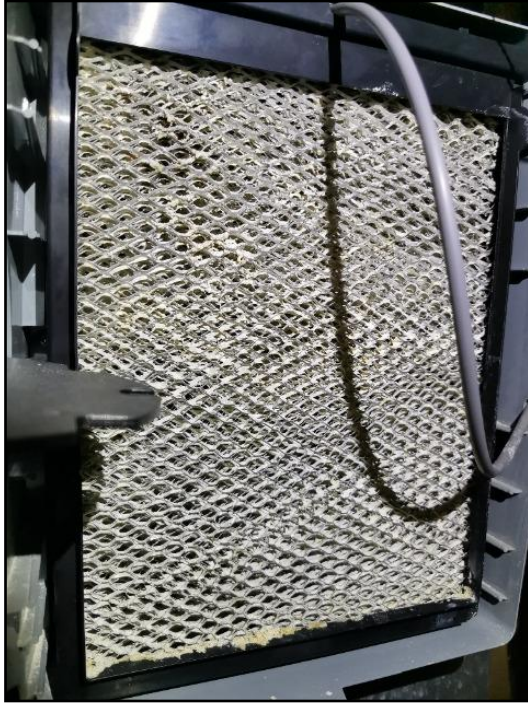
101. Clogged pad, mesh or nozzle

36. Condition: • Clogged pad, mesh or nozzle

Task: Replace

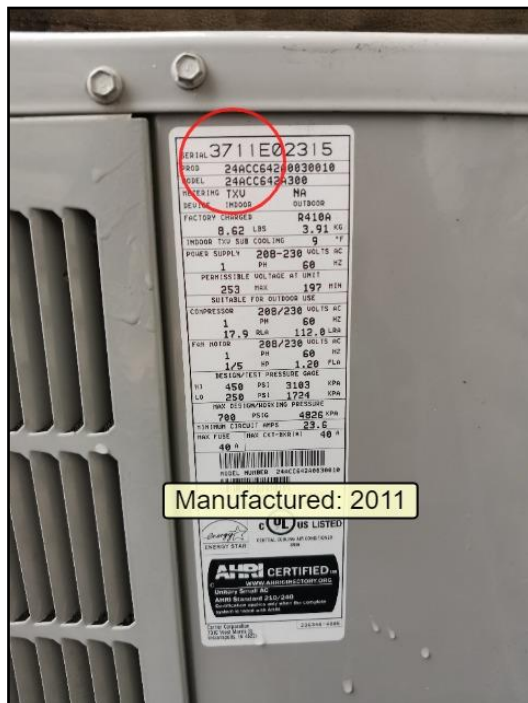
105. Near end of life expectancy

40. Condition: • Near end of life expectancy

Implication(s): Reduced comfort | Equipment failure

Task: Replace

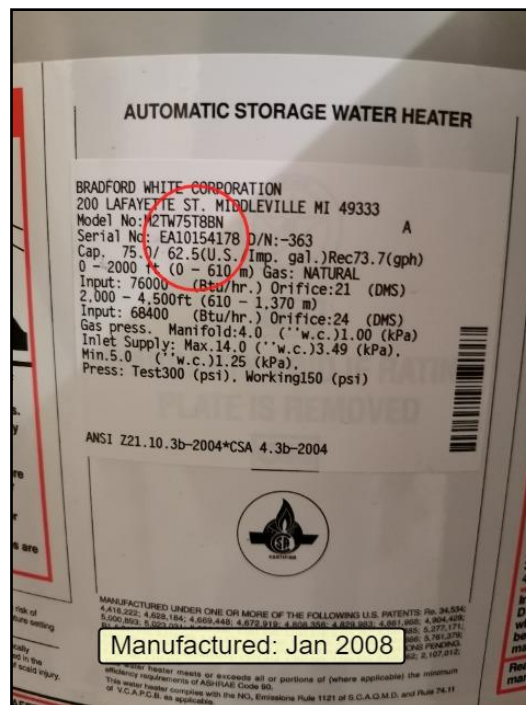
114. Near end of life expectancy

44. Condition: • Near end of life expectancy

Task: Replace

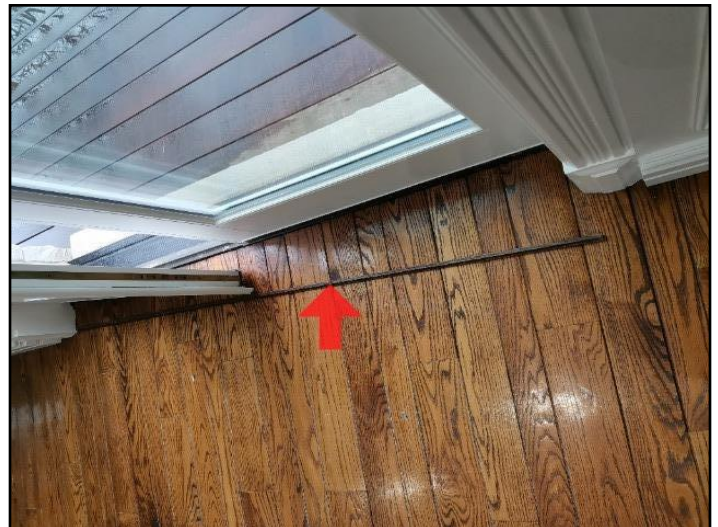
120. Loose or missing

49. Condition: • Loose or missing

Task: Repair

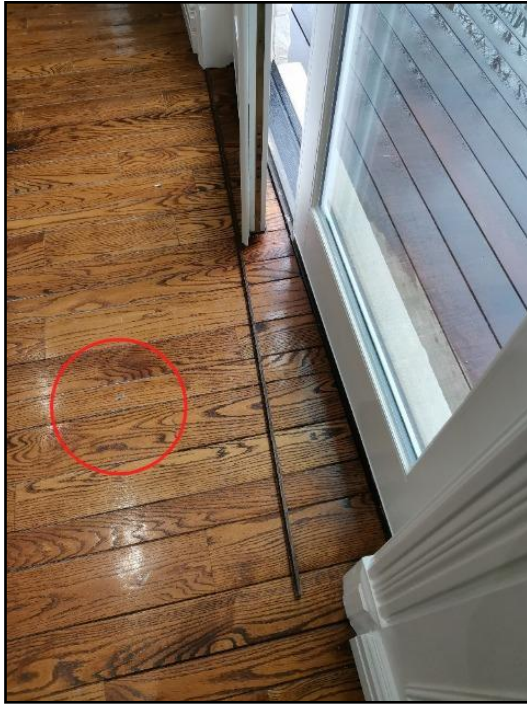
121. Typical flaws

50. Condition: • Typical flaws

Task: Repair

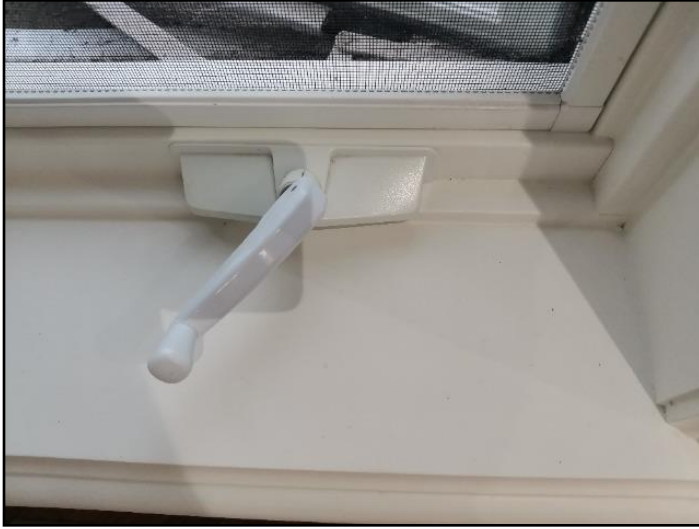
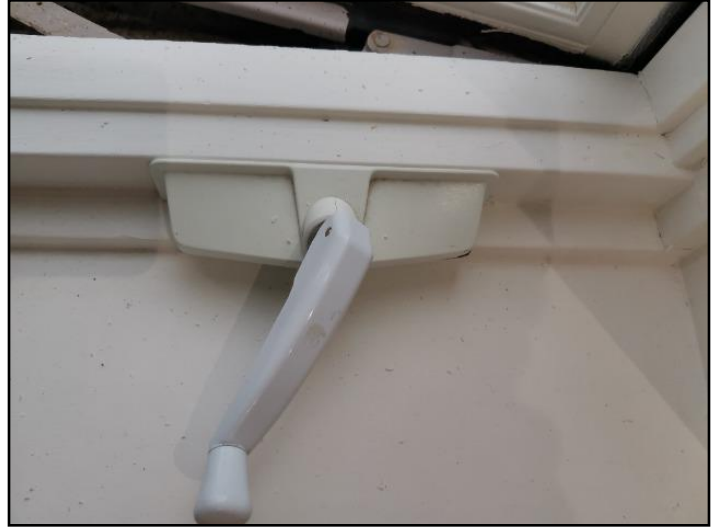
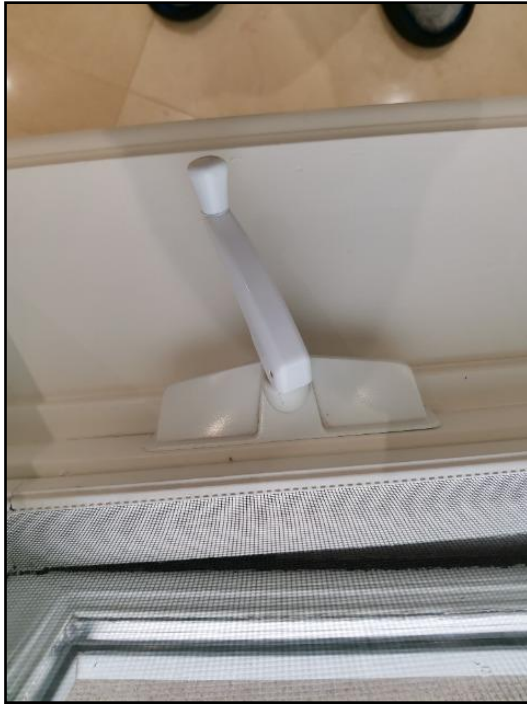
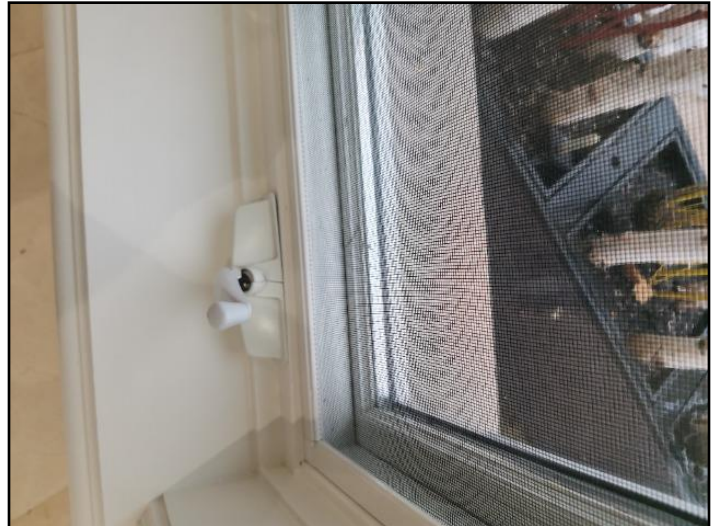
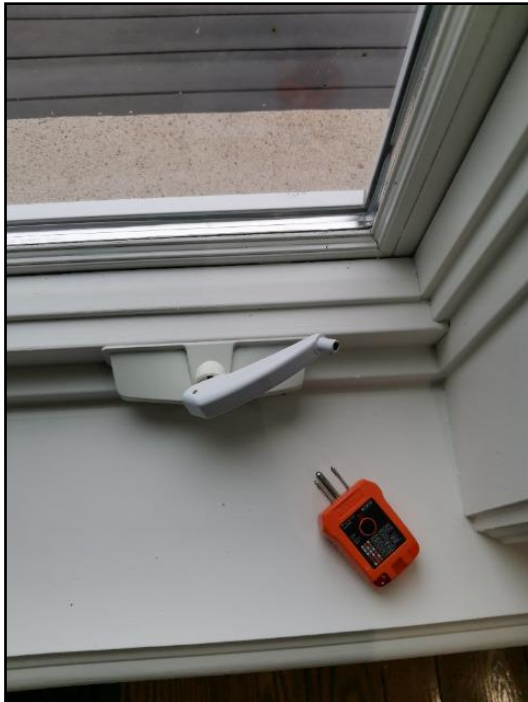
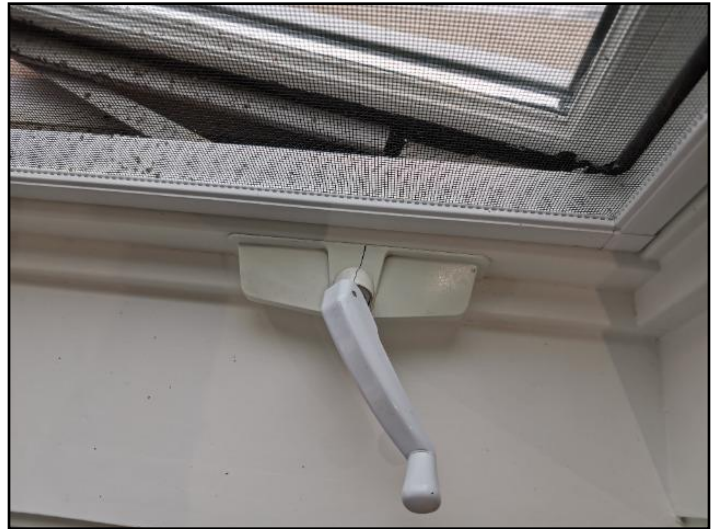
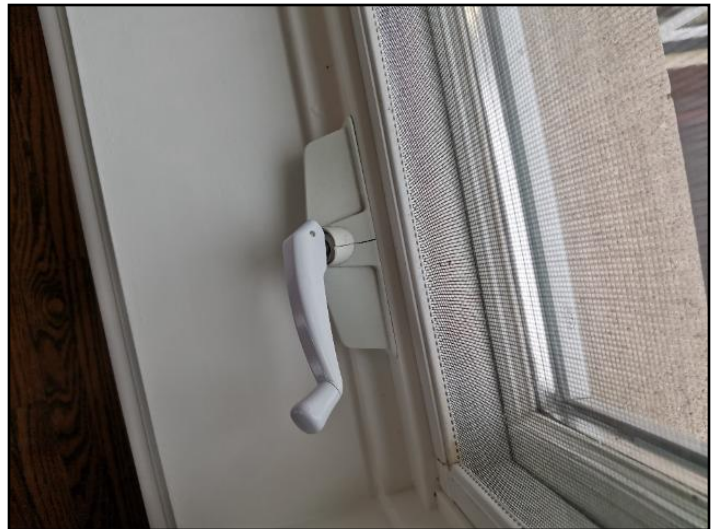
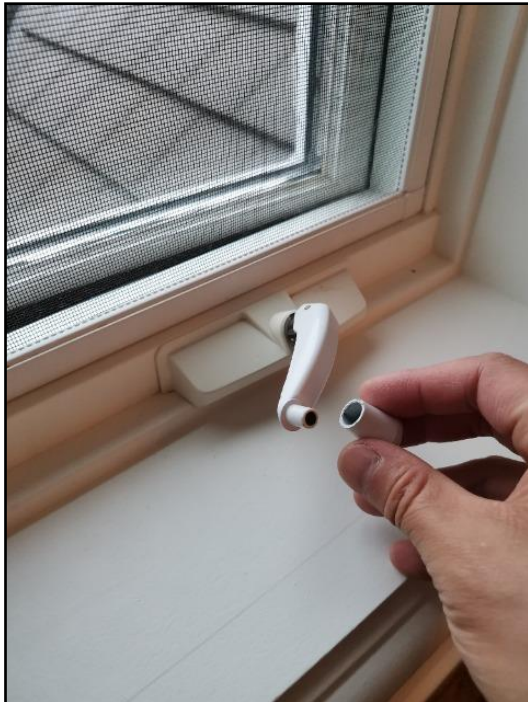
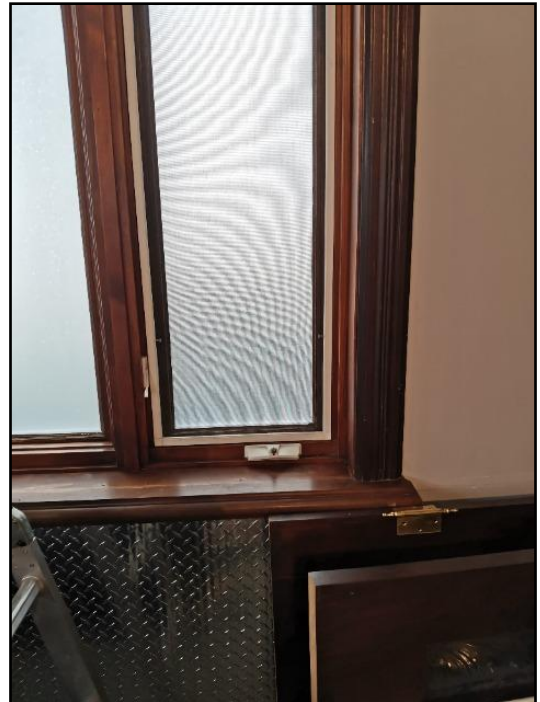
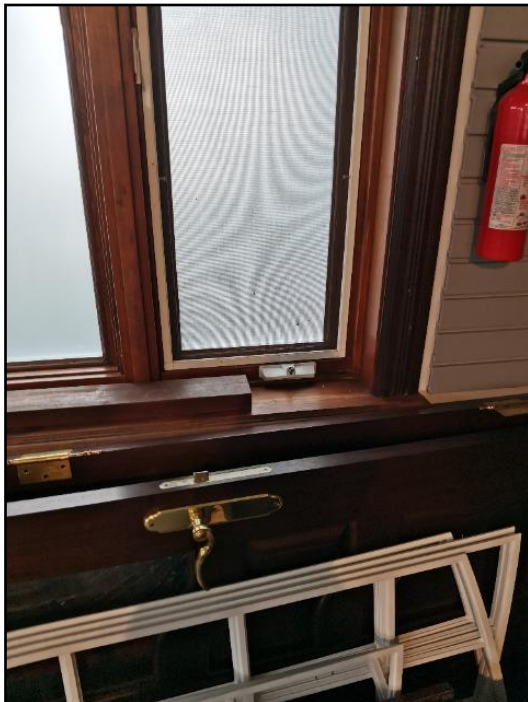
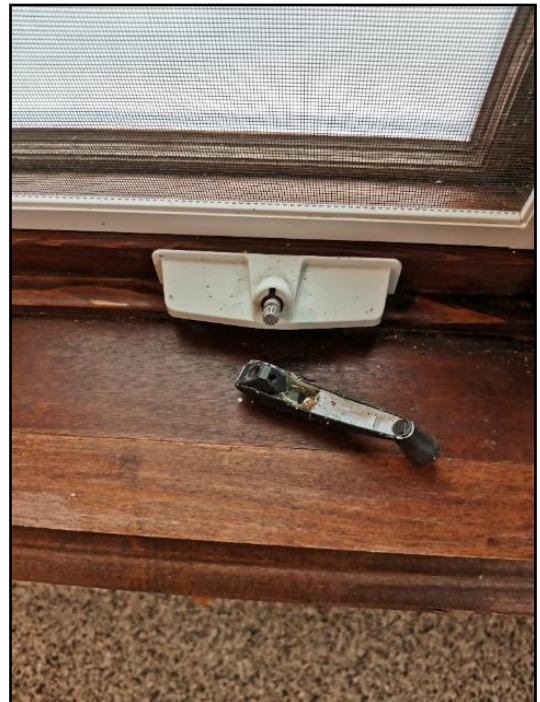
56. Condition: • Broken

Task: Repair or replace

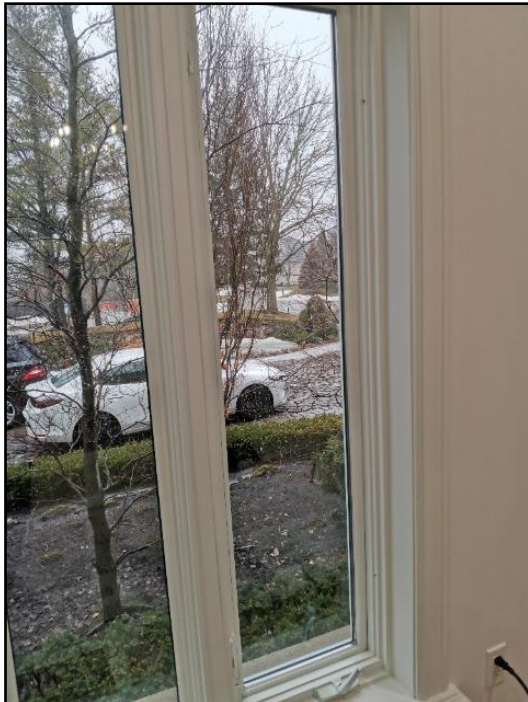
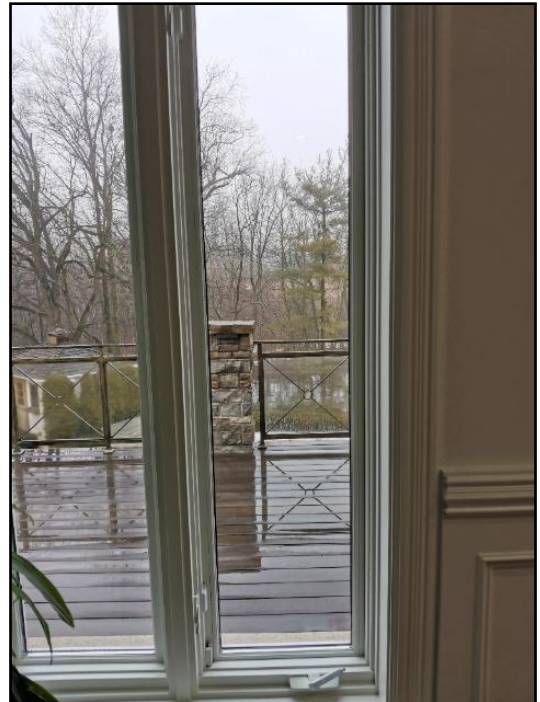
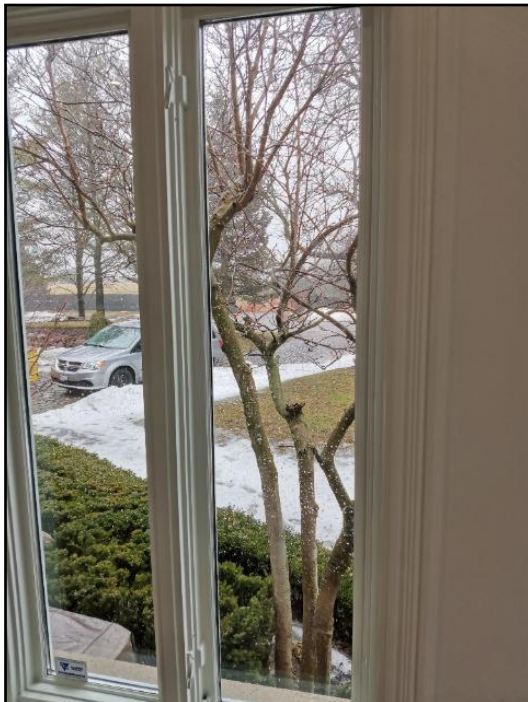
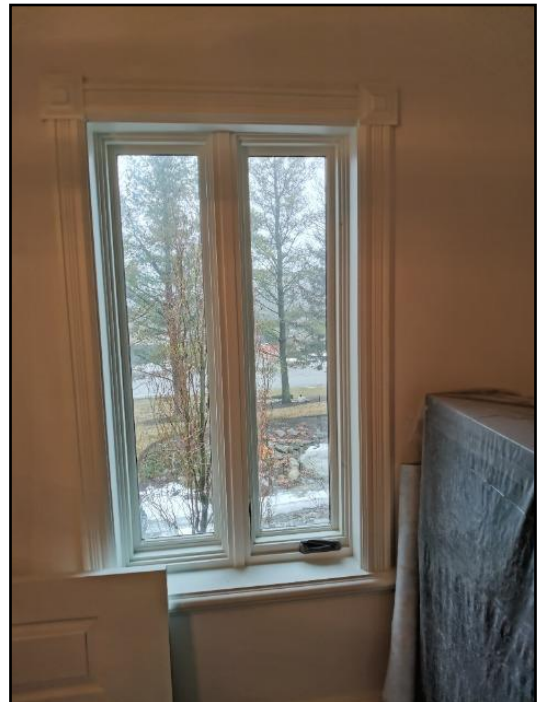
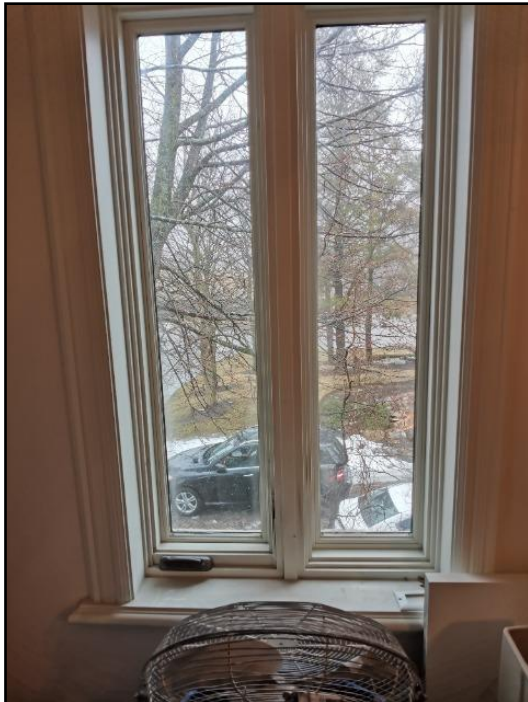
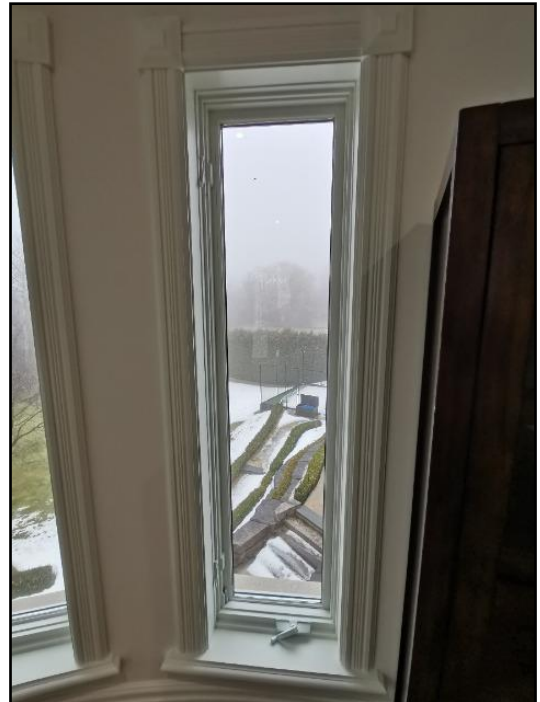
57. Condition: • Missing

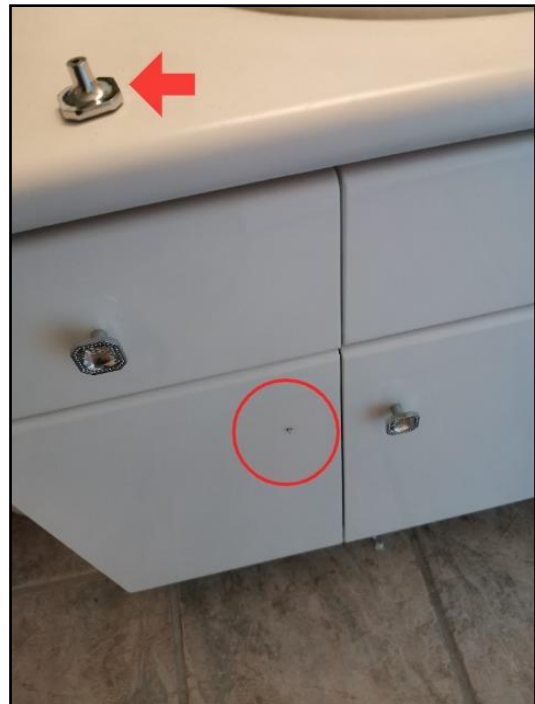
158. Pieces missing or loose

59. Condition: • Pieces missing or loose

Implication(s): Damage or physical injury due to falling materials

Task: Repair or replace

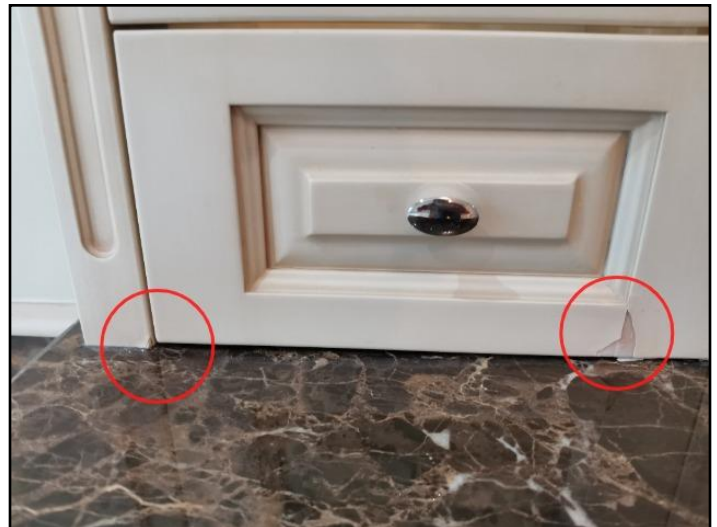
160. Water damage

60. Condition: • Water damage

Implication(s): Material deterioration

Task: Repair

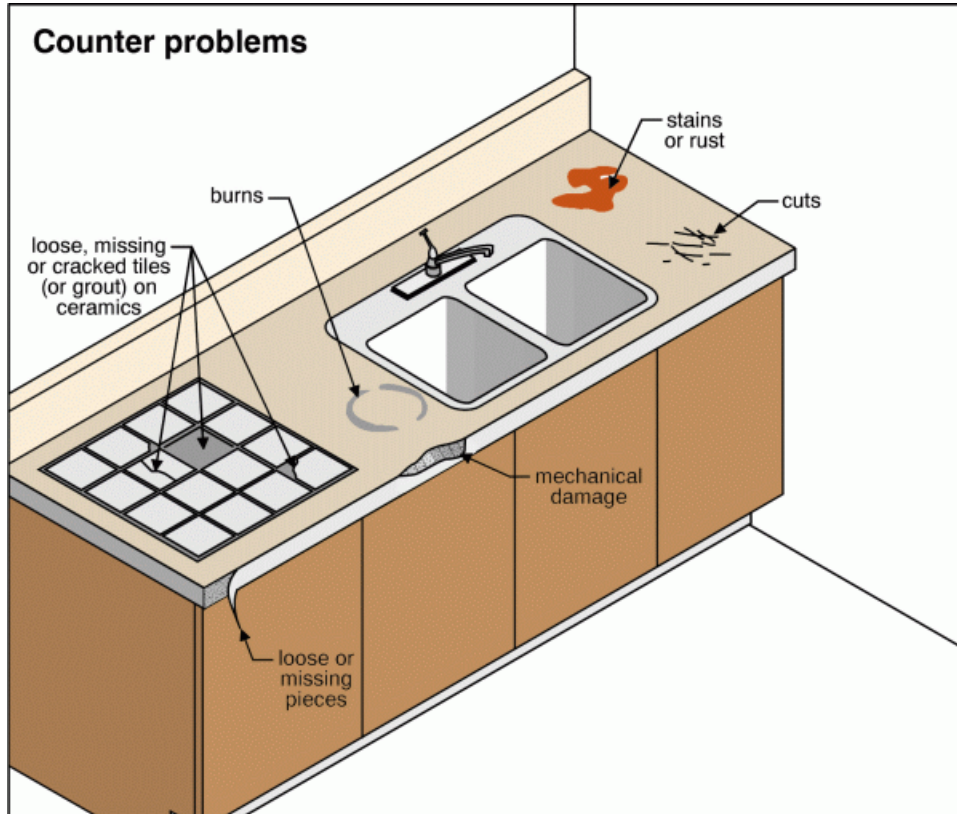
163. Tiles loose, missing, cracked, stained or...

62. Condition: • Tiles loose, missing, cracked, stained or broken

Marble countertop cracked.

Task: Repair or replace

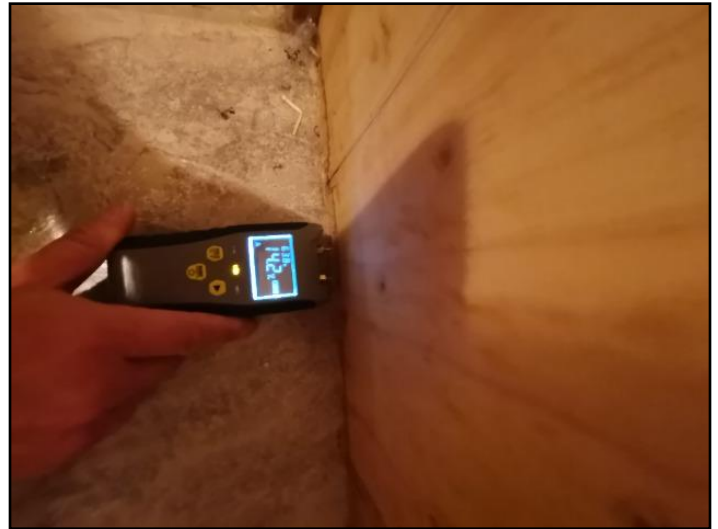
166. Finished: risk of condensation problems

64. Condition: • Finished: risk of condensation problems

Implication(s): Odors, molds, etc. | Material deterioration

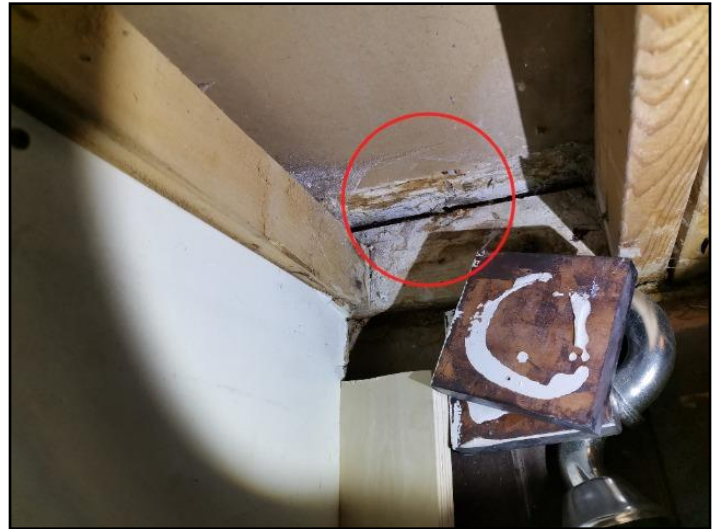
171. Mold

68. Condition: • Mold

Mold drywall spalling caused by previous long term water damage, currently dried, change the damaged drywall and wood part recommended.

Implication(s): Contaminants may enter building air | Chance of water damage to structure, finishes and contents

Task: Repair

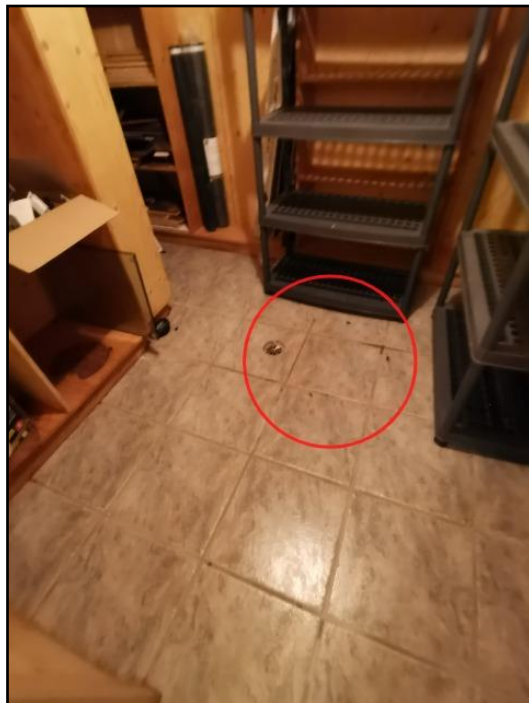
172. Water marks

69. Condition: • Water marks

Implication(s): Chance of water damage to structure, finishes and contents

Task: Repair

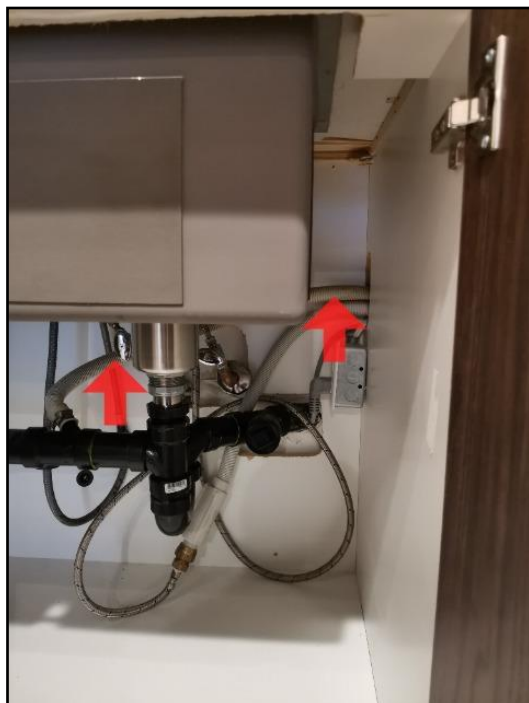
175. Backflow prevention high loop missing

71. Condition: • Backflow prevention high loop missing

Task: Repair
