# Septic Inspection Report

Prepared by: DAN LIU  
On behalf of: AWESOME HOME INSPECTIONS  
August 22, 2021

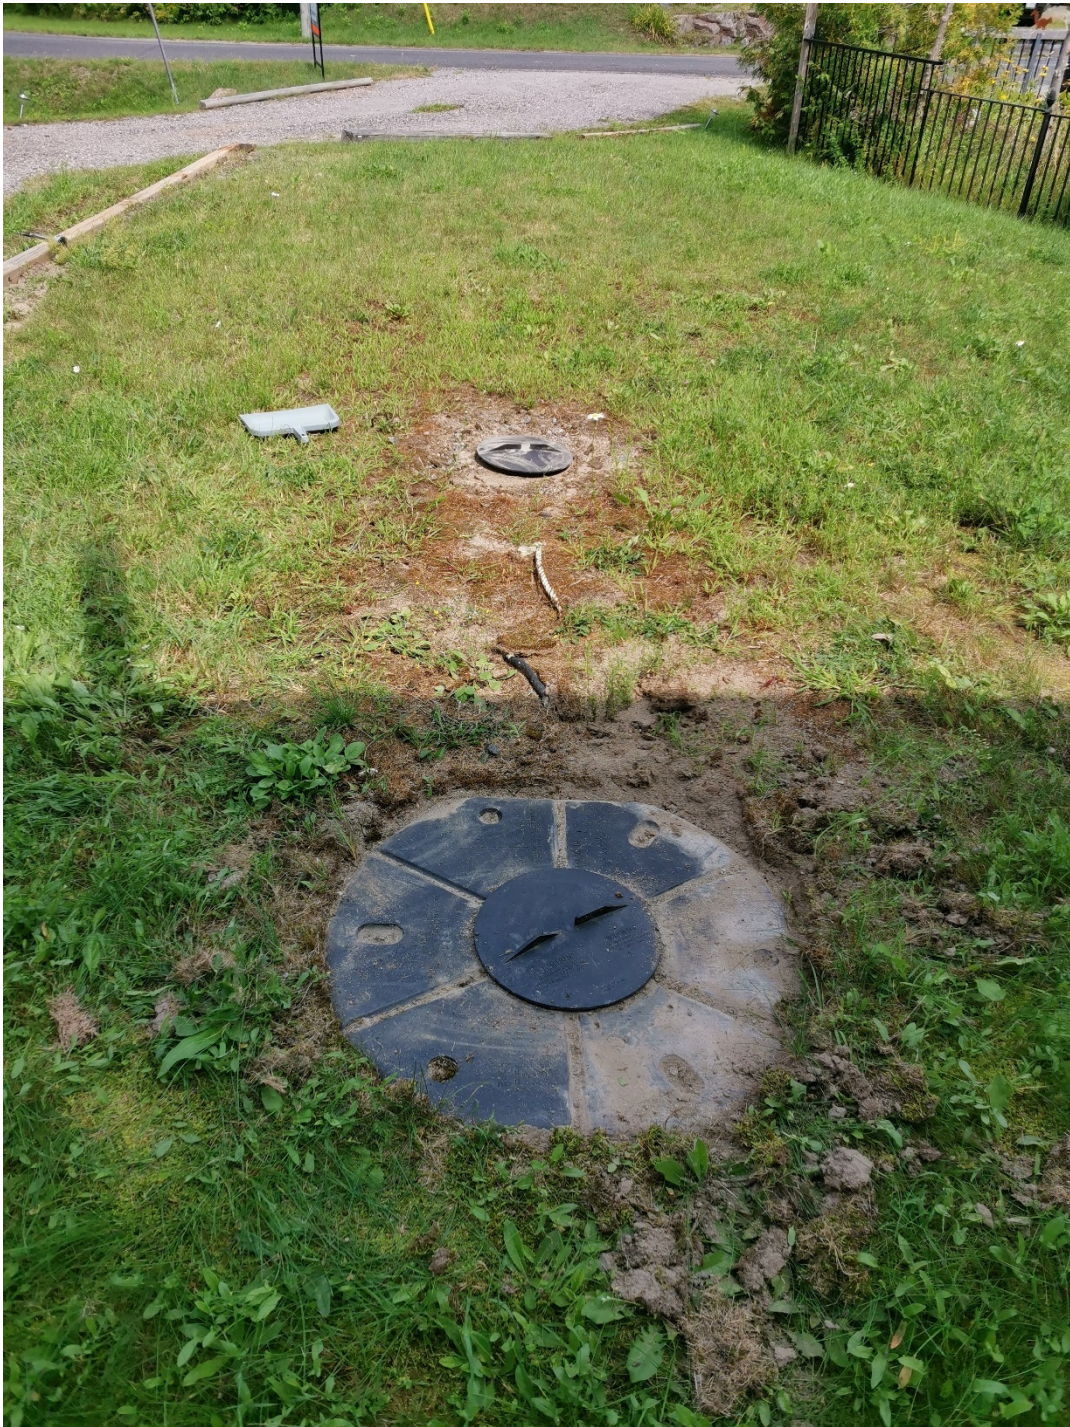
***Fig. 1 Septic System Layout***

The septic tank and leaching field are located on the northeast side of the property in the front yard. The septic system is shown in Figure 1.

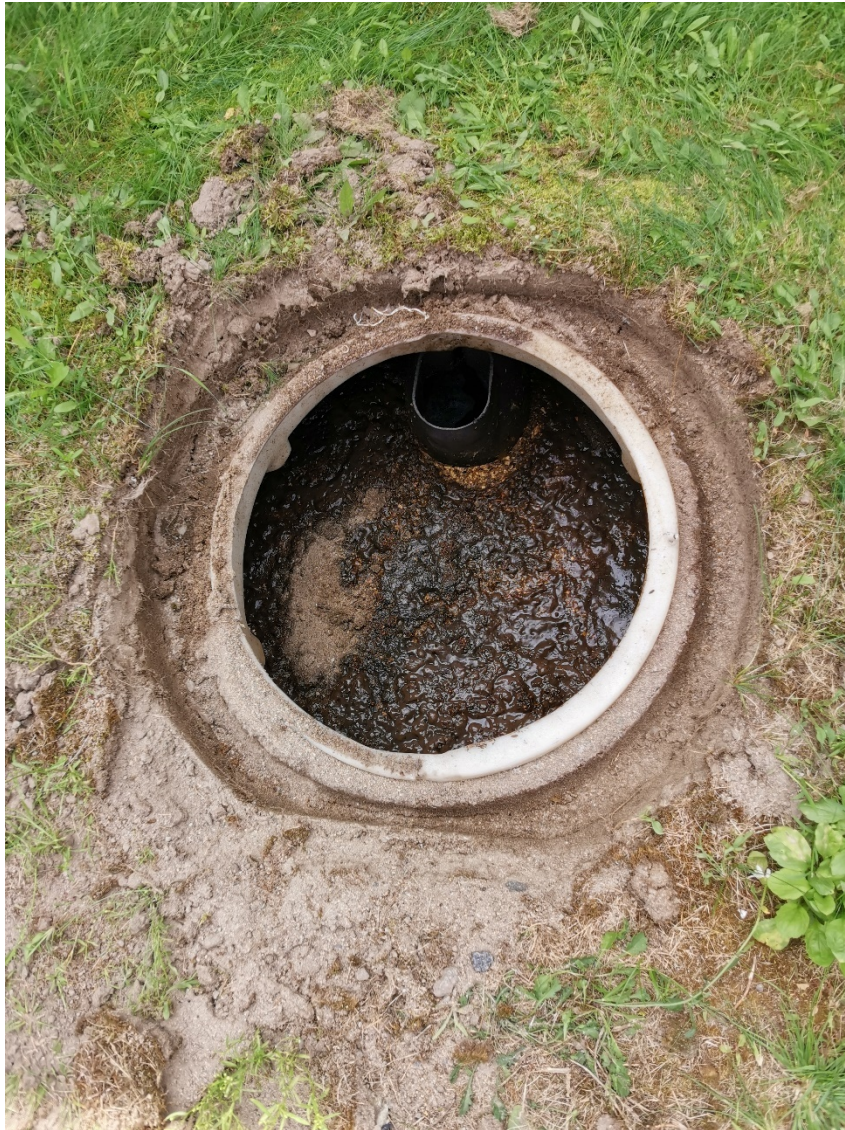
***Figure 2: Inlet Chamber of the septic tank (Working level – 3.5 feet – sludge measurement 4 inches, scum measurement 1-1/8 inches)***

Both inlet and outlet chambers have baffles attached to the tank. These baffles help with reducing turbulence in the tank and directing solids to the bottom and preventing floating scum from entering the leaching field. The inlet baffle is readily accessible from the access lid.

Cleaning of the inlet baffle is recommended at the next tank pump out.

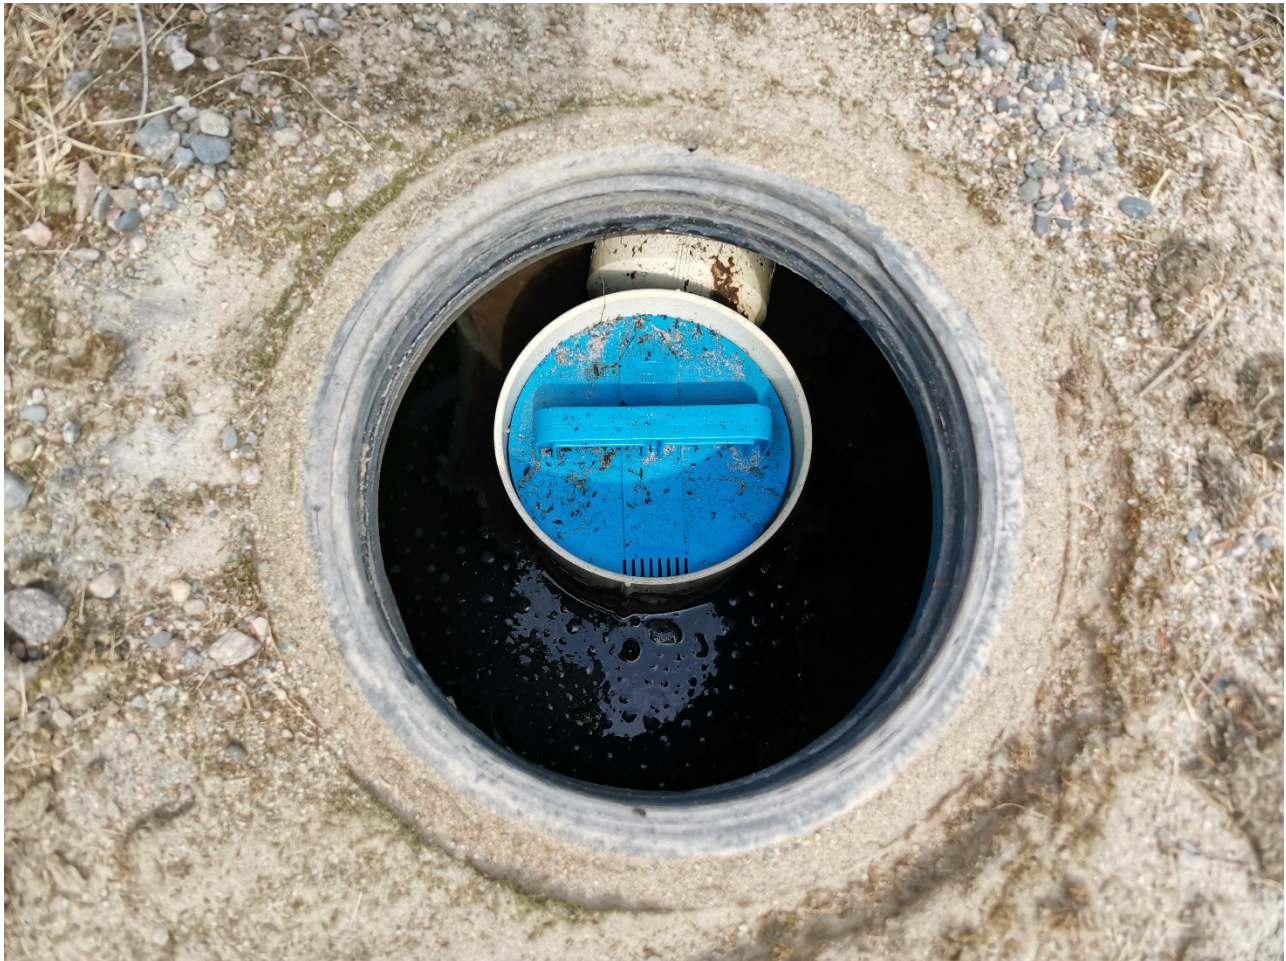
***Figure 3: Outlet Chamber of the septic tank (Working level 3.5 feet, sludge measurement < 1 inch, scum measurement < 1/8 inch)***

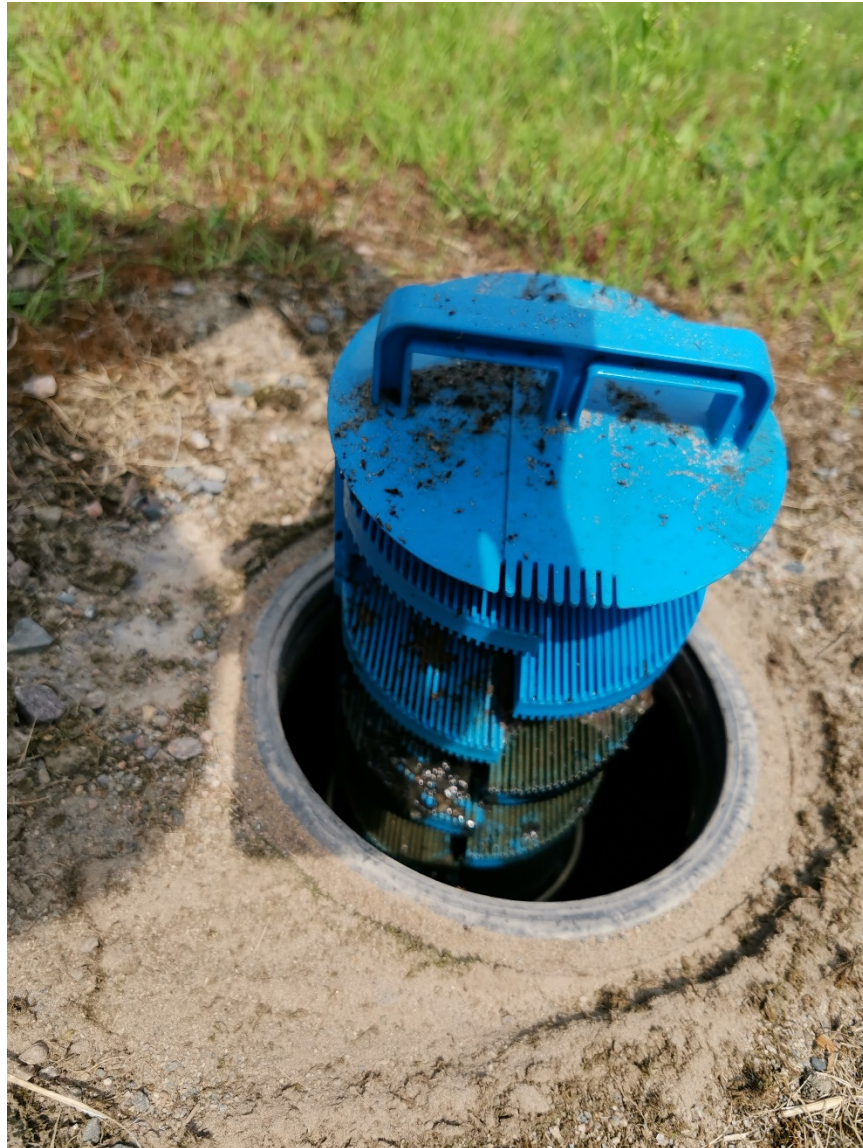
**Figure 4: Effluent filter**

An effluent filter is readily installed on the outlet chamber of the septic tank. An effluent filter will prevent suspended solids from entering the leaching field.

Checking and cleaning of the effluent filter is recommended each year.

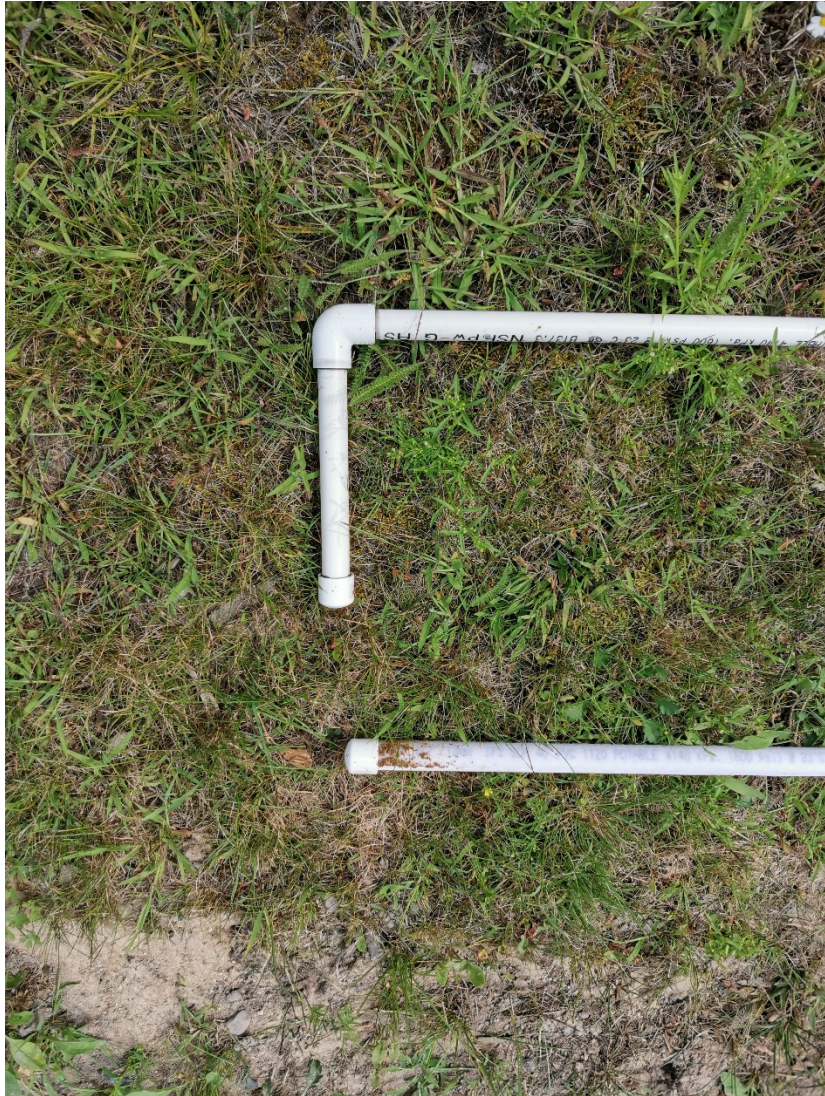
**Figure 5: Sludge judge**

The chambers of the tank were measured with a sludge judge (Figures 5) to determine if it requires a pump out.

The septic tank does not require a pump out currently. Septic tanks should be pumped out every 3 to 5 years or when the combined sludge and scum levels in the tank exceed 1/3 the working volume of the tank.

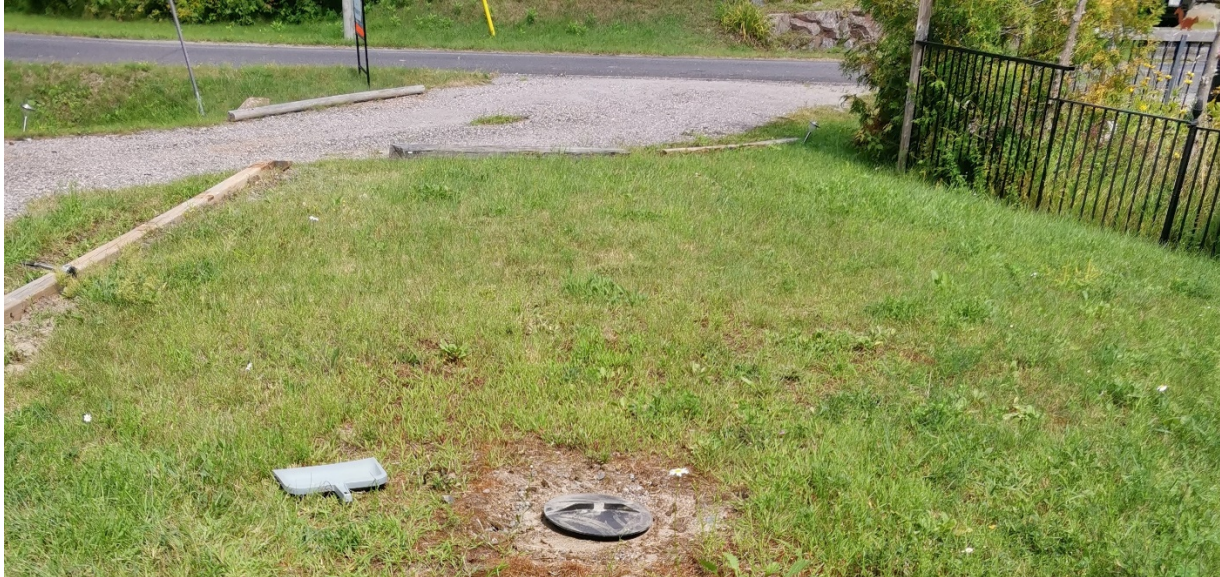
***Figure 6: Leaching Field (South looking North)***

The leaching field is in the northeast corner of the front yard. The leaching field consists of perforated pipe laid in trenches. The grading around the leaching field is currently in good condition.
