Infrared Inspection Report

Test Cust

Sample Roof
555 Mockingbird Lane
Austin, Texas 78758

Report Date: 03/29/2024
Job Number: TEST0002
Type of Inspection: Roof Moisture
Purpose of Inspection: Condition Assessment
Date of Inspection: 03/28/2024
End User: David Gierke
Project Location: Sample Roof
555 Mockingbird Lane
Austin, Texas 78758
Thermographer: Gierke, David
Certification Number: 16917
Certification Level: 1
Qualified Assistant(s): Alonsio Carrizales

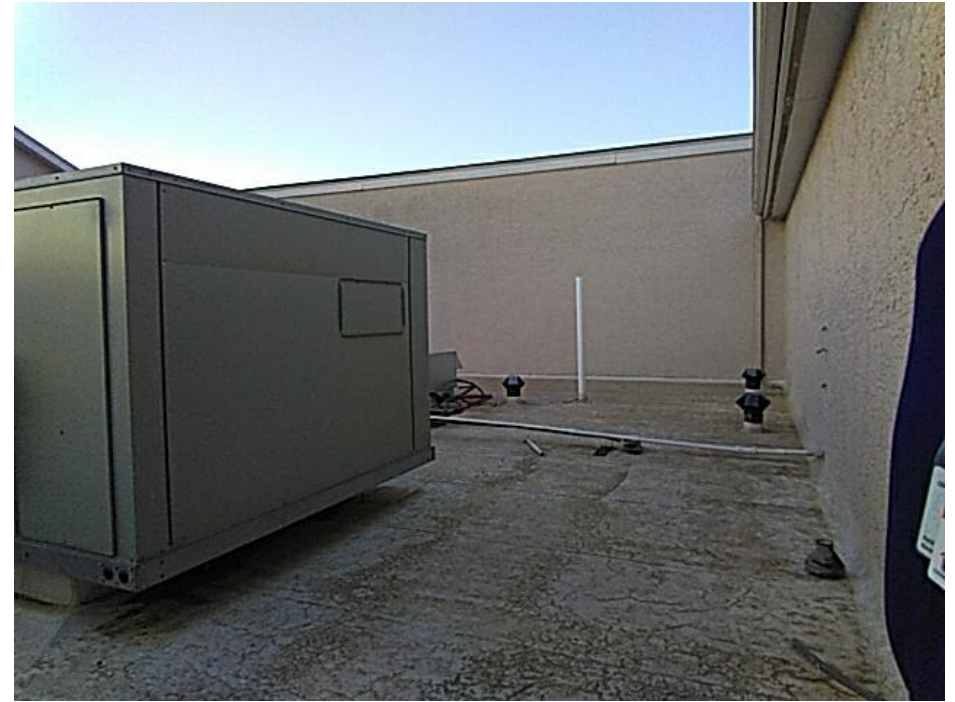
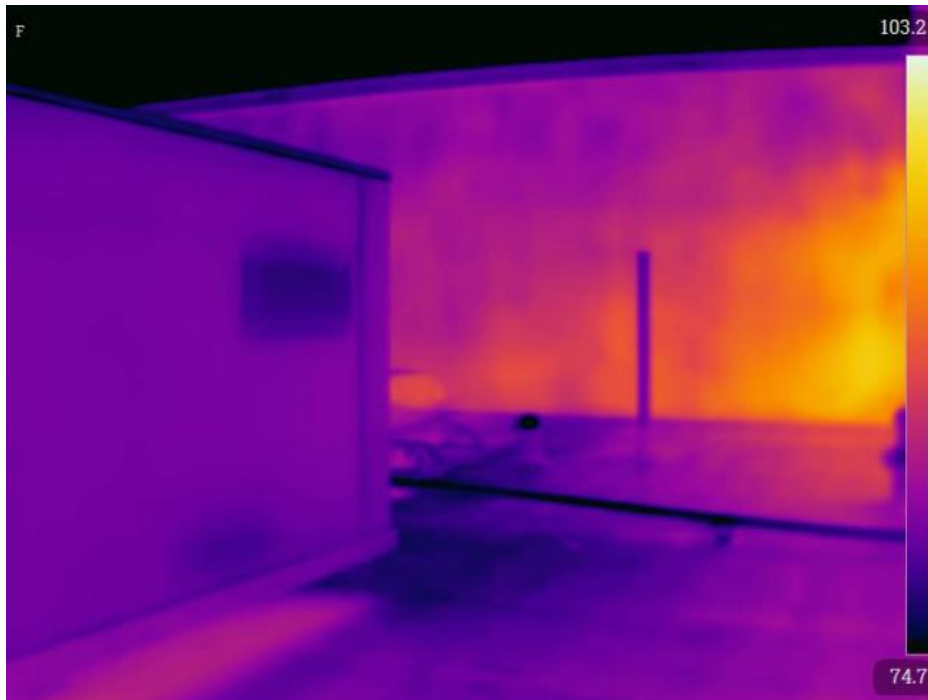
Area/Image No. 1

Wide Angle Shot of Roof

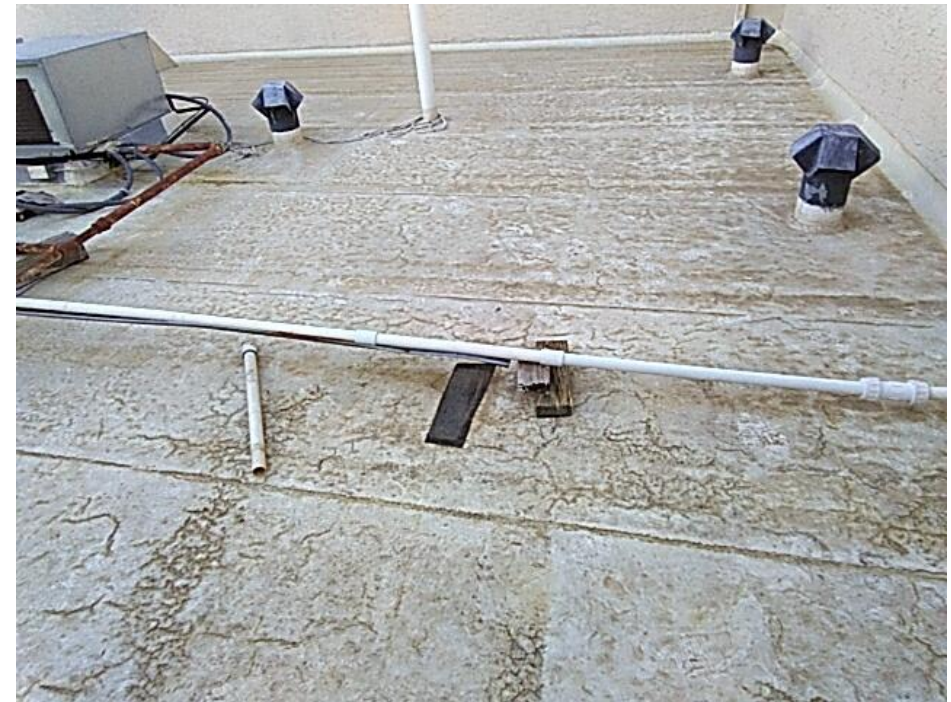
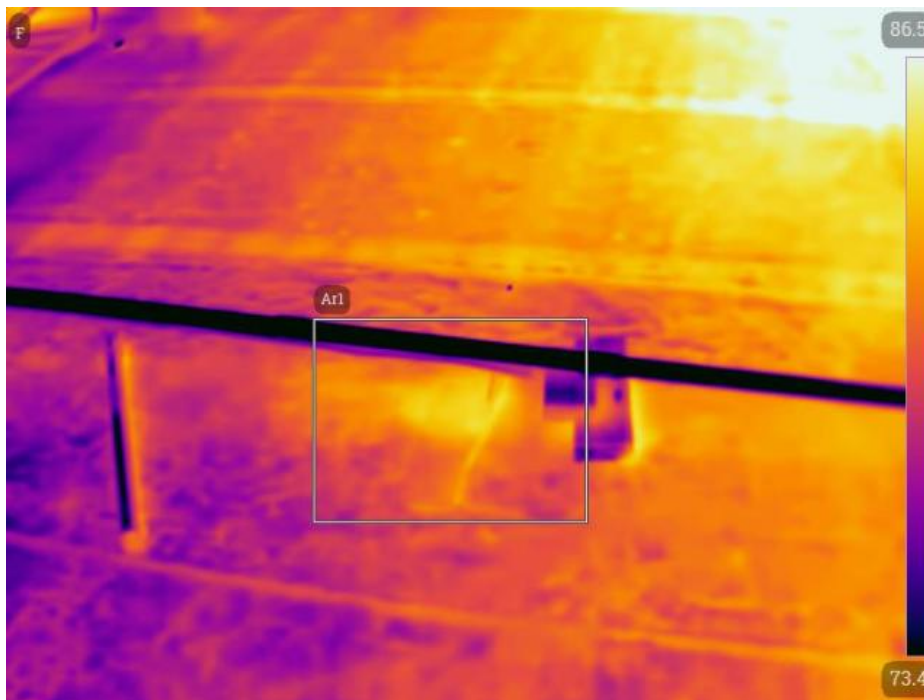
Area/Image No. 2

Damage Type Moisture Suspect

Moisture Probe: Negative

Thermal Anomaly: Possible Moisture

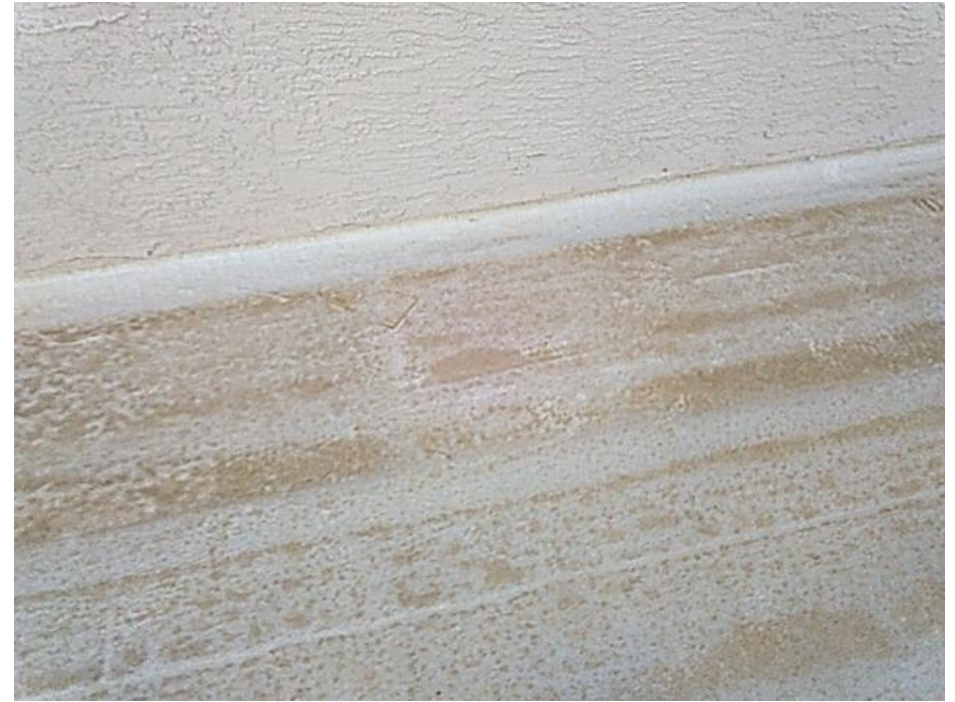
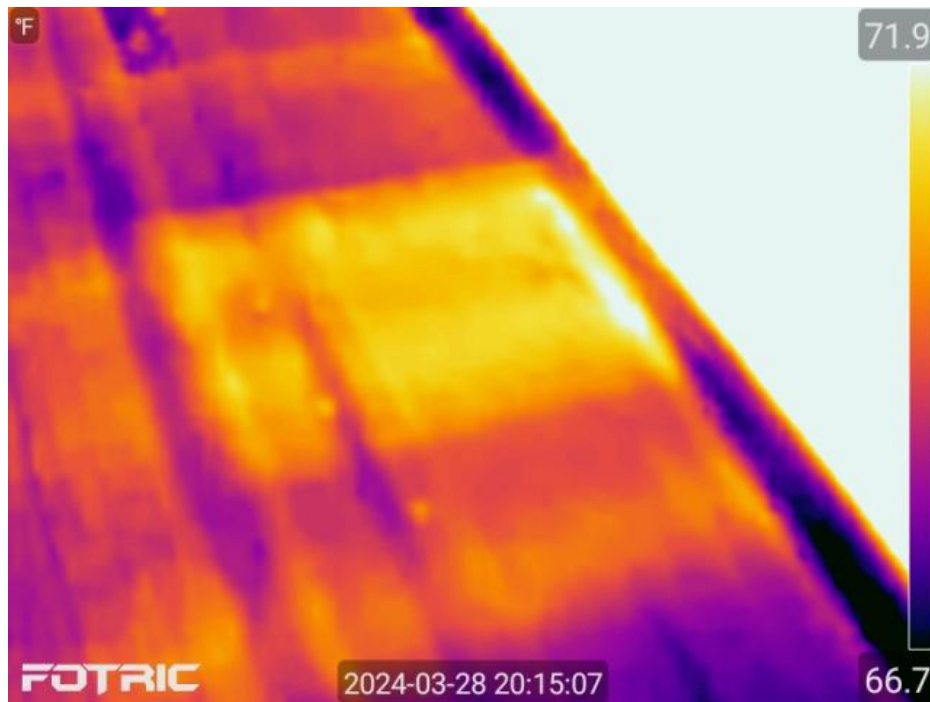
Area/Image No. 3

Moisture Probe: Negative

Thermal Anomaly: Possible Moisture

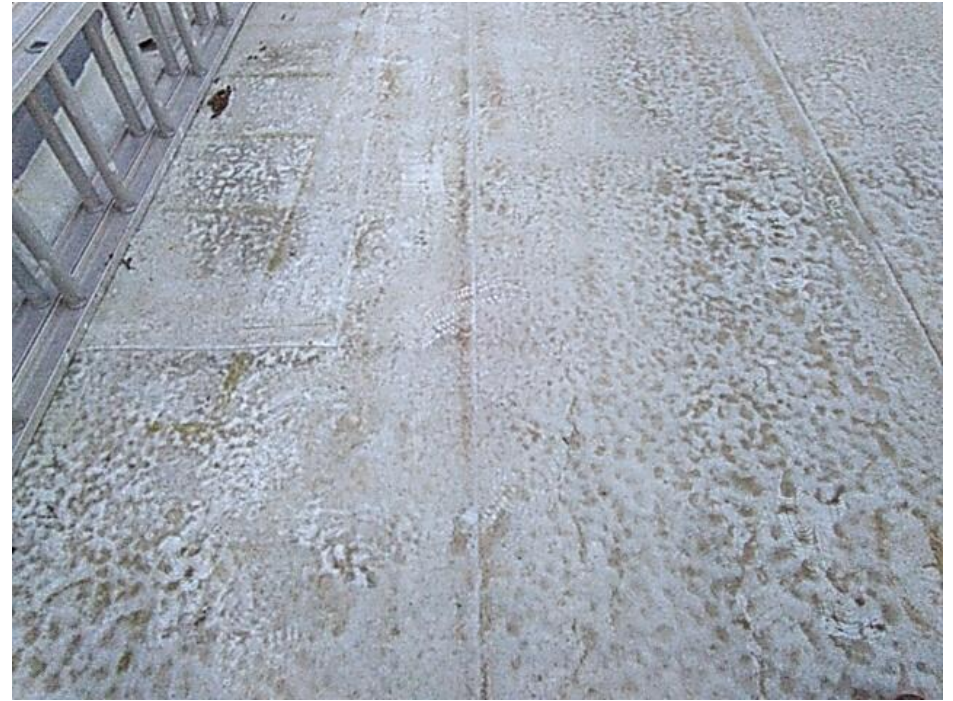
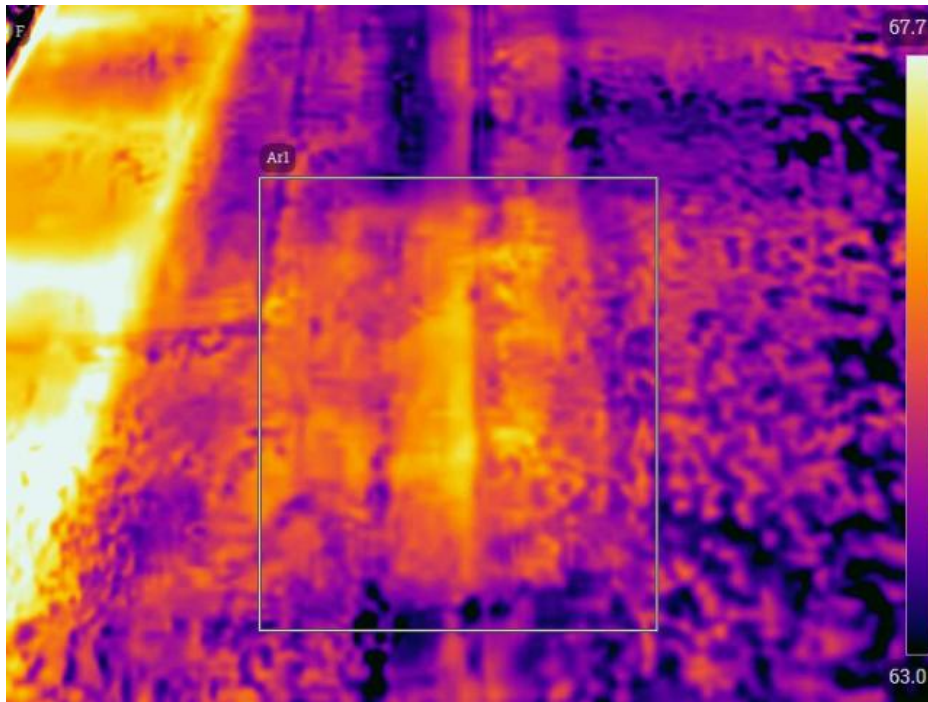
Area/Image No. 4

Damage Type Moisture Suspect

Moisture Probe: Negative

Thermal Anomaly: Possible Moisture

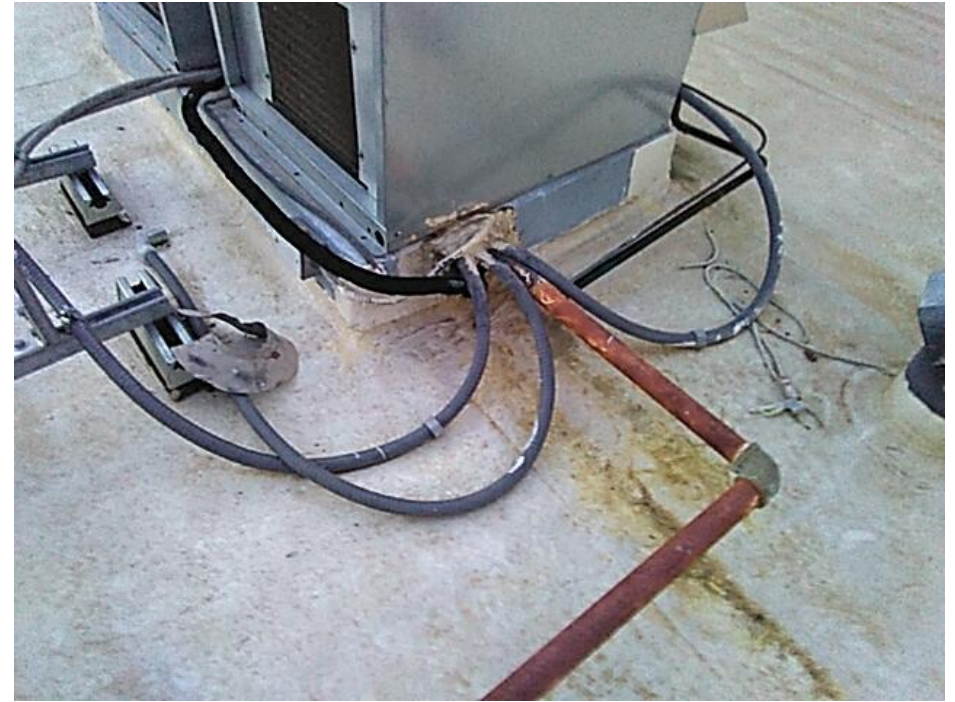
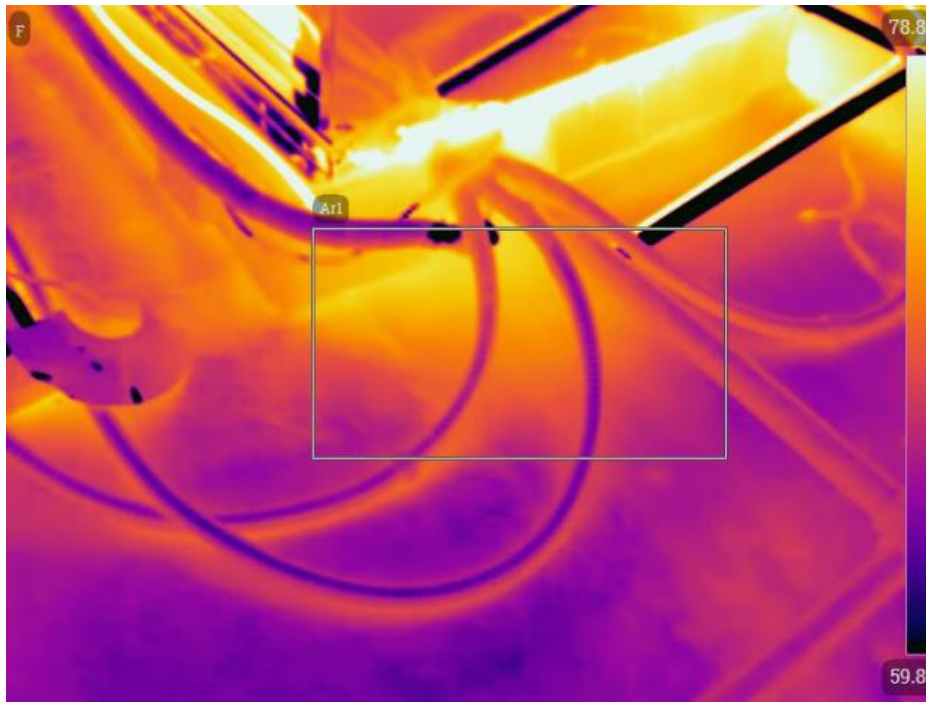
Area/Image No. 5

Moisture Probe: Positive

Thermal Anomaly: Confirmed Moisture

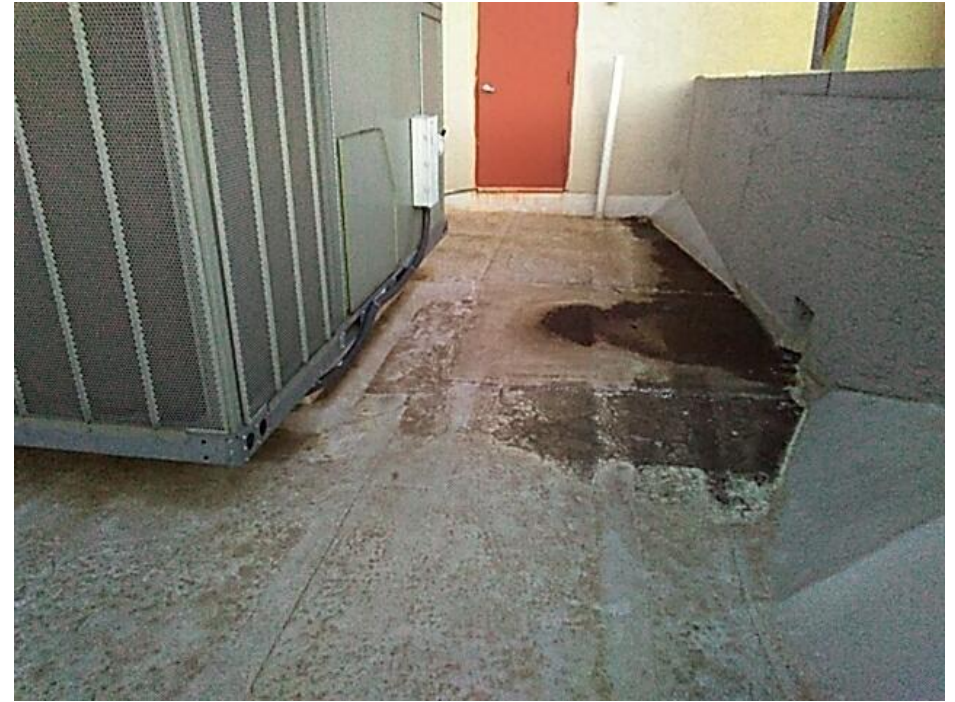
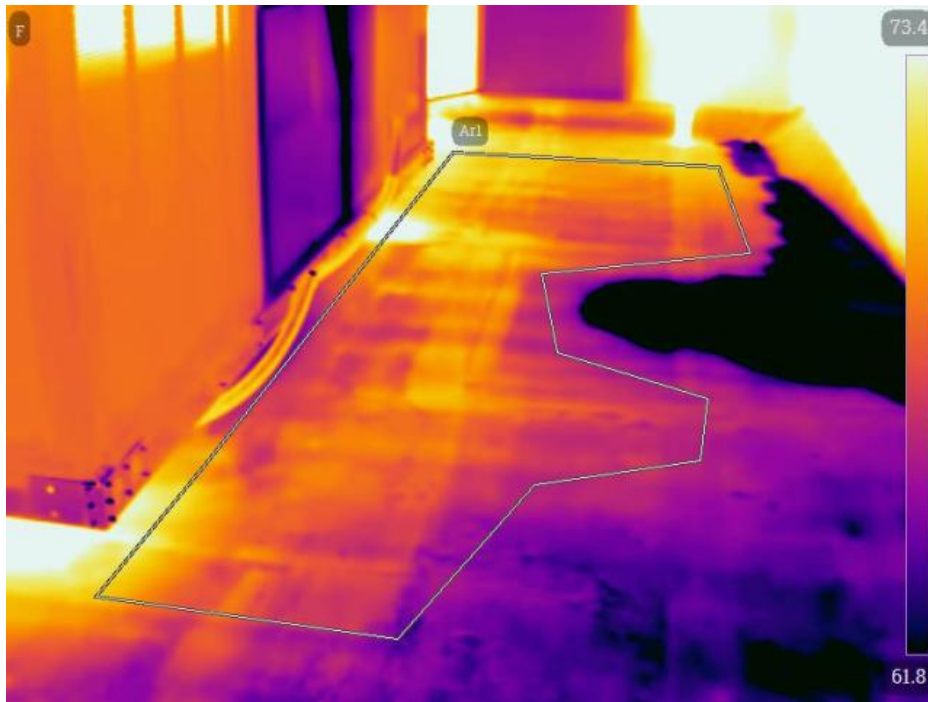
Area/Image No. 6

Previously Patched: Yes

Moisture Probe: Positive

Thermal Anomaly: Confirmed Moisture

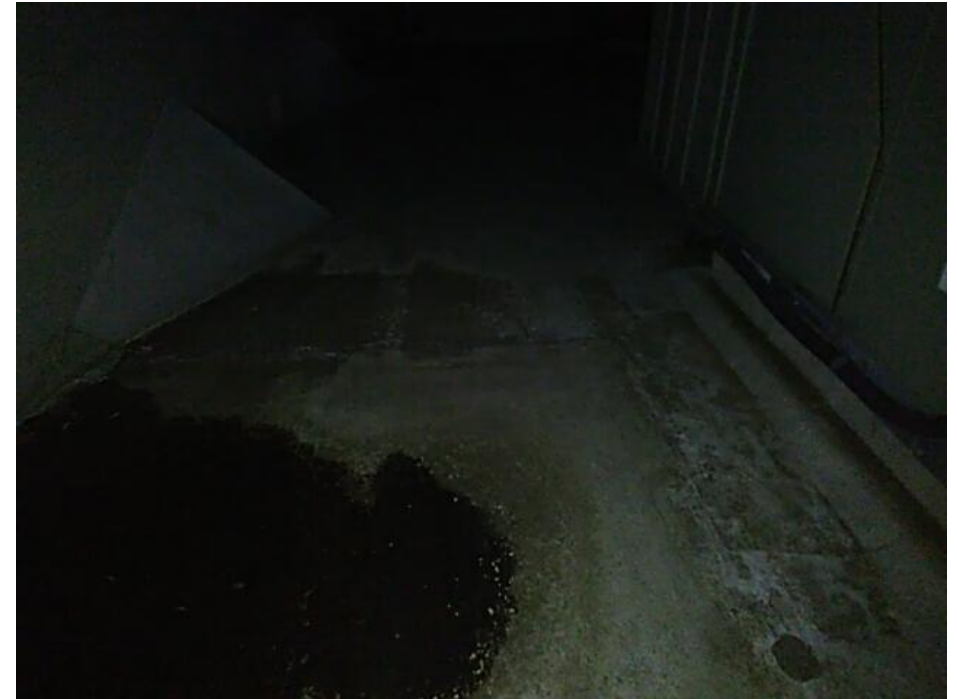
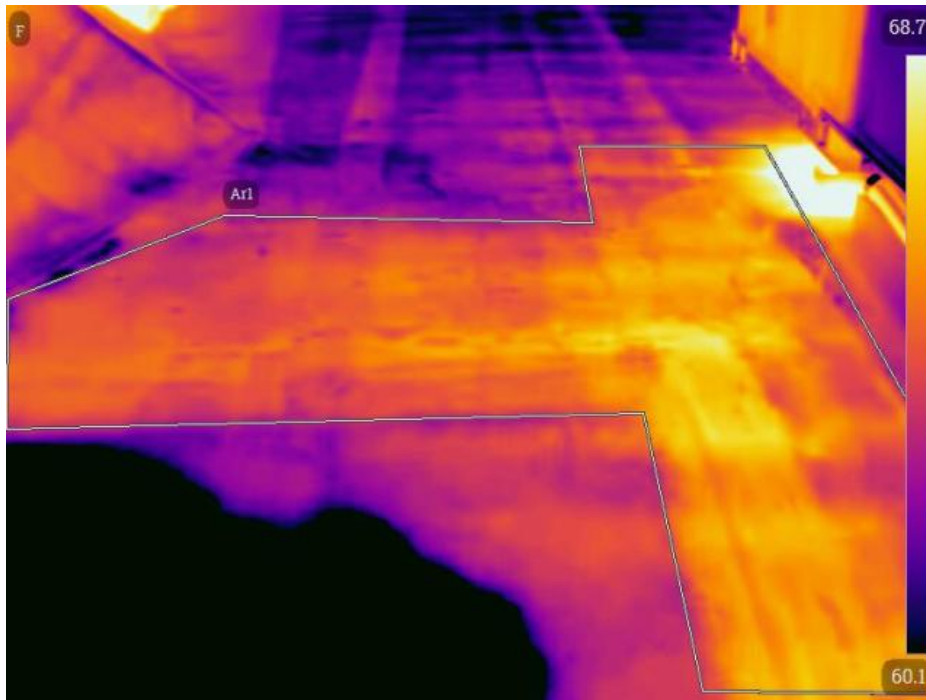
Area/Image No. 7

Previously Patched: Yes

Moisture Probe: Positive

Thermal Anomaly: Confirmed Moisture

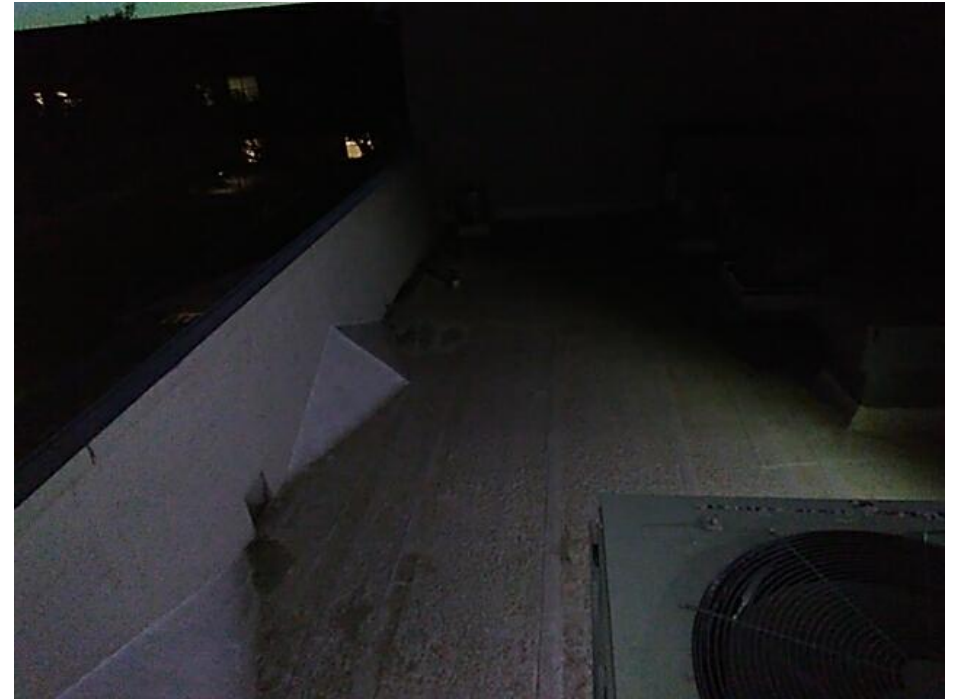
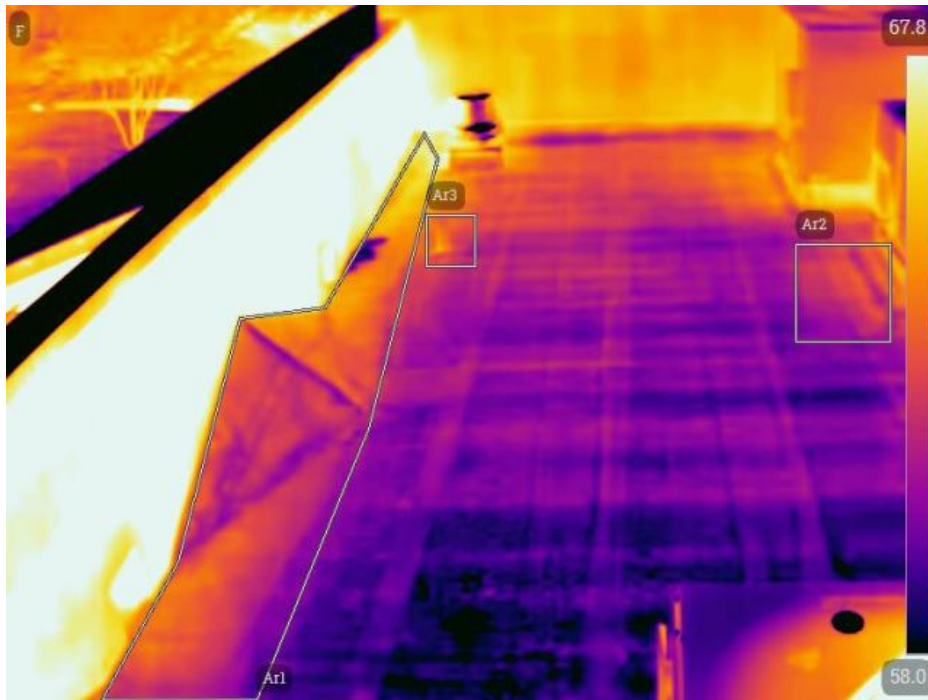
Area/Image No. 8

Previously Patched: Yes

Moisture Probe: Positive

Thermal Anomaly: Confirmed Moisture

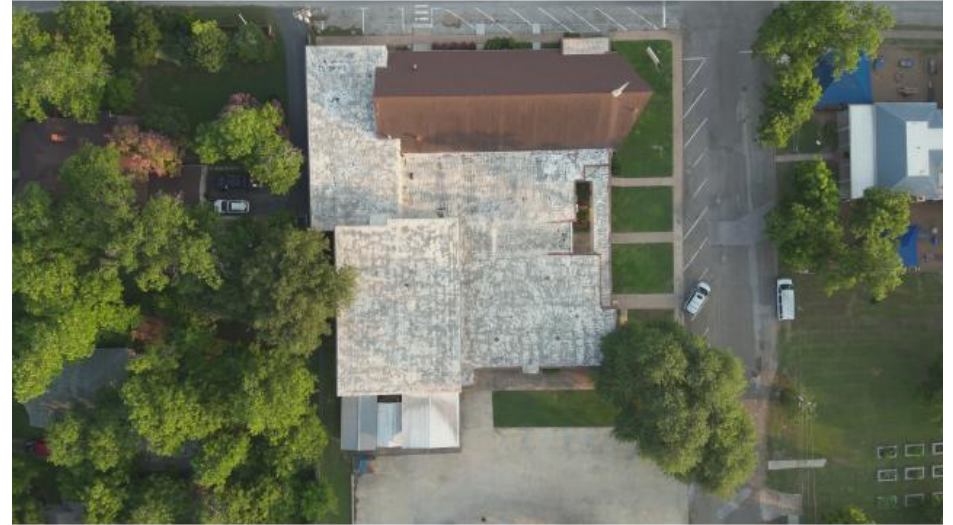
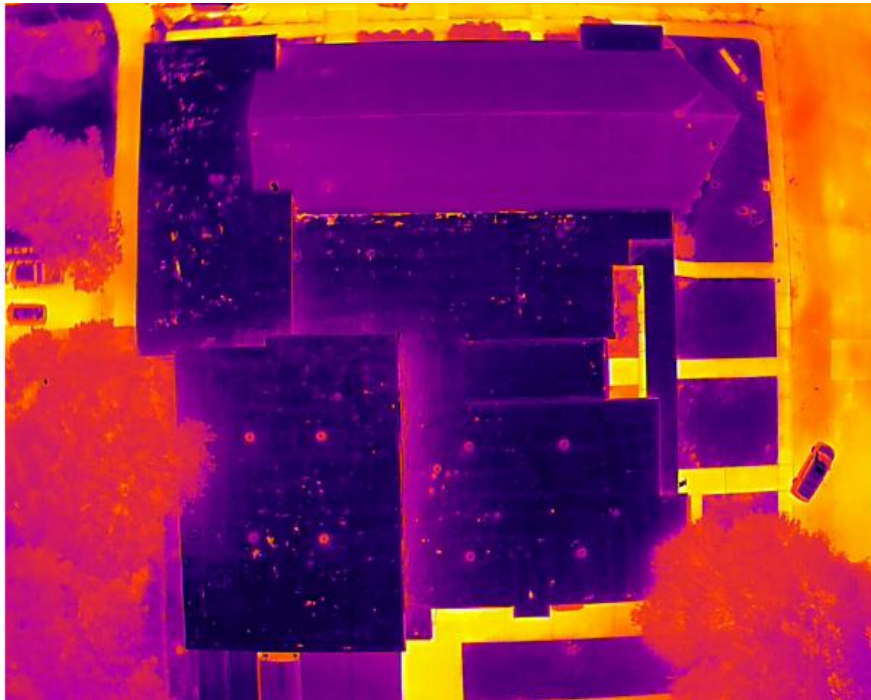
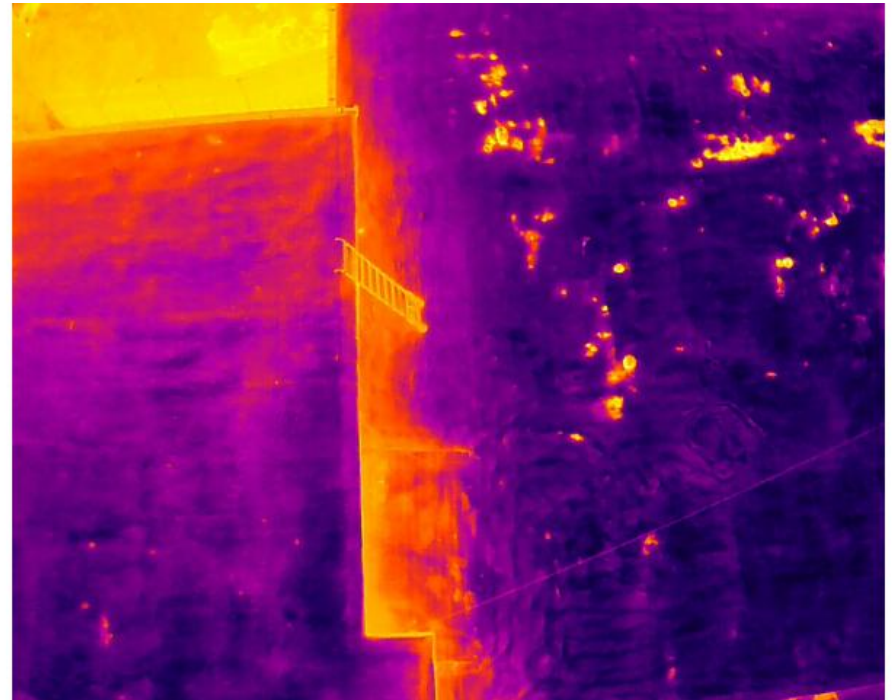
Area/Image No. 9

Drone shot showing possible moisture infiltration.

Recommend having a core sample performed by a licensed professional.

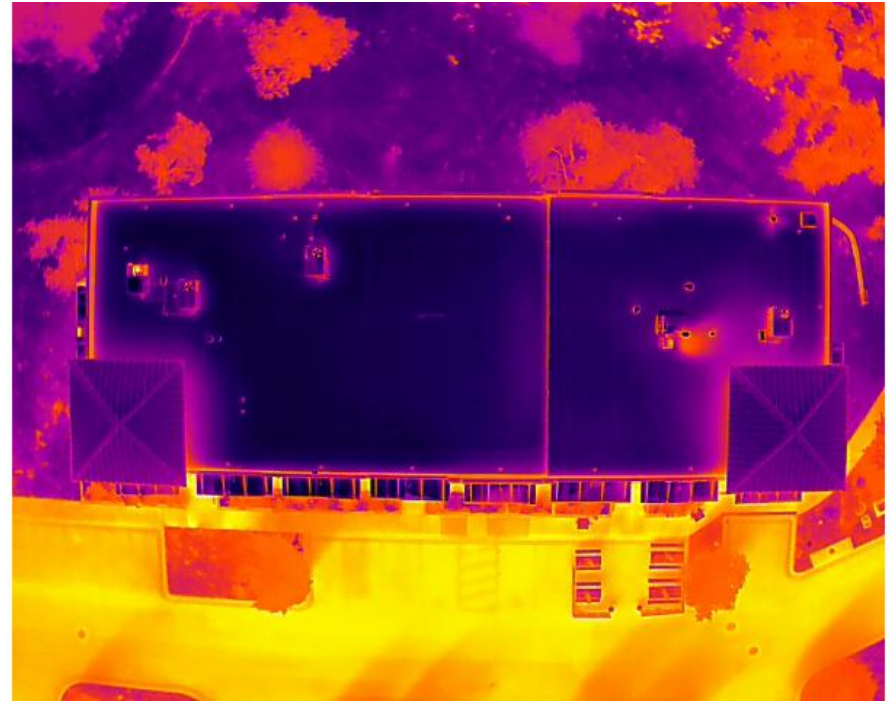
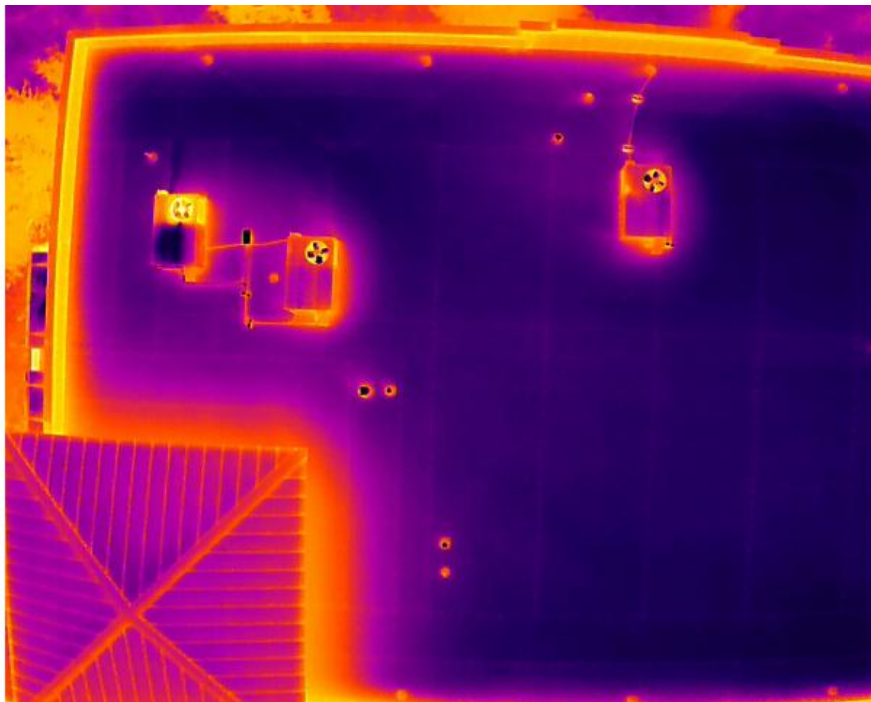
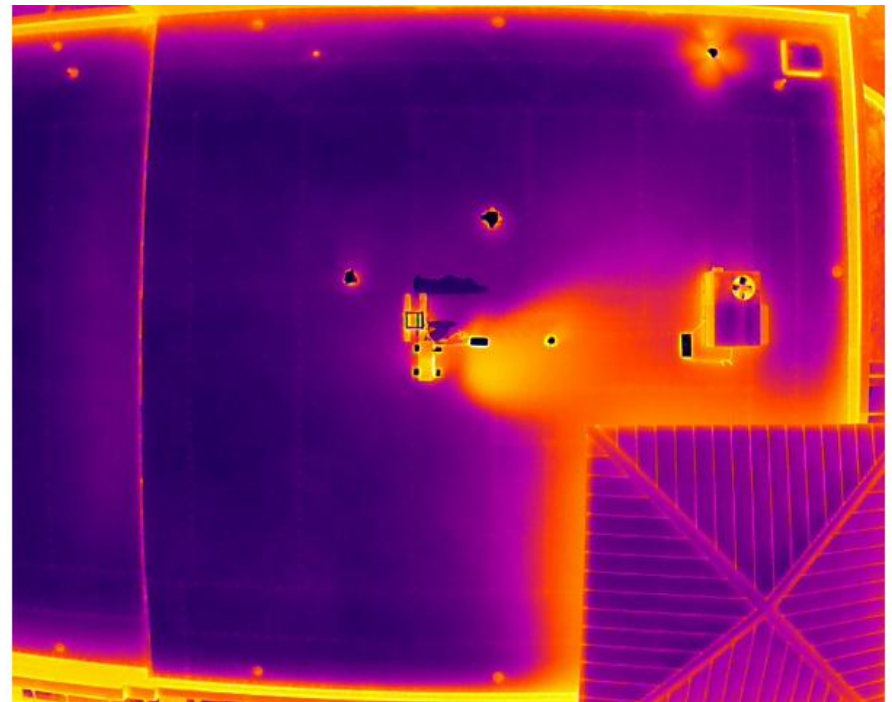
Area/Image No. 10

Aerial View

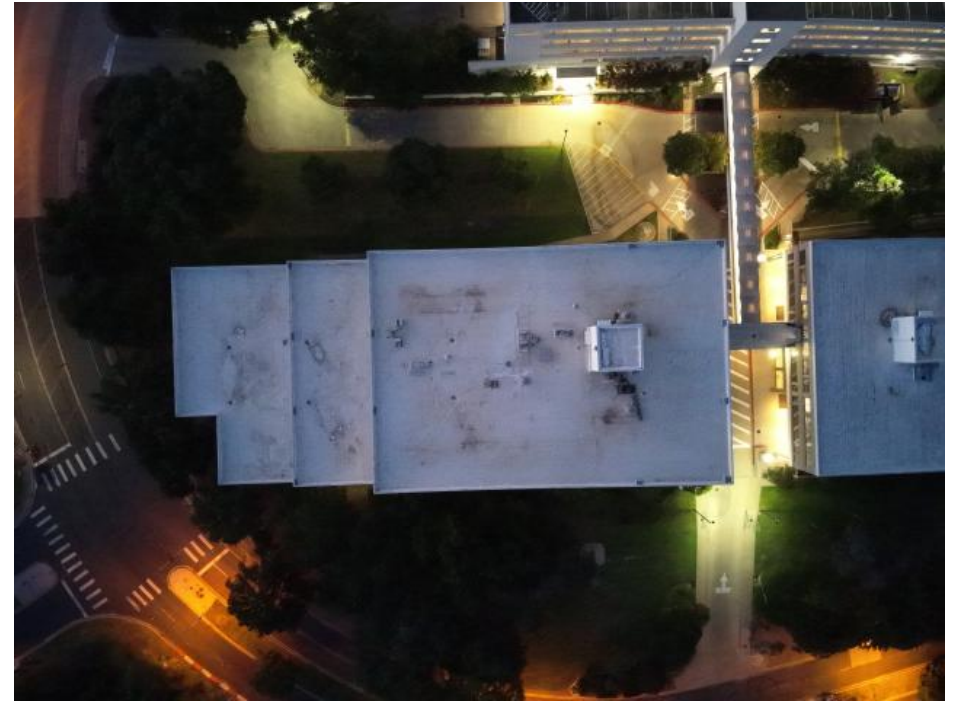
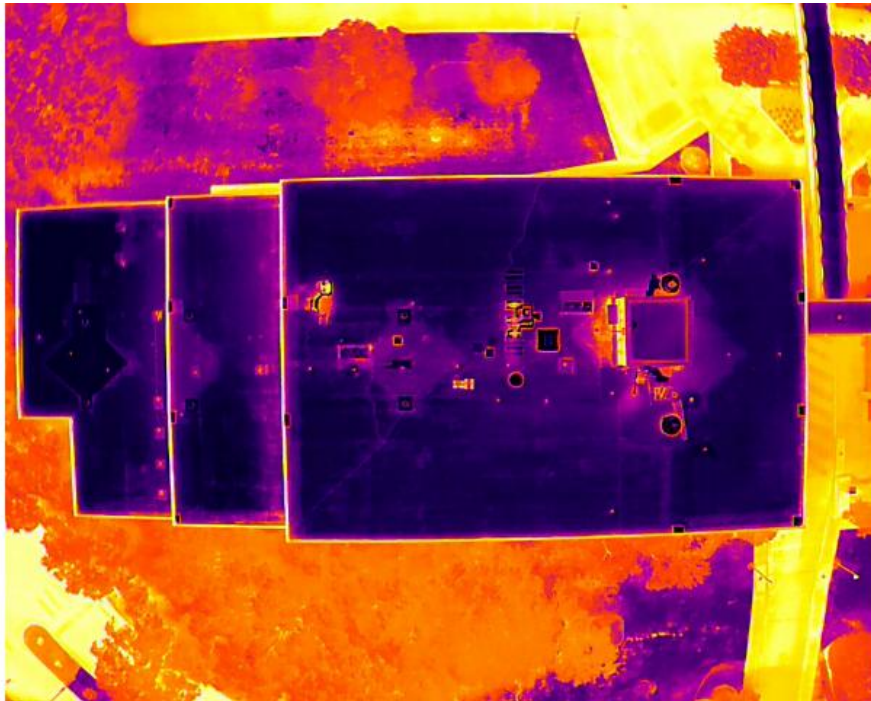
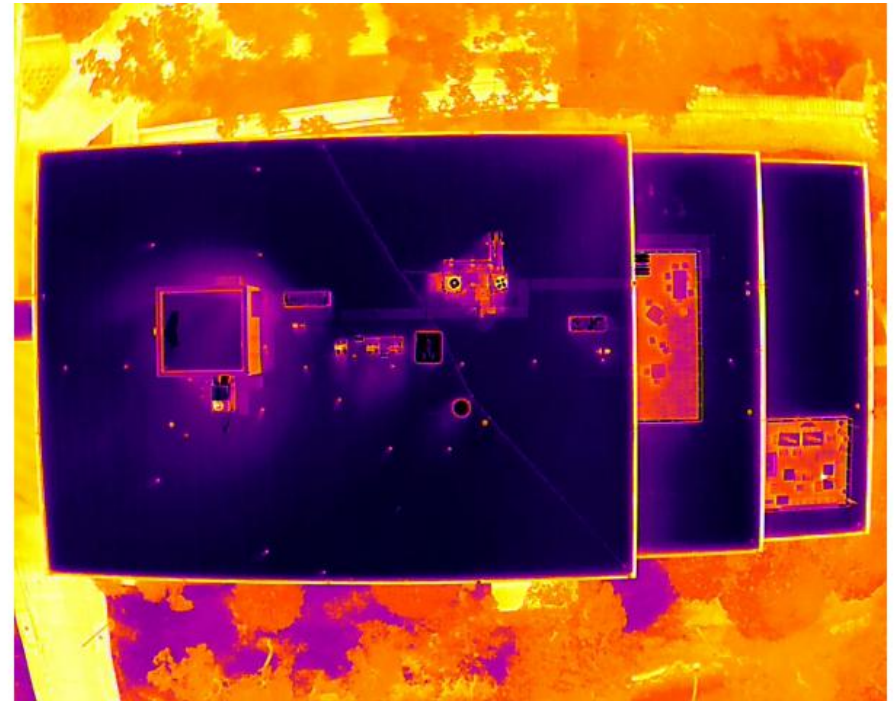
Area/Image No. 11

Moisture Probe: Positive

Core Sample: Positive

High Altitude View showing minor trapped moisture in the roof.
