APPENDIX B
Record Photographs

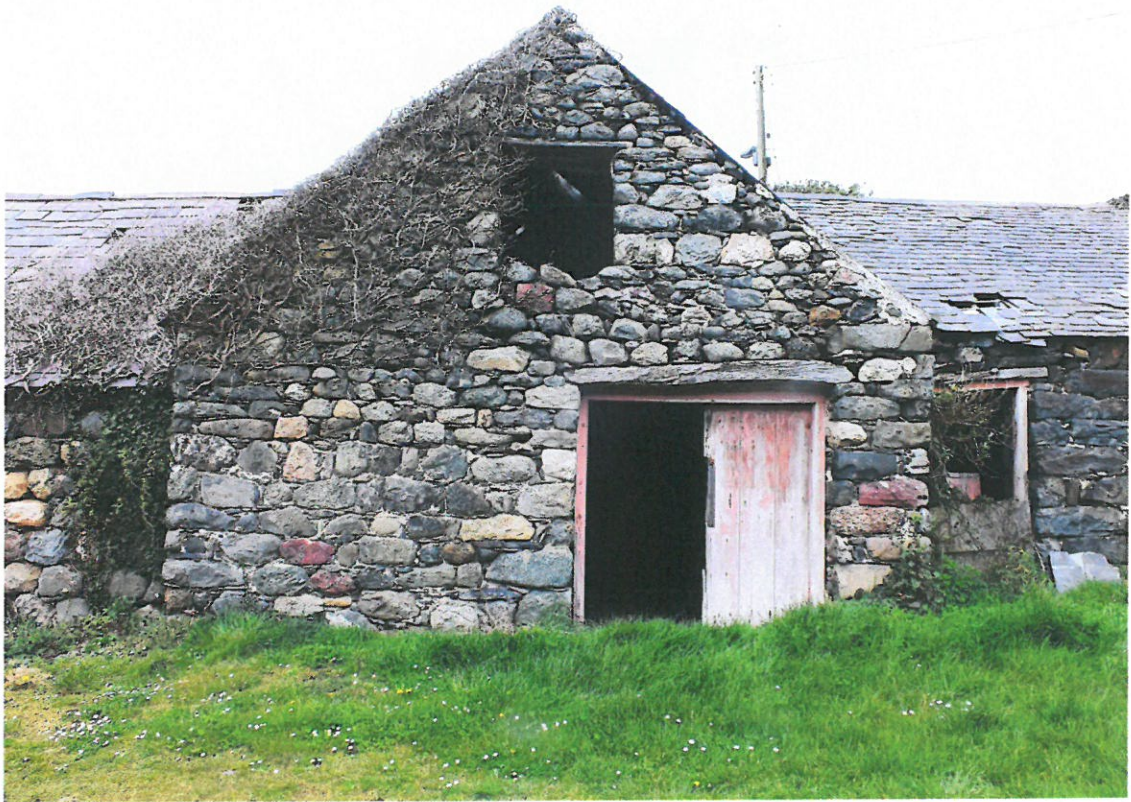
1

South-East Elevation – Area A

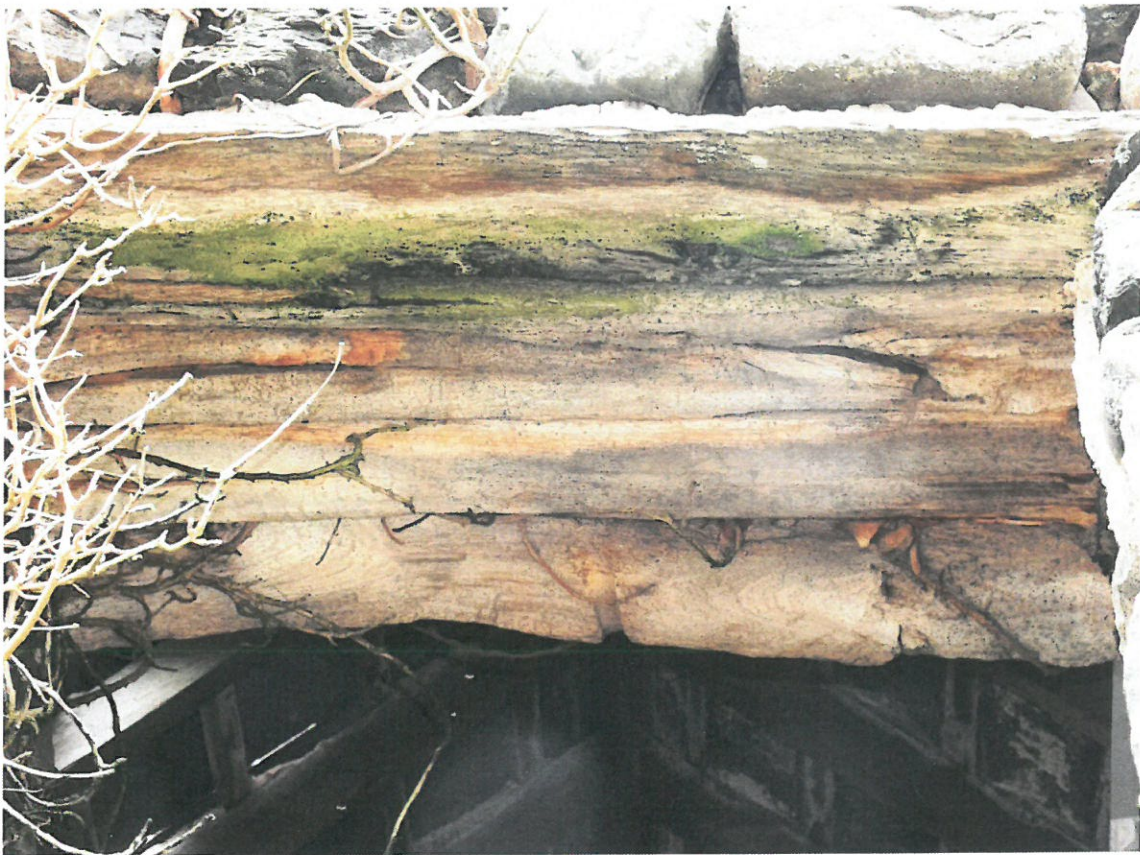
2

South-East Elevation – Area A - Window Lintel

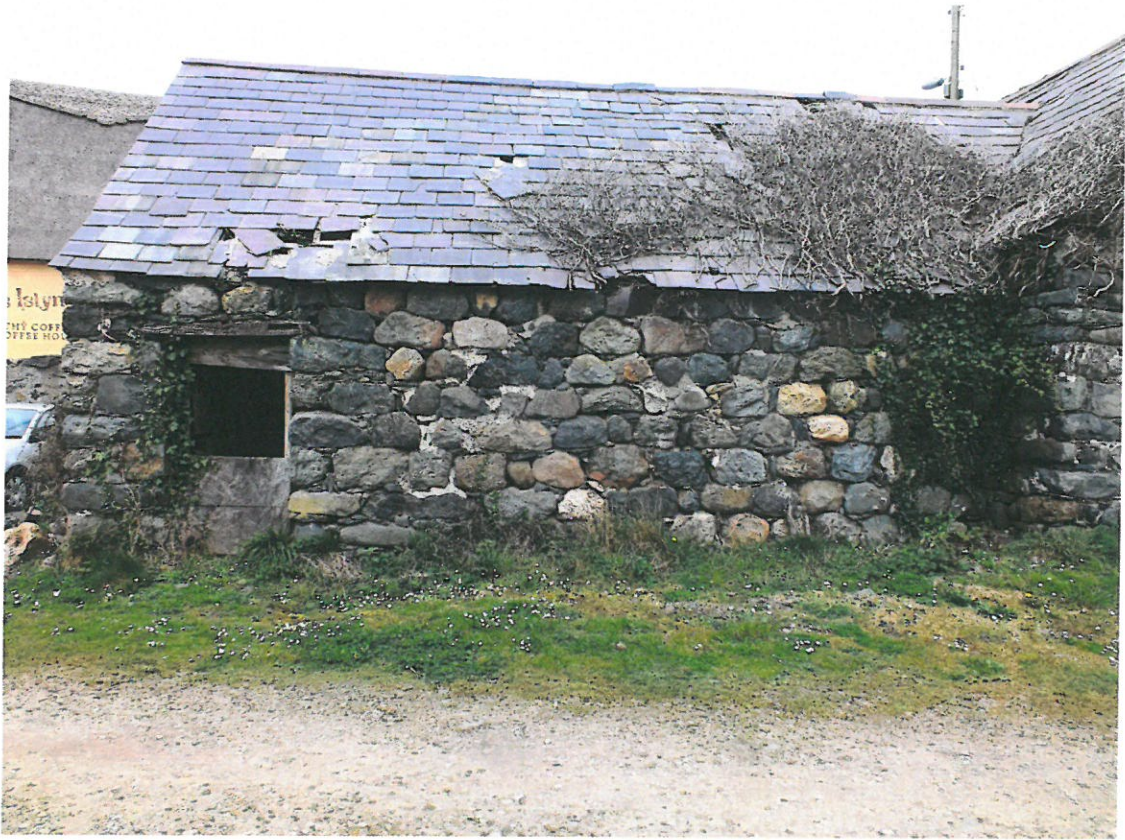
3
South-East Elevation – Area C

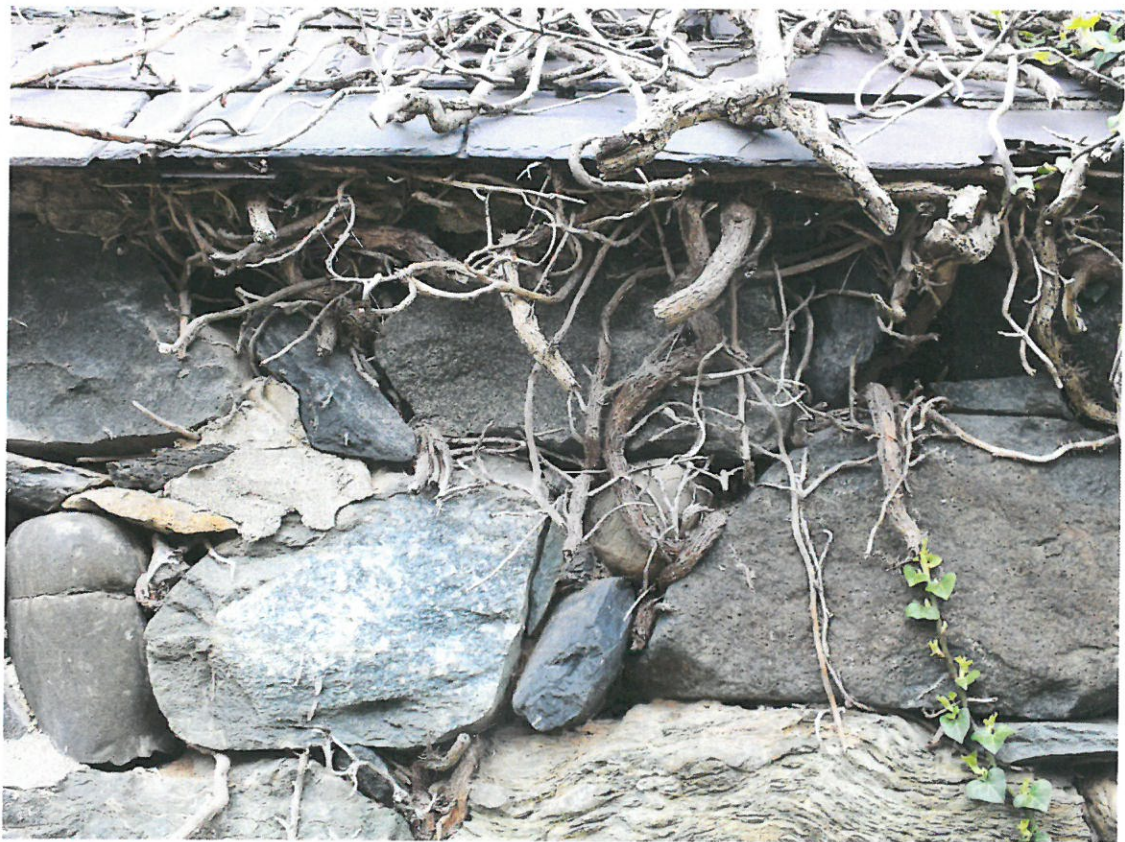
4
South-East Elevation – Area C

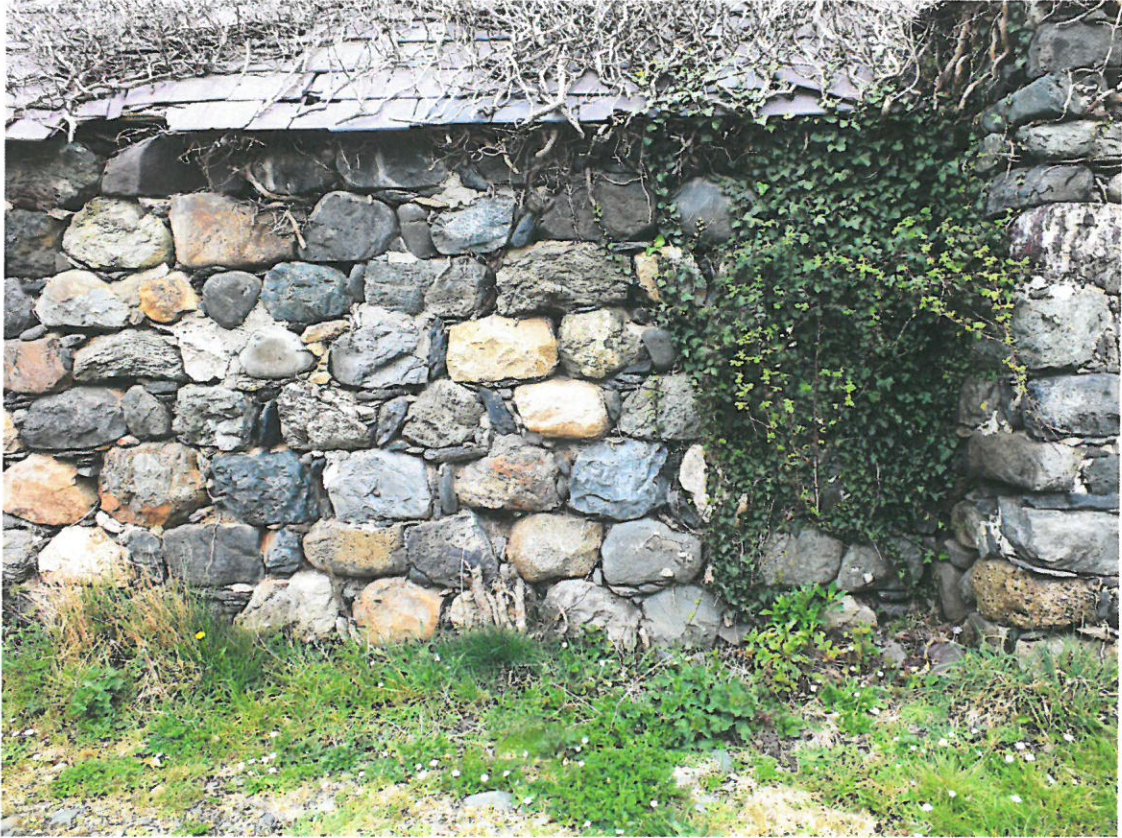
5
South-East Elevation – Area C

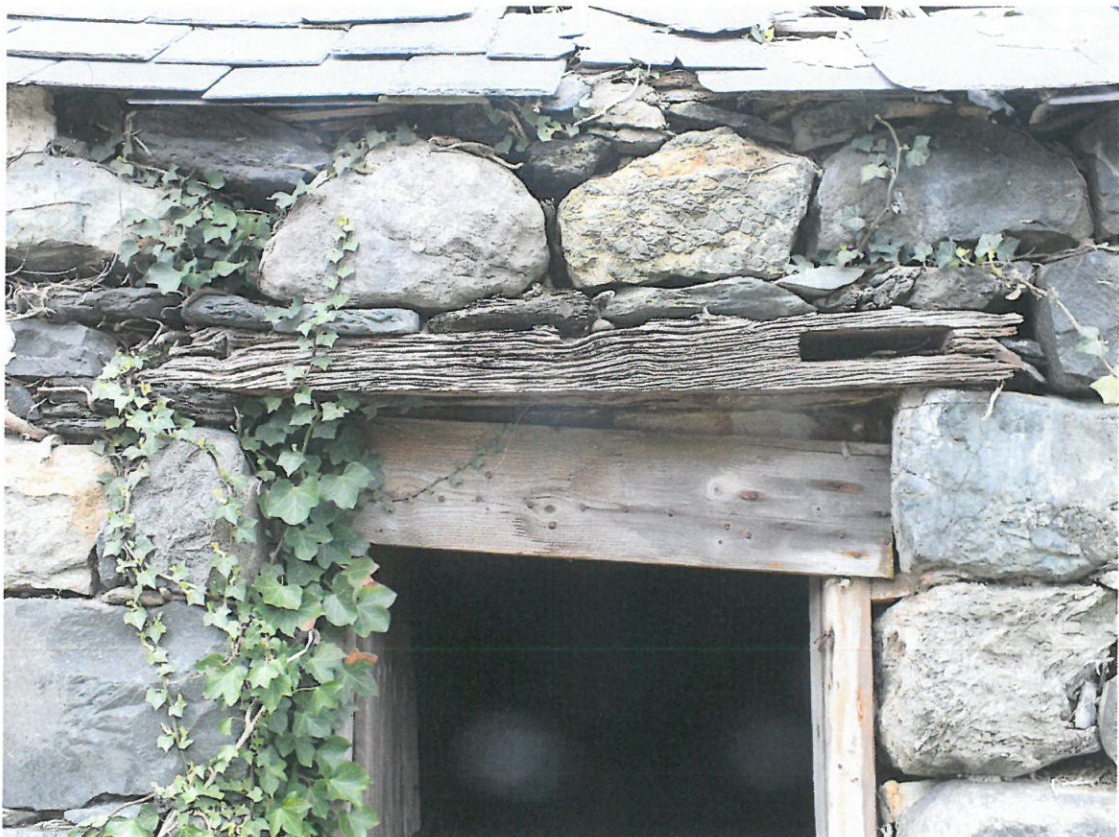
6
South-East elevation – Area C – Door Lintel

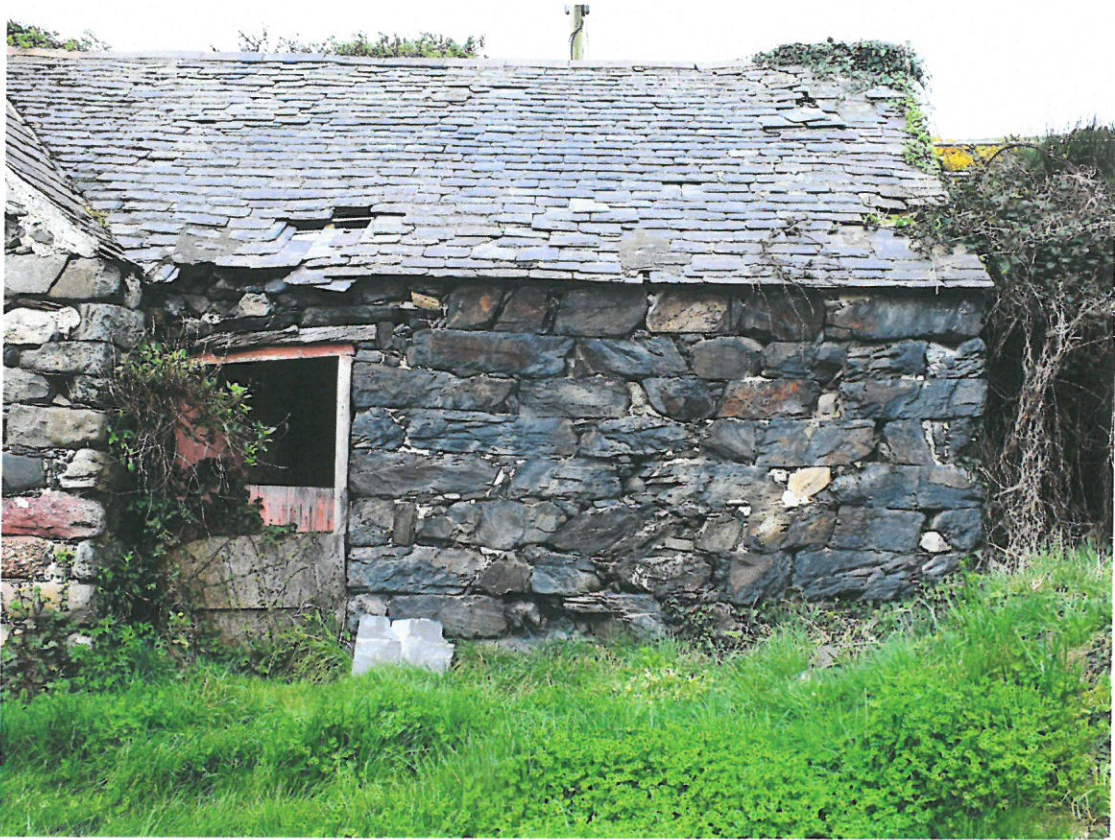
7

South-East Elevation – Stable

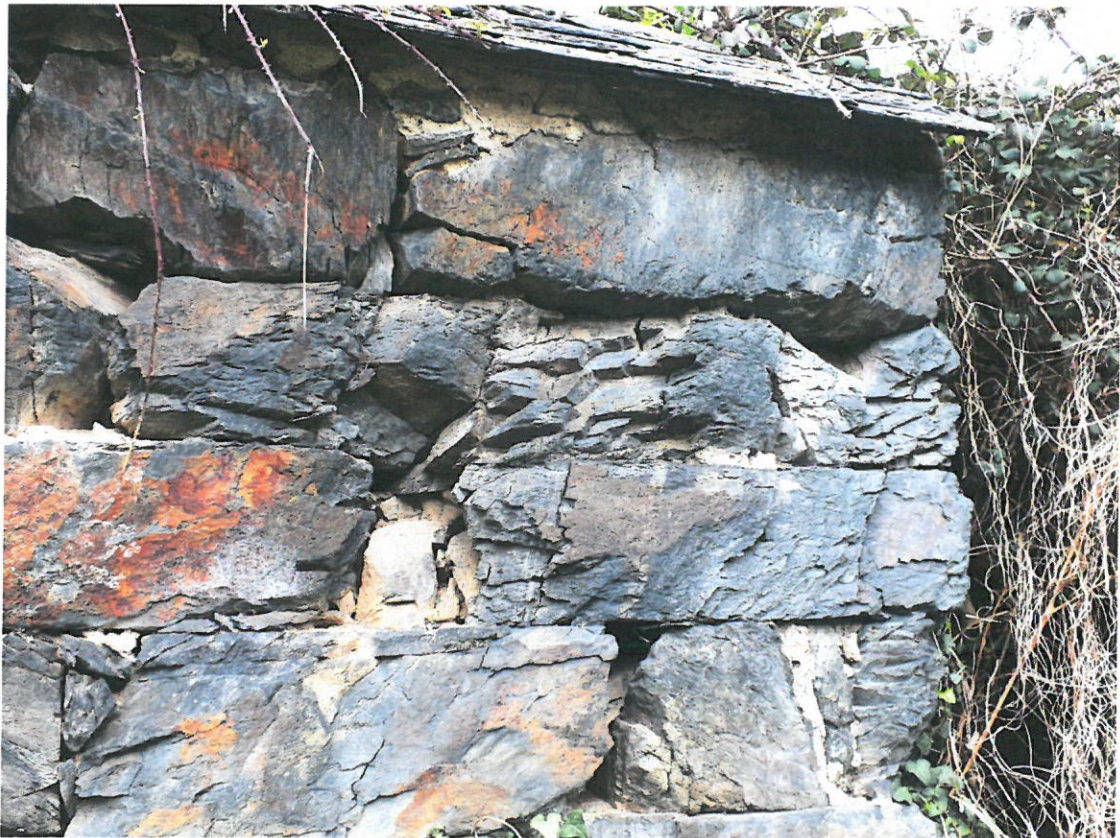
8

South-East Elevation – Stable – Fragmented Stone

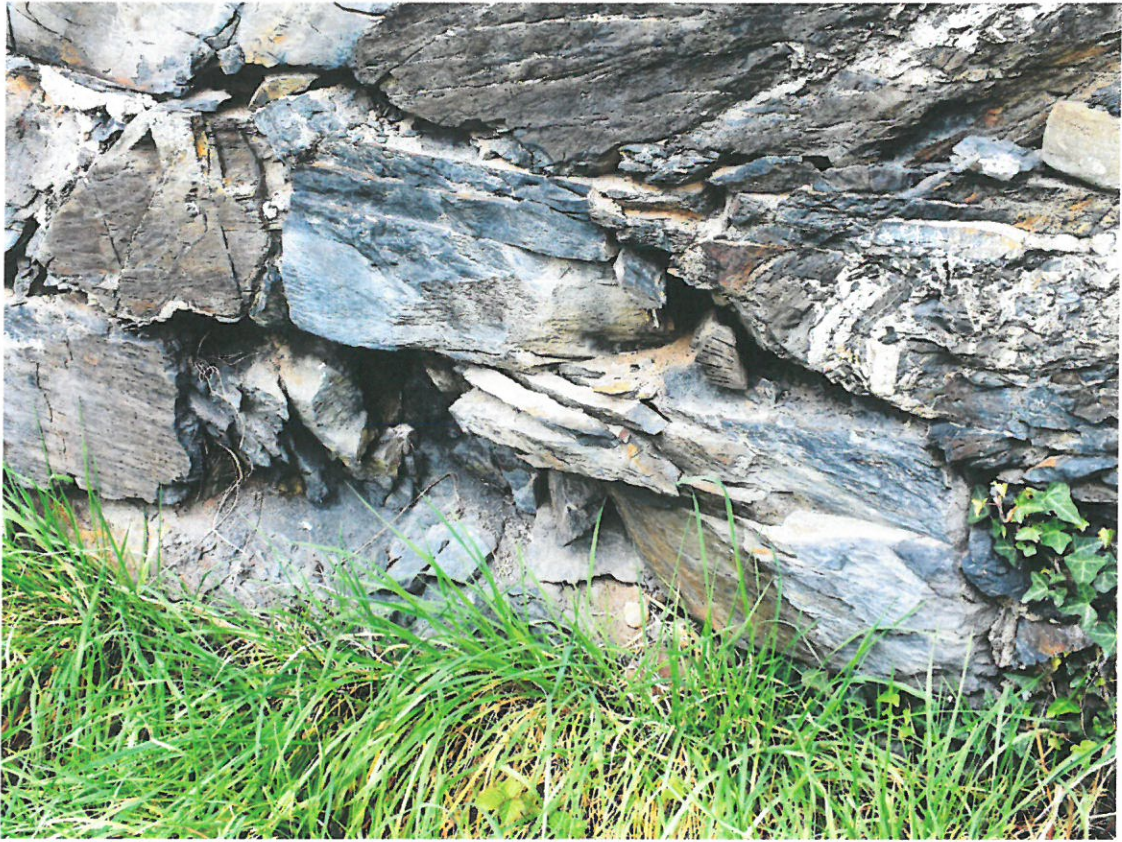
9

South-East Elevation – Stable – Fragmented Stone

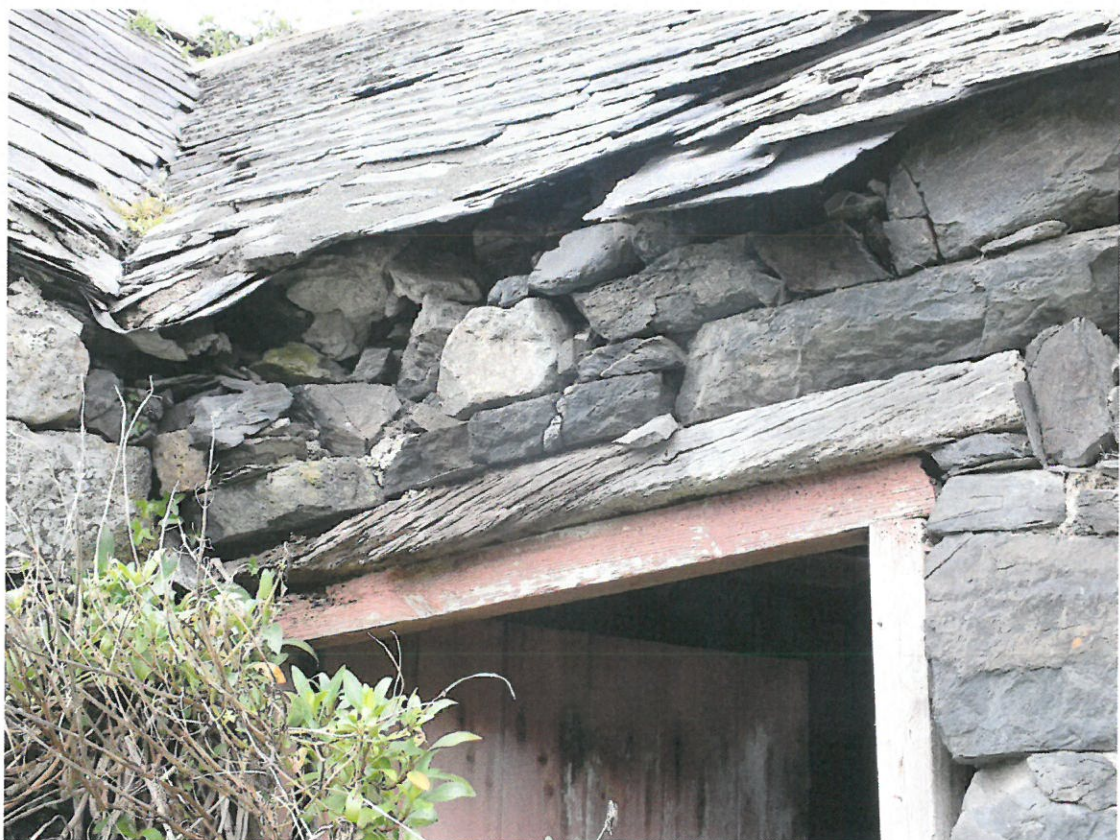
10

South-East Elevation – Stable – Defective Lintel

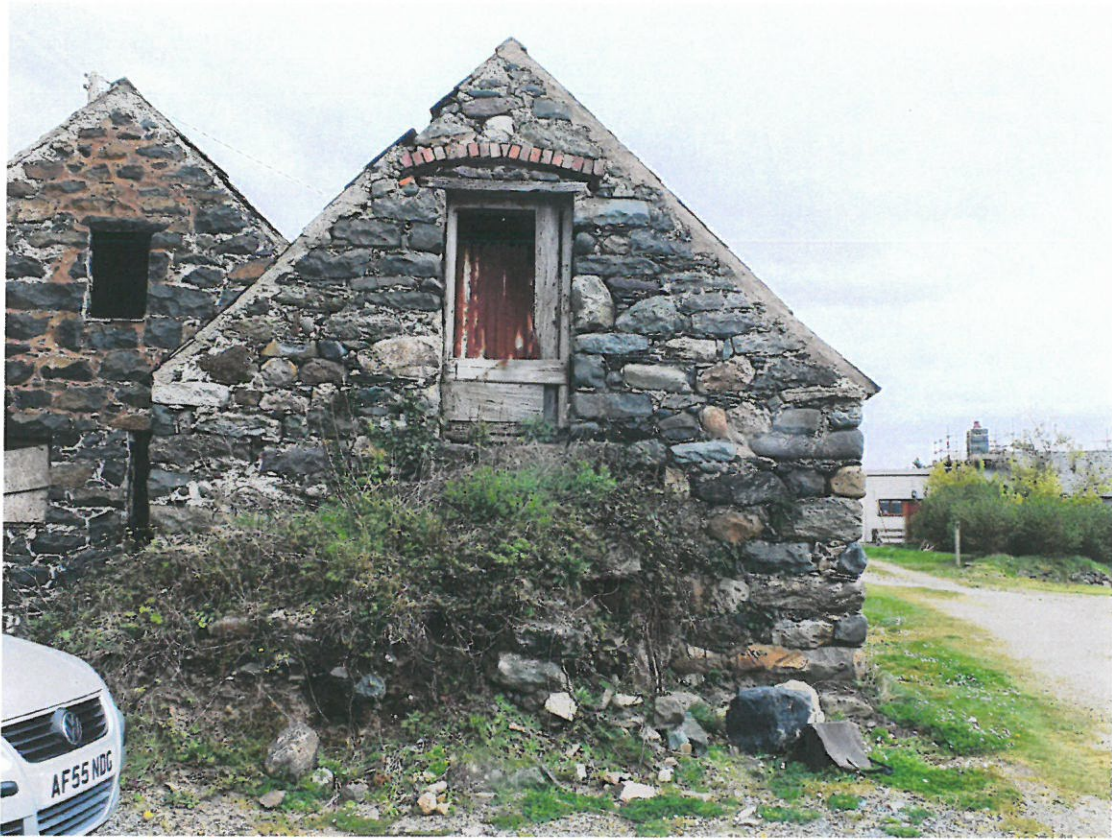
11
South-West Elevation – Area C

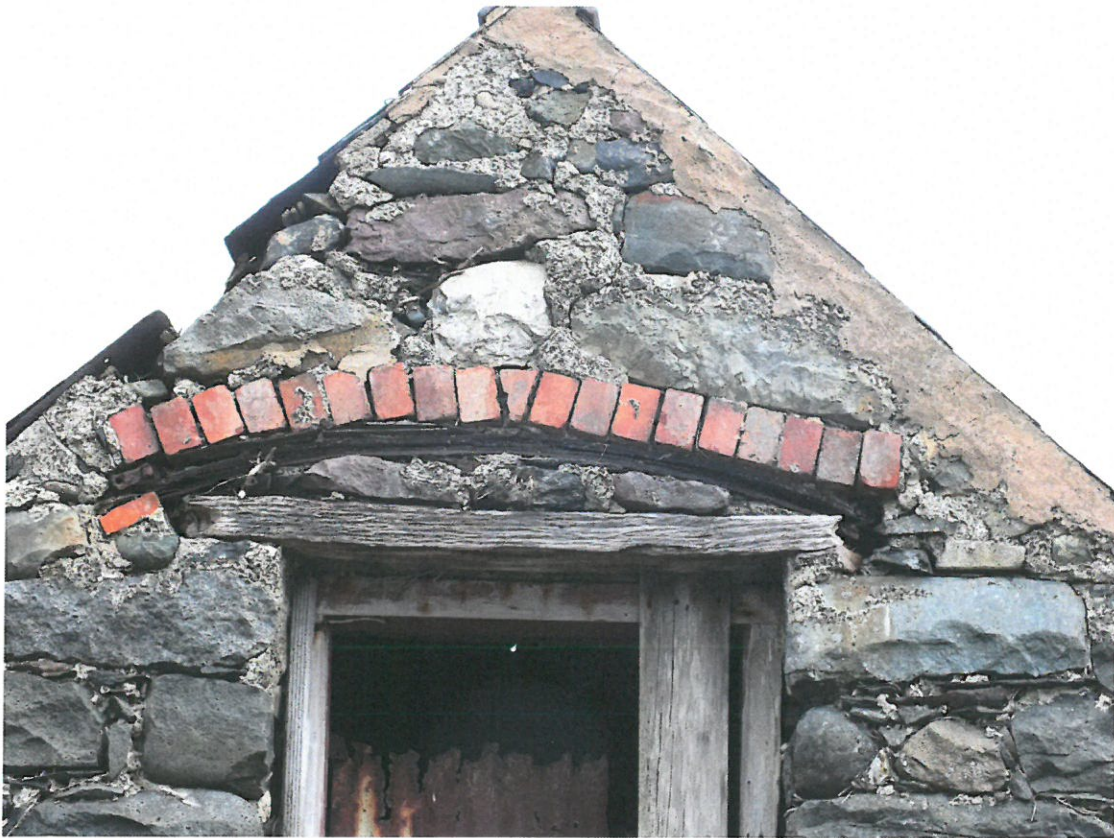
12
South-West Elevation – Area C – Door Lintel

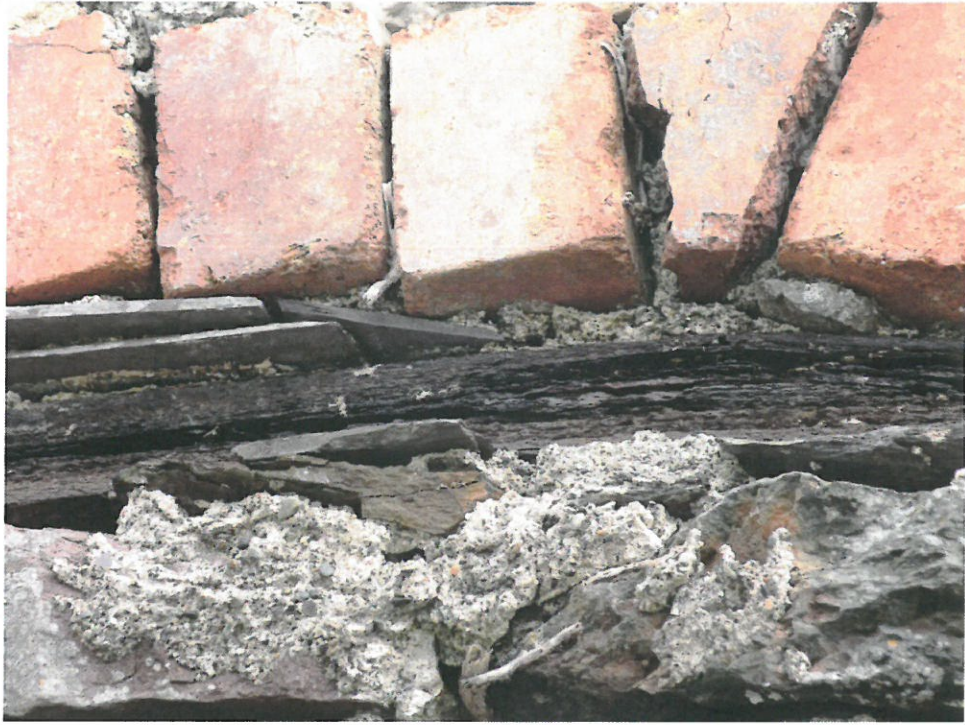
13

South-West Elevation – Area C – Corroded Plate

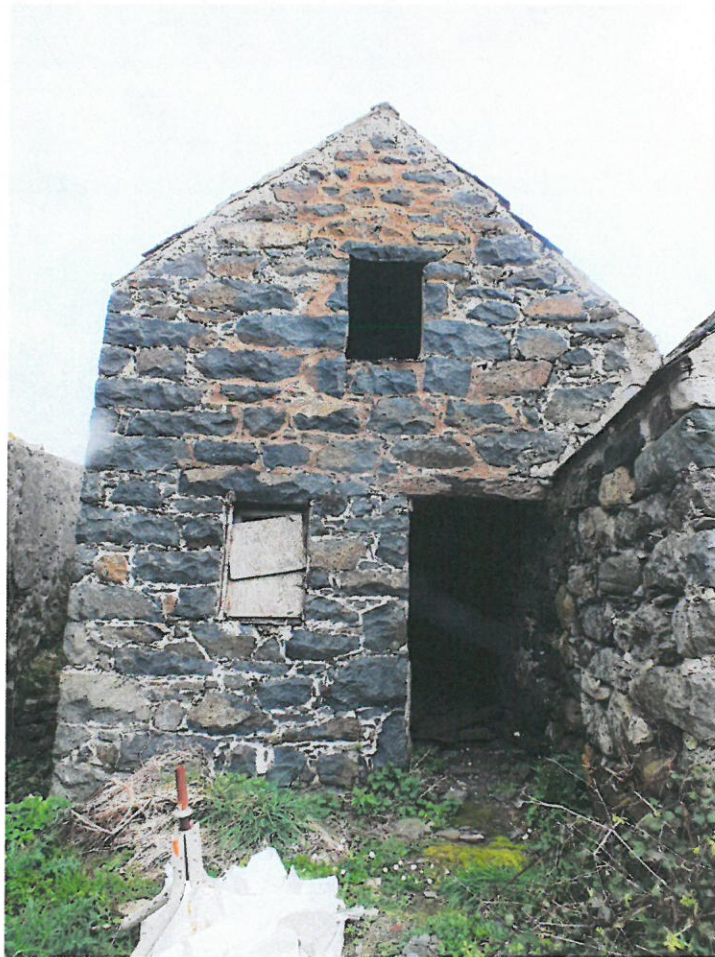
14

South-West Elevation – Area B

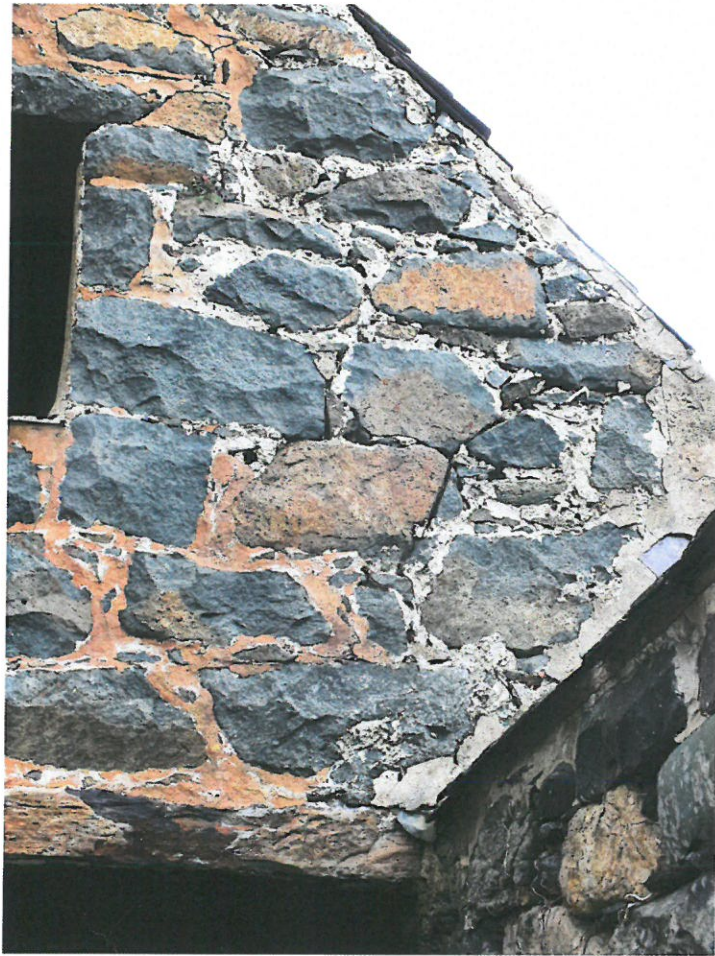
15

South-West Elevation – Area B – Vertical Cracking

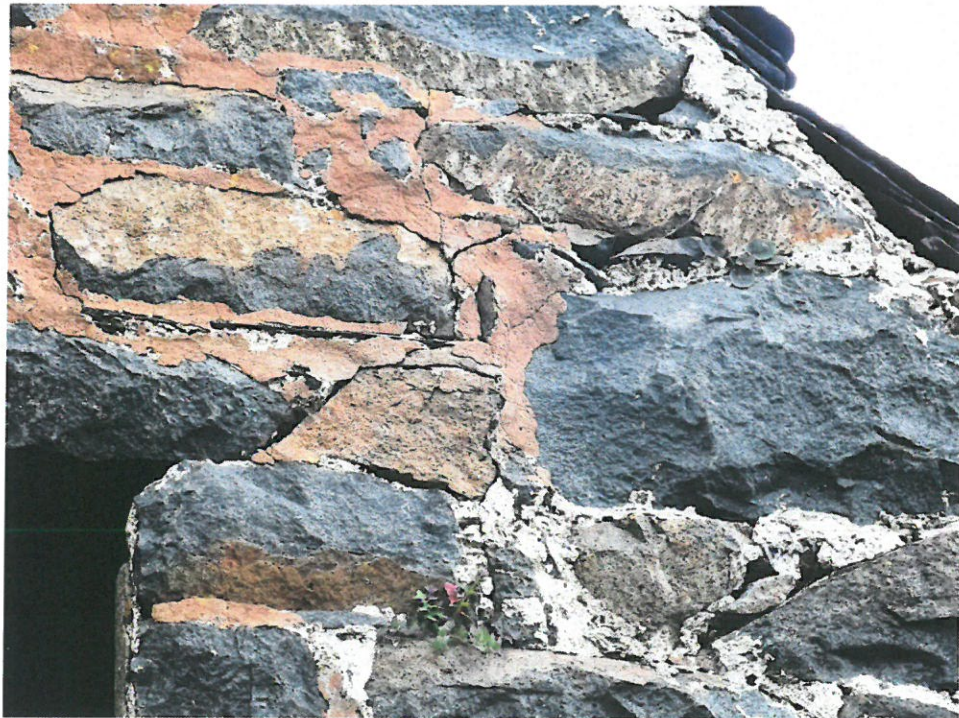
16

South-West Elevation – Area B – Cracking Above Window

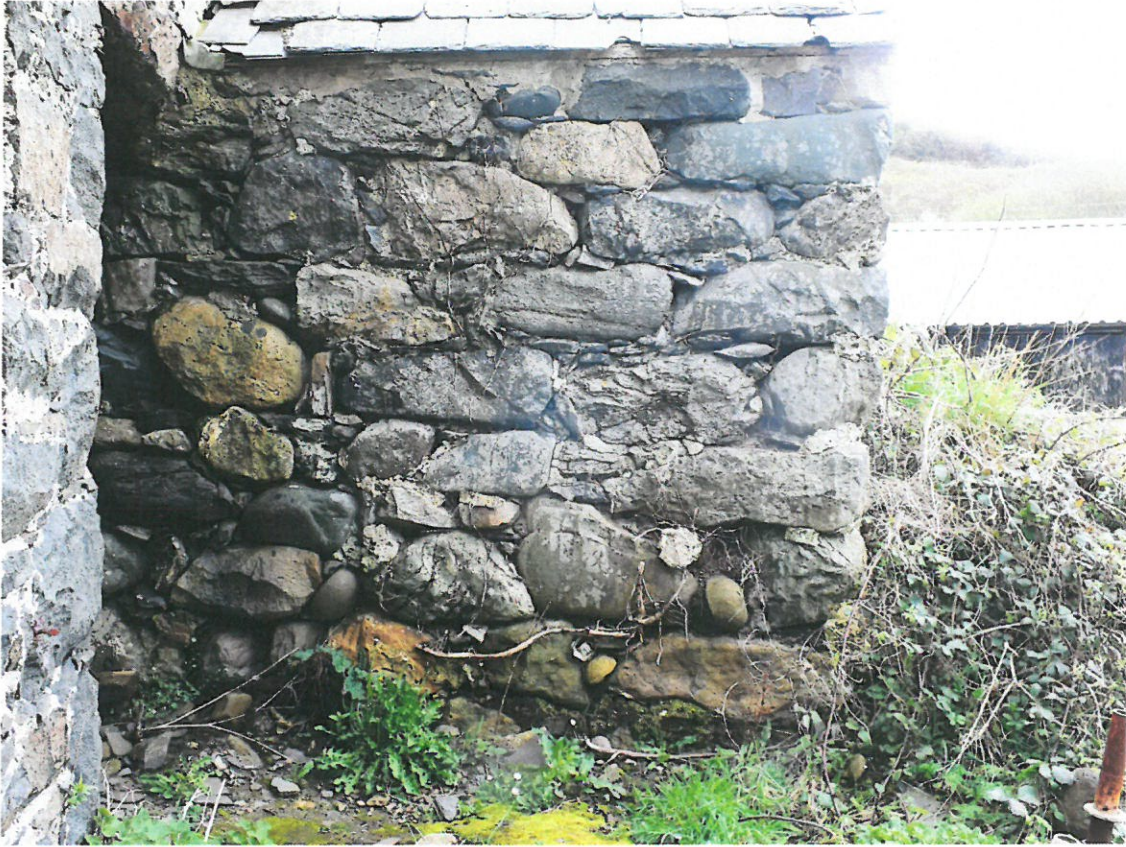
17

North-West Elevation – Area C

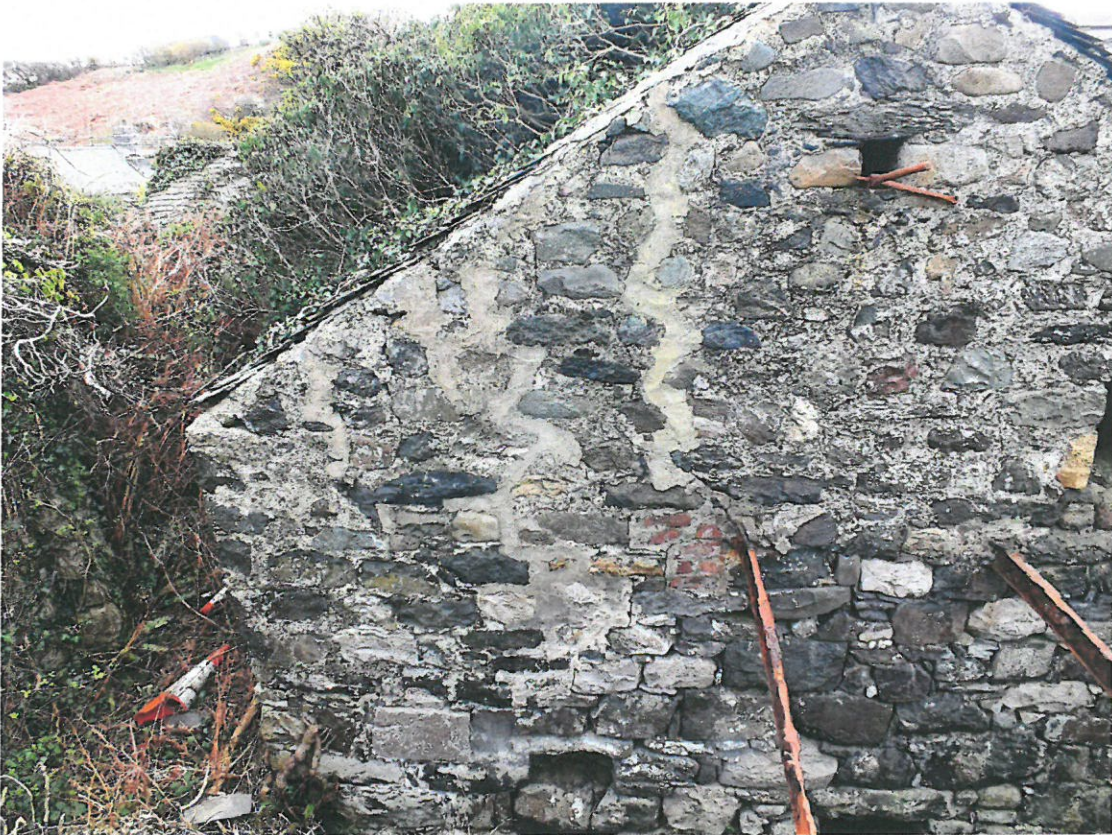
18

North-West Elevation – Area A – Cracking near North Corner

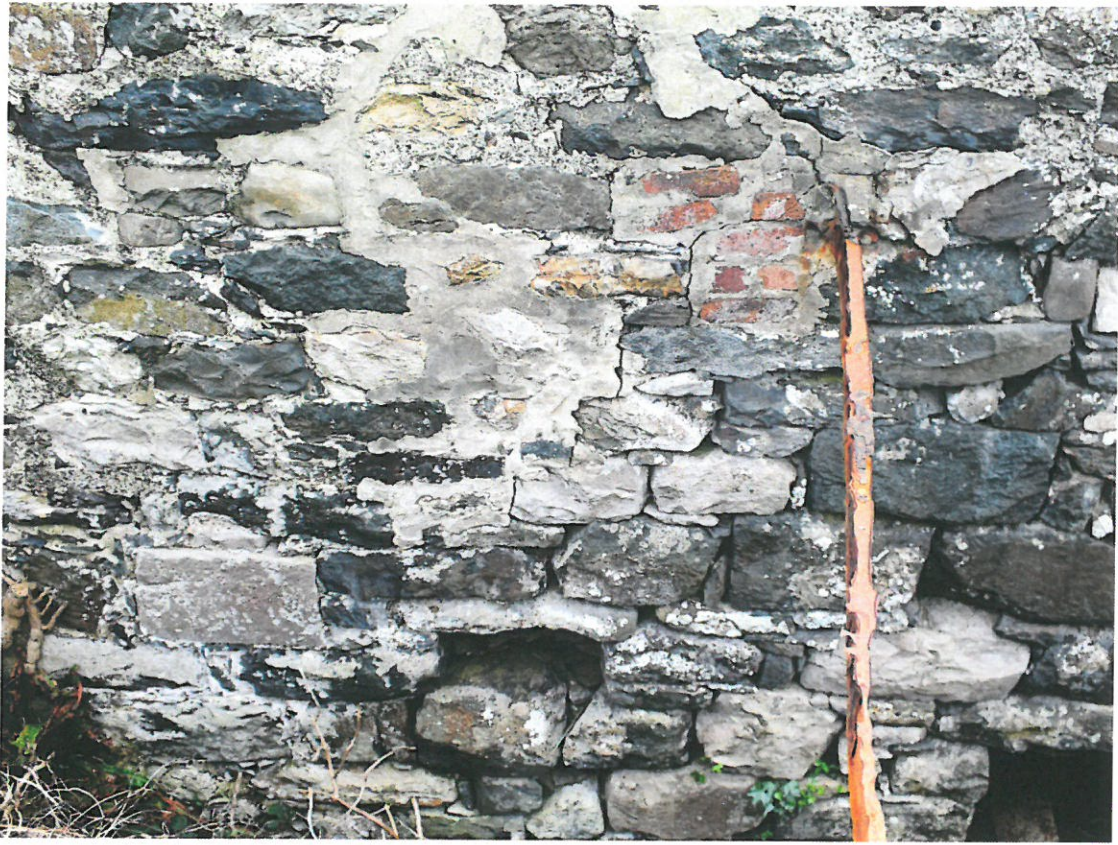
19

North-West elevation – Area A – Vertical Cracking

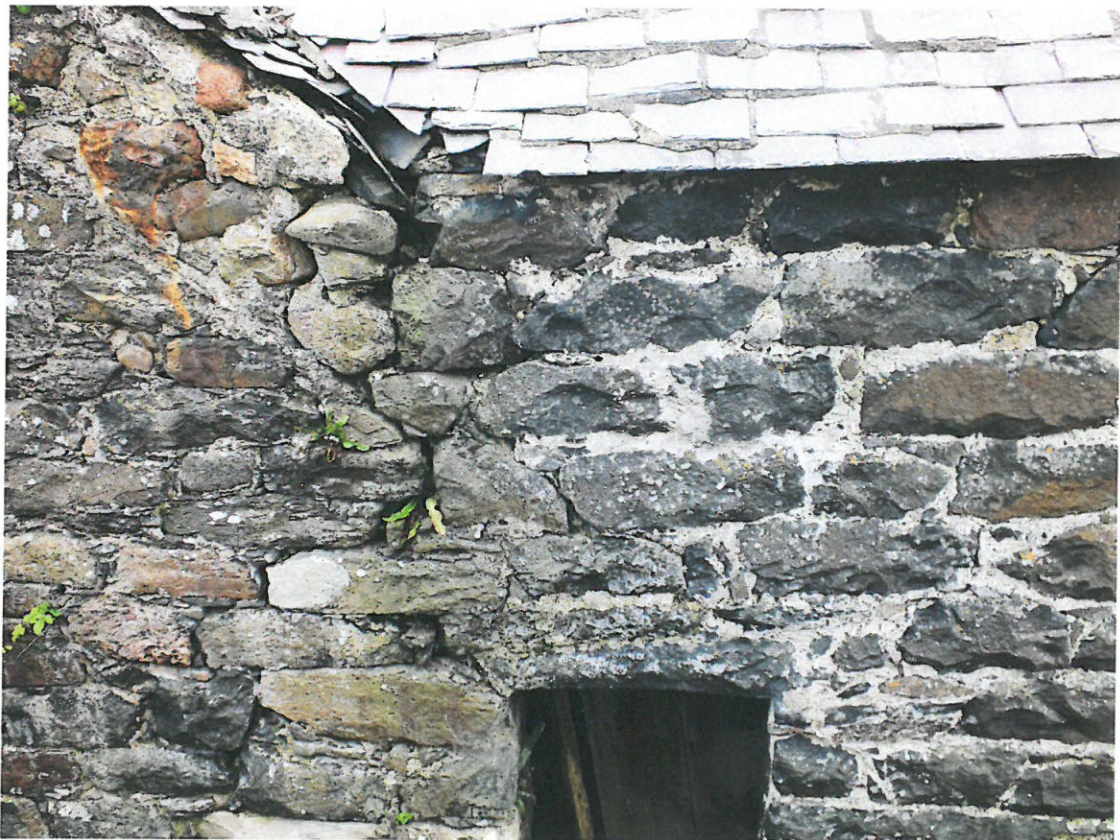
20

North-West Elevation – Area A – Cracking at Junction with Area B

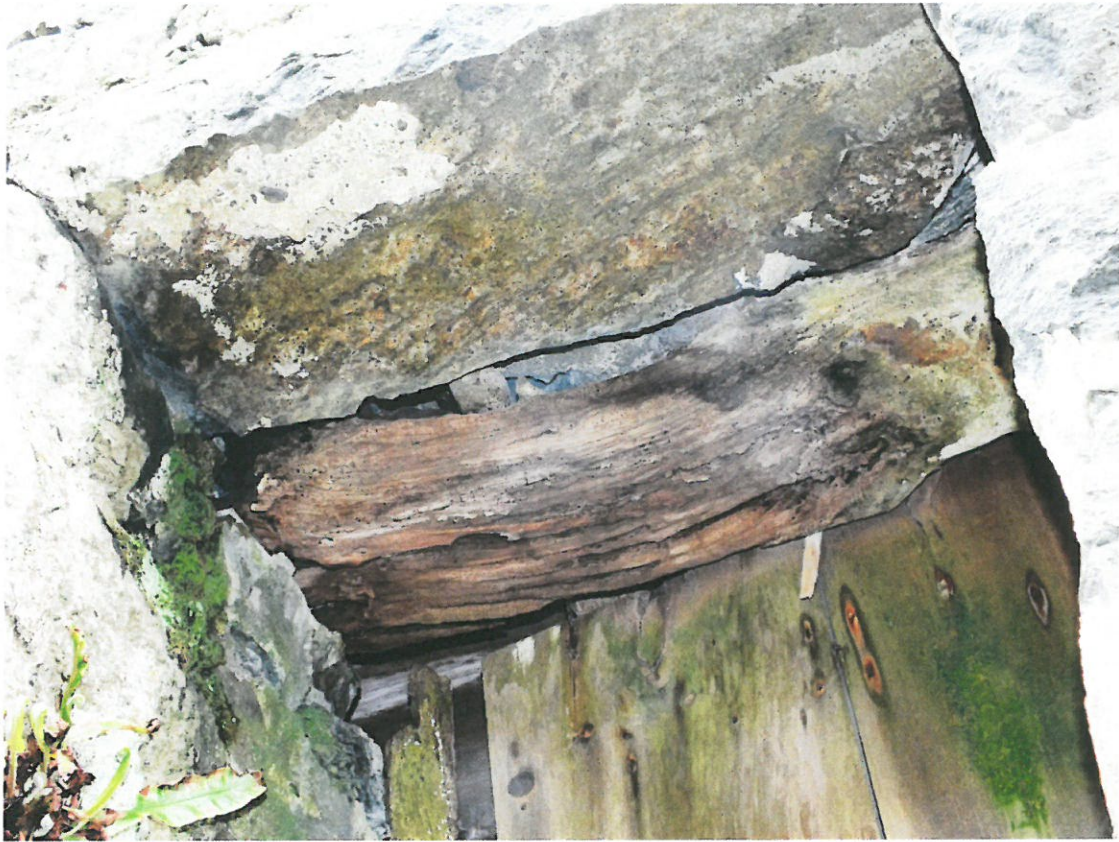
21

North-West Elevation – Area B – Window Lintel

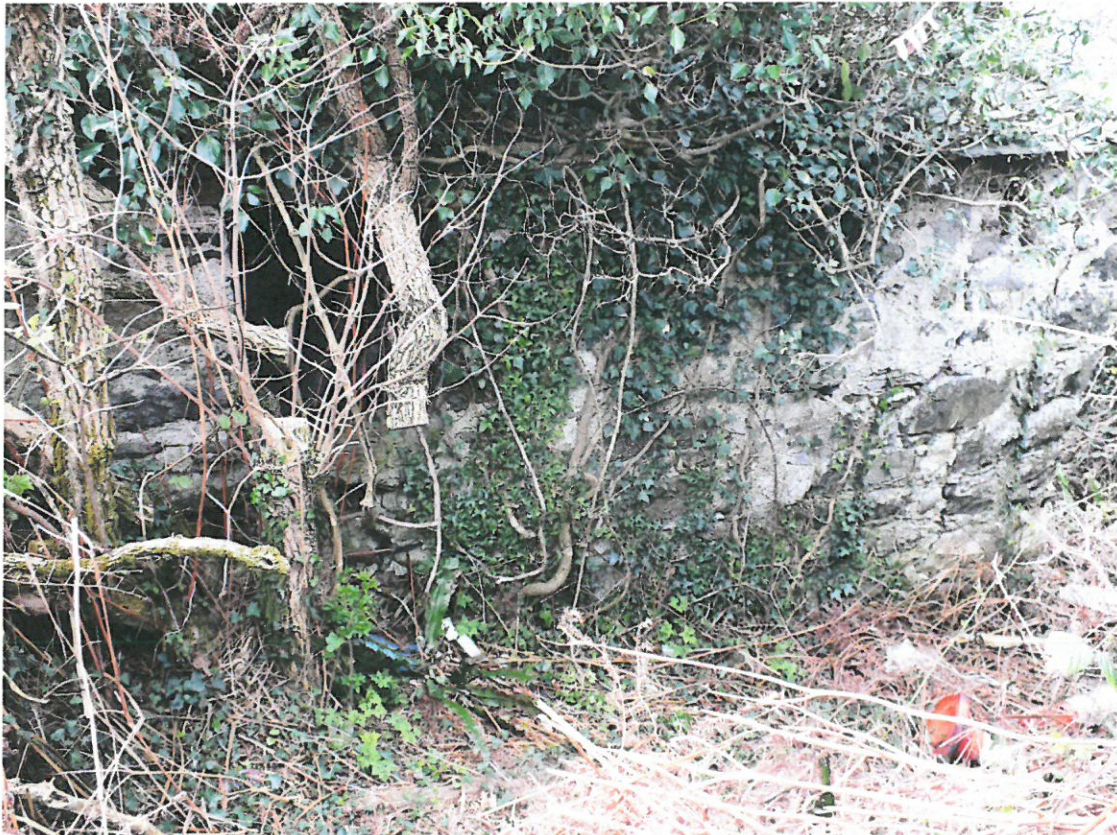
22

North-East Elevation – Area A

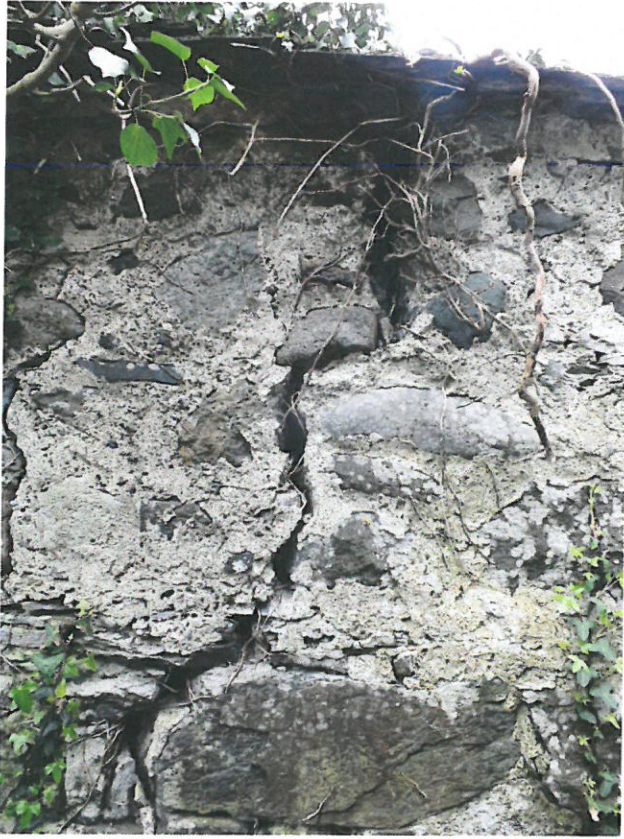
23

North-East Elevation – Area A – Vertical Crack

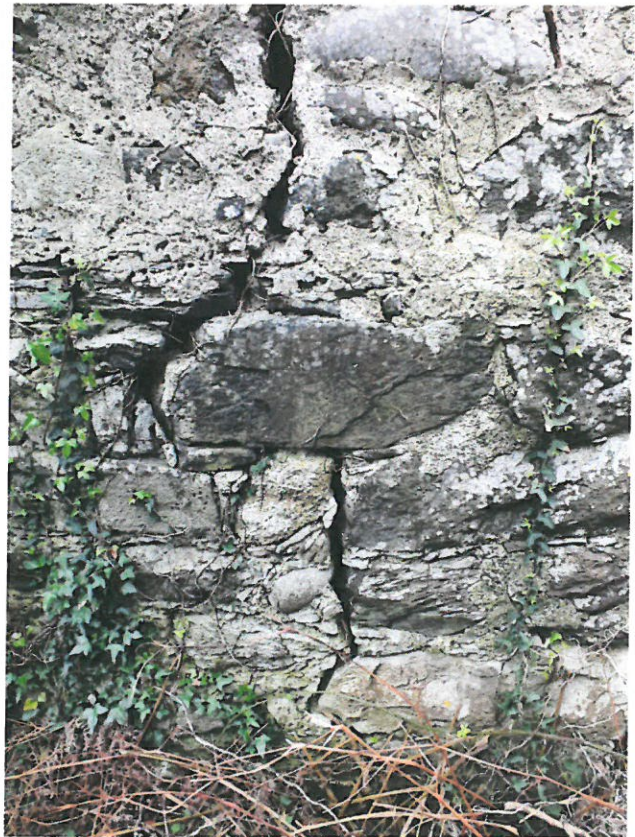
24

North-East Elevation – Area A – Vertical Crack

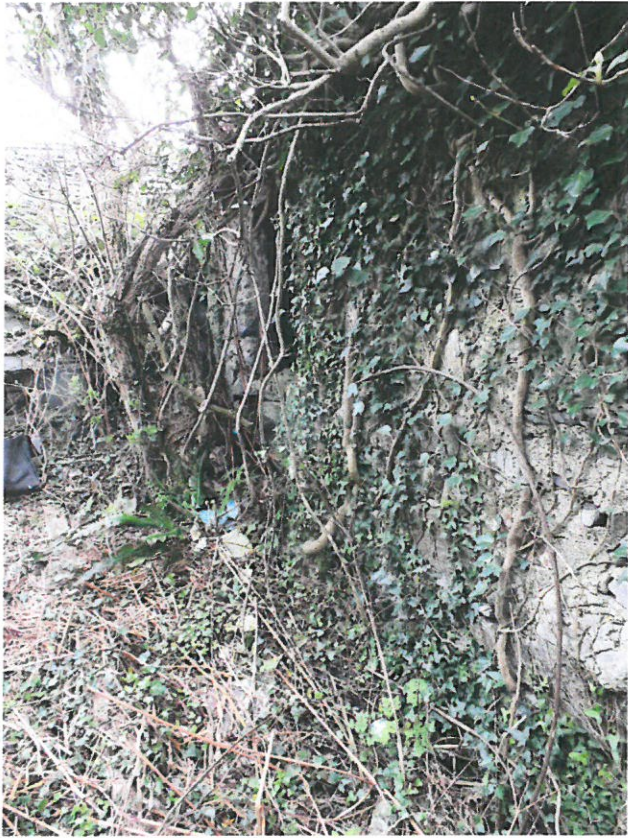
25

North-East elevation – Area A – Wall Lean

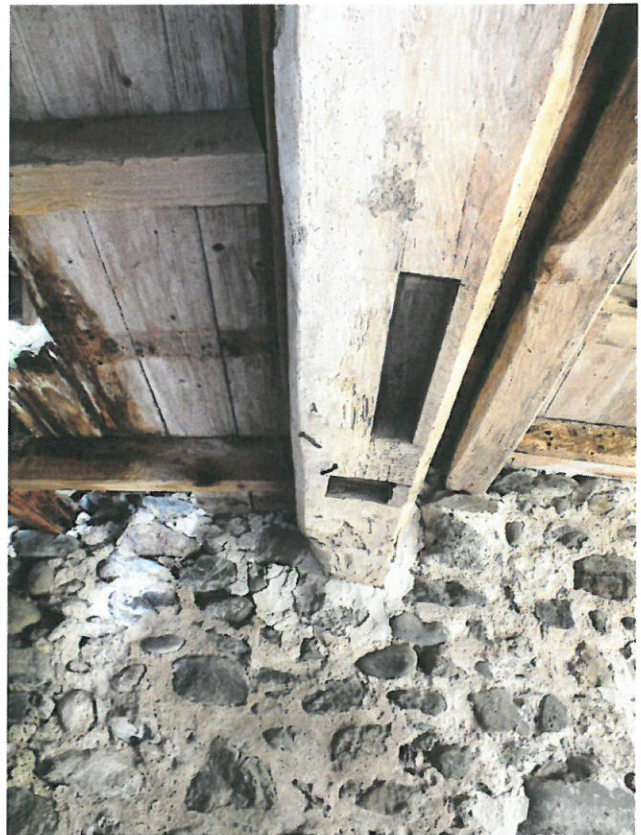
26

Area A – Main Beam

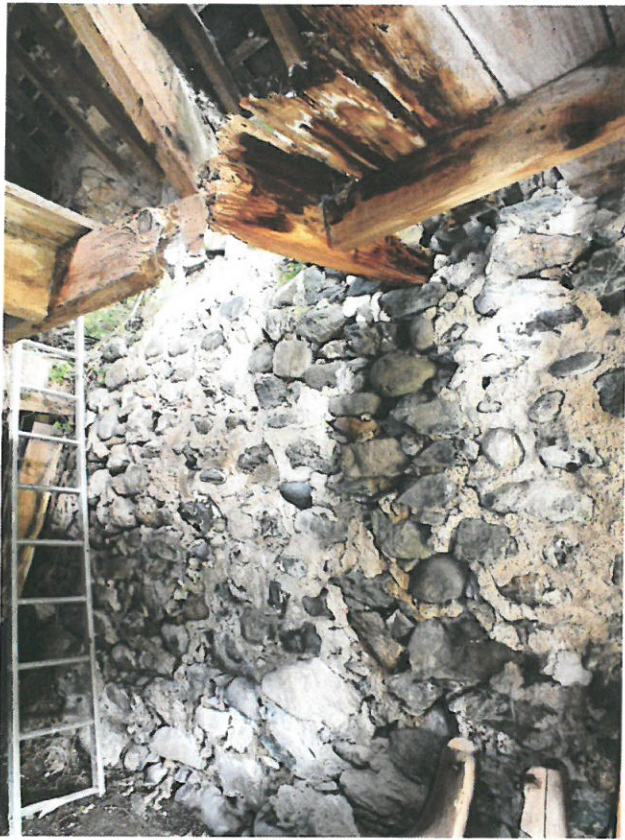
27
Area A – North-East Wall

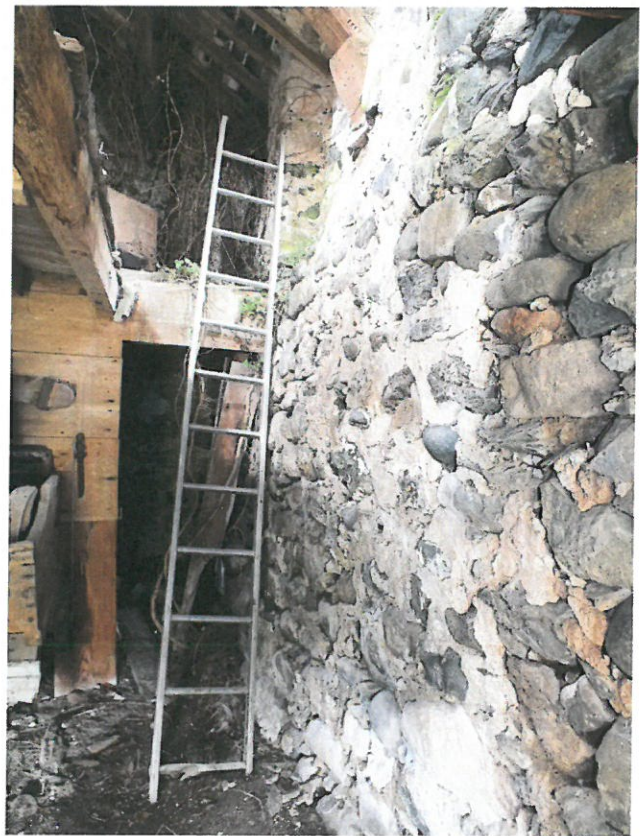
28
Area A – North-East wall
